# **A Review of Environmental Incidents at Anaerobic Digestion (AD) Plants and Associated Sites between 2010 and 2018**

September 2019

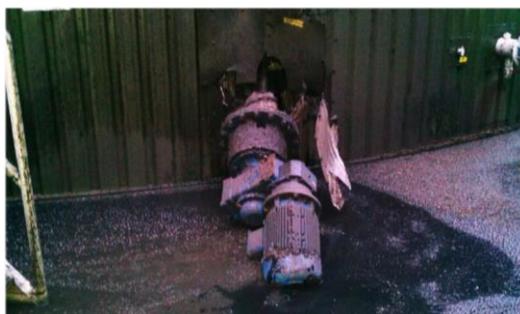
Complete loss of digester tank contents to ground. The site had been built without full planning permission or a permit and the site was discovered after the pollution incident.

The digester mechanical stirrer fixings failed causing a hole in the concrete digestate tank. Secondary containment not in place.

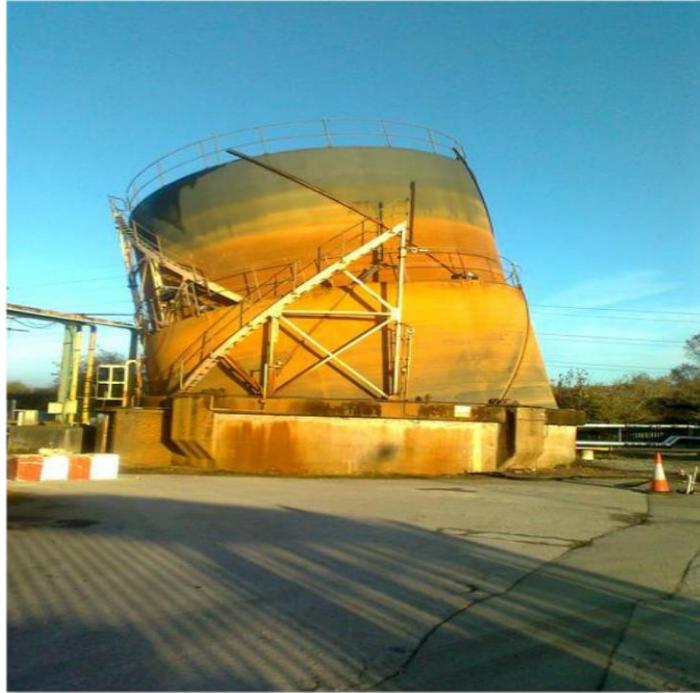
An estimated 50,000M3 of biogas was lost to the atmosphere over 19 days as a result of the catastrophic failure (collapse) of the gas holder and the subsequent release of biogas via the pressure/vacuum release valves as a safety measure, between the above dates. The standby flare failed to operate and a temporary flare was not installed.

Three sets of guide wheels on the holder had disengaged, its limit switches had failed and sections of the guide rails were corroded. This led to the holder tilting dangerously and gas being released. The Fire Service had to be called because there was a risk of an explosion.

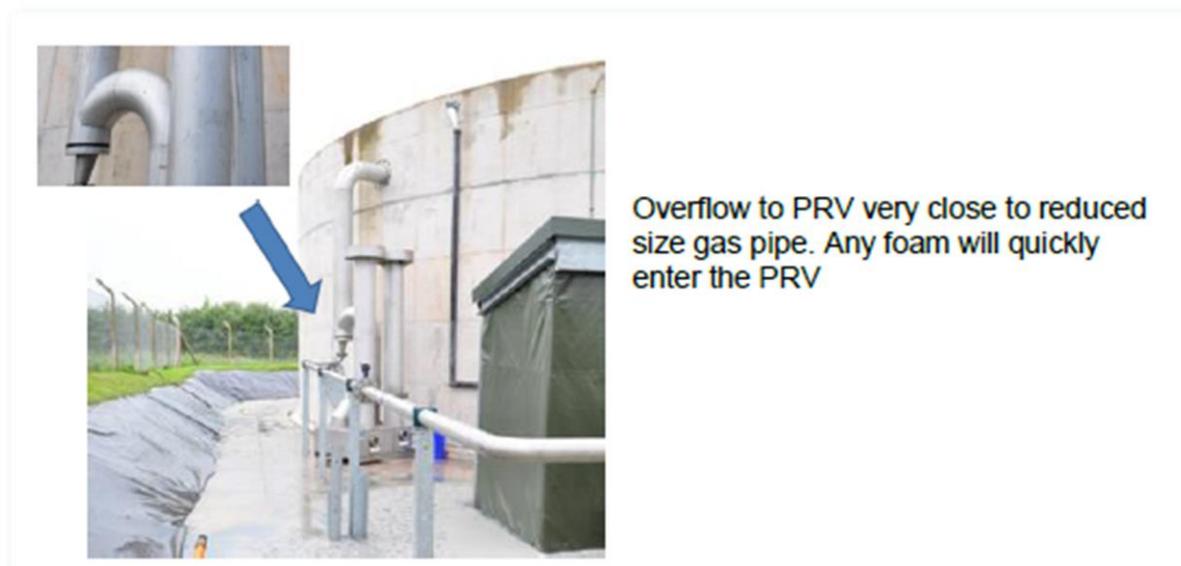
The pressure release system was found to be blocked by foam. Foam is a common occurrence and can be formed by a number of different factors including overloading, presence of detergents and high nitrogen content feedstocks.

The digester was fitted with a water spray to knock down any foam but this was found to have been turned off. There was no foam sensor system and the design of the gas pipework did not protect the pressure release valve from foam carryover. Human error and a management system failure was the root cause of the incident. Very little thought was given to the effects of foaming on the PRV and there was no critical alarm on the gas flow to the CHP.

The pipework was changed to protect the pressure release valve. Foam sensors were added to the catch pot.

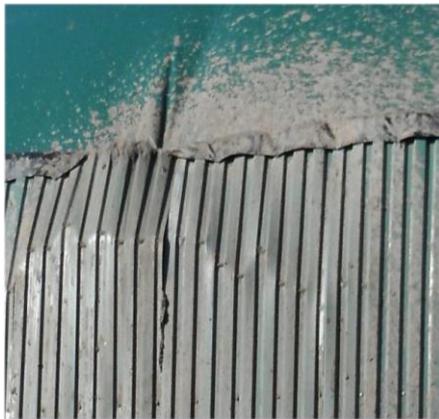
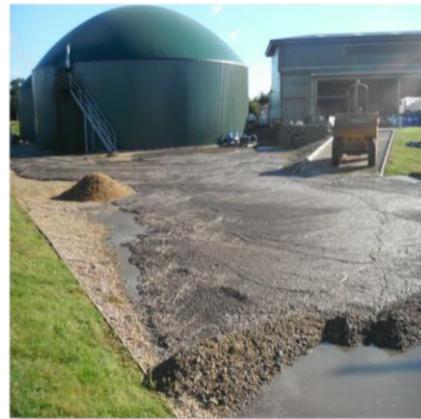
The membrane roof and steel sides of the digester were damaged due to foaming. The clean-up operation was extensive. Biogas was lost to atmosphere whilst the digestate was contained within the bund. The bunded area was graveled which made clean up difficult.

The pressure release system was found to be blocked by foam. In this case the excessive foam was caused by overfeeding the reactor i.e. operator error. The design of the digester did not cope with the amount of foam. Fully trained and competent employees were not operating the plant at the time of the incident which meant VFA levels were not being monitored and led to over-feeding.

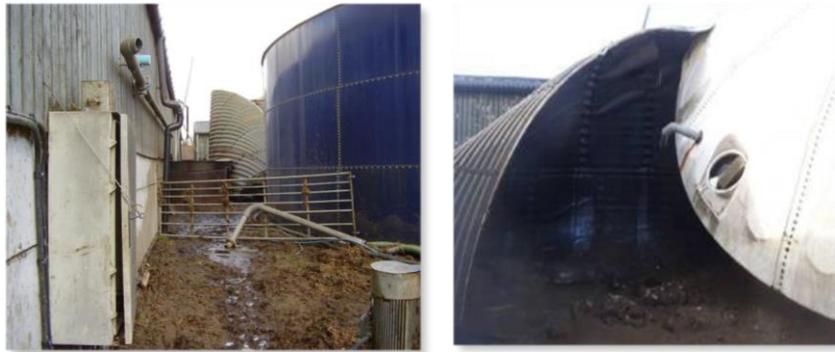
A 330 cubic meter glass fused steel digester tank violently burst open under pressure (luckily whilst the site was unattended). Biogas was lost to atmosphere and digestate lost to ground.

The inclusion of partially chopped/ macerated straw in a slurry feedstock with a low total solids percentage, especially in wet weather, led to a floating layer of material on the liquid in the tank. This may have disabled the correct operation of the float switch because it had to be inverted by its own buoyancy to operate. This meant the tank may have been overfilled by the feed pump. The floating layer would have obstructed the tank roof pressure relief valves, allowing hydraulic pressure to build within the tank. The topography provided secondary containment however this may not have coped if the digester storage tank had gone as well.

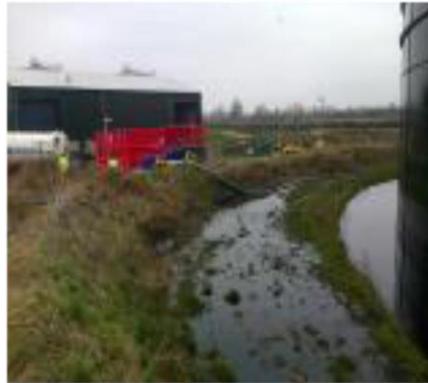
At least 750,000 gallons of digested slurry escaped from an above-ground digestate holding tank and retaining bund.

It appeared that the loss of containment had been due to a separation of the inner surface of the tank wall from the tank base and a loss of integrity of the mastic sealant between the two. Once the seal between the tank wall and the base lost its integrity there was a direct path for the digestate to leak to the outside. Once the inner contents had escaped the secondary containment feature i.e. the earth bund, failed to hold.

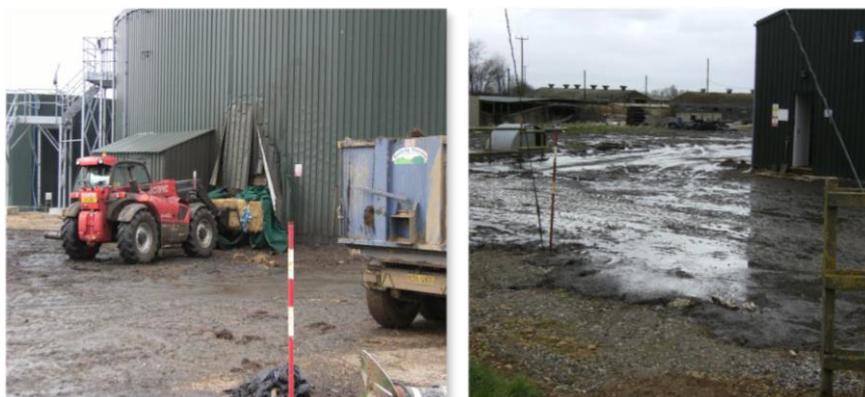
A large quantity of digestate escaped from a 3000m<sup>3</sup> digestion tank, with an estimated 200 to 400m<sup>3</sup> entering nearby ditches.

The seal around the agitator arm at the bottom of the tank failed, bolts were loose and the agitator was moving and making noise for several days. The partial secondary containment system was not a purpose built system. The majority of drainage from around the AD area flowed to the intensive pig farm, which had a drainage system leading to a series of storage lagoons. If livestock had been in their housing at the time of the incident they would have been fatally impacted.

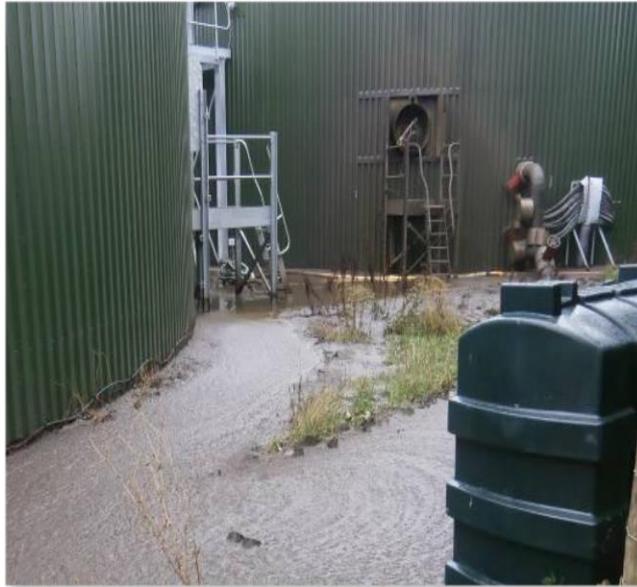
Approximately 700 m<sup>3</sup> of its contents escaped from a digester. An unknown quantity of the digestate entered a beck, causing pollution of about 3.6 kilometers downstream. A faulty agitator had torn a hole in the side of the tank. There was no secondary containment for the digester.

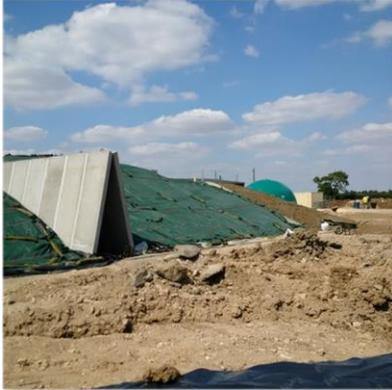
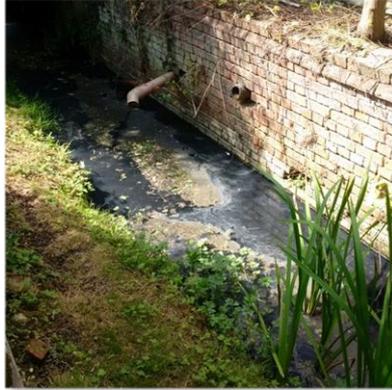
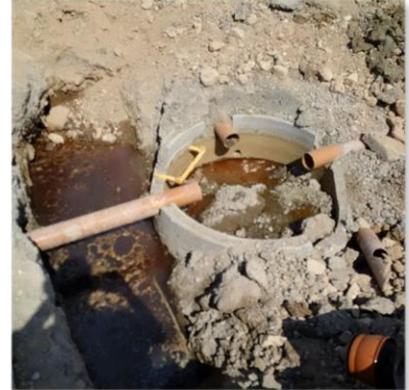
Silage liquor escaped a silage clamp and drained into a nearby watercourse. The AD plant was not operational at the time however the silage clamps were storing feedstock.

Water pollution was spotted and reported to the local water company who investigated and found slurry in the land drain. Further investigation was done by the farmer who found a small leak on the silage pipe. The farmer was not sure when the leak started however the slurry tank was filled the previous month (July) and seemed to be running at that time. There was no indication of loss of flow. When the leak was discovered the farmer took immediate action by creating a sump to contain the slurry and prevent further pollution. He then emptied the slurry tank to prevent further impact.

Poor infrastructure was the main cause of incident. The effluent leaked through a join in the concrete, into the ground then to a land drain before discharging into the watercourse. About 1km of watercourse was impacted resulting in a category 2 incident.

- The land drain was blocked to stop the flow of effluent.
- The joint in the clamp was cut, cleaned and resealed.
- Additional pipes were installed around the clamp as a precaution to direct effluent to an underground storage tank.
- A vacuum tanker was purchased by the operator in case of future emergency.

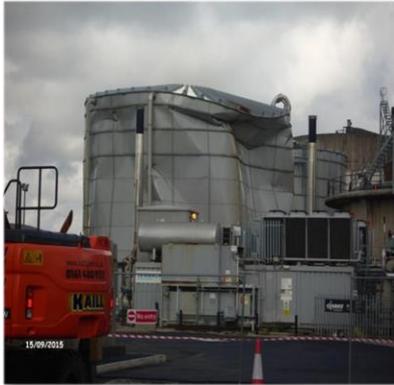
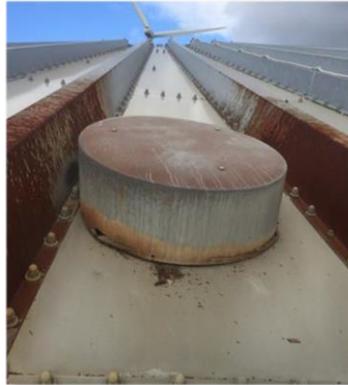
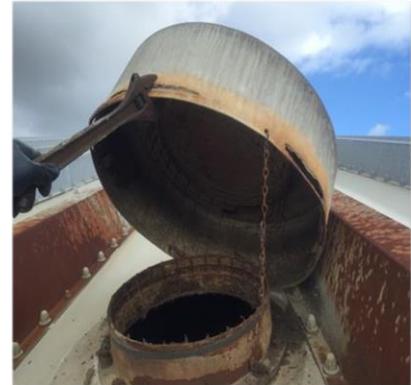
A vacuum within a storage tank occurred leading to the tank buckling inwards. Fortunately there was no loss of containment.

The top hat PRV had rusted due to the acidic atmosphere and dropped down, creating a seal. When the odour control unit began operating a vacuum was formed in the screened sludge storage tank resulting in the tank walls, which were made of steel, being drawn in under vacuum and buckling.

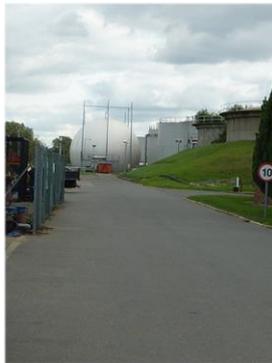
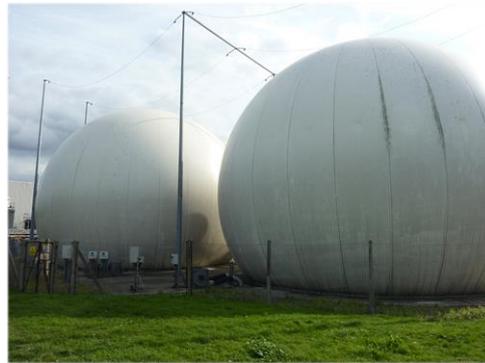
A release of approximately 24,750m<sup>3</sup> biogas from pressure relief valves on 3 digester tanks occurred as a result of a failed (leaking) gas storage dome. Two storage domes were in situ on site but one was already out of service and had not been replaced/repared. The Environment Agency 'red-carded' the plant (i.e. did not visit because of potential H&S implications).

- Failing to identify and provide adequate contingency measures for the management of gas and sludge under abnormal operating conditions. Inadequate HAZOP assessment.
- Lack of maintenance and inspection and review of previous failures.
- Failing to react to indicators that the gas dome was failing. Continued feed to reactors resulting in diversion to PRV for gas management.
- Failing to follow procedures.
- Pipe-work connections meant there was no ability to by-pass the gas-domes and send the gas directly to the flare or CHP's resulting in direct release to atmosphere from PRV's.
- Pipe-work was mostly underground making inspection for further leaks difficult.

- Installation of temporary pipe-work to by-pass gas storage domes and enable gas flow to CHP & flare.
- Full root cause analysis undertaken.
- Full HAZID assessment.
- Replacement of gas storage domes.
- Review of procedures, in particular inspection & maintenance schedules and Accident Management Plan.
- Review of internal processes.

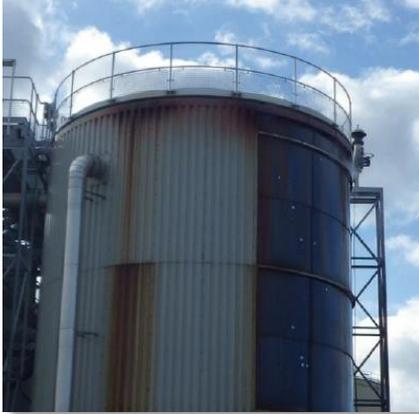
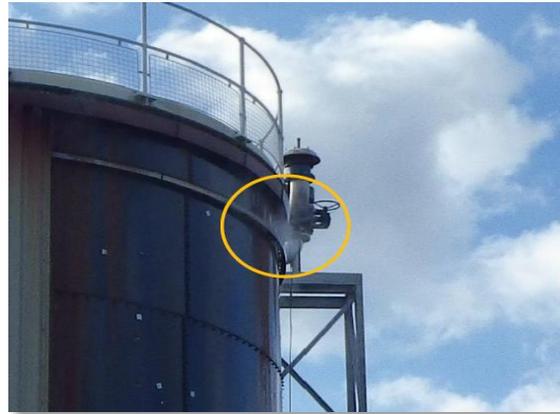
Following reports of odour which could be detected over 3km away, the regulator inspected a permitted sewage sludge treatment centre and traced the source of the odour to a reactor tank which was visibly venting biogas from the top of the tank.

Sewage sludge inside the reactor tank is heated up to 55 degrees centigrade to kill off pathogens as part of the treatment process. The operator had already removed some of the insulation cladding, and based on the rust staining on the tank and on the remaining cladding, it appeared the tank had suffered from leaks at the point the lid of the tank meets the side walls.

Sewage sludge can be highly corrosive on steel tanks particularly at the point where the tank falls short of being full where liquid interfaces with the air/gas space inside the tank.

The tank had sustained some visible damage back in 2011 when it was over pressurised. Monitoring of the tank's condition since then was done by visual inspection alone and no informative structural survey was carried out to determine the future operational life of the tank. Cladded tanks can hinder the effective inspection of the tank walls themselves in spotting the early signs of corrosion occurring. Therefore, when installing cladded tanks consideration needs to be given to providing access to inspect the tank walls especially at the level of where a tank is normally filled to.

- A drop off in biogas supply to Combined Heat & Power (CHP) plants or gas engines could be a strong indicator of biogas escaping from the system requiring immediate investigation and attention
- Retain critical and specialist parts in stock
- The tank was subsequently replaced with a new tank

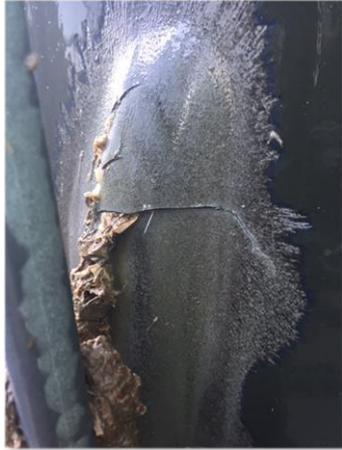
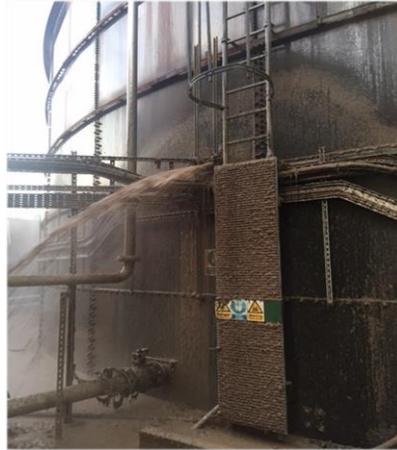
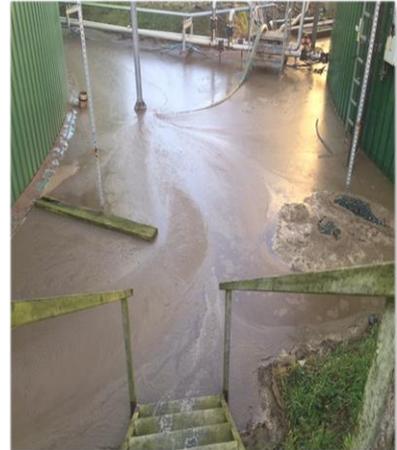
177 tonnes of raw processed food waste was lost into the contained area of an AD facility. No pollution to the environment occurred from the spilled digestate because of full containment being installed.

A submersible mixer within the tank had moved and damaged the tank due to incorrect installation. The mixing tank had recently been brought back into service following a tank refurbishment. There had been insufficient oversight of the process to re-commission the tank.

- Immediate emergency steps were taken to lower the tank contents to stop the leak. This involved utilising an adjacent tank which was empty and open awaiting refurbishment.
- The operator was able to access additional storage (alligator bags, tankers, empty clamp, hired in skips) to hold liquids. The ABP status meant these required disposal/further treatment.
- Consequences of flooding were reviewed and dome fans raised off the ground.
- Document review to address control of change and commissioning procedures.

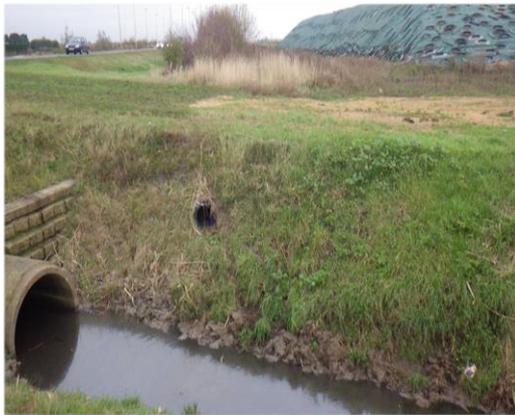
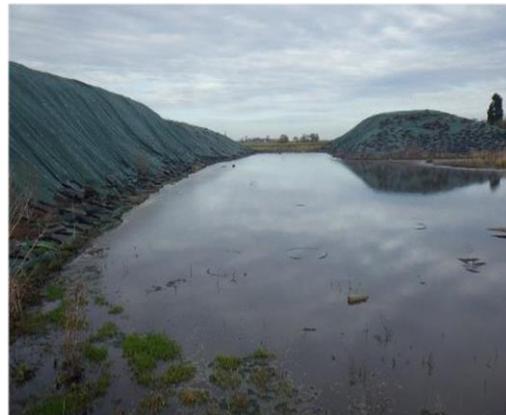
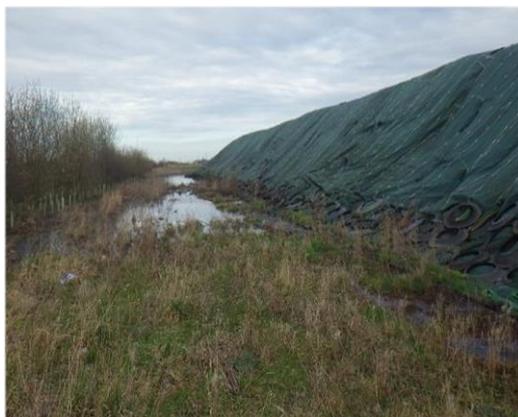
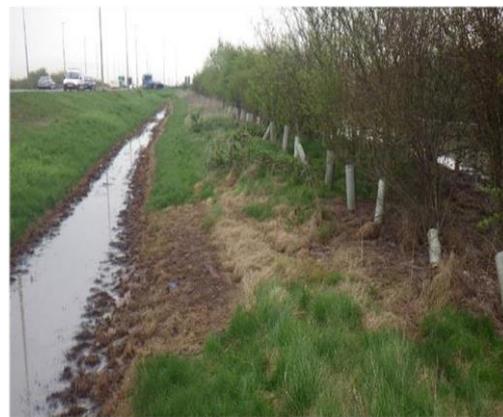
Environment Agency officers responded to reports of water pollution on 2 separate occasions. Large maize storage heaps produced significant quantities of silage effluent during winter which pooled in the field and entered a land drain, discharging directly into a nearby watercourse. On a second occasion silage effluent flowed over a bank into a roadside swale which connected to the same watercourse. Land drainage routes had been highlighted as a possible issue to the operator (land tenant) prior to storage.

The maize silage was stored for an excessive period of time due to the anticipated AD plant identified to receive the silage not being built. This led to a build-up of effluent and there was inadequate containment to manage it. The operator wasn't aware of any land drains, but they hadn't done proper checks for them at the storage location.

The field heaps were eventually moved by the farmer and advice was provided to him with regards to storage and land-drain assessment. For incident 1, the watercourse was bunded off and tankered out and the land drain was blocked off. For incident 2, the swales and pools of effluent by the heap were tankered out.

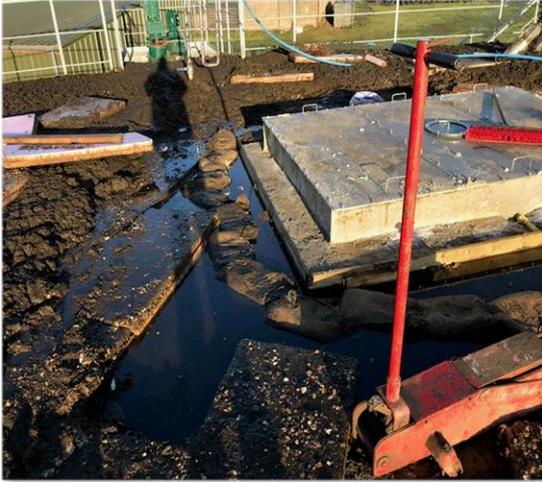
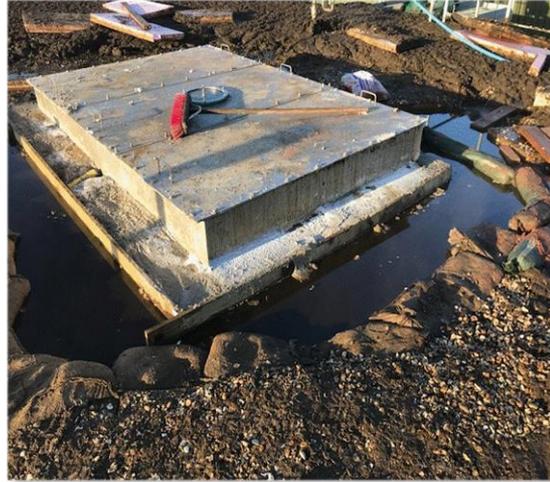
Following complete loss of power, a digester suffered an over-pressure event leading to the release of biogas and over-topping of digestate through the top hatch and relief valves. This was the second over-pressure event at the plant.

There was no uninterruptable power supply (UPS) for the router to enable remote access which meant off-site operators were unable to adequately assess the situation. Power to critical safety features such as the flare, dome inflation and process monitoring was not maintained because of failure of the back-up power generation system.

- The Power Failure procedure was re-written and made live on the system.
- The router for the site was connected to the UPS.
- 24 hour manning was put in place.
- The electrical import value was increased to 500 KW on a permanent basis meaning the generator and mains transformer would not need to work in parallel.
- Tank inspection undertaken.
- Digestate spill (contained on-site) was cleaned up.

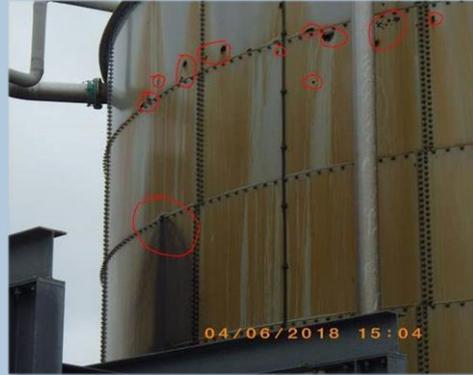
Case study 1 - Large holes due to corrosion midway down a sludge tank resulting in a pollution incident and loss of storage capacity.

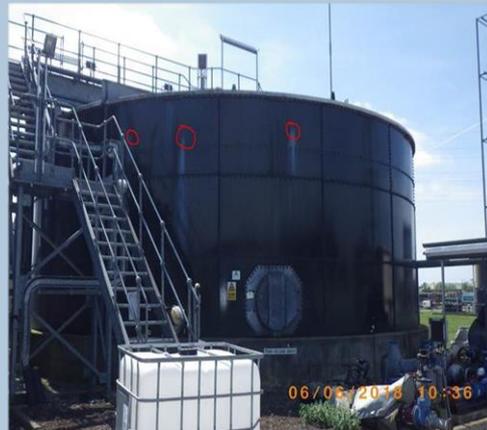
Case study 2 - Holes appearing in pre-treatment and pre-thickened buffer tanks due to Hydrogen Sulphide corrosion. Ineffective maintenance programme that ensured tanks were repaired or replaced before visible holes occurred.

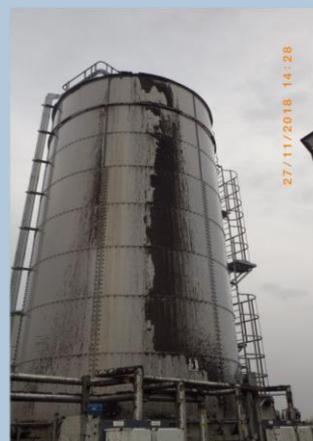
Case study 3 - Failure in the automated process where a pump filling a cake reception silo did not cut out and continued to fill the silo resulting in loss of containment and odour pollution.

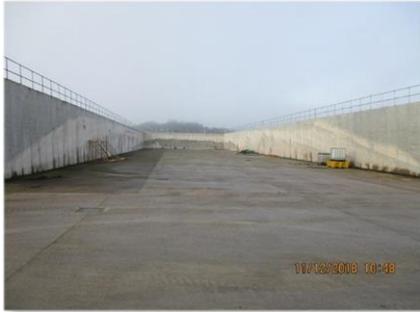
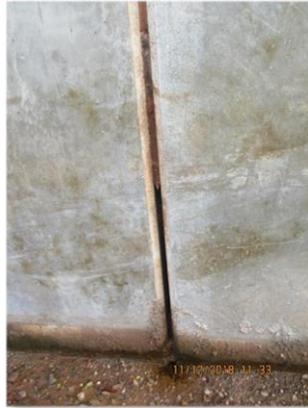
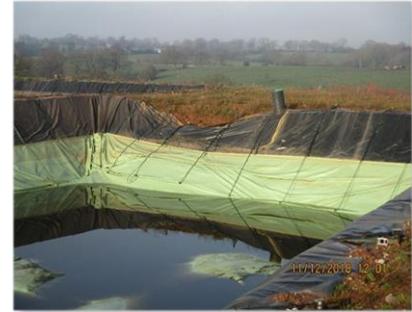
Significant loss of silage effluent to ground from numerous points on site including the silage clamps, site drains and lagoon. Scale of the loss was estimated to be approximately 500m<sup>3</sup>. Ammonia levels averaged ~50mg/l and BOD ~700mg/l.

Poor construction methods and CQA process. Poor management and inspection of plant and equipment.

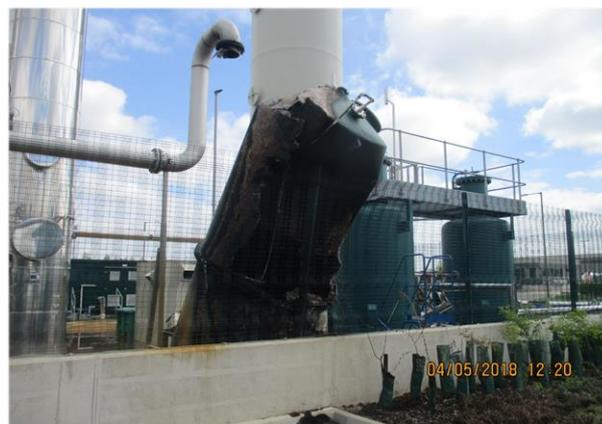
The AD plant has a biogas upgrading system for biomethane injection to the gas grid. The biomethane is separated from the rest of the gases in the biogas mixture by a water absorption system. The waste gases of mainly carbon dioxide, and low levels of hydrogen sulphide and VOC's are treated before emission to air.

Investigation into the cause of the fire concluded that the most likely cause was the formation of pyrophoric iron sulphide within the CIF. This can form if there is not enough oxygen to react with the iron sulphide.

The system had a constant air flow into the unit and it was not possible to block or bypass this as it would automatically shut the gas upgrading system. Also the media had to be water washed daily to remove sulphur build up and expose the media surface. This was completed automatically on a wash cycle. The system was operated in accordance with the manufacturers recommendations and the fire was thought to be an exceptional event.

Improvements to the system were identified after the incident. The CIF was replaced with two large ferrosorp units as these presented a reduced fire risk. Temperature monitoring and a firewater system was installed and additional in-line H<sub>2</sub>S monitoring put in between each stage.

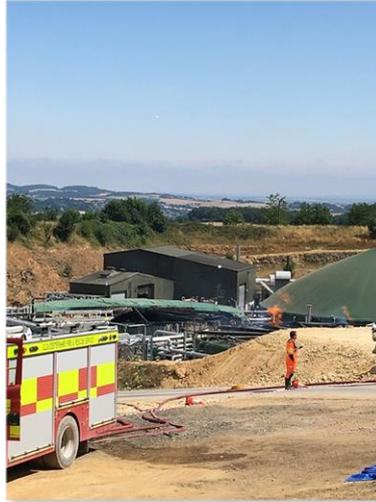
A fire engulfed a control room and spread to nearby mixing and digester tanks and their associated pipework. Biogas holders above the tanks were completely destroyed by the fire and the biogas burned off to atmosphere. Damage was also caused to pipework and the concrete walls of the two affected tanks but they did not collapse and no digestate was lost.

- New concrete bund to provide secondary containment for all digestate tanks built to CIRIA c736 standard. (Gas engines kept outside the bund)
- All 'legacy' plastic pipework and fittings (only small number of these) replaced.
- Affected tanks replaced with new concrete tanks.
- CQA of existing tanks in place providing confidence in construction materials & methods
- Cladding on all tanks replaced with an alternative material with higher level of fire resistance.
- Additional gas alarms were installed on site.
- Revised Fire Response Plan (avoiding use of cold water on hot concrete)
- Improved liaison with the Fire & Rescue Service in AD matters.

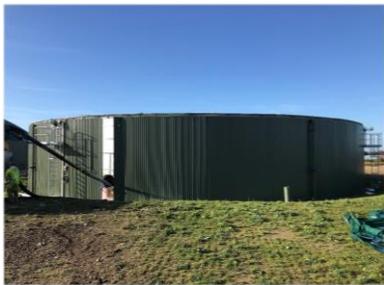
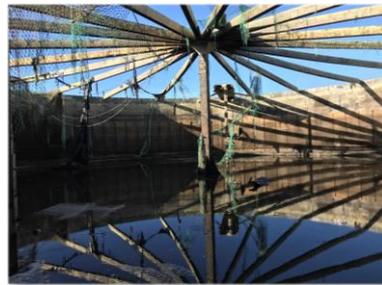
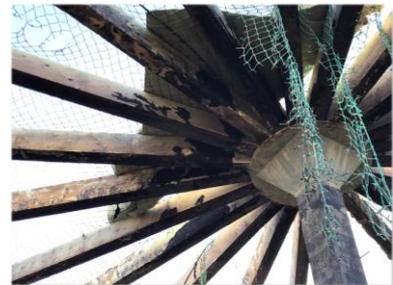
A lightning strike hit a digestate storage tank resulting in a fire which destroyed the inner and outer roof membranes. The strike hit at 01:30am so the site was unmanned at the time. The Fire Service attended and SCADA alarms alerted the operator. The tank had been mostly drained (~1m depth) of its digestate beforehand due to planned maintenance the following day. The gas supply had already been isolated from the rest of the tanks and gas was not being drawn from it. Minimal biogas lost to atmosphere and minimal environmental impact as a result however process downtime and costs associated with replacing the roof.

- Operator logged in remotely immediately after being alerted and attended site within 15 minutes. Fire Service already present.
- Members of the local fire brigade who attended had received on-site AD awareness training by the same farmer/EA and therefore aware of the risks associated with the plant.
- The strike interrupted both solid feeders and various other electrical components but the flare and CHP reactivated so no venting of gas from other tanks. Strike affected internet supply in the upgrading plant and some hardware.
- Network Entry Unit damaged therefore CHP utilised.
- Full visual inspection of tank integrity (concrete) by independent structural engineer. No significant damage to tank walls, base or internal struts. Roof required full replacement.
- Full re-commissioning of tank
- De-brief between EA, operator & Fire Service
