Preston New Road Well Pad Integrity Inspection - 29 October 2018

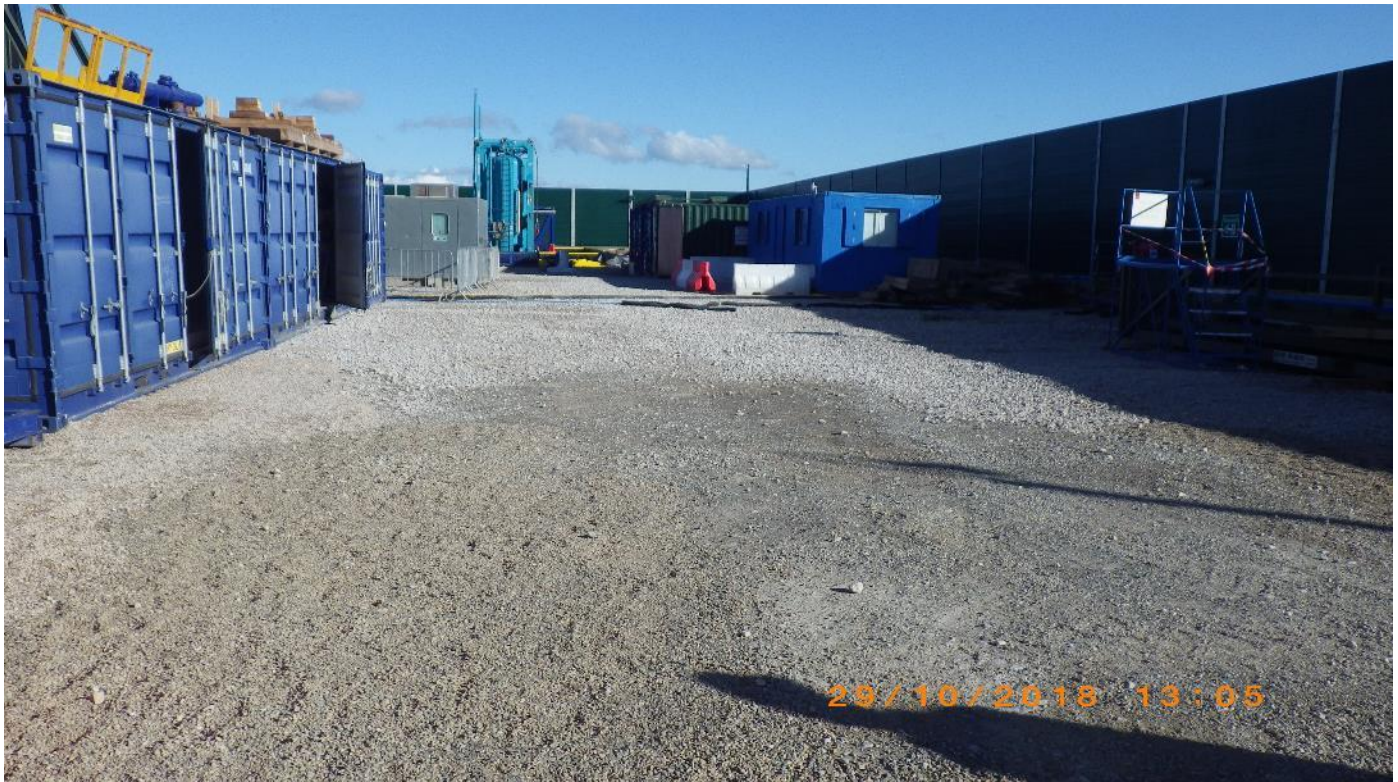
Photograph 1: An area of the well pad showing different grades of gravel which could be mistaken for damp patches when viewed from aerial footage.

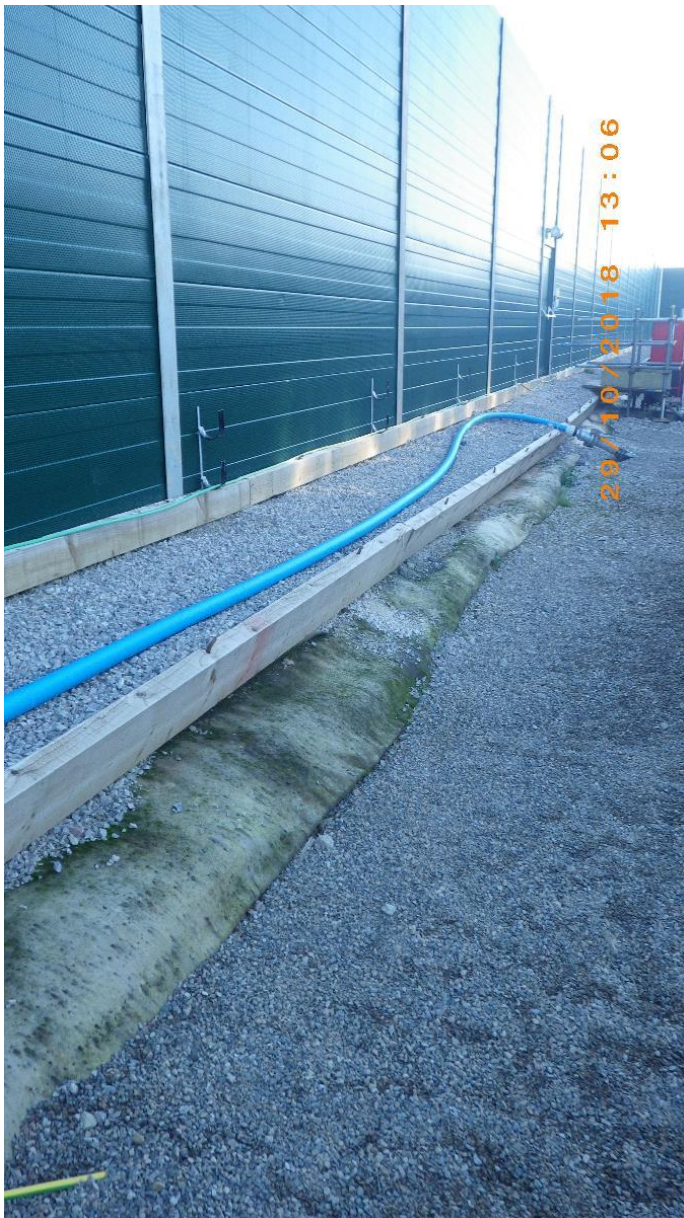
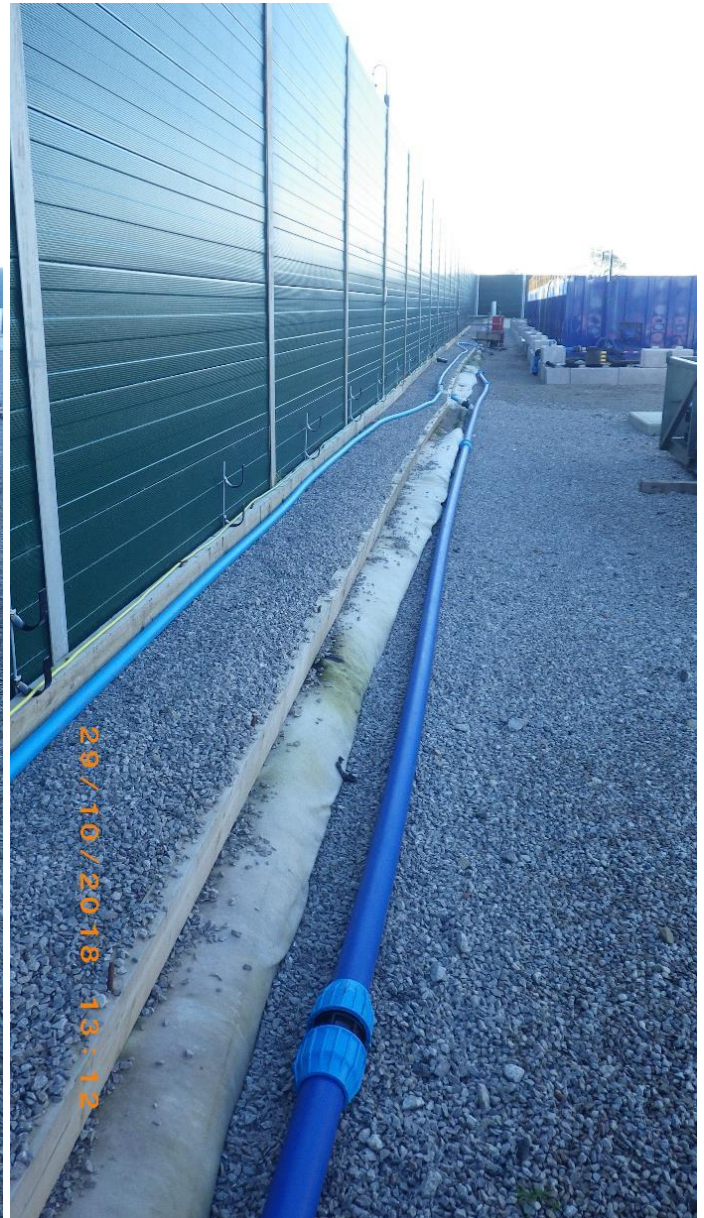
Photographs 2a (left) and 2b (right): Boundary fence with fresh water pipes at the top and flowback pipe at the bottom. Areas of geotextile membrane can be seen which are protecting the lining of the well pad. Discolouration or rucking of the geotextile membrane is not an indication of damage to the well pad liner.

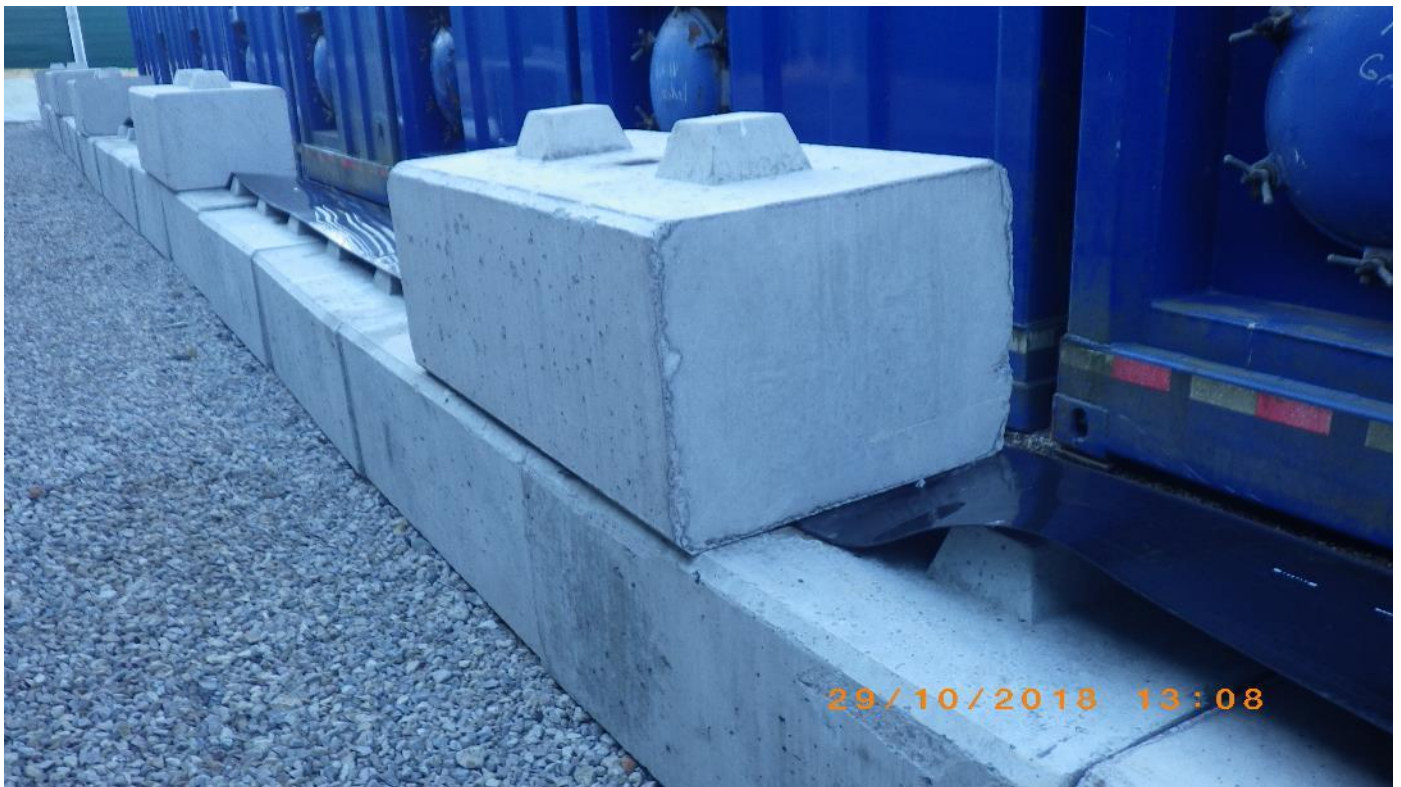
Photograph 3: Showing construction of the temporary bund which is in addition to the well pad liner. This uses a 2mm HDPE liner.

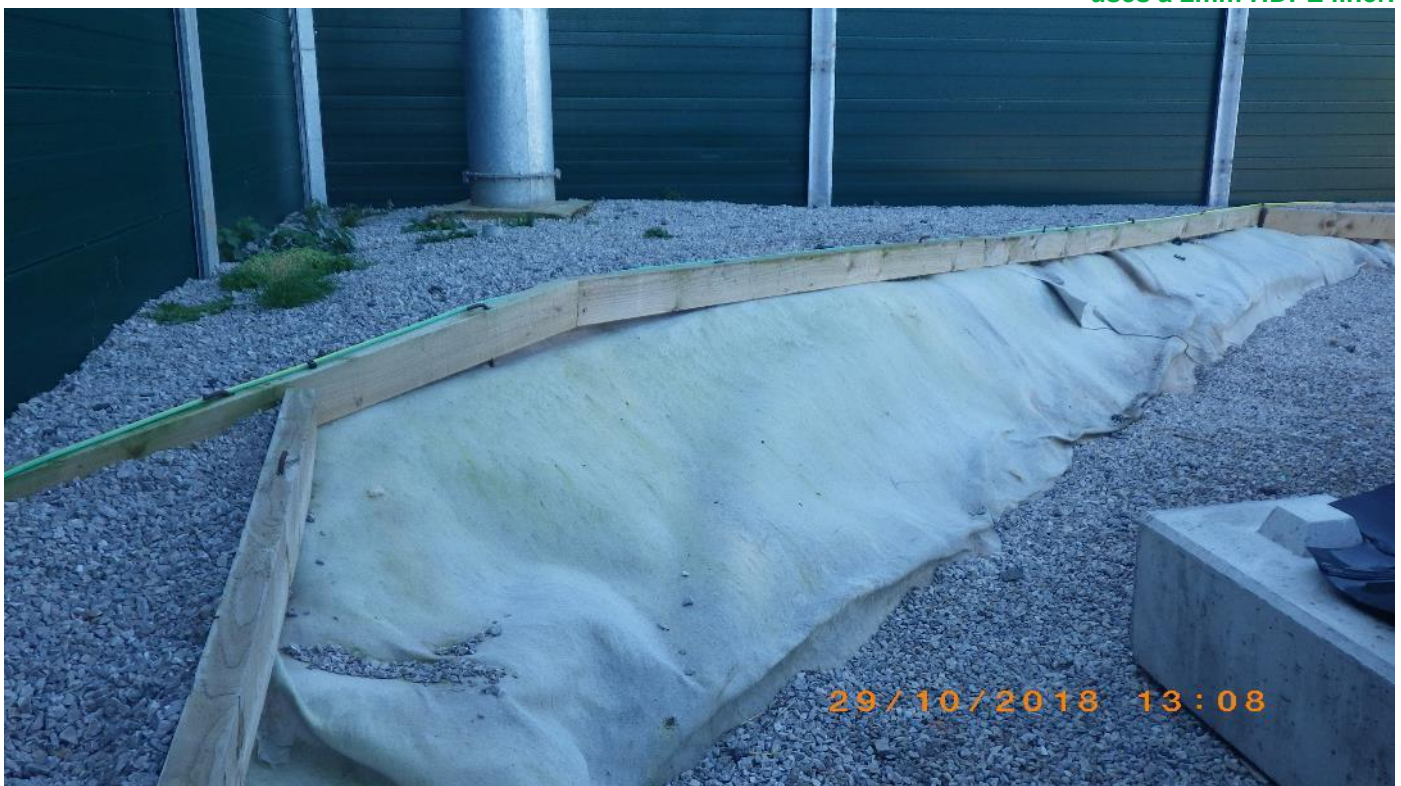
Photograph 4: Showing geotextile membrane in place to protect the well pad liner in the corner of the site.

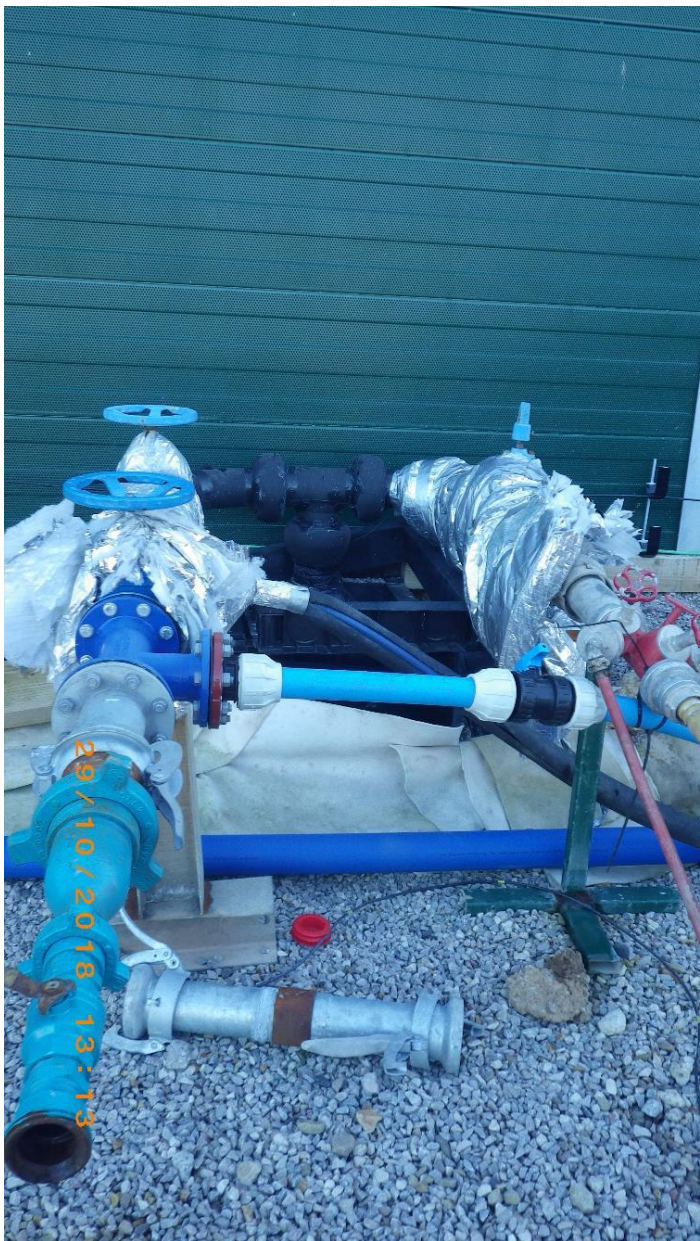
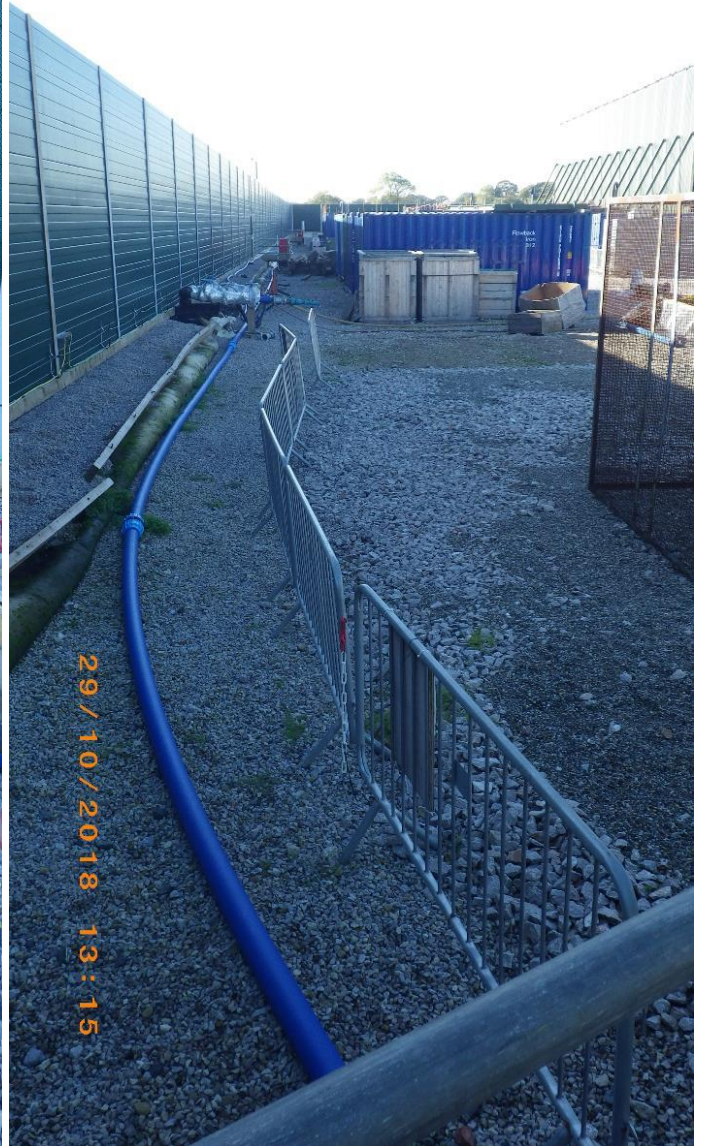
Photographs 5a (left) and 5b (right): Showing the freshwater inlet at the boundary (5a) and flowback pipe running down the boundary. Different grades of gravel can also be seen in the image.

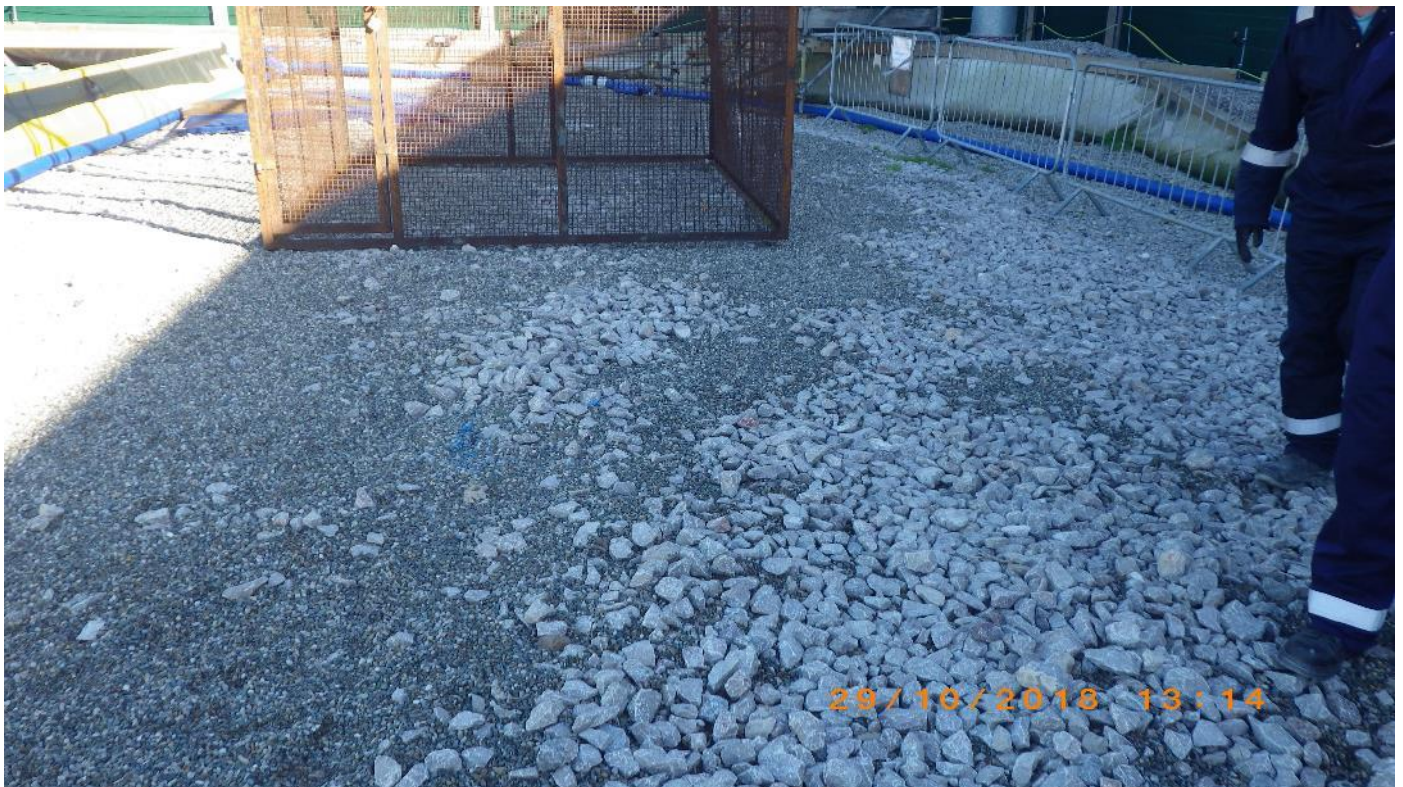
Photograph 6: Different grades of gravel which may appear as damp patches. No standing water, leaks or damp patches observed.

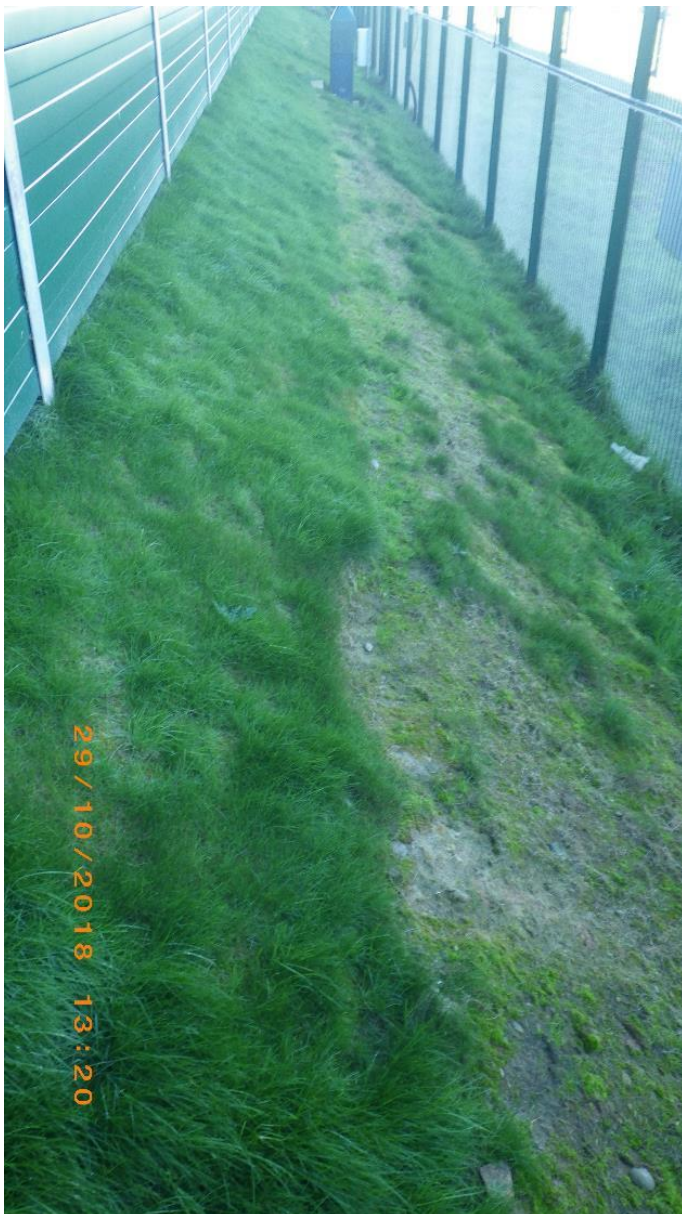
Photograph 7a (left) and 7b (right): Banking outside of the site (7a) showing areas where grass has not taken on the bank. No signs of leaks from the well pad observed. 7b showing the grips installed to improve drainage in areas prone to ponding. No standing water or leaks observed.

Cuadrilla was asked to comment on these photographs and responded with the following information: Picture 7a shows the bank on the northwest side of the pad. The grass has established better in some areas than in others because of the northerly facing orientation (Not much sunshine) and the poor soil quality (heavy clay). When this area was seeded, the hydro seed method was used, which involves spraying the bank with a mulch of seed and fibrous pulp. It rained quite hard after this was applied, washing some of the pulp down the slope, which in turn left some bare patches.

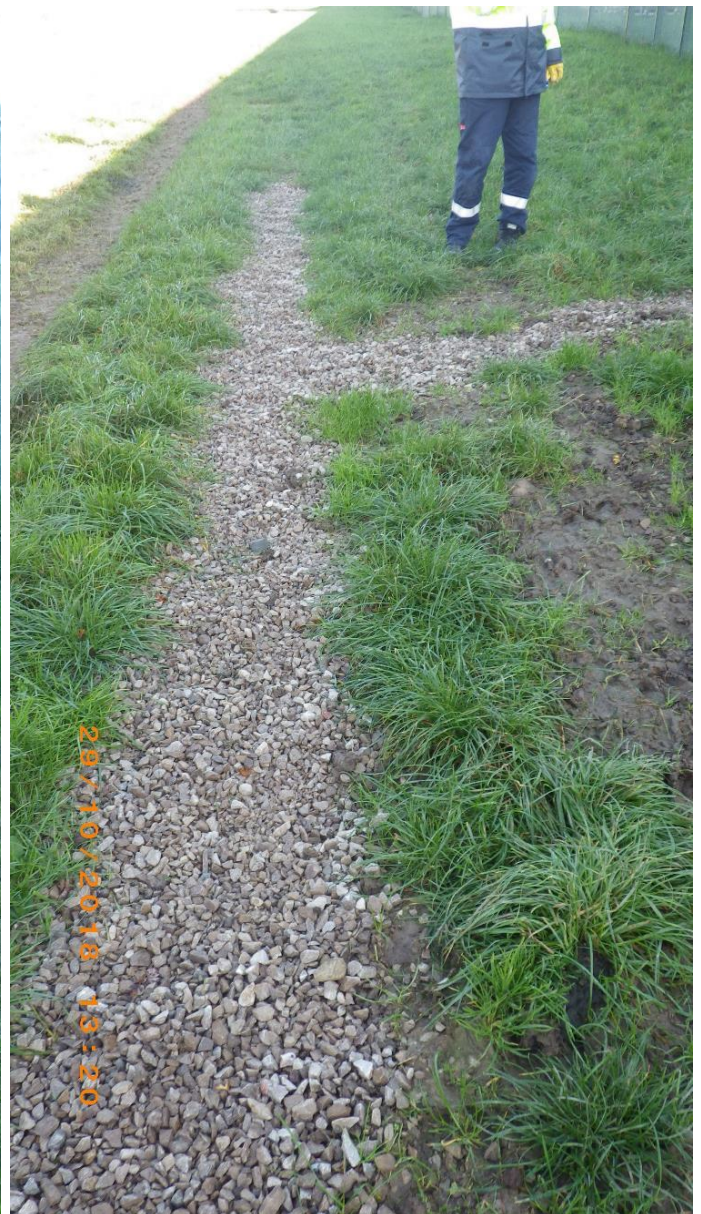
Picture 7b shows some of the area outside of site along the north western side. This is where stone has been placed around the existing header drain to assist in draining run off from adjacent fields. Some connecting grips were also dug to several lower laying areas adjacent to the header drain to enable better drainage in this area as a whole.

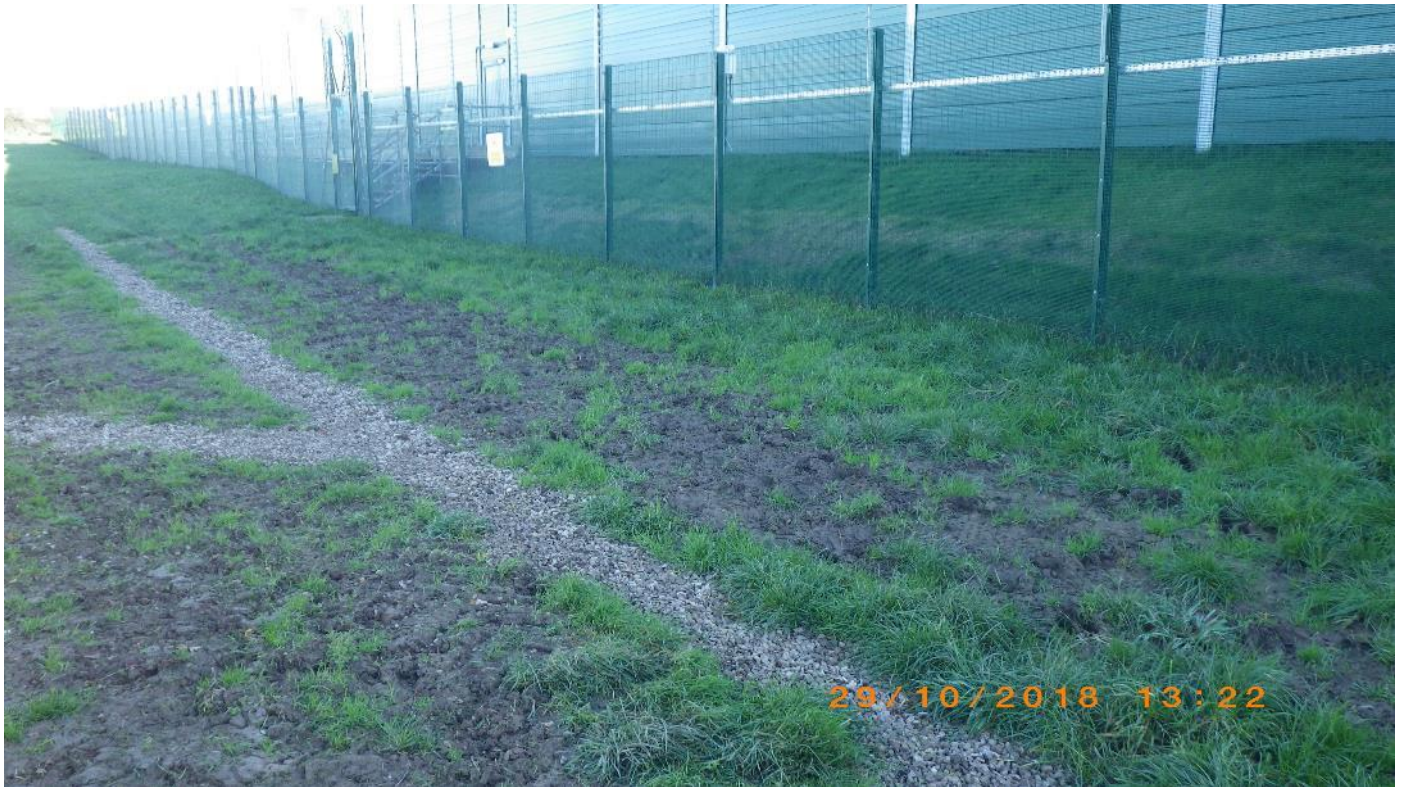
Photograph 8: Grips allowing water from the fields to drain more effectively around the boundary of the site.

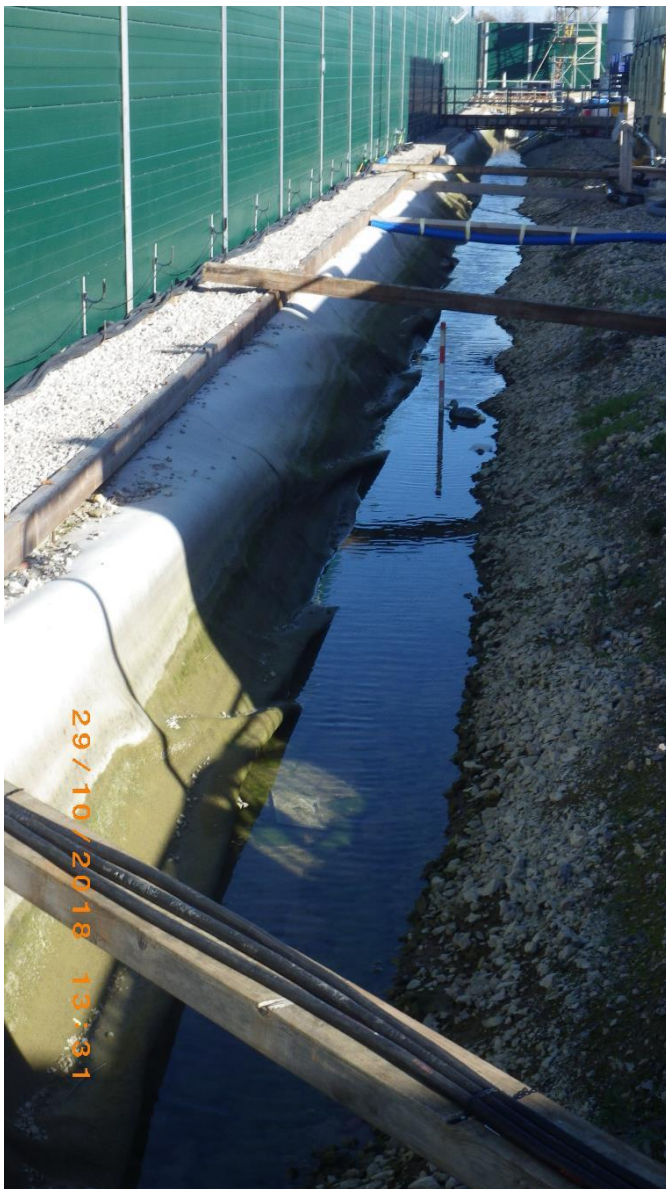
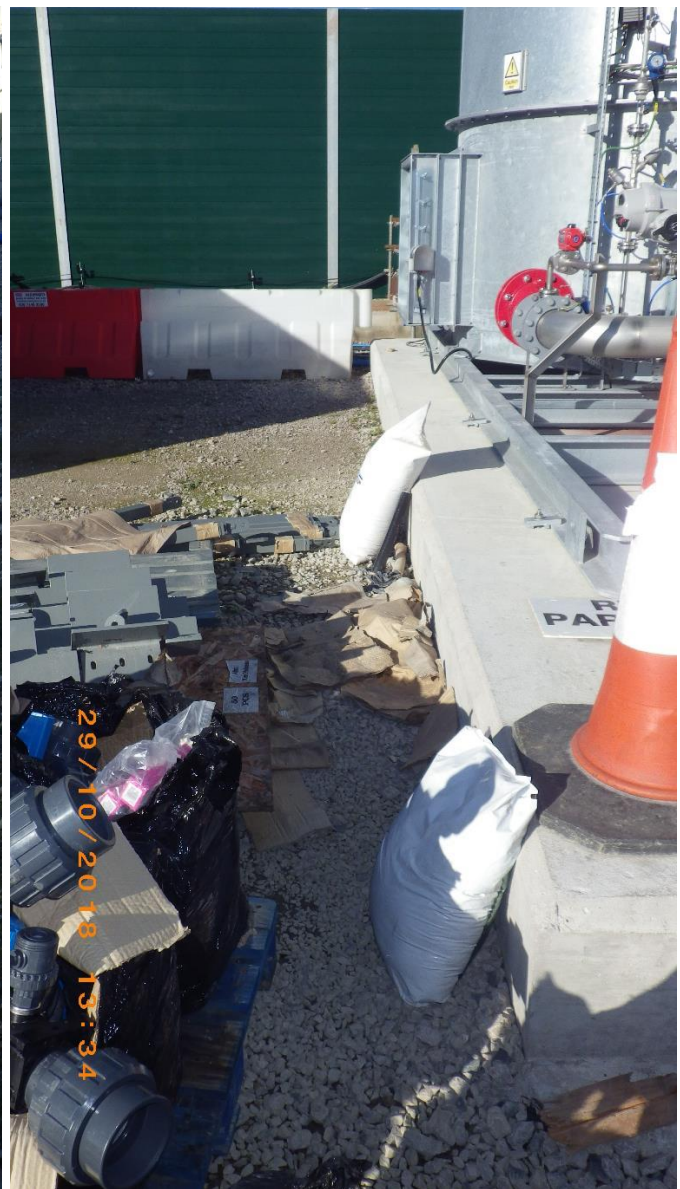
Photograph 9a (left) and 9b (right): The drainage ditch (9a) with areas of the geotextile membrane visible. This is in place to protect the well pad liner. Areas of discolouration and rucking are not an indication of damage to the well pad liner. No issues with the liner were observed. Photograph 9b shows the concrete pad supporting the flares. The pad appeared stable and no leaks were observed. The white bags photographed are not sandbags.

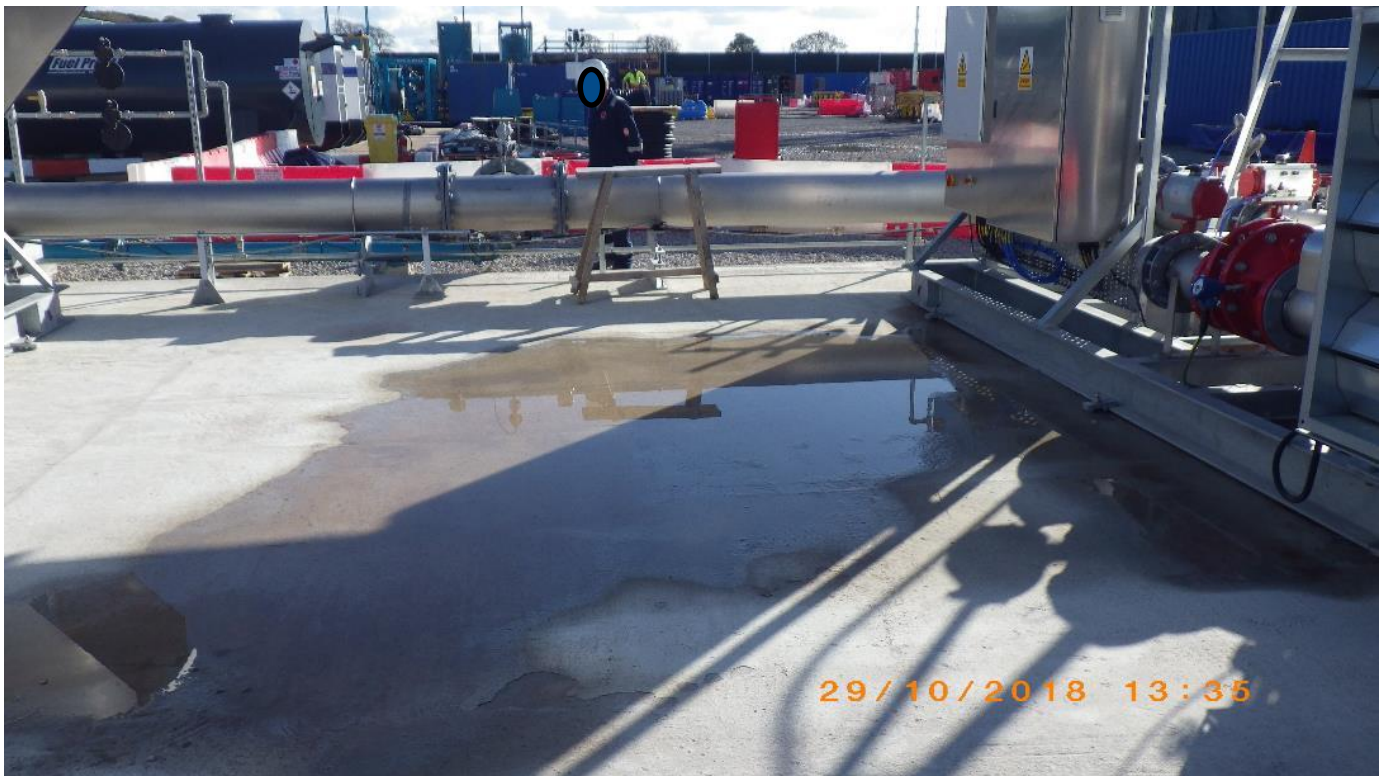
Photograph 10: The flare concrete pad showing some standing water where rainwater has settled in a low spot or from condensation from the flares. No leaks observed.

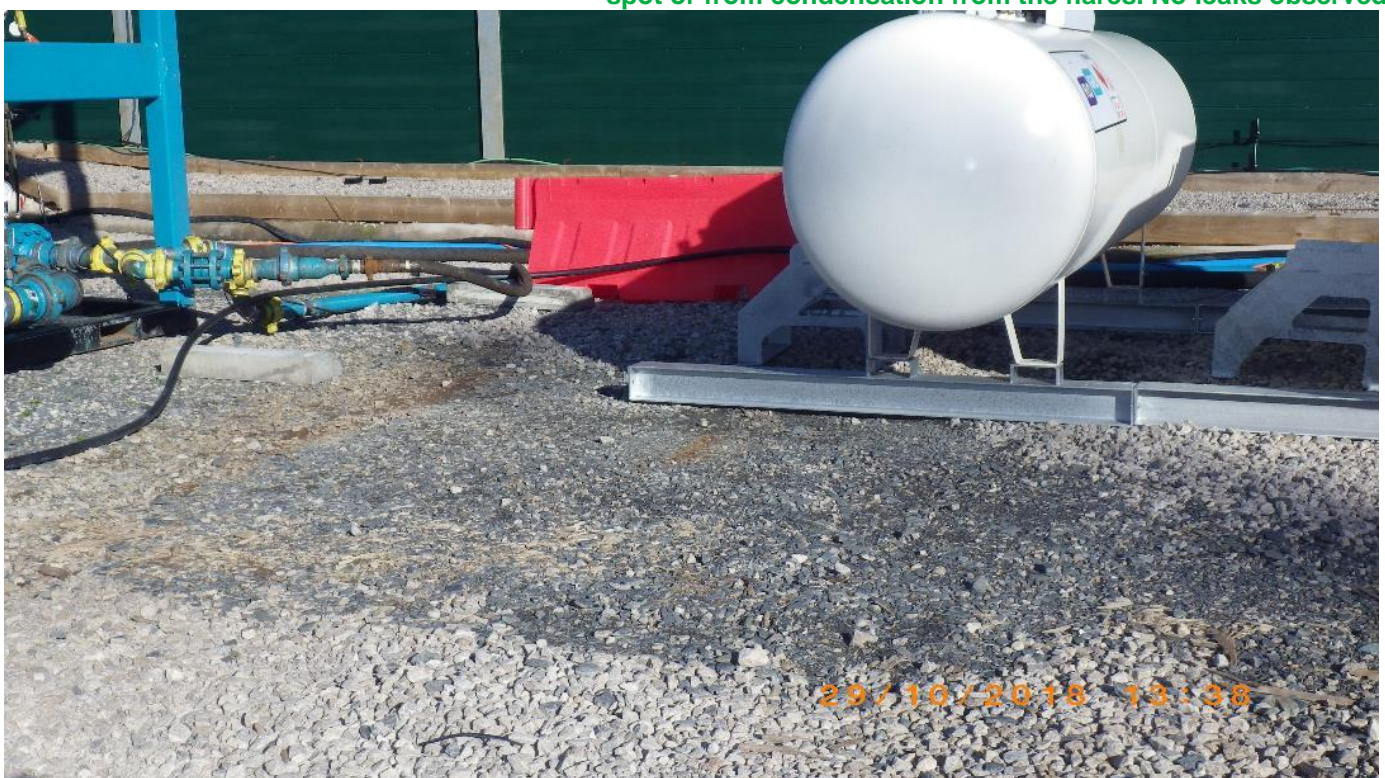
Photograph 11: Areas of different grades of gravel. This area was previously used to house site cabins and therefore the surface may appear uneven and a different grade of gravel has been used since removal of the cabins.

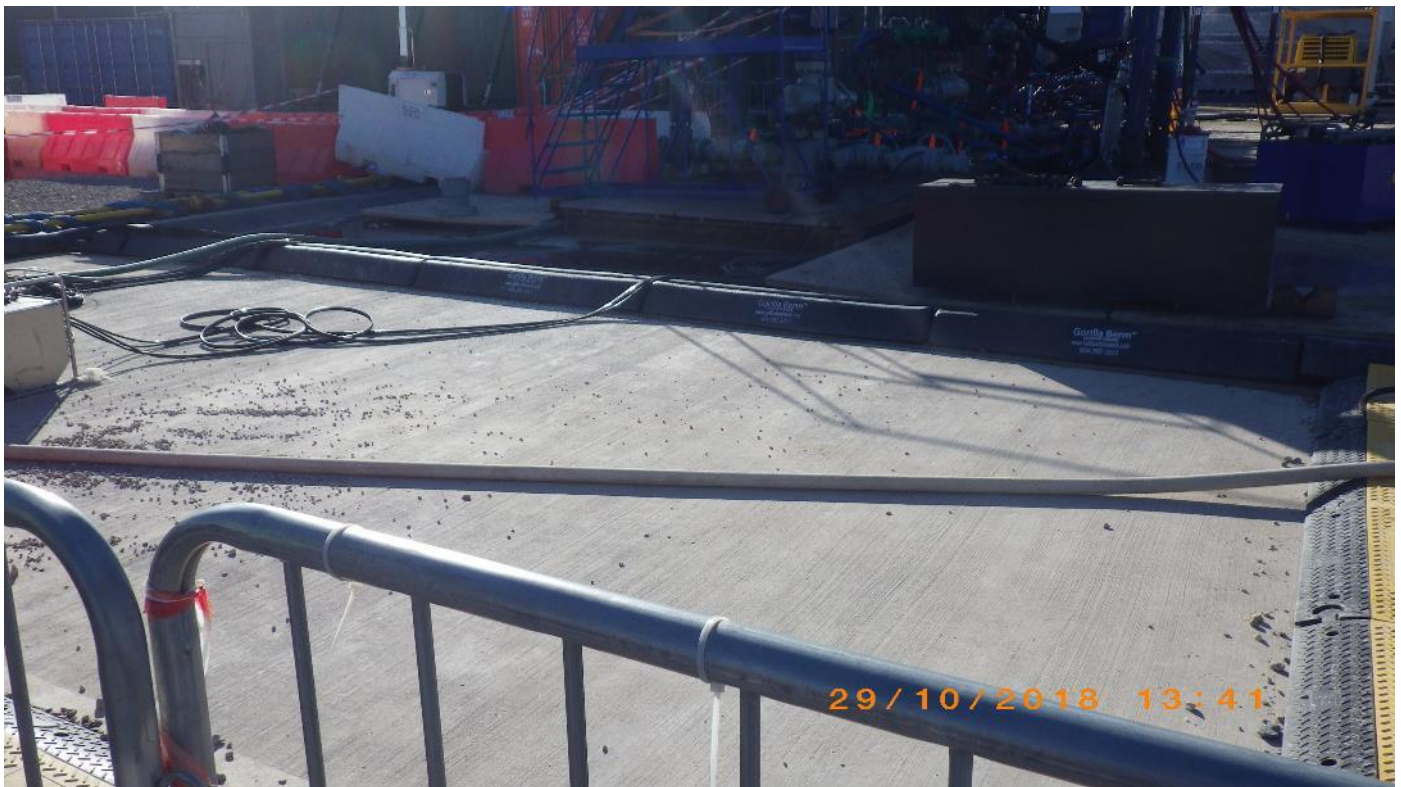
Photograph 12: Area around the well heads. No leaks observed and all activities contained in bunded areas.
