Russell Green Quarry

**Stability Risk Assessment and Restoration Design
(September 2022)**

Prepared for: Land Logical Ltd

Report Number: 8198-001-R-01

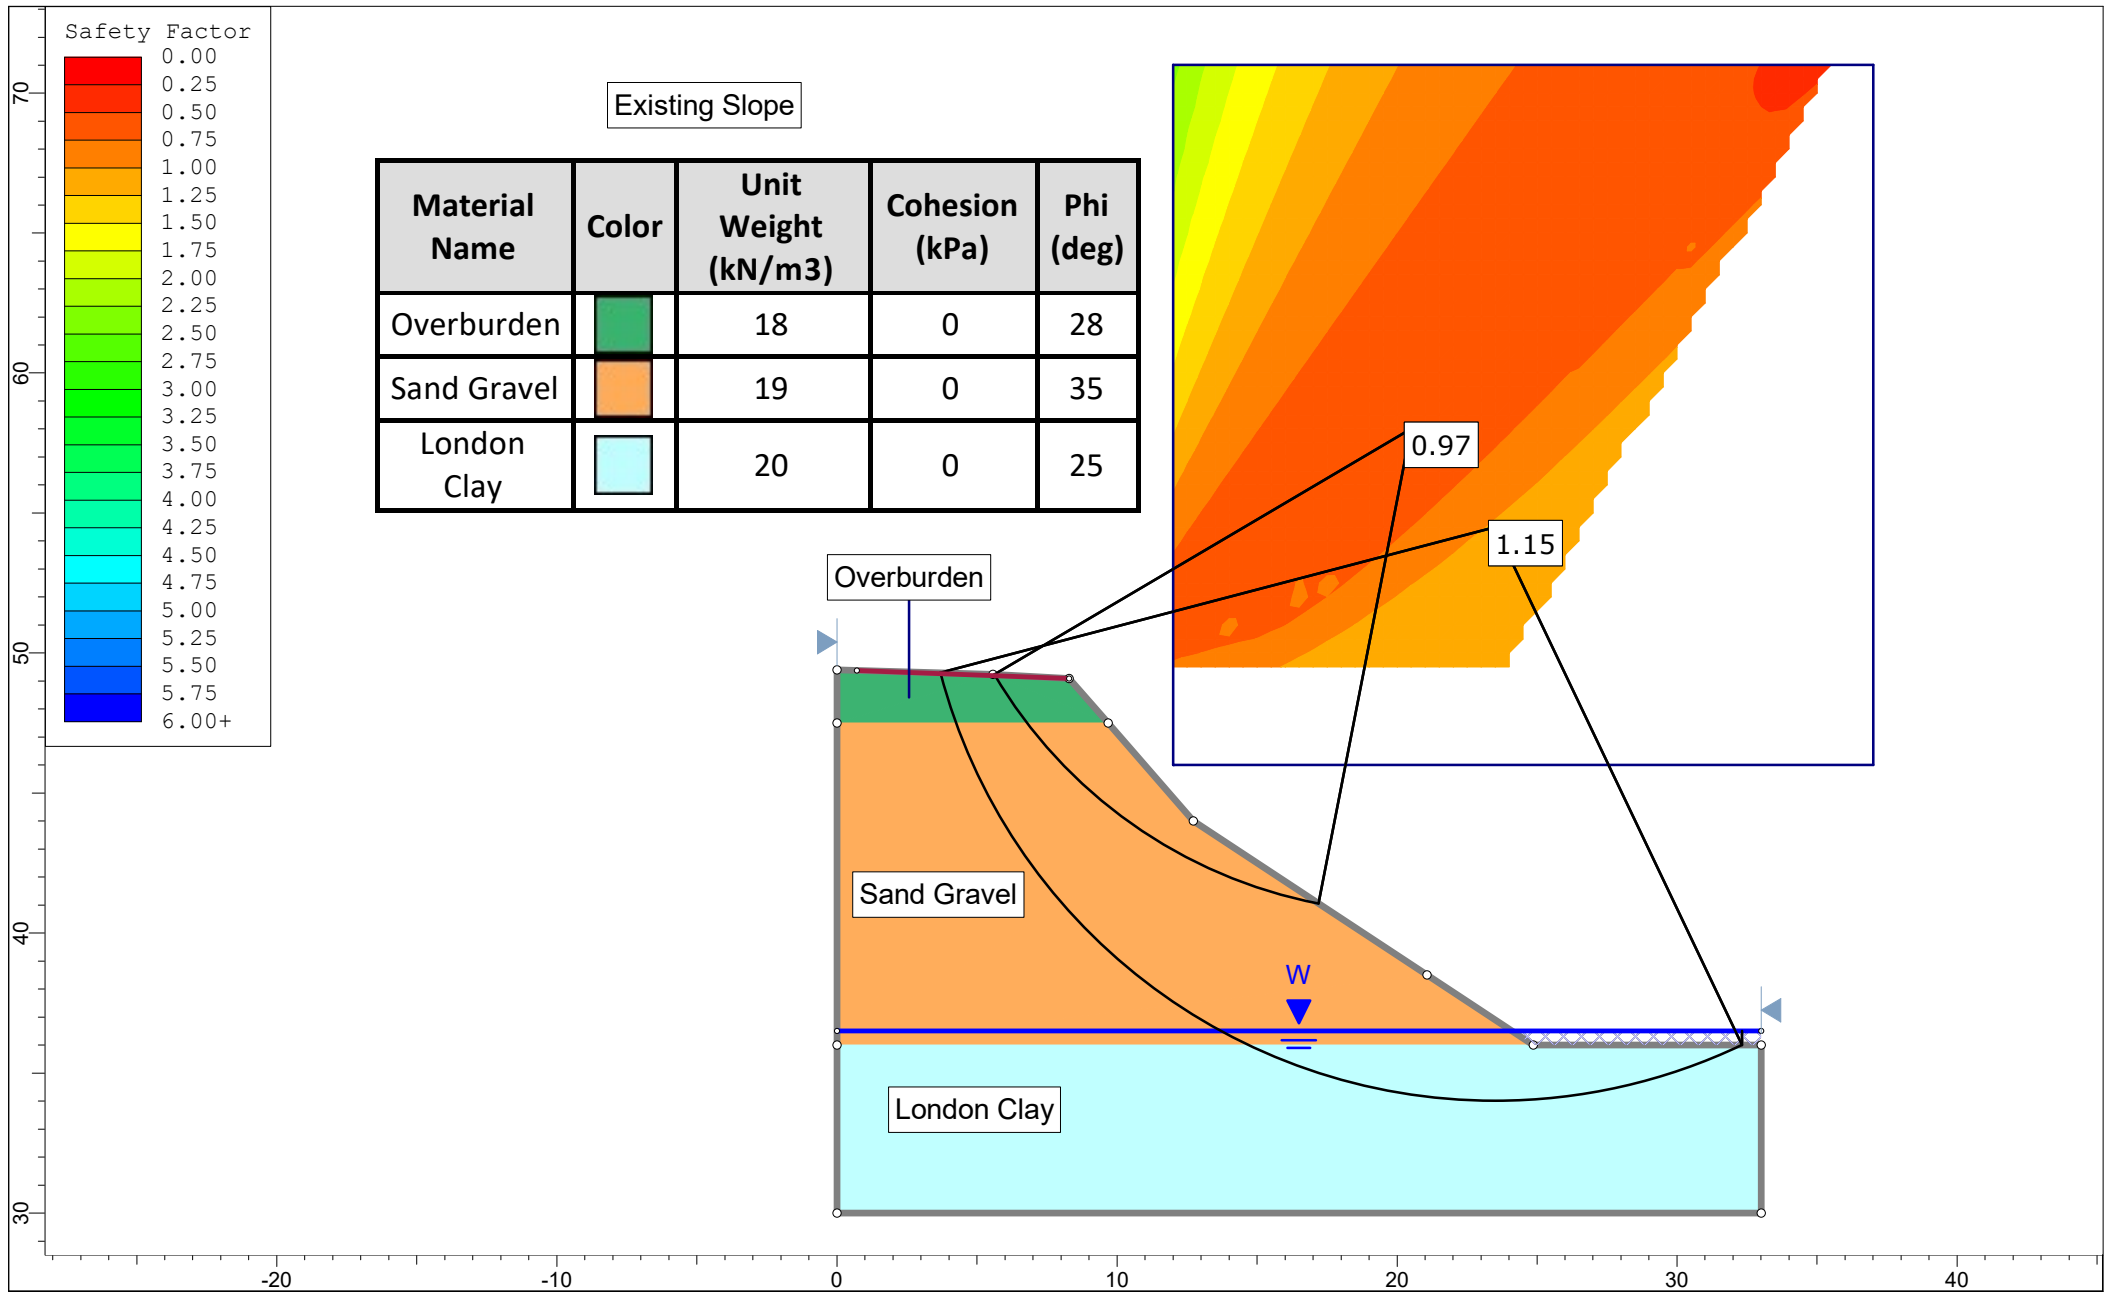
The results of the slope stability analyses indicate that slope failures will ultimately occur at the steeper western quarry faces in the long term if the quarry faces are left unrestored. Localised slope failures have already occurred along the western quarry faces and further slope failures would likely continue to occur due to the progressive deterioration of the ground conditions.

Figure 1 - Existing quarry face/slope

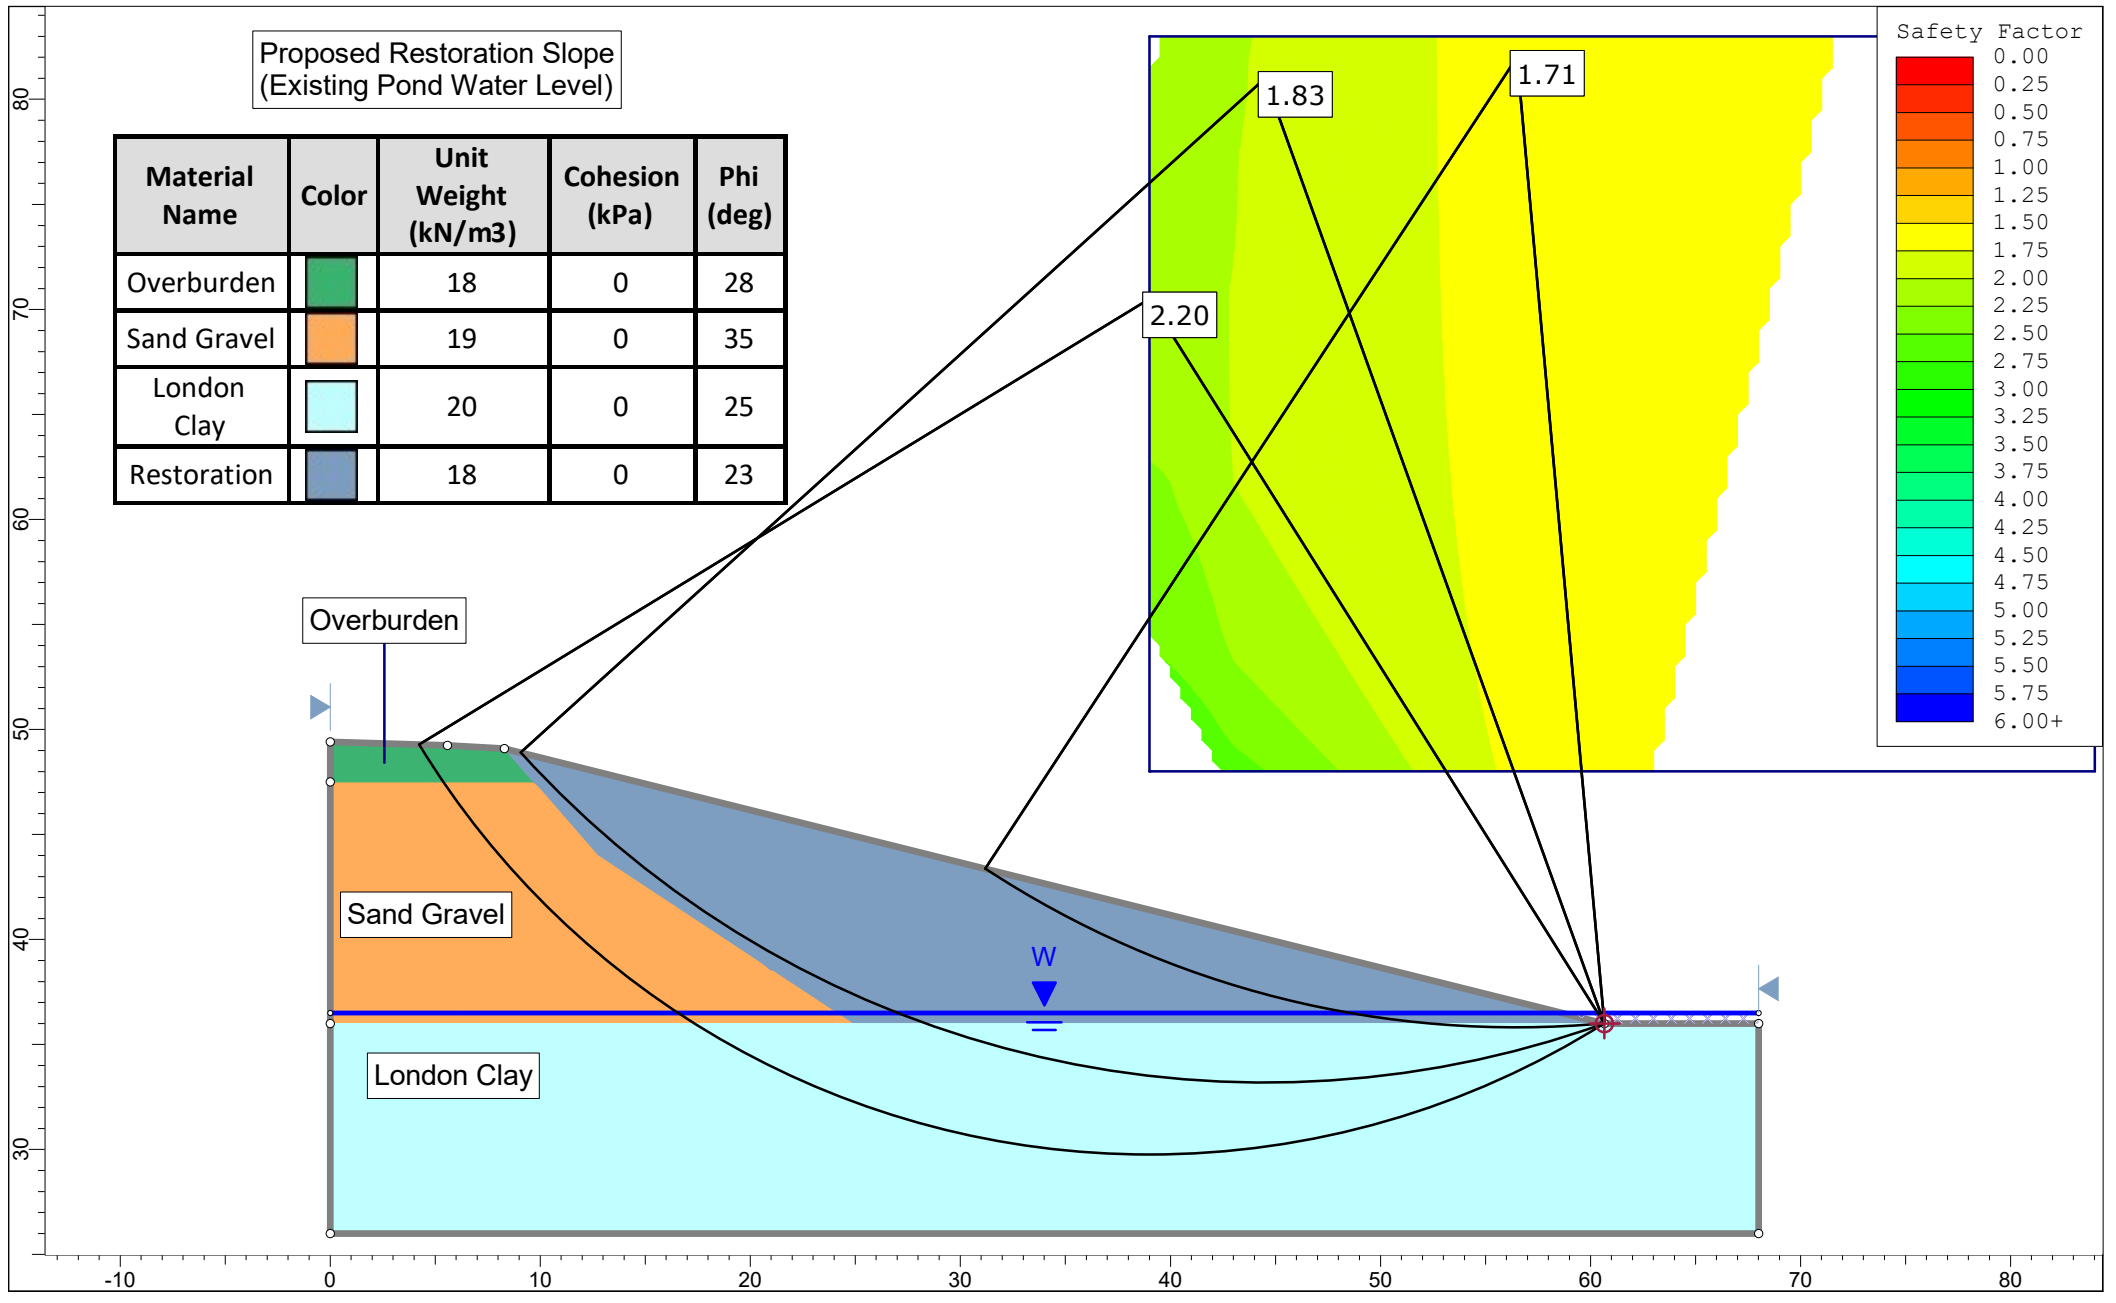
The analysis results indicate that the proposed restoration slopes will be stable with a minimum factor of safety over 1.71 against any slope failures.

Figure 2 - Proposed restoration slope (minimum pond water level)

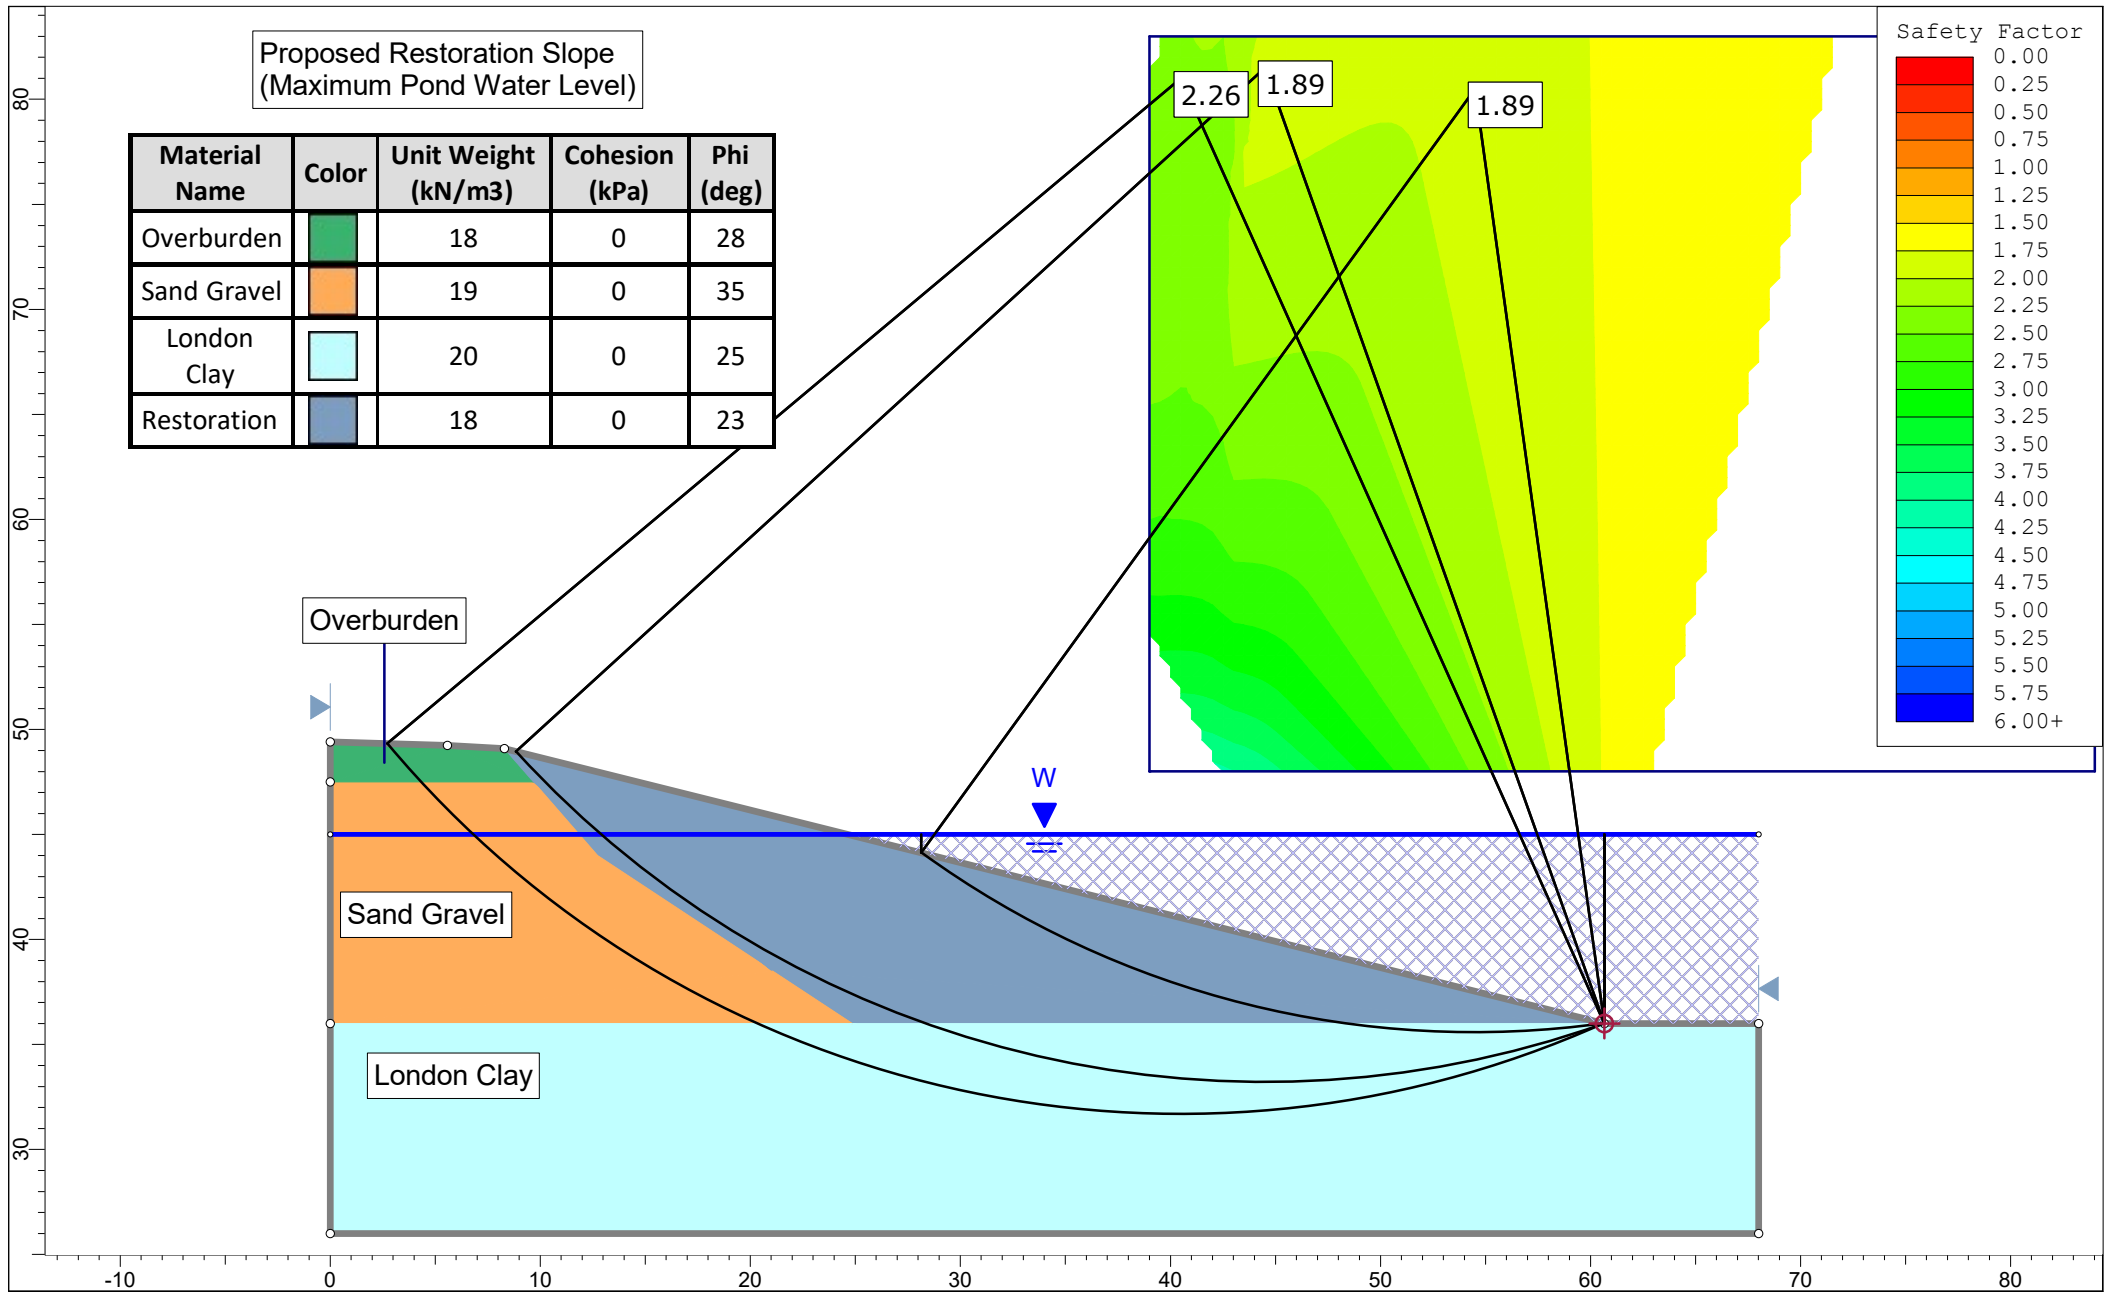
The results of the analysis indicate that the proposed restoration slopes will remain stable as the pond water level increase and the pond water level have minimal impact on the overall stability of the restoration slope.

Figure 3 - Proposed restoration slope (maximum pond water level)

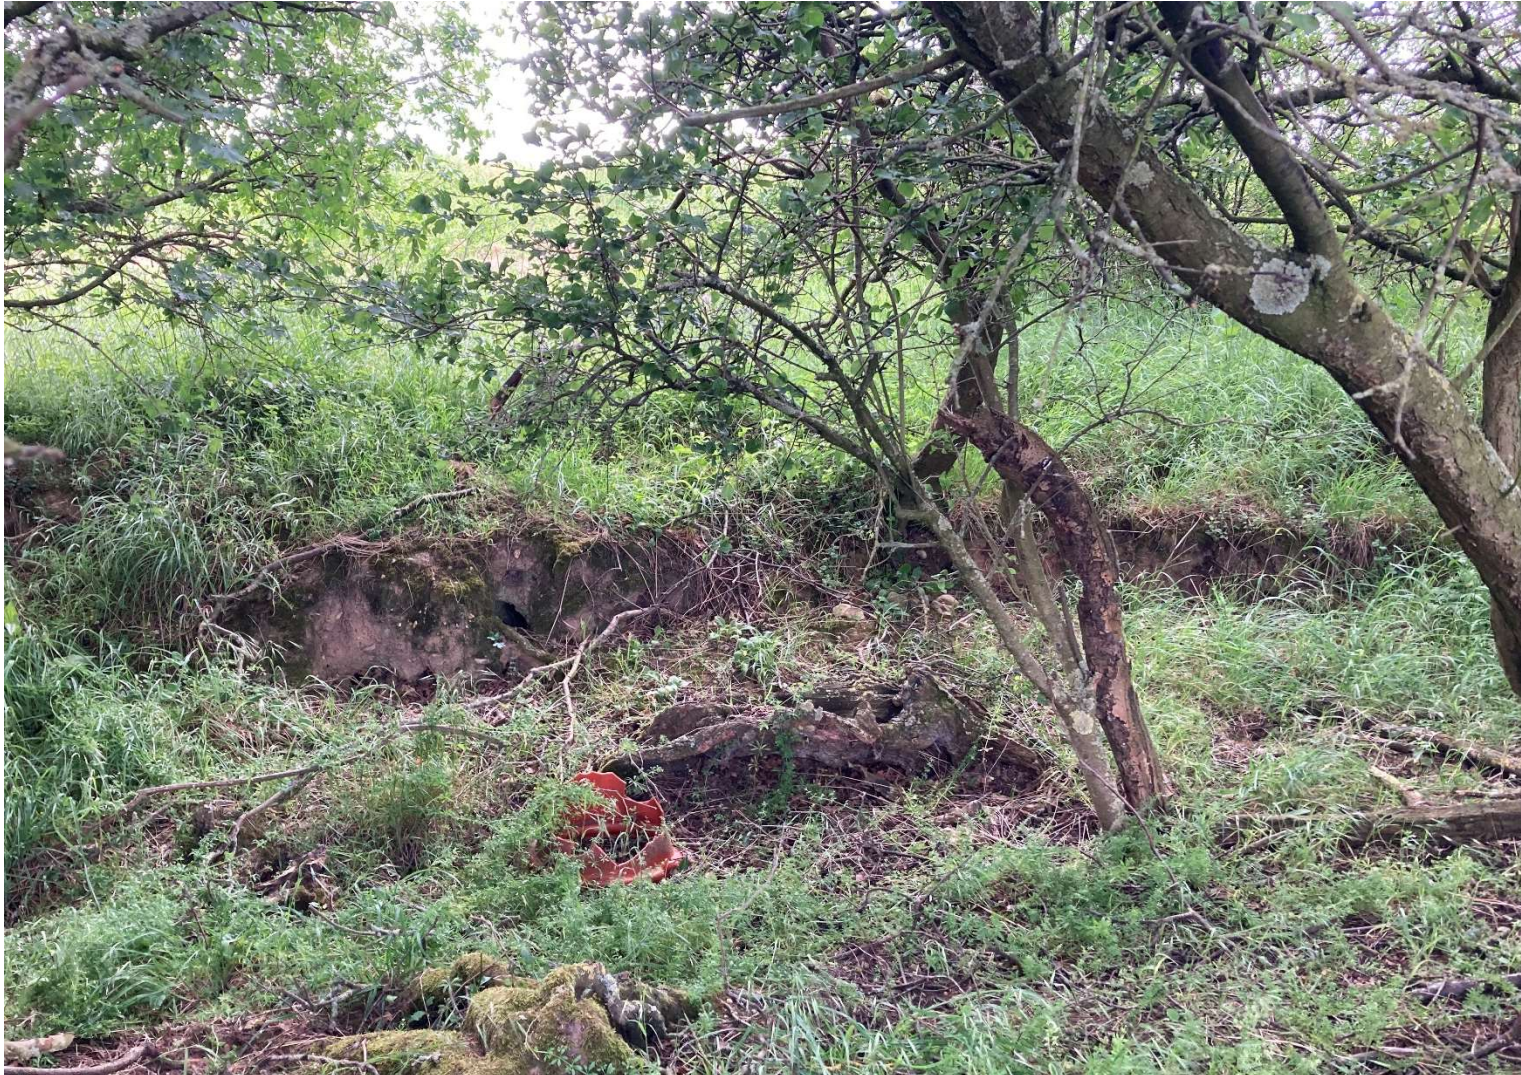
An inspection of the south-western slopes of the site was undertaken by Key GeoSolutions Ltd (KGS) on 7th June 2022. Localised progressive failures were observed during the inspection and near vertical quarry faces at the upper slope have been noted (Photo 1 and 2).

The progressive slope failures have taken the crest of the slope closer to the site boundary, these failures can be expected to continue to occur whilst the near vertical sections of slope exist, at least until a slope with natural angle of repose of c. 35° from horizontal is ultimately established over the full height of the slope. This process could ultimately take the crest of the slope beyond the site ownership boundary if left unchecked.

Photo 1 – instable ground approximately 3m behind the crest of the western quarry face (potential slope failure in the long term)

It is therefore recommended that an appropriate restoration of the south-western slope should be undertaken in order to;

- Provide long-term stability, and
- Provide a more acceptable visual aesthetic across the site.

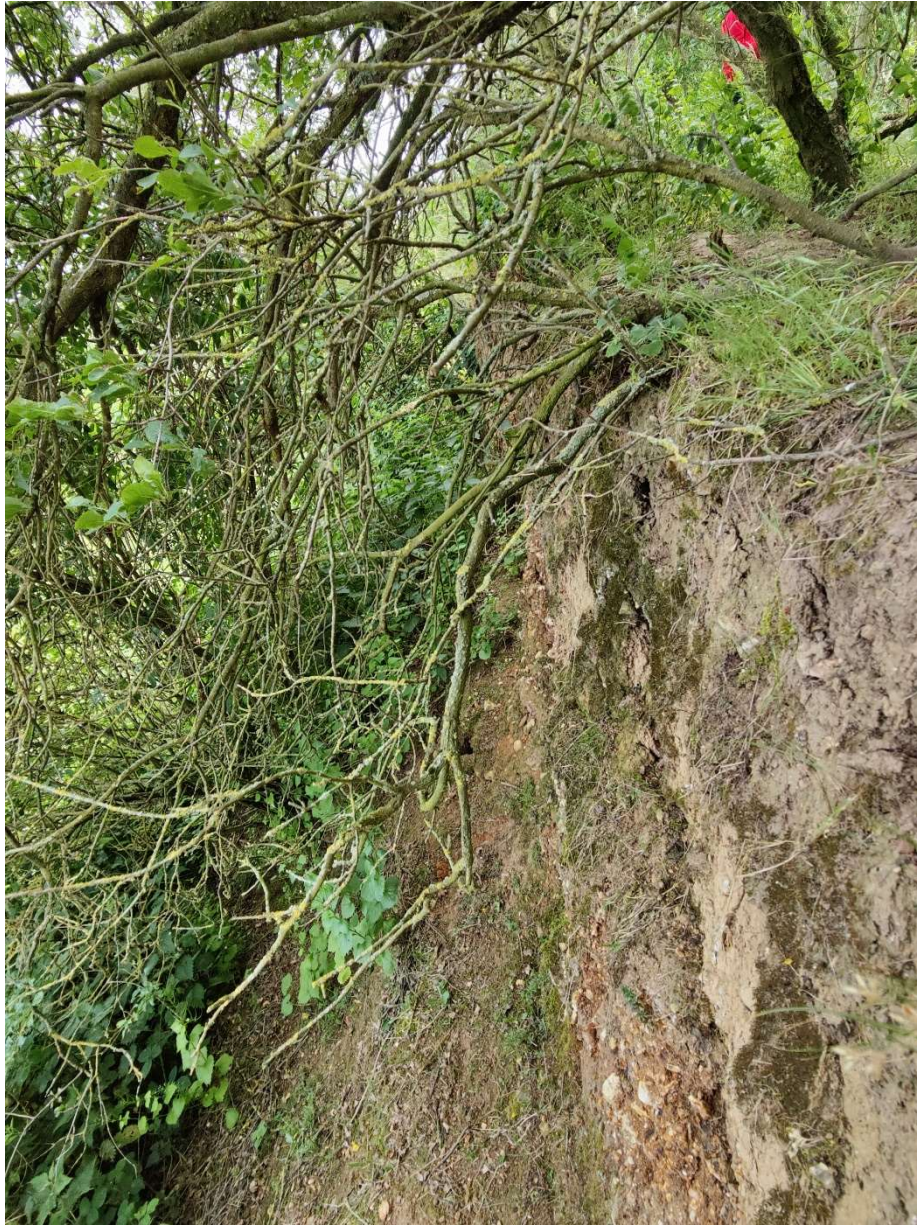
Slope failures have been observed during the recent inspection undertaken in June 2022. Localised near vertical slope sections have been formed from historical slope failures and these over-steepen slopes will ultimately collapse in the long term.

Photo 2 near vertical quarry face/slope

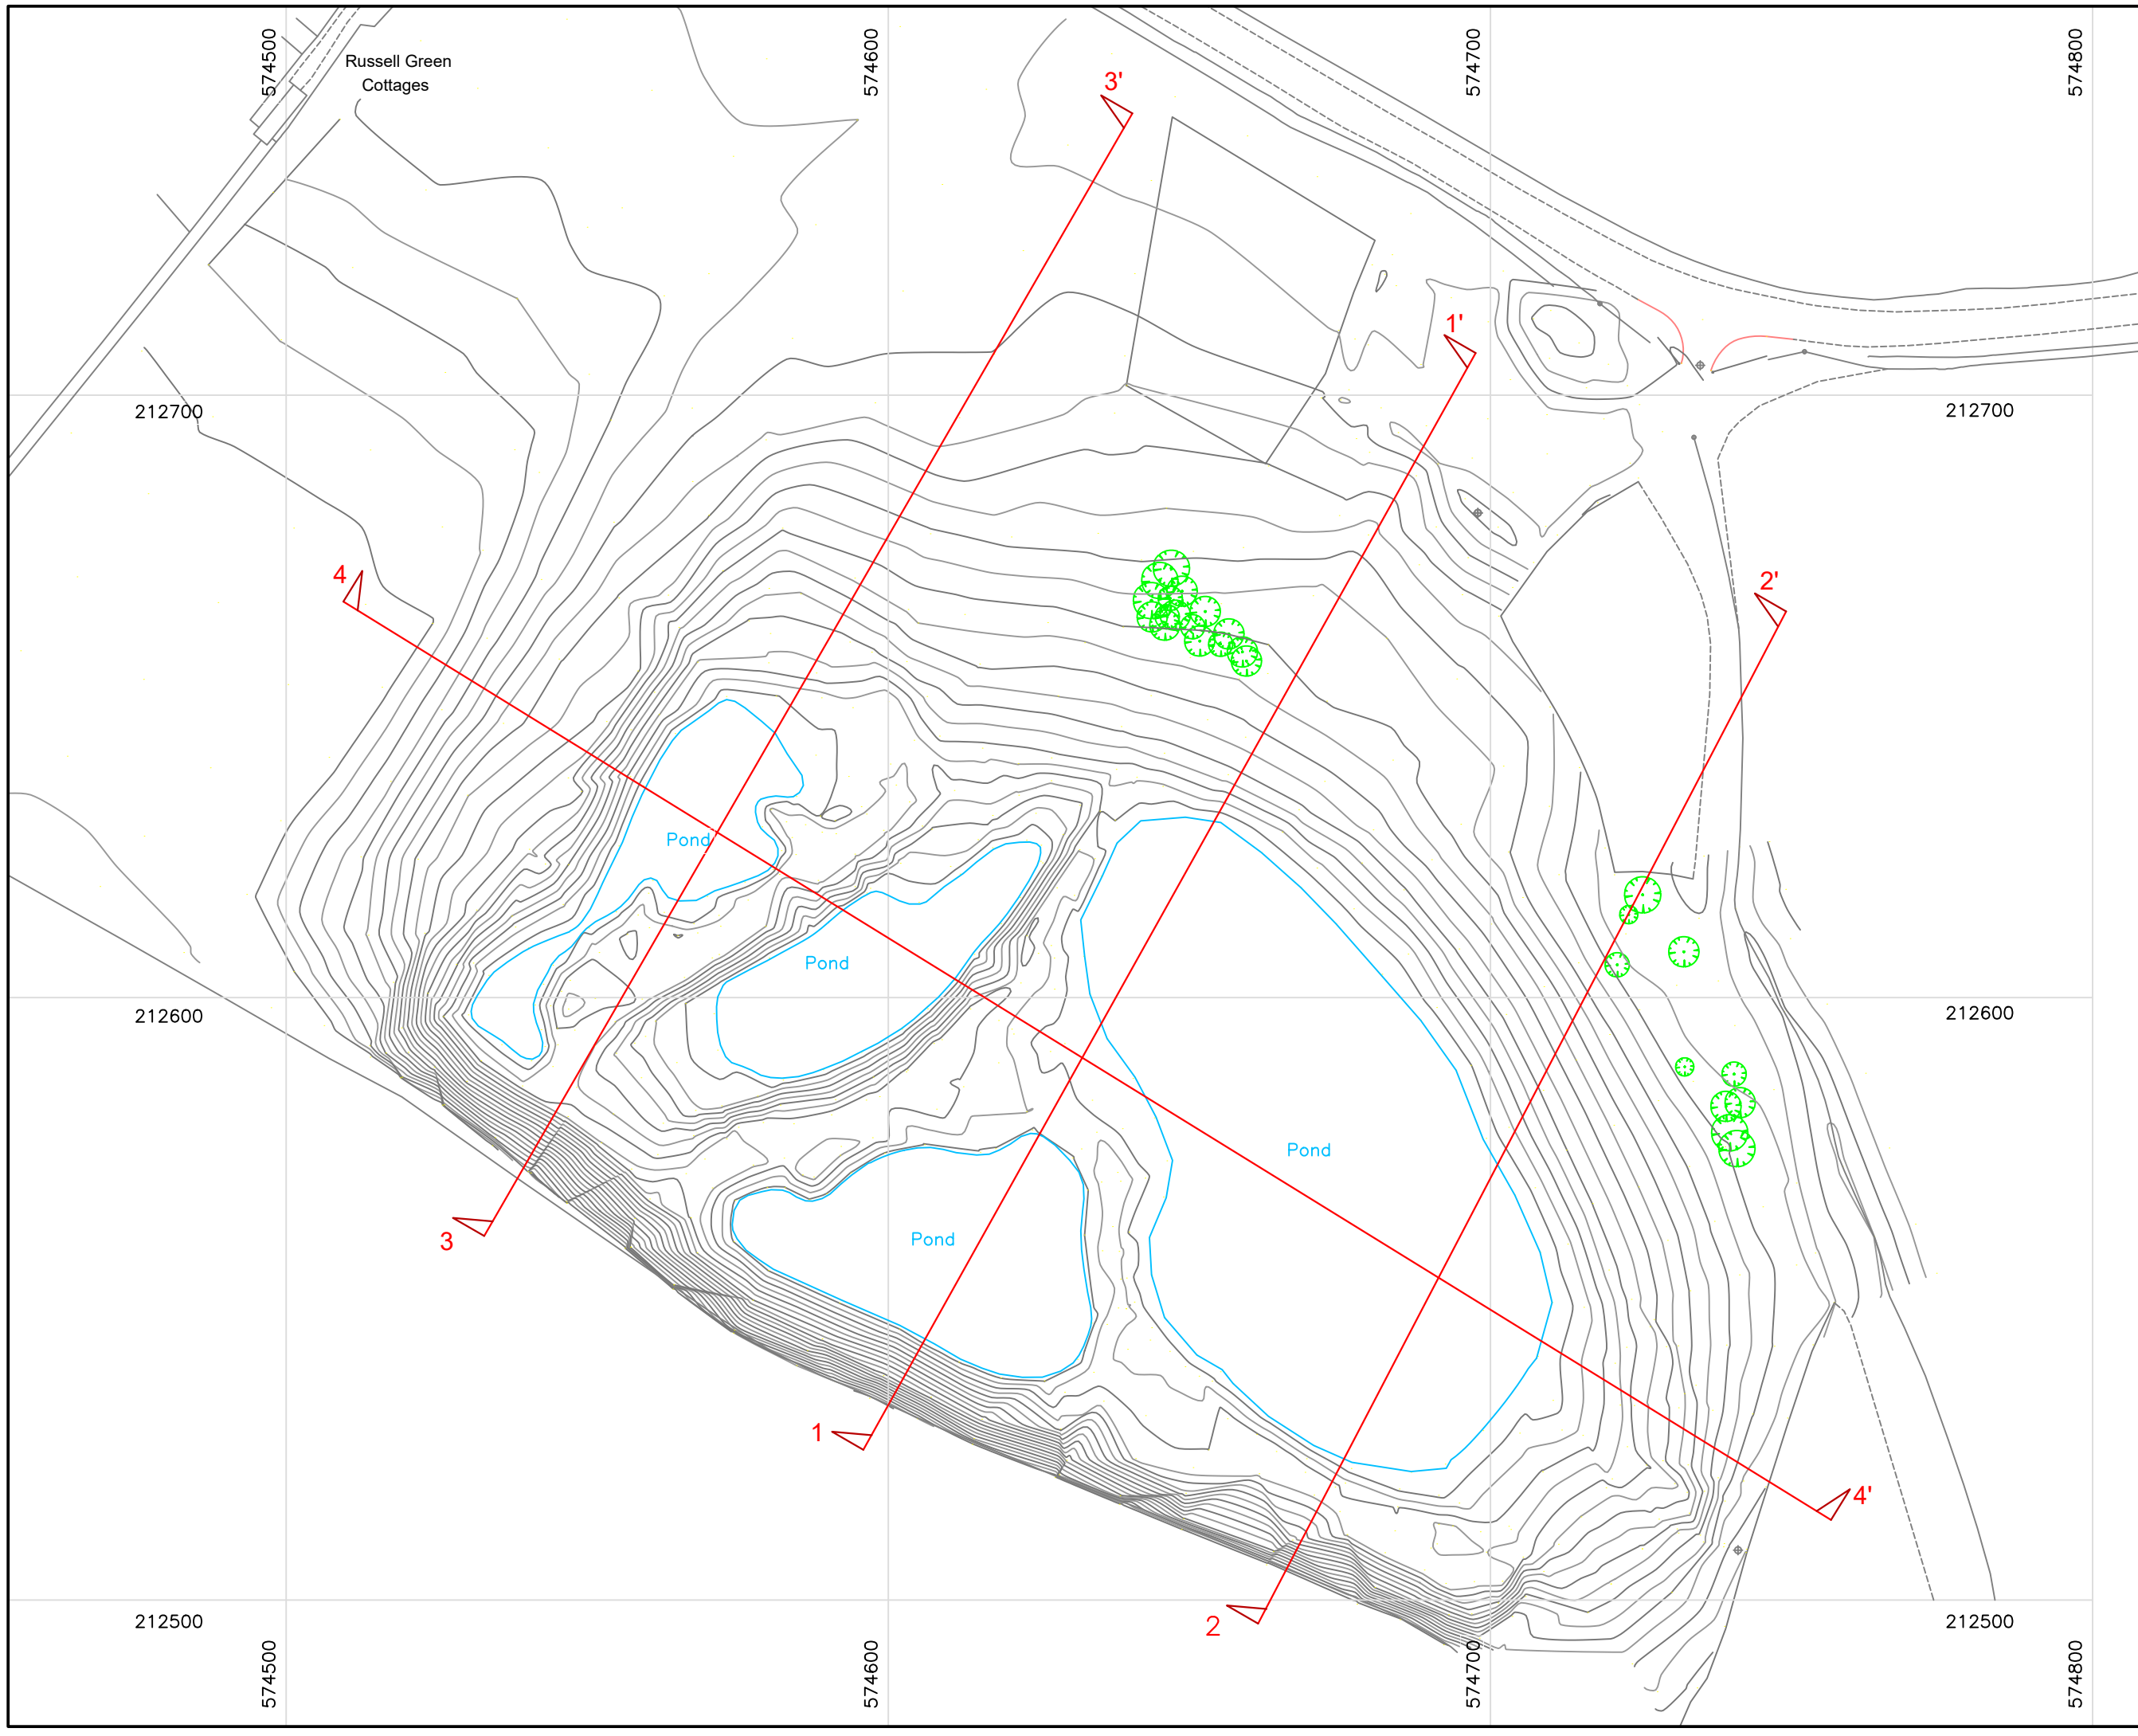
TITLE:
Existing Site Conditions

The height of the quarry face and the slope profile have been determined from the topographical survey provided by Land Logical Ltd (see Drawing No. 8198-001-001).
