# **Meriden Quarry**

## **Clay Liner CQA Report**

**NRS Waste Care Ltd**

Job No: 25-273  
Report No: 25-273-R-001

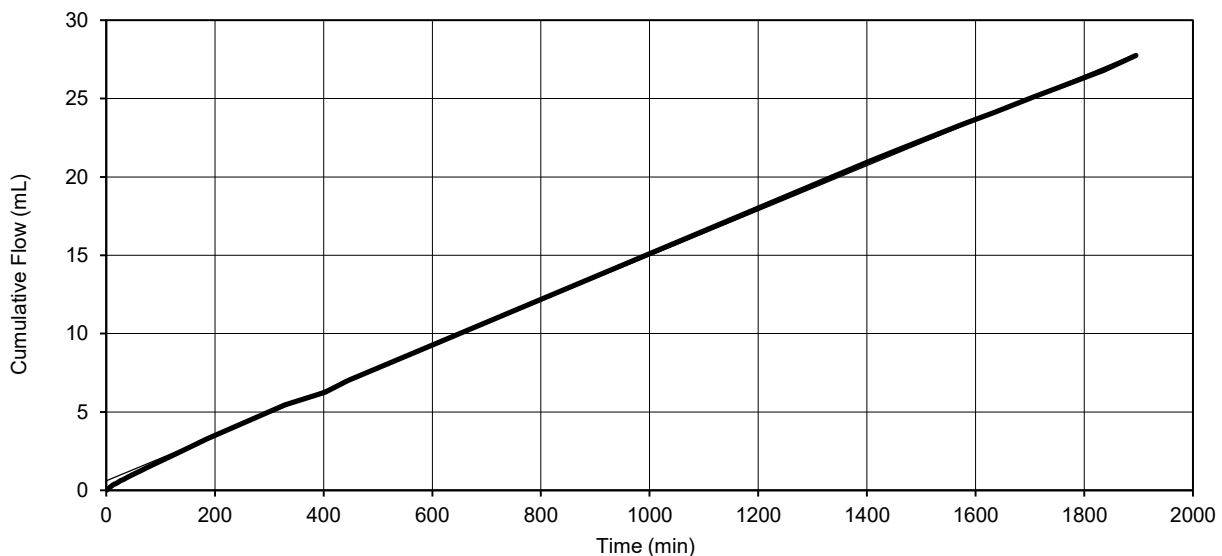
| Test Reference | Test Result | Description |
|---|---|---|
| 44094 - 241700 | 1.6x10 <sup>-9</sup> m/s | Undisturbed. Firm orangish brown slightly gravelly sandy CLAY |

**Coefficient of Permeability** $k_v \text{ at } 20^\circ\text{C} = 1.6 \times 10^{-9} \text{ m/s}$

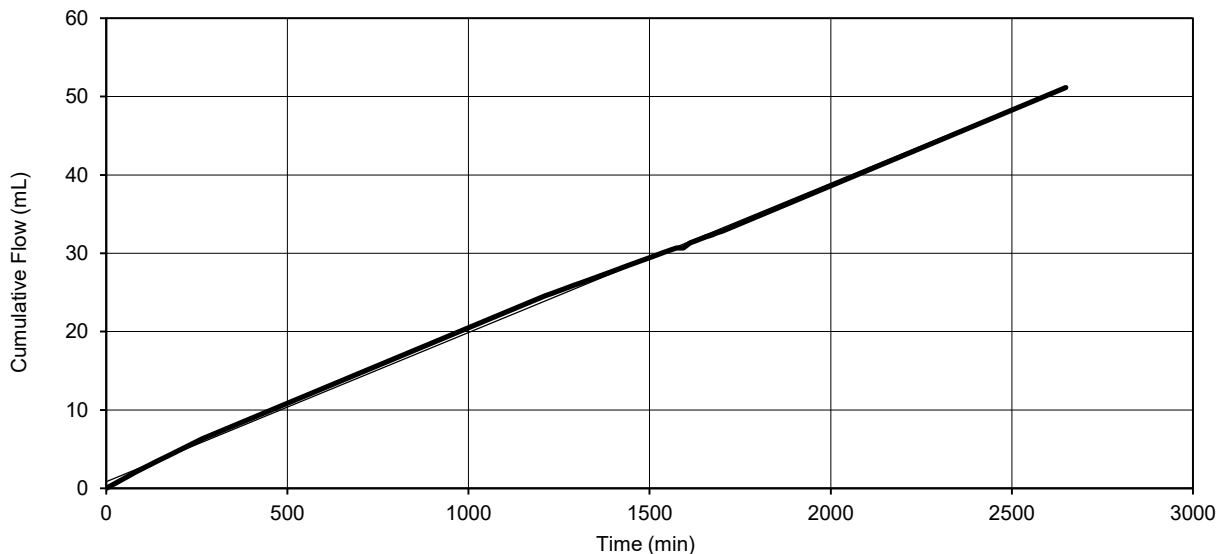
| Test Reference | Test Result | Description |
|---|---|---|
| 44094 - 241701 | 2.1x10 <sup>-9</sup> m/s | Undisturbed. Firm red brown mottled dark grey slightly gravelly sandy CLAY |

$k_v$  at 20 °C =  $2.1 \times 10^{-9}$  m/s

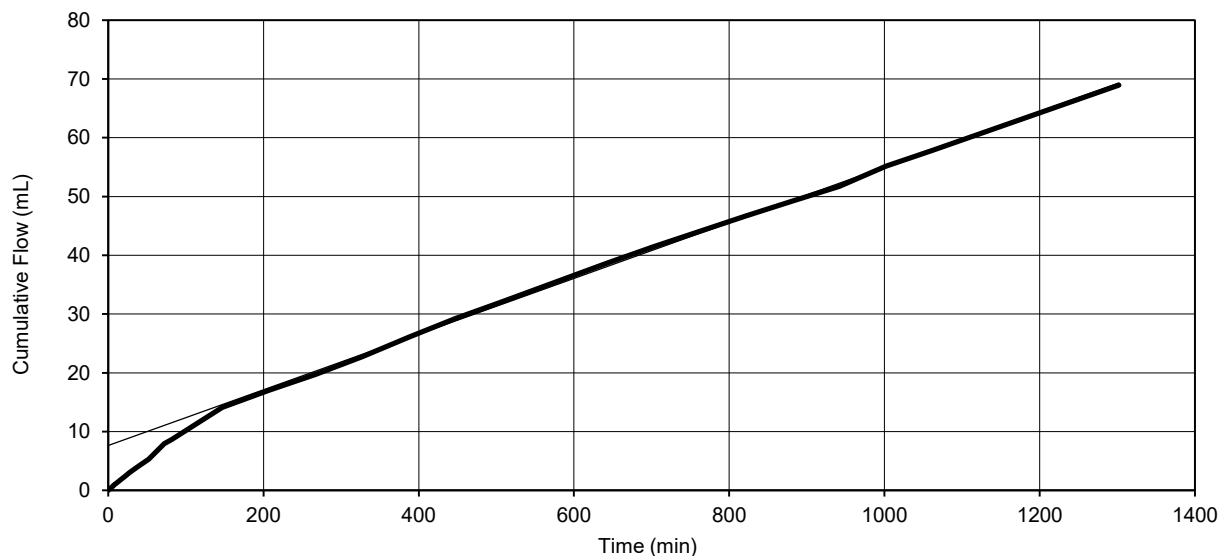
| Test Reference | Test Result | Description |
|---|---|---|
| 44094 - 241702 | 5.1x10 <sup>-9</sup> m/s | Undisturbed. Firm reddish brown mottled light grey gravelly sandy CLAY |

$k_v$  at 20 °C =  $5.1 \times 10^{-9}$  m/s

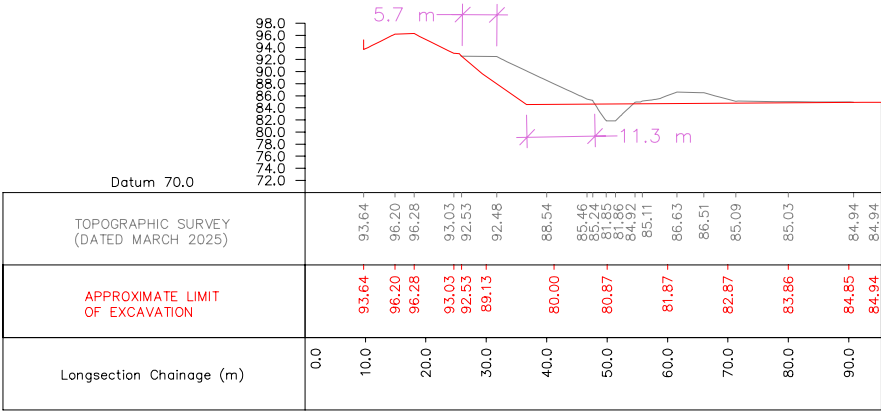
XS 1 - 1'

The surveys demonstrate that a sidewall geological barrier of a minimum width of 3.8m has been placed from the crest of the slope down, based on 1V in 2H in artificial geological barrier and 70° buried face. (See cross section drawing 25-273-D-002).

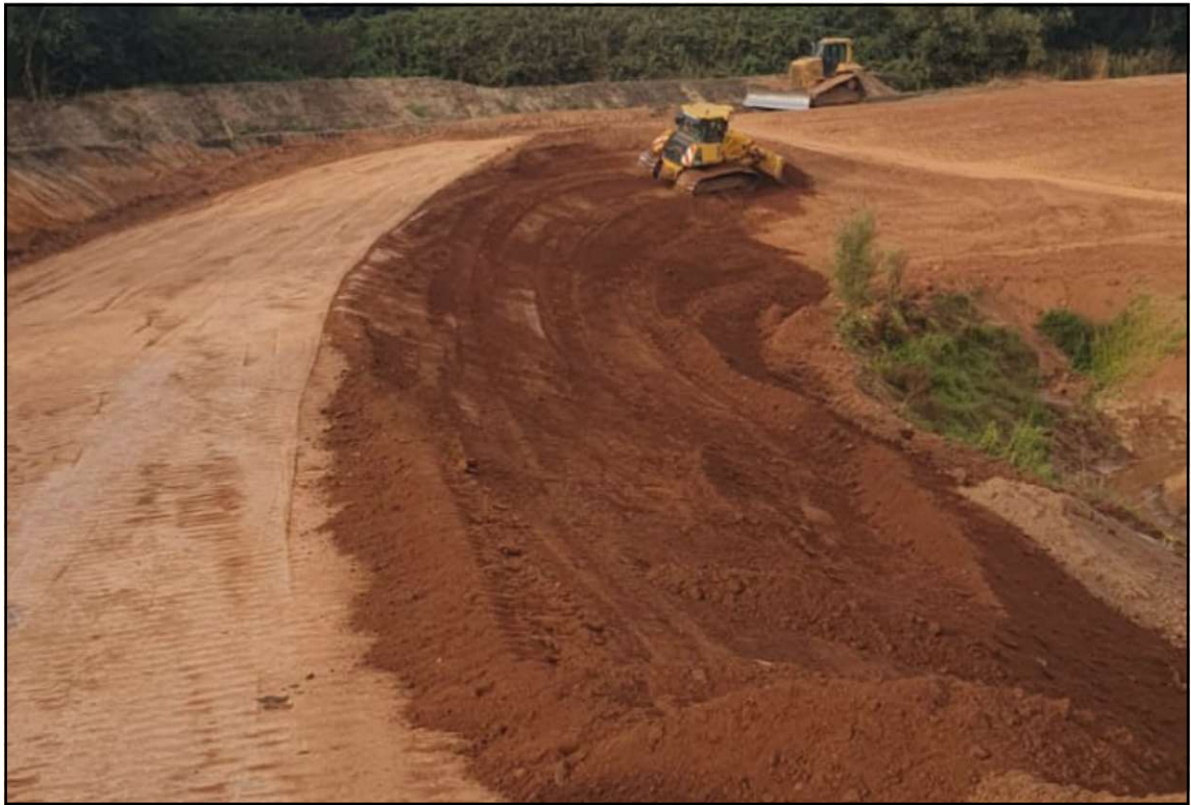
Photo 1. Material placement prior to wetting

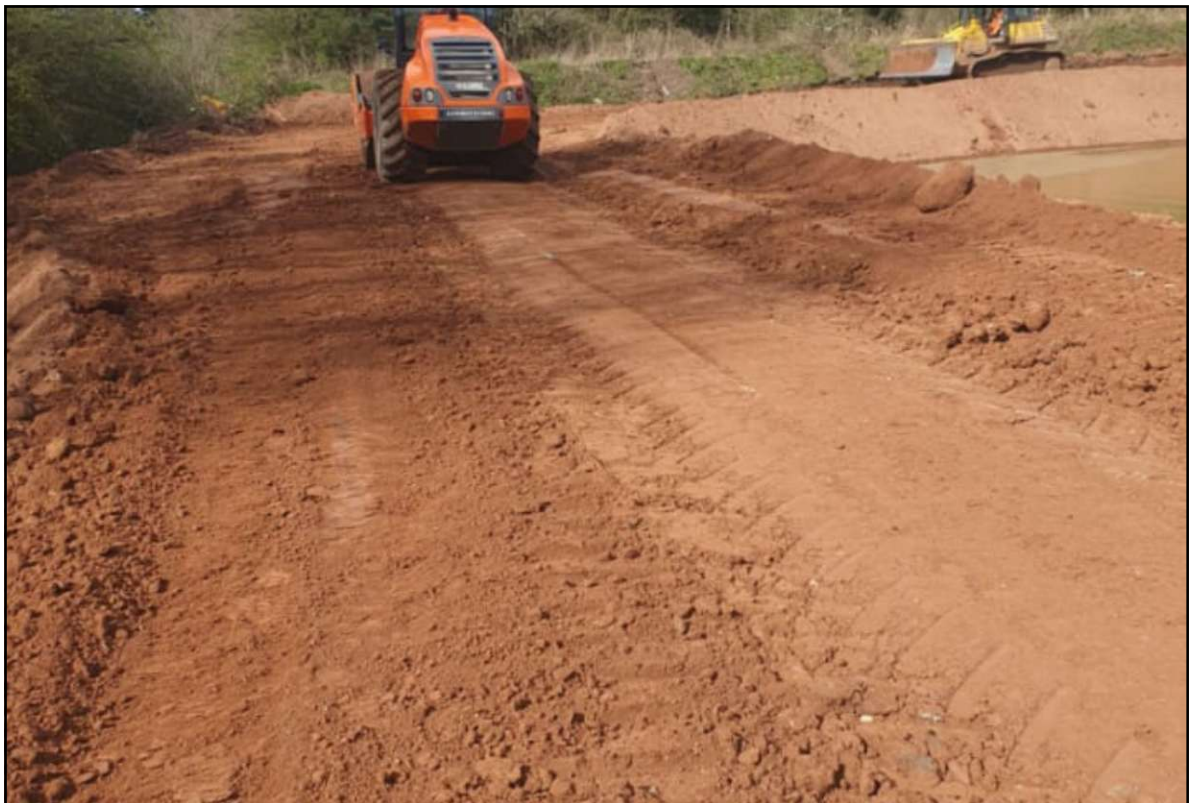
NRS personnel report that the clay was excavated from the floor of the excavation and placed and compacted in layers. Compaction was undertaken using a Hamm H13i self-propelled vibratory roller. The completed liner geometry has been verified through comparison of the topographic surveys and permeability testing.

Photo 2. Material compaction
