Fire Risk Assessment Report

Crayford MRF, Century Wharf, Crayford Creek Rd,
Dartford, DA1 4QG

KFS Report FRA_25451_01

N+P Crayford MRF Ltd

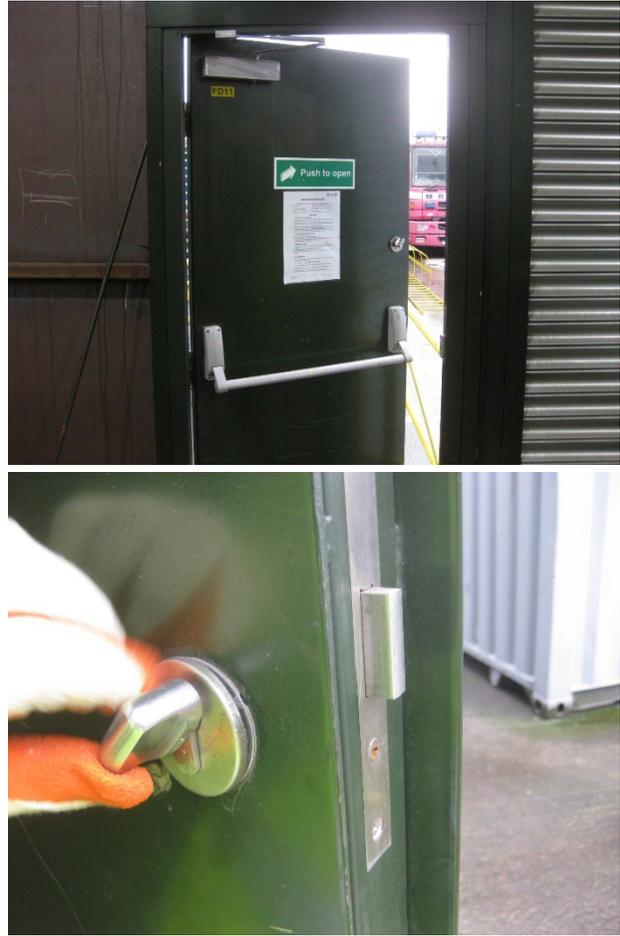
FINDING NUMBER	FINDING DESCRIPTION	RECOMMENDED RISK REDUCTION METHOD	PRIORITY	PHOTOS
2021-4	<p>Final exit doors fitted with more than one opening method. It was unclear if the mechanisms were working correctly as the door should open by operating the push bar only.</p> <p>2024 update – this has not yet been completed.</p>	<p>Repair the door mechanisms so that final exit doors with double lock mechanisms operate correctly by operating the push bar only.</p> <p>Alternatively, remove the additional twist to open locks from final exit doors to enable quick and easy egress from the buildings in an emergency.</p> <p>2024 update – this has not yet been completed.</p>	Medium

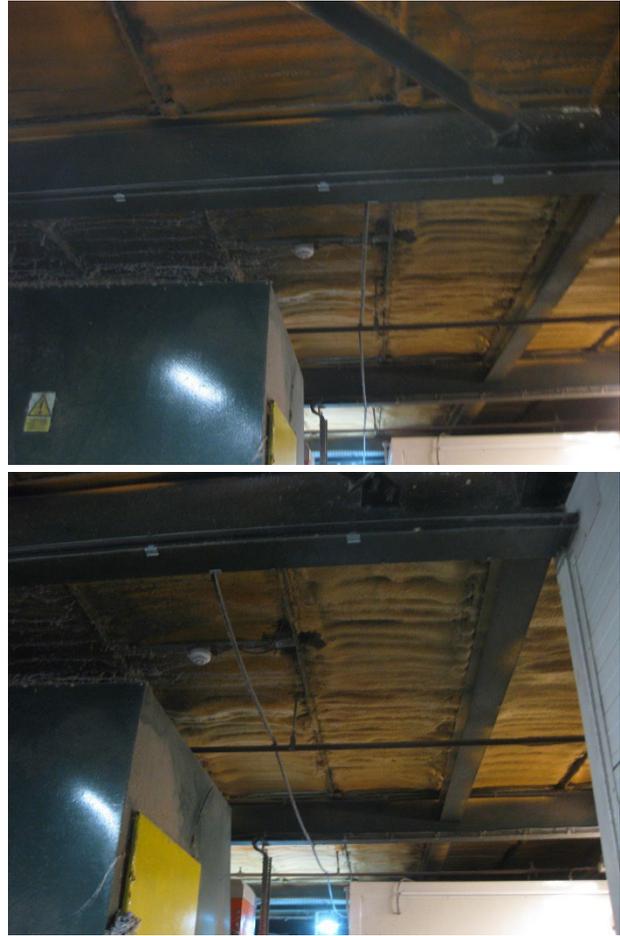
FINDING NUMBER	FINDING DESCRIPTION	RECOMMENDED RISK REDUCTION METHOD	PRIORITY	PHOTOS
01	<p>The corrugated ceiling of the mezzanine within the picking area of the MRF is coated in spray foam insulation of an unknown type.</p> <p>It is advised that the fire risk of this was considered before installation, however, evidence of the product or specifications are unknown.</p> <p>Some spray foams are highly combustible and release large quantities of smoke. This would rapidly fill the picking cabins and enclosed areas and may make escape routes smoke logged making escape difficult and possibly conditions untenable.</p>	<p>Ensure that the type of spray foam is identified and the risk to occupants is assessed for the type of use to the ceiling as insulation.</p>	High

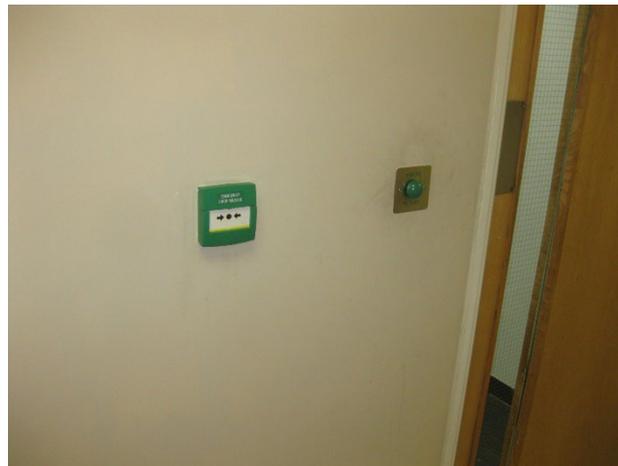
FINDING NUMBER	FINDING DESCRIPTION	RECOMMENDED RISK REDUCTION METHOD	PRIORITY	PHOTOS
02	Some electronic locks are provided to doors on means of escape within the office building. These are fitted with 'green box' manual overrides in the event of system malfunction, push to exit button malfunction or interface failure. The green boxes are not currently believed to be tested and maintained in accordance with BS7273-4:2015+A2:2023.	Ensure all green box manual overrides are user tested and serviced in accordance with BS7273-4:2015+A2:2023.	Medium

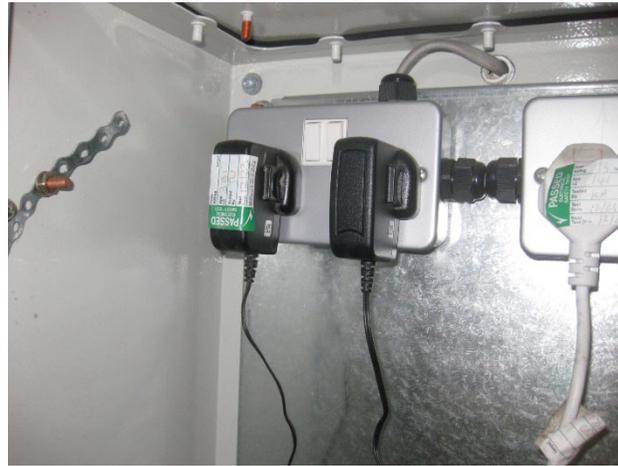
03	Some portable items were tested in 2021 due 2022 and others carried a recent test label tested December 2023 due December 2024. Other items are new and have not yet been tested.	Ensure that all portable items are adequately tested and added to an inventory. All new items should be tested at the time of the next testing event and added to the inventory.	Medium

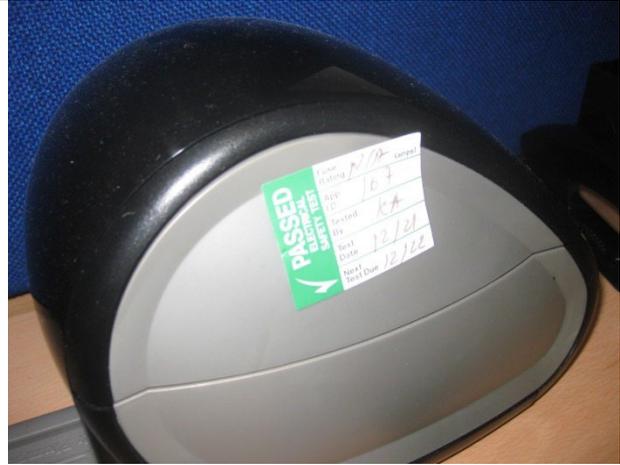
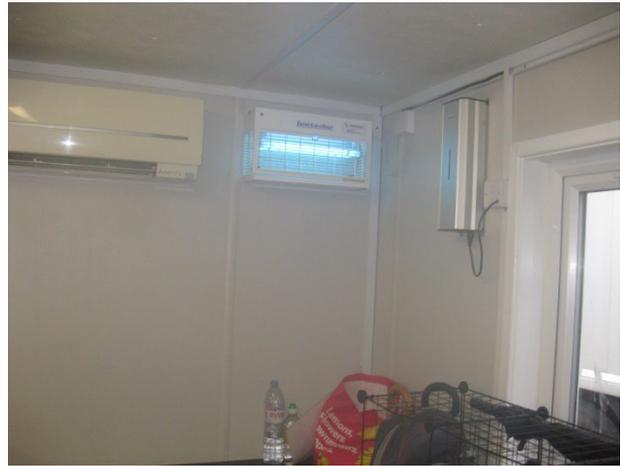
04	<p>Portable electrical fly killers are in use around the site with combustible items stored below them. There is case evidence of smouldering flies bouncing out of the units onto combustibles below.</p>	<p>Ensure that fly killer units are adequately monitored, regularly cleaned and the areas in the vicinity are free of combustibles.</p>	Medium

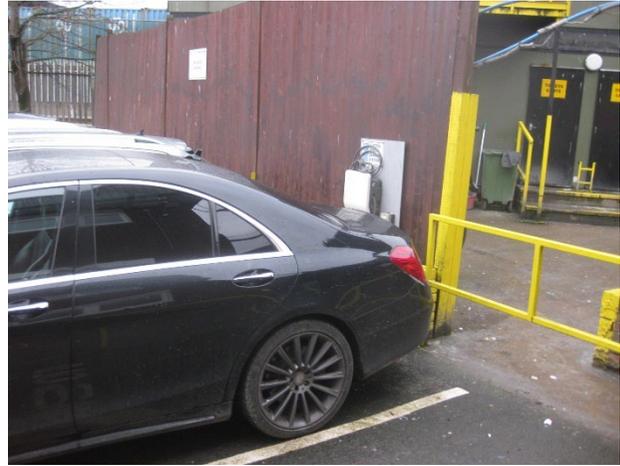
FINDING NUMBER	FINDING DESCRIPTION	RECOMMENDED RISK REDUCTION METHOD	PRIORITY	PHOTOS
06	<p>An electric vehicle charging point is provided on the car park. This is considered far enough away from the building (over 6 metres) to mean that the risk from fire is reduced to a tolerable level.</p>	<p>Ensure they are added to a maintenance programme, and that the equipment is maintained in line with the manufacturer’s instructions.</p>	Low

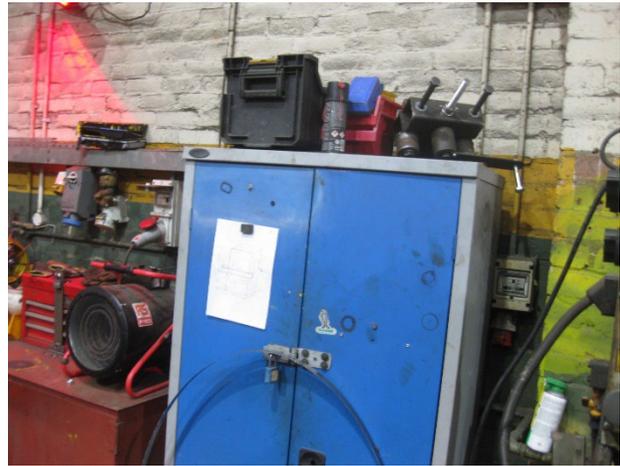
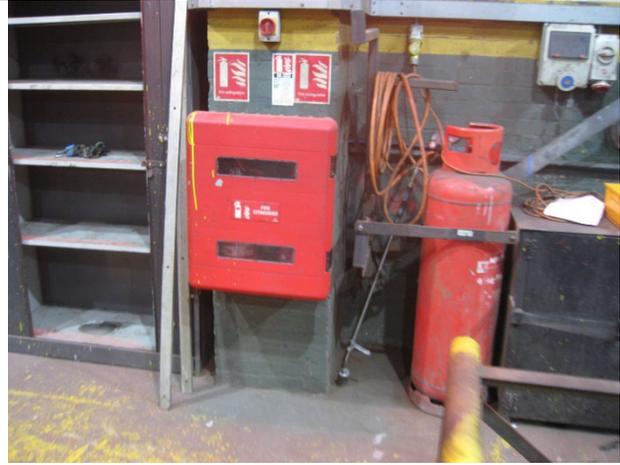
07	<p>The COSHH cupboard within the engineering workshop is not adequately signed. No signage is present in the area of the gas cylinder in the engineering workshop.</p>	<p>Ensure the COSHH cupboards across the site are appropriately signed to indicate that flammable liquids and gases are stored. It is also recommended that the entrance doors are appropriately signed for the benefit of the fire service and all other areas where flammable items are stored.</p> <p>Ensure that the area of the gas cylinder is appropriately signed in the engineering workshop.</p>	Medium

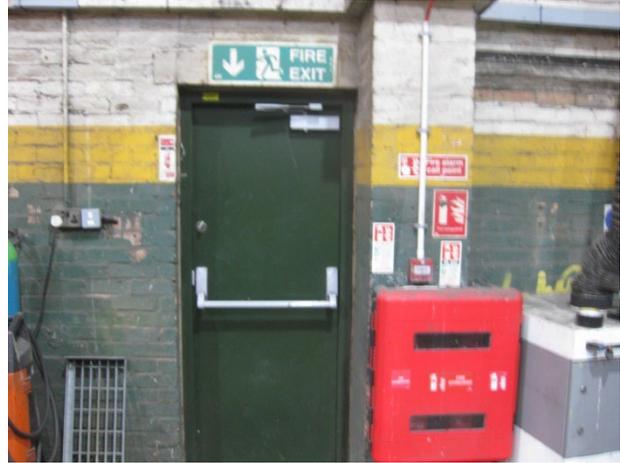
08	Exit fastenings are generally provided with appropriate signage giving their method of opening, however, 'Push Bar to Open' signage was not provided to the steel final exit doors within the engineering department.	Supply and fit 'Push Bar to Open' signage to doors within engineering and any other push bar doors where required.

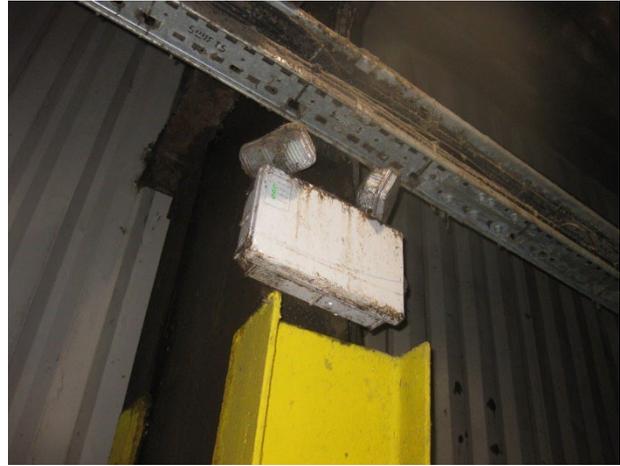
FINDING NUMBER	FINDING DESCRIPTION	RECOMMENDED RISK REDUCTION METHOD	PRIORITY	PHOTOS
09	Some high dust levels were observed to elements of structure.	Ensure dust to elements of structure and are targeted during deep cleans.	Medium

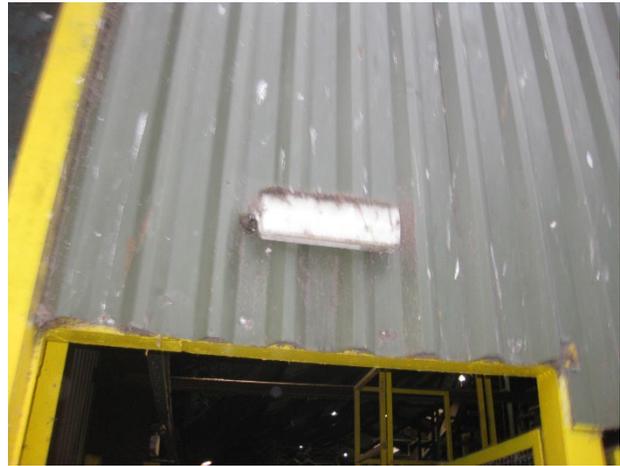
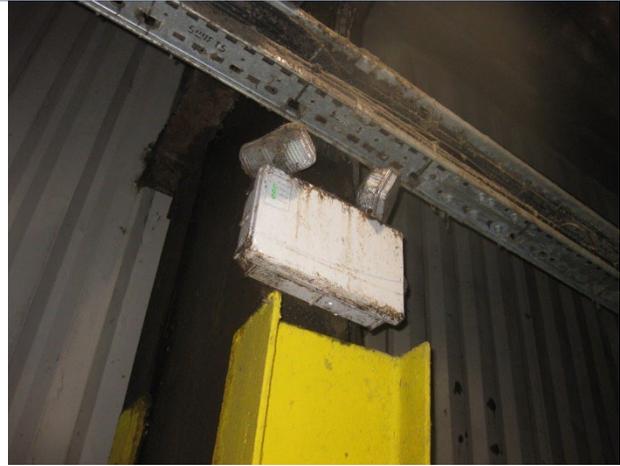
10	Some high dust levels were observed to emergency lighting fittings.	Ensure dust to emergency lighting are targeted during deep cleans. Emergency lighting should be inspected during user tests and also during escape route inspections.	Medium
