Phase 1 Laboratory Testing and Review

Pollington Site Investigation

Report Reference: CE-POL0231-RP01 April 2010 Version 1.0

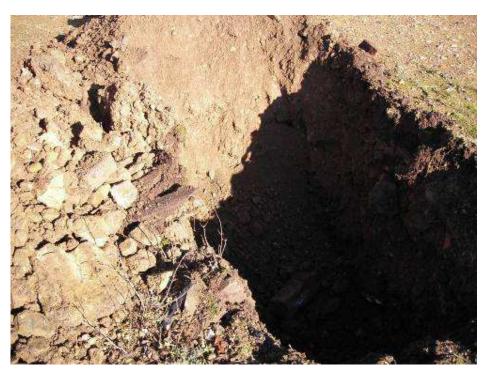
Detail of Trial Pit 1

- elevated pH levels in TP1, TP3 and TP4
- elevated levels of SVOCs within TP1 over a number of determinants
- elevated level of VOC (naphthalene) within TP4
- elevated level of fluoride within TP4
- elevated level of sulphate within TP5
- elevated levels of total dissolved solids within TP4 and TP5

Trial Pit 1 (TP1) 2.7m

Brown mottled grey slightly gravely CLAY. Sand is brown and fine gravel is angular fine to medium of sandstone and brick with occasional rootlets and plastic.

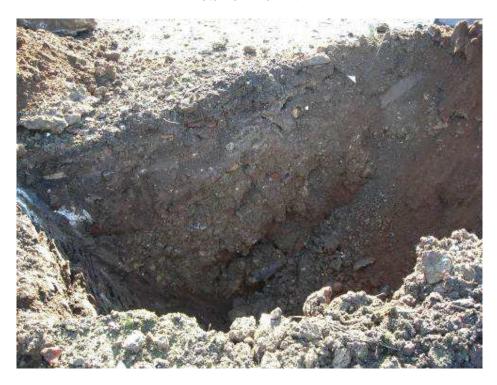
Detail of Trial Pit 2

Trial Pit 2 (TP2) 2.8m

Dark brown slightly gravely slightly clayey fine SAND. Gravel is angular fine to medium of concrete and brick. Occasional cobbles of concrete and brick.

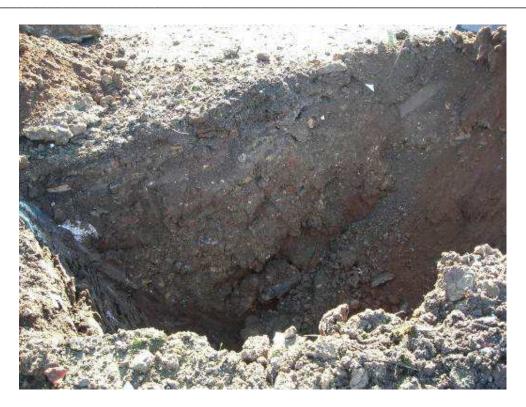
Detail of Trial Pit 3

Trial Pit 3 (TP3) 2.6m

Grey mottled brown slightly sandy slightly gravely CLAY. Sand is brown and fine gravel is angular fine to medium of concrete sandstone and brick.

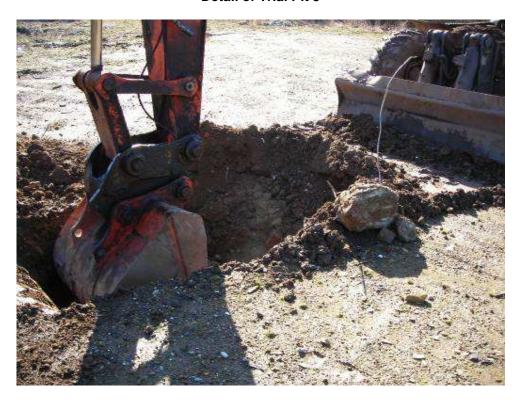
Detail of Trial Pit 4

Trial Pit 4 (TP4) 2.1m

Grey mottled brown slightly sandy slightly gravely CLAY. Sand is brown and fine gravel is angular medium to large of sandstone concrete and brick. Occasional timber rootlets ceramics glass and cobbles of concrete with reinforcing bars.

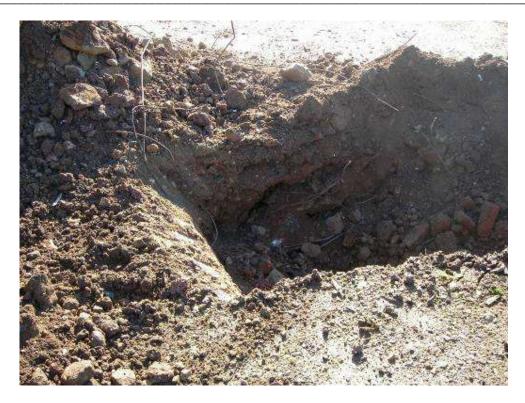
Detail of Trial Pit 5

Trial Pit 5 (TP5) 2.5m

Dark grey slightly sandy slightly gravely CLAY. Sand is brown and fine gravel is well rounded of quartz with many plant rootlets plastic timber and cobbles of concrete with reinforcing bar.

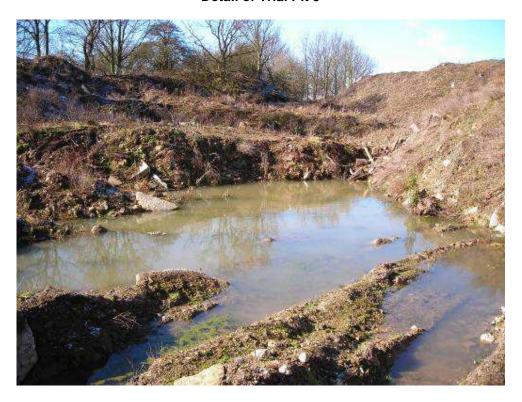
The sample of standing water tested for leachable inorganic compounds indicated that levels showed a very low probability that compounds were being leached from the deposited materials into this surface water body at the time of testing.

Standing water to north east of site, sample taken

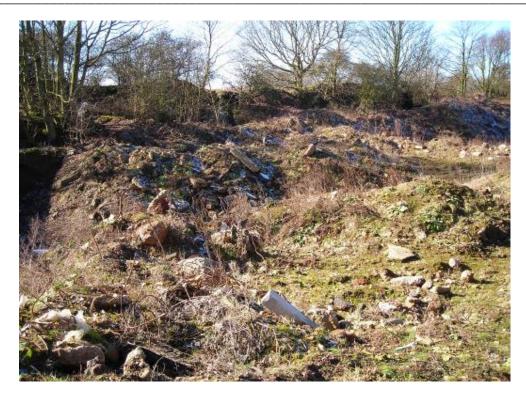
Existing condition of site prior to deposition of materials.

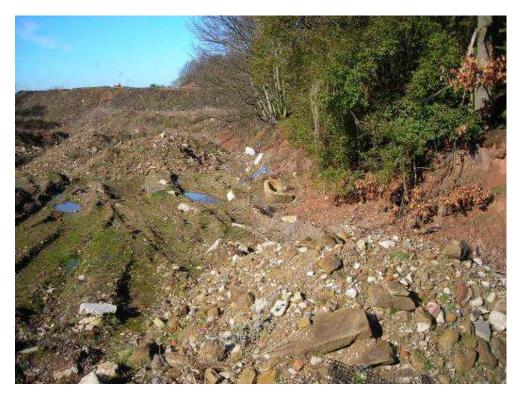
Existing condition of site prior to deposition of materials – Evidence of historic tipping of inert waste materials.
