CHADWICH LANE QUARRY LTD

CONSTRUCTION QUALITY ASSURANCE VALIDATION REPORT

EARTHWORKS CONSTRUCTION FOR SIDE WALL SEAL GEOLOGICAL BARRIER PHASE 3
Sections 1 and 12

REF:ARM/SCM/CLQ/CQA/1.00/2009

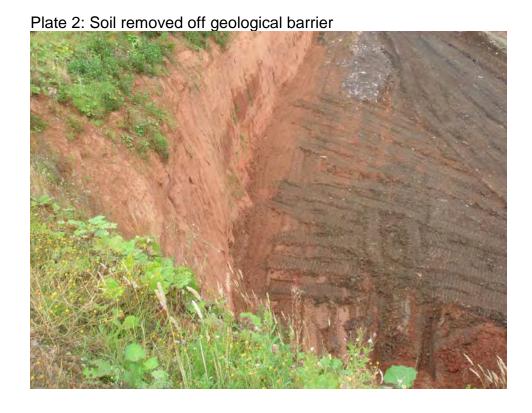
Some material had fallen onto the liner during the cessation of works and highlighted during an Environment Agency visit. This was subsequently cleaned off prior to placement of additional lifts. No other non-conformances were reported during the placement of the geological barrier side wall seal in Phase 3 Lifts 1 to 12.

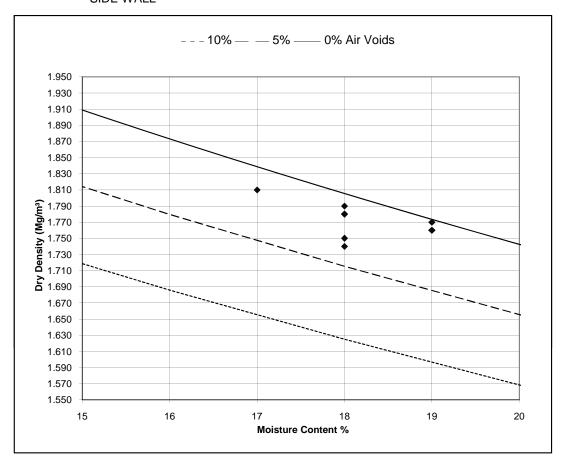
Graph 1 2.675 Average SG SIDE WALL

All of the plots were above the 5% air voids line.

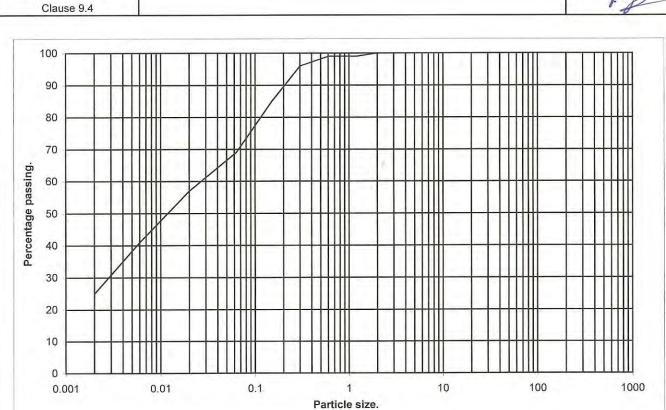
Lift 3

% Clay	25	
% Silt	44	
% Sand	31	
% Gravel	0	
% Cobbles	0	
P. C. M. W. Landson

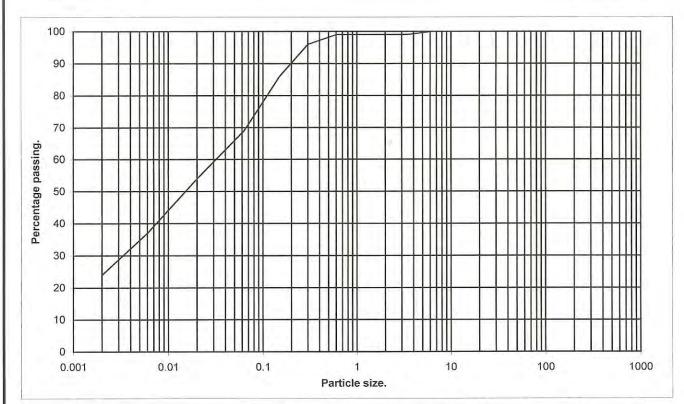
Lift 7

% Clay	24
% Silt	45
% Sand	30
% Gravel	1
% Cobbles	0

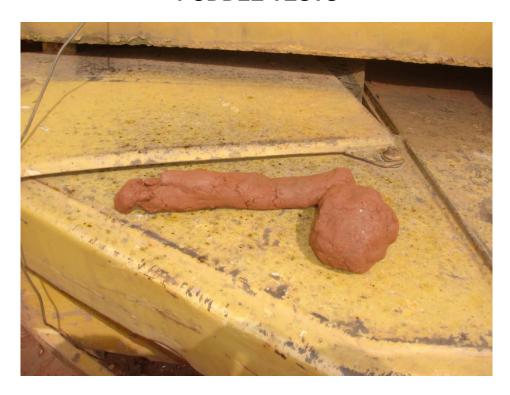
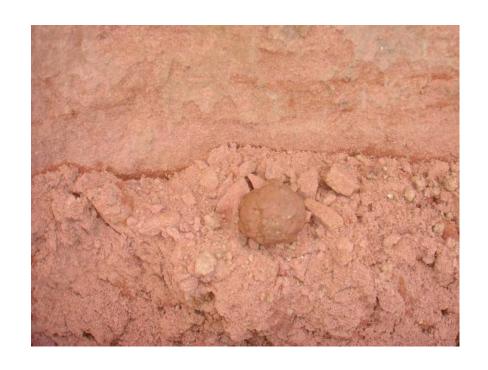
CHADWICH LANE QUARRY PUDDLE TESTS

Tests were carried out in accordance with the Environment Agency guidance to ensure that the clay could be rolled in to ball and form a sausage shape without cracking. The results are presented at Appendix 6. Compaction moulding was assessed viewing a removed core cutter also presented at Appendix 6. No fissures of major voids were reported.
