025/5003/AG/cc

15<sup>th</sup> January 2025

### Lower Edge Quarry – well repair and sampling

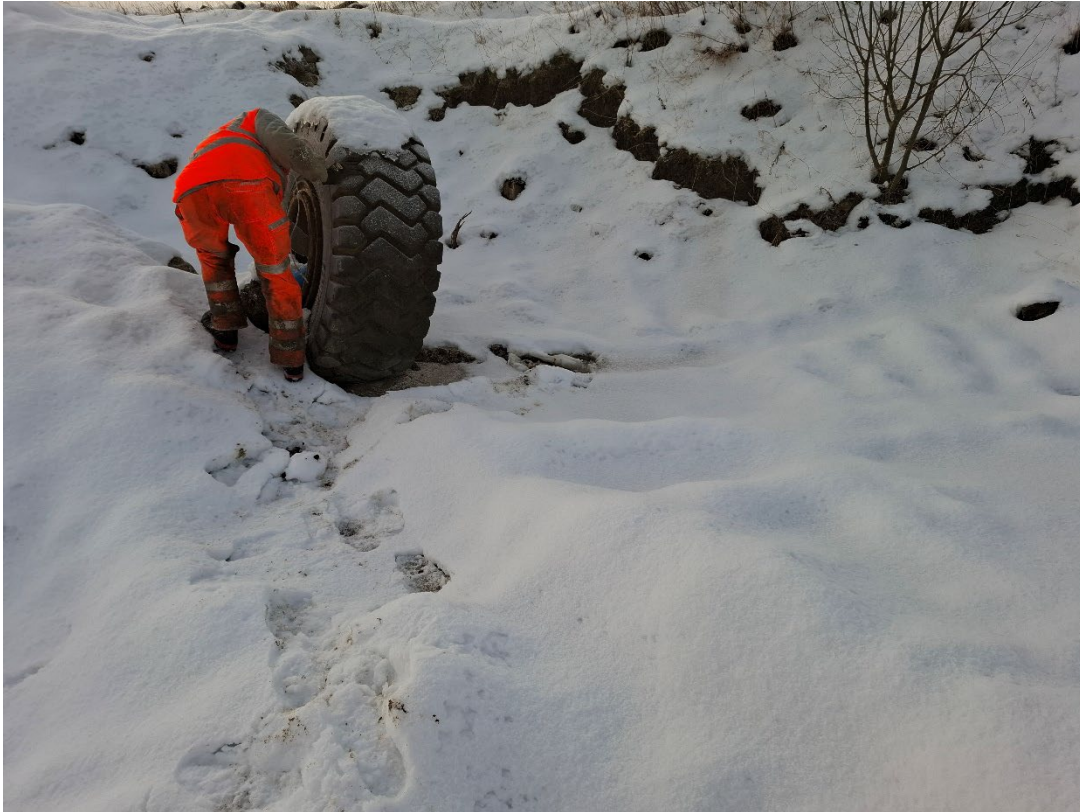
BH04 Before Repair

Both BHs 04 & 05 were protected using large vehicle tyres after installation in November 2024. The vehicle tyre used to protect BH04 had been moved and was upstanding, and the top section of pipe and well cover had been removed and relocated c. 5m from the original well position. At the time of visit 3, the ground was covered in snow, giving limited visibility. It was decided to wait until the snow thawed to further inspect the area for potential well remains.

On the 13<sup>th</sup> January, under the instruction and supervision of a Lithos engineer, a tracked excavator slowly scraped the surface within the vicinity of BH04's original location. Both the 50mm and 19mm pipes were discovered c. 0.8m below original ground level.

A full length of plain pipe (1m) and around 30cm of slotted pipe had been removed during the destruction of the well and the remaining 19mm pipe was blocked with soils. Due to the blockage and damage to the slotted pipe, a new 3m pipe length comprising 2m slotted, 1m plain 19mm pipe was installed.

It is clear from the above that 3.24m at the base of the well has been blocked/filled with soil and/or stones and 1.69m of the response zone is blocked, leaving 2.31m available. Attempts were made to dislodge and remove the materials from the base of the well using a surge blocker and waterra tubing.

The 50mm pipe had been broken and therefore the damaged section of 50mm pipe was removed and replaced with a new length of plain 50mm pipe, to bring the installation back up to original ground levels.

A new cover and bentonite seal was also installed.

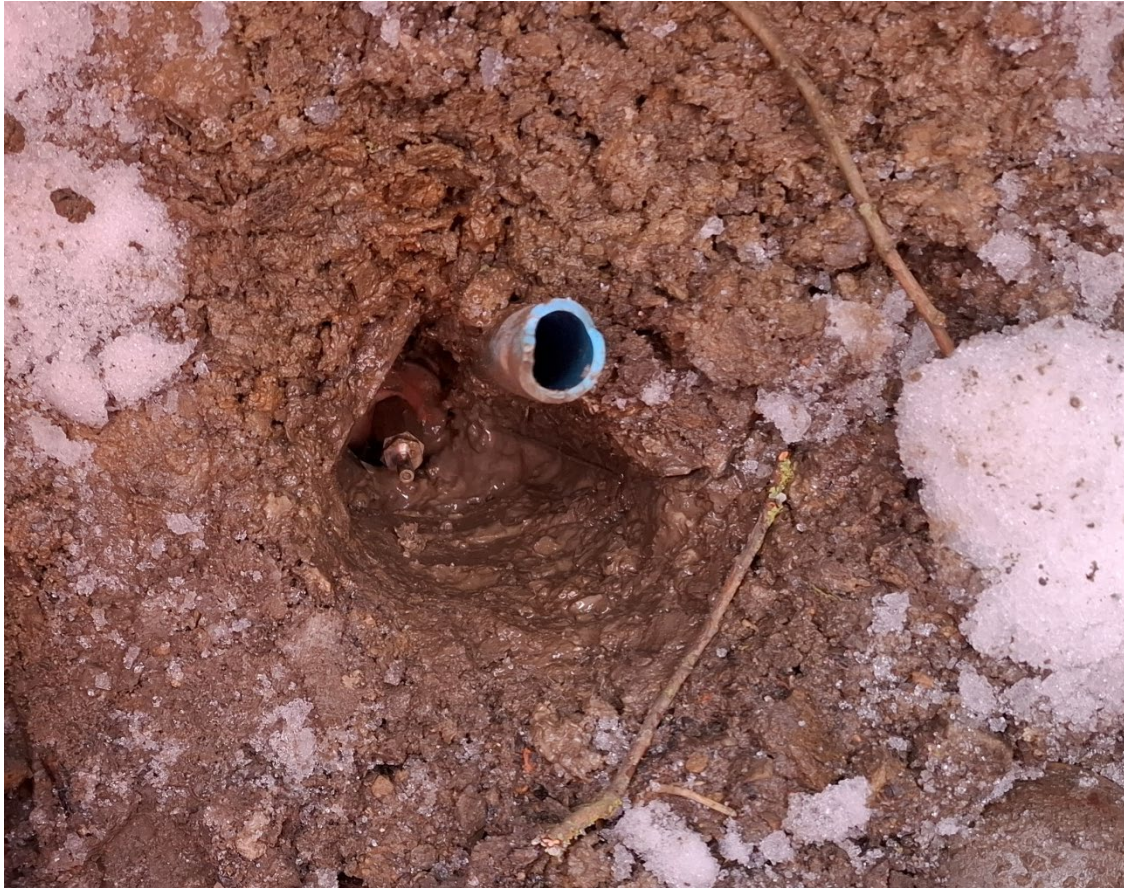
BH05 Before Repair

Damage to BH05 was less severe and comprised removal of the raised cover, snapping of the top c. 0.4m of the 19mm pipe and removal of the top section of 50mm plain pipe to c. 0.5m below ground level.

Both the 19mm pipe and 50mm pipes were dipped to determine the damage to the response zones. It can be seen that no damage has occurred for the 19mm pipe, however, the base of the 50mm pipe has been raised to 38.60m bgl.

The tracked excavator lowered surrounding ground levels, to expose the 50mm pipe that was below ground. A new section of pipe was added to raise the installation to original ground levels and the well cover and bentonite seal was replaced.

A surge blocker and watterra tubing was used to dislodge the material from the base of the well, which resulted in 0.42m of pipe being cleared, leaving an available response zone of 3.52m.
