Construction Quality Assurance Report - Silage Clamp

The following CQA report covers the silage clamps used to store silage and feedstock for the anaerobic digester at Much Fawley Farm. Construction details for the in-situ poured can be found in the attached drawing EMS Section 18. 01180-03-B Much Fawley "Wall and Floor construction". The construction is in situ poured walls in front of sandstone back wall to the north and horizontal precast panels along the southern side. The horizontal panel construction detail is identical to the bund construction in drawing 01180-01-A Horizontal Panel Install.

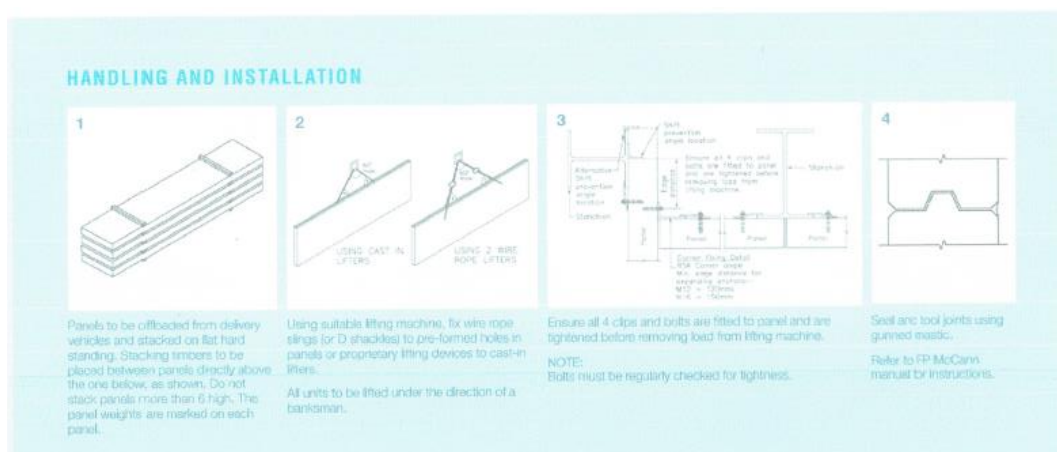
Wall and pad integrity visually checked prior to use. Installation carried out as per digrams below. Leak detection pipework left uncovered following initial use to observe for issues. Leak detection checked with Ammonia test kit and results recorded.
