20.0576/CB/KJH
28 July 2020

LONGCROSS FILM STUDIOS, CHOBHAM LANE, LONCROSS, CHERTSEY, KT16 0EE FOUNDATION INSPECTION PIT FINDINGS

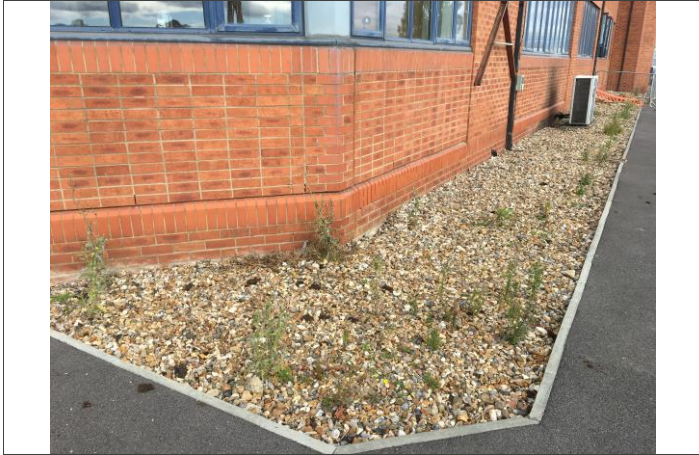
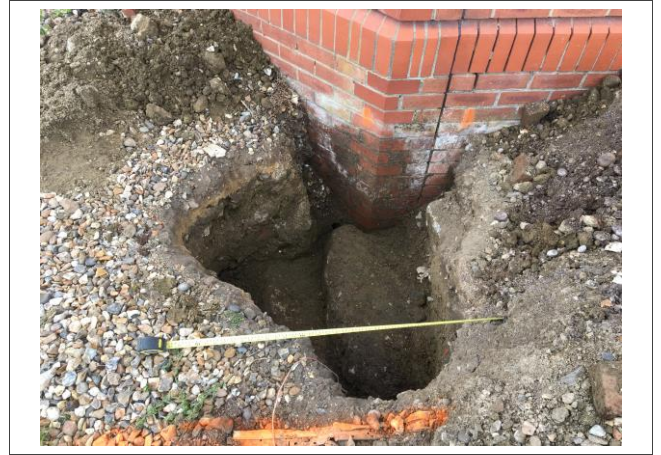
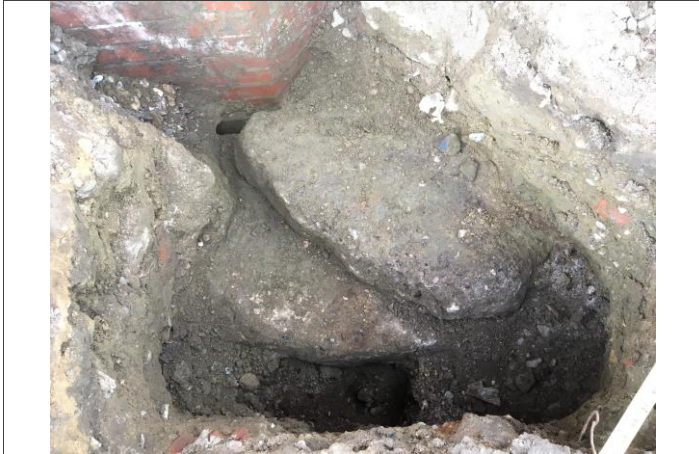
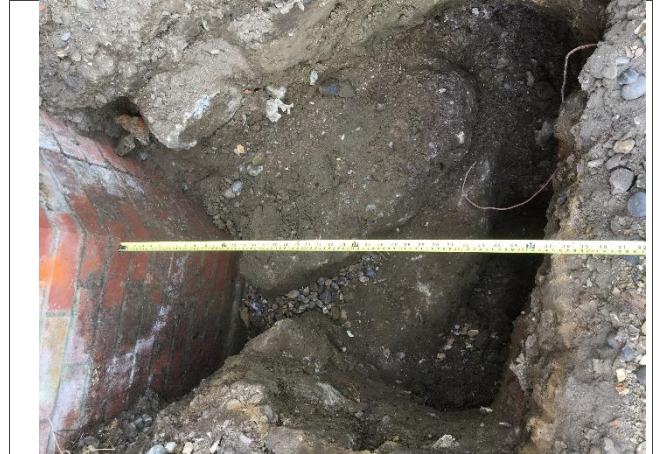
05: HDP1

HDP1 identified two large concrete blocks, both 200mm and dipping slightly northwards. It was not possible to find the lateral extent of the slabs due to the presence of services. These slabs filled the majority of the safe working area, and it was not possible to dig deeper without breaking the slab. The decision was made not to break the slabs, in case they were articulation slabs and serve a purpose.

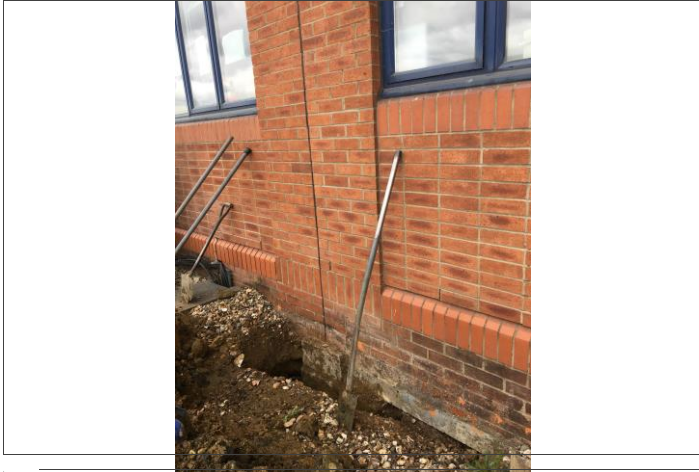
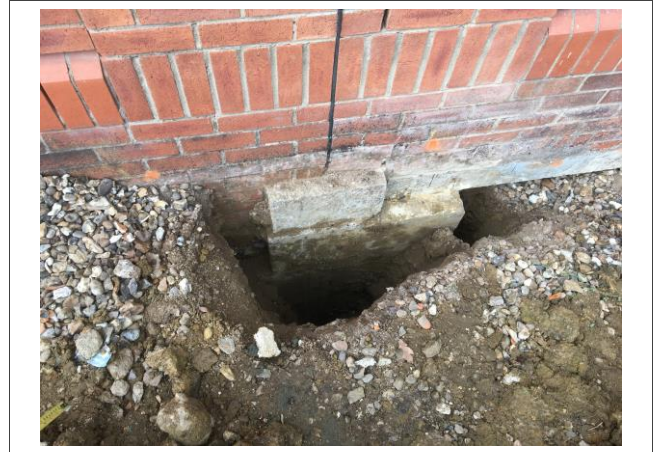
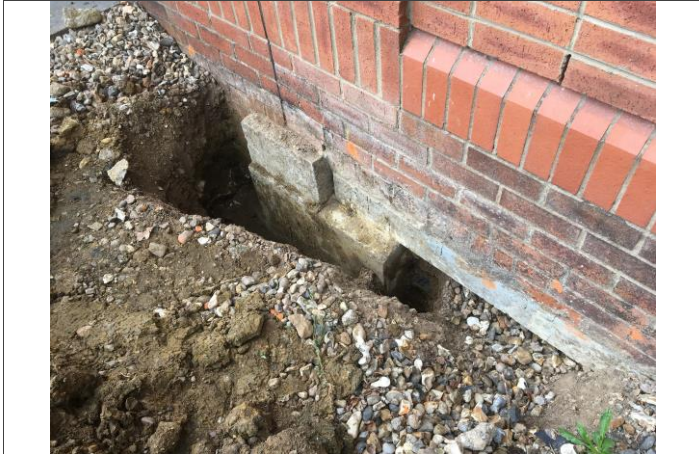
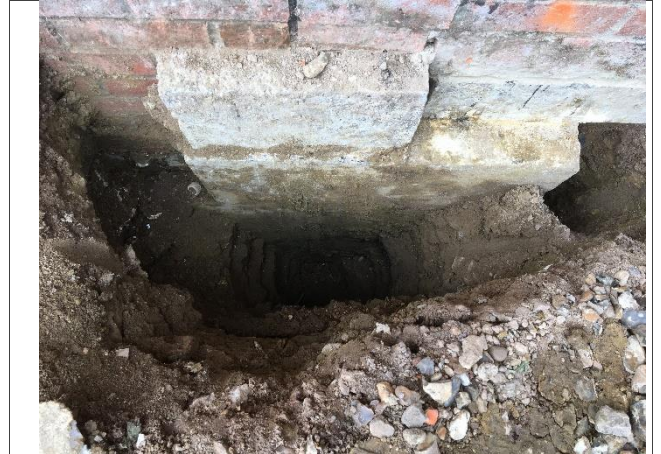
09: HDP2

Columns were identified in HDP2 and HDP4, which extending to a depth of 1.8mbgl and 2.05m respectively where a flat concrete bed was encountered. It was assumed that this was a pad footing. It was not possible to find the extent of the pad due to the presence of services.

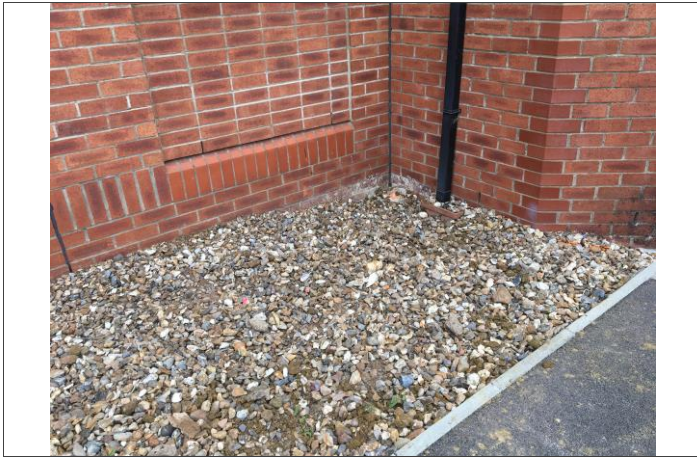
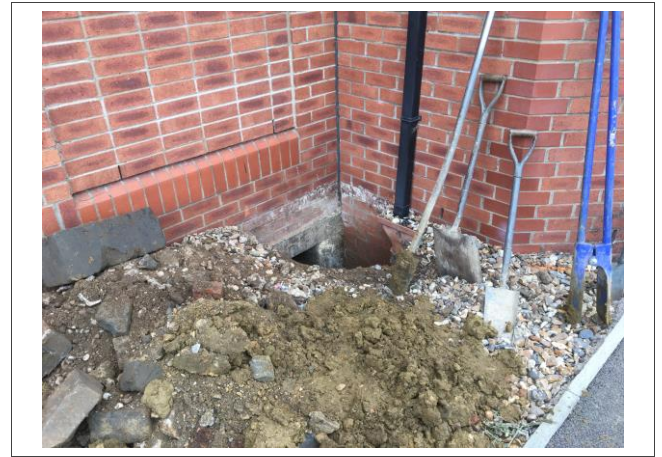
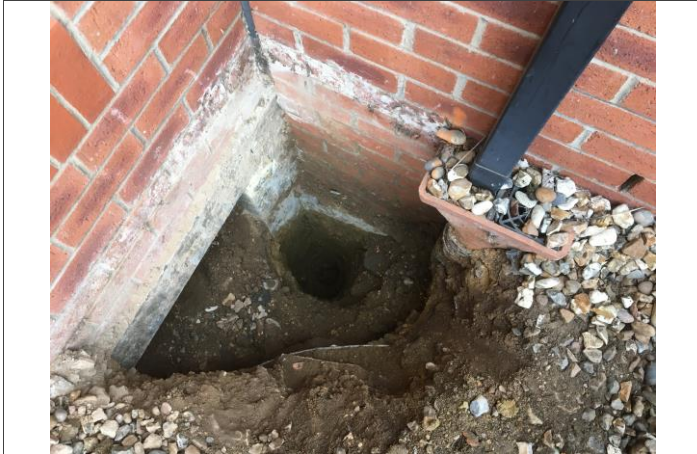
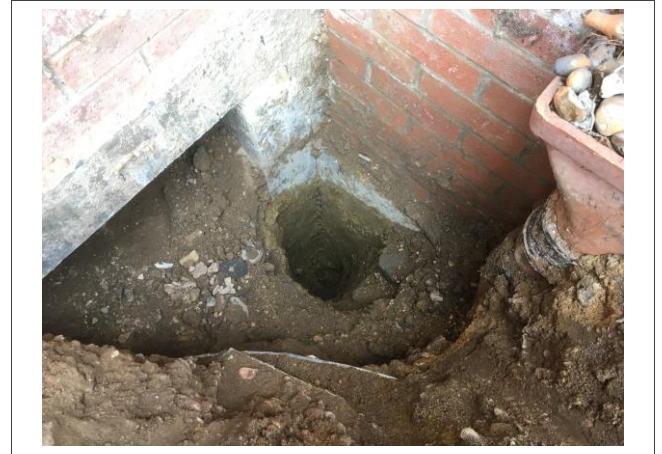
13: HDP3

HDP3 was excavated within a corner against the site of the stairwell and wall, and was slightly different to the remaining pits as it had brickwork on the side of the stairwell to a depth of 0.75m bgl, before extending onto a concrete column to 1.85mbgl. The photographs of this position show that a column was also present on the perpendicular wall and a suspended floor slab was present beneath the ground floor level.

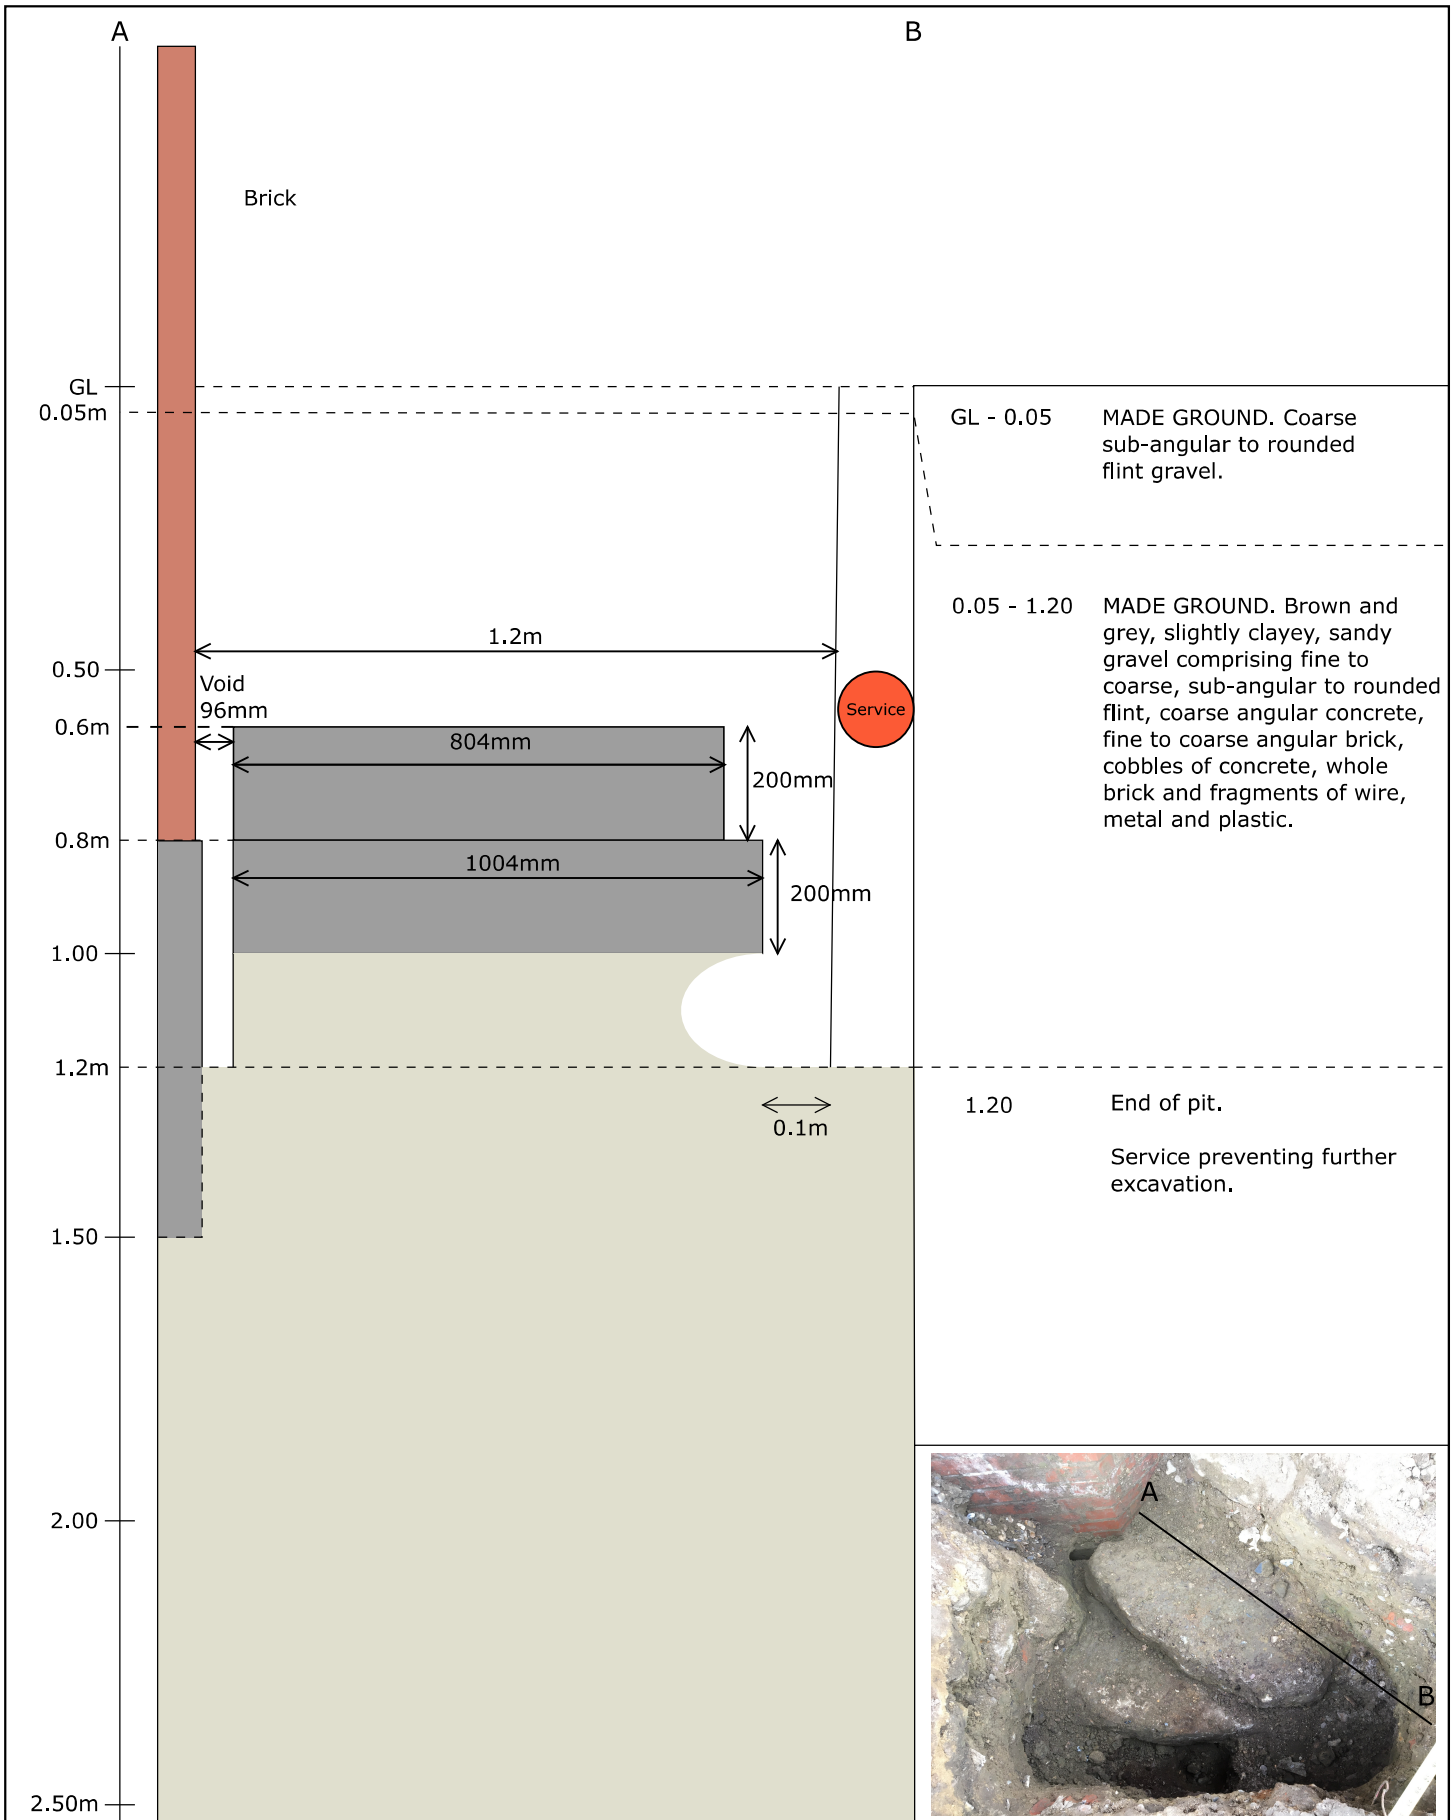
Paragon Building Consultancy The Harlequin Building 65 Southwark Street London SE1 0HR 0207125 0112 www.paragonbc.co.uk	Project Longcross Studios	Drawing Number 1
		Drawing Title HDP 1	Date 17/07/2020

GL - 0.05 MADE GROUND. Coarse sub-angular to rounded flint gravel.

0.05 - 1.20 MADE GROUND. Brown and grey, slightly clayey, sandy gravel comprising fine to coarse, sub-angular to rounded flint, coarse angular concrete, fine to coarse angular brick, cobbles of concrete, whole brick and fragments of wire, metal and plastic.

1.20 End of pit.
Service preventing further excavation.
