**AN APPLICATION FOR AN ENVIRONMENTAL PERMIT
TO AUTHORISE THE DEPOSITION OF WASTE ON
LAND AS A RECOVERY ACTIVITY FOR THE
RESTORATION OF PHASES 12, 13A AND 13C AT
BROOKSBY QUARRY, MELTON ROAD, BROOKSBY,
LEICESTERSHIRE**

STABILITY RISK ASSESSMENT

Report reference: TAR/BRO/TWC/3236/01/SRA
November 2024

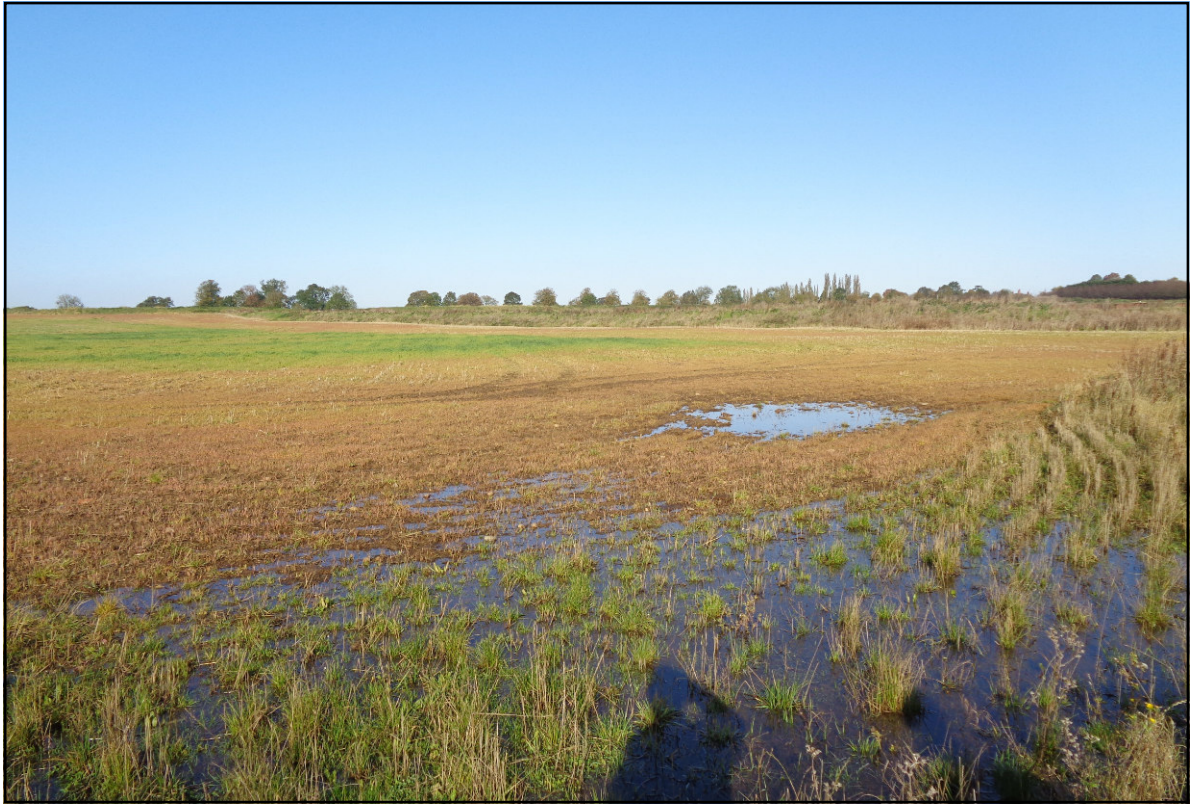
Photo 1. Backfilled Phases 5-8.

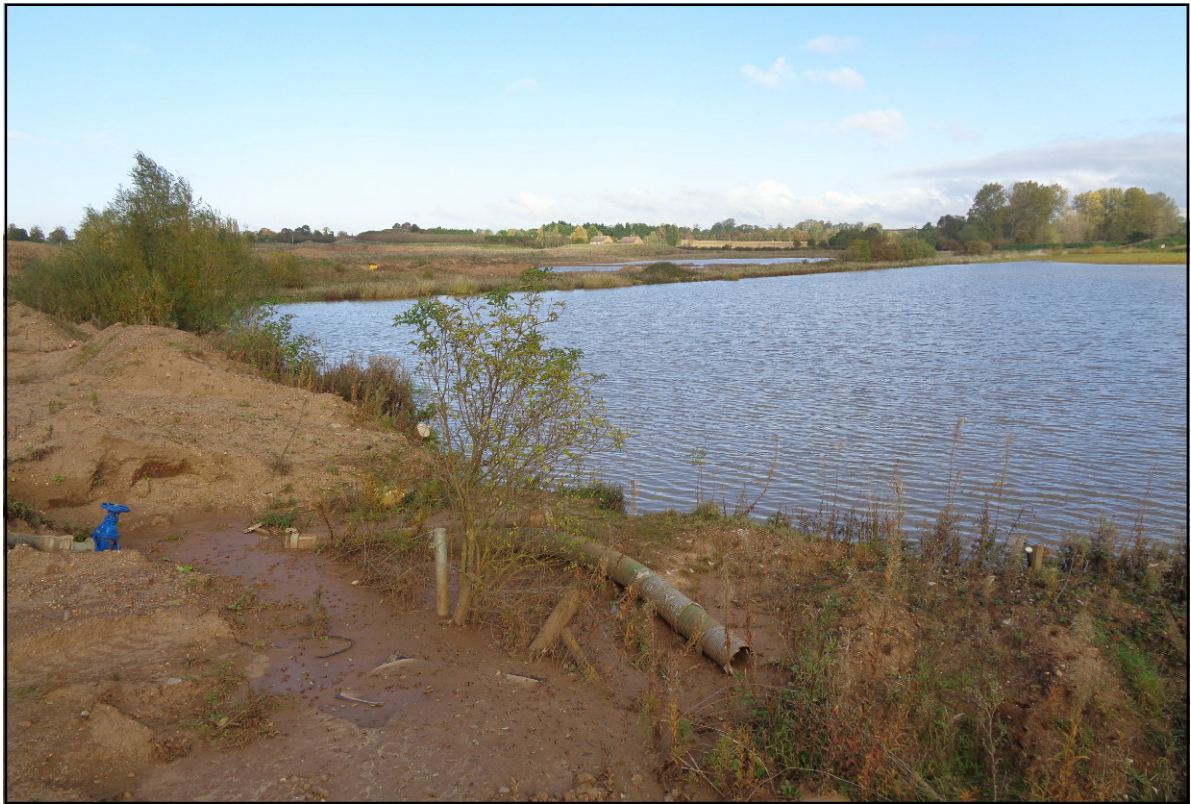
Photo 2. View of Silt Lagoon No.1, looking north.

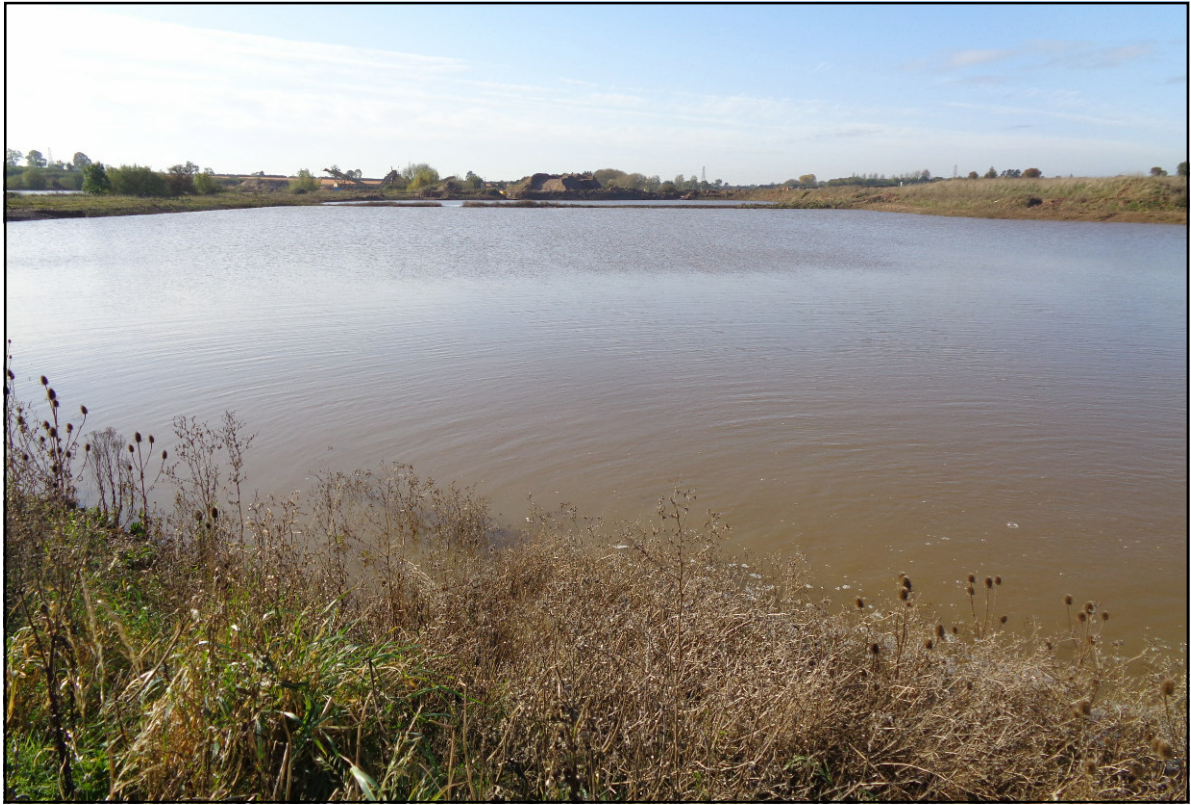
Photo 3. Recently constructed silt lagoons.

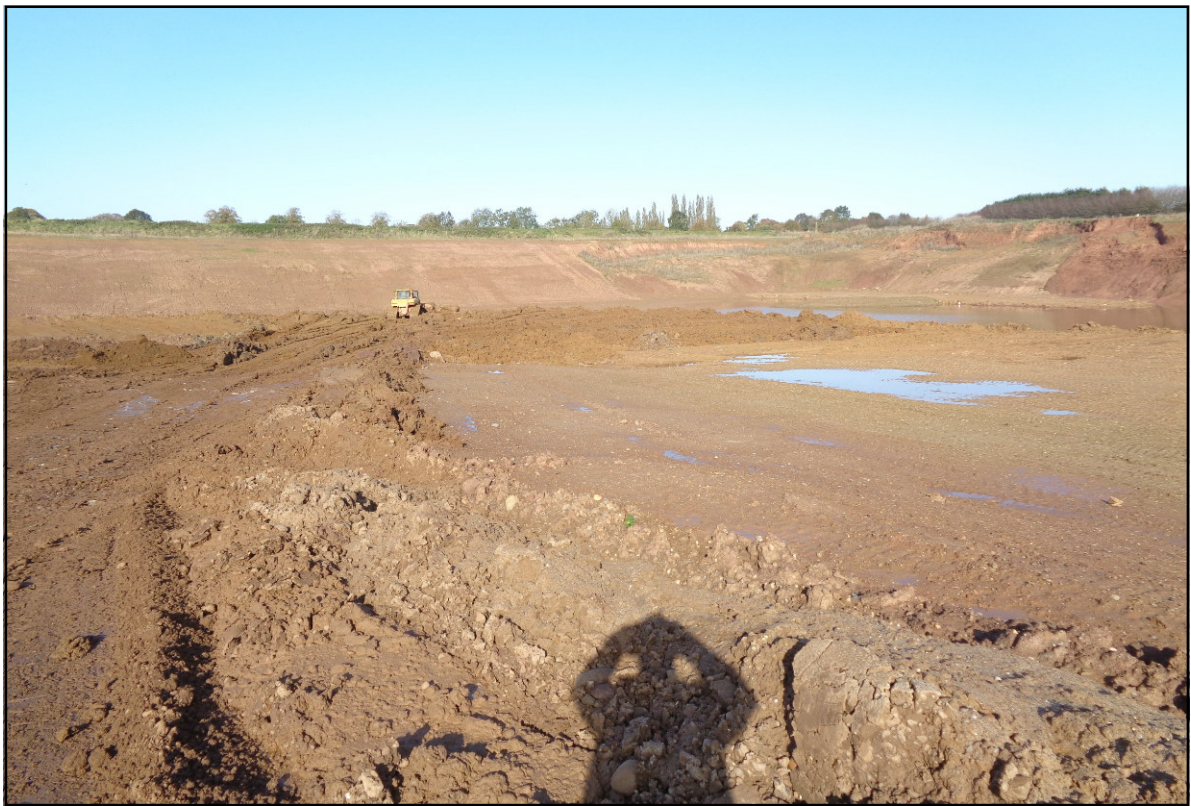
Photo 4. Inert Landfill (Phase 10)

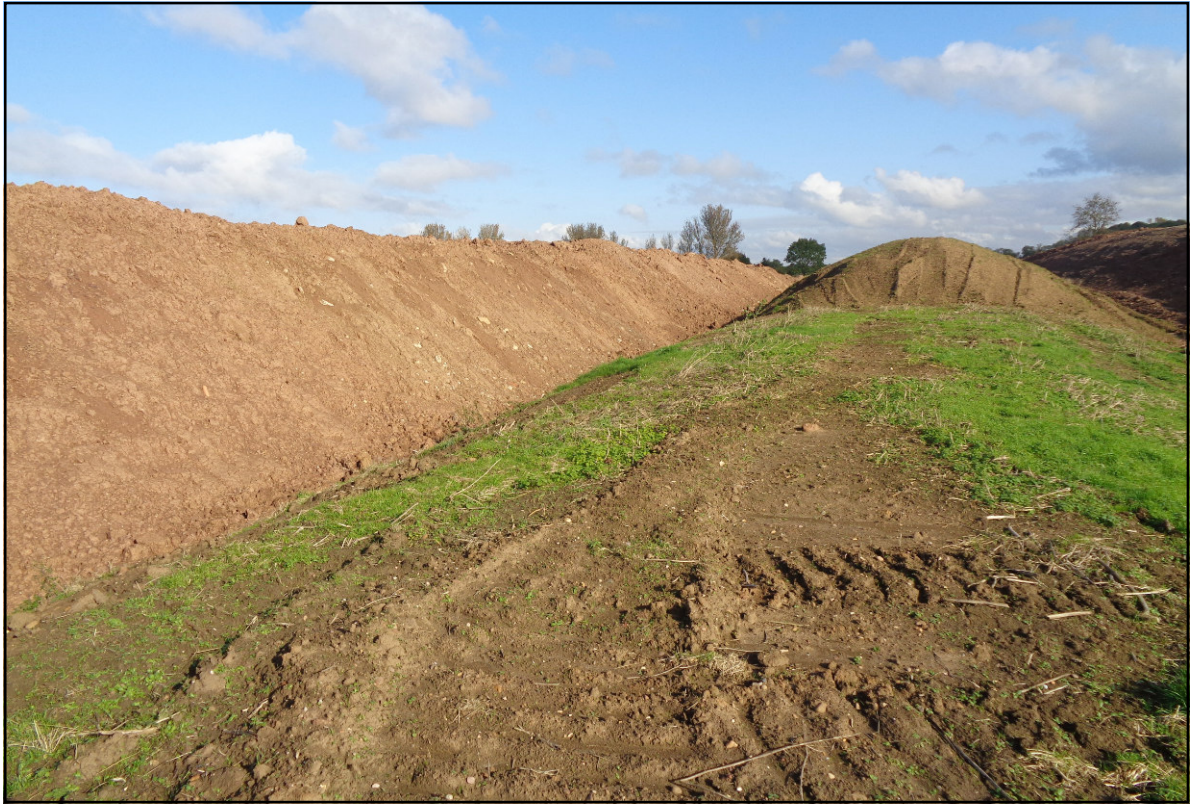
Photo 5. Overburden Mounds.

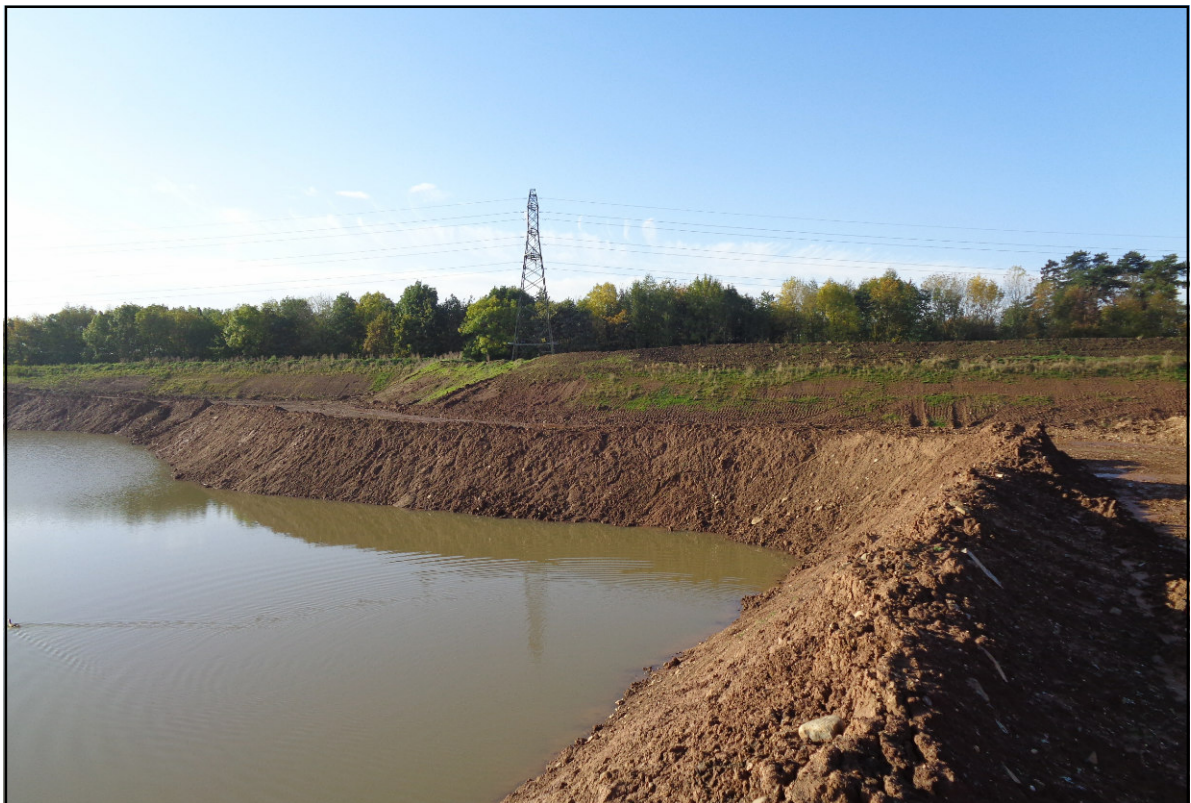
<p>north pylon was noted. No evidence of slope distress noted. See Photograph 6.</p> <p>4. Restoration Lake; high water level within lake compared to flooded Phase 13 excavation, narrow dividing bund separates the two water bodies. It is recommended that the water level within the Restoration Lake be reduced to equalise the head differential across the dividing bund. See Photograph 7.</p> <p>5. Install lifebuoys and signage at Restoration Lake.</p> <p>6. Phase 2 Excavation has recently been flooded and extensive erosion of side slopes of the excavation was noted in the vicinity of the electricity cable post. As discussed on site it is recommended that the area of erosion be backfilled with coarse granular rock (the larger the blocksize the better). Once the washed out section of slope has been re-instated, the excavation may then be de-watered prior to resuming excavation. Monitor the stability of the electric cable post and the excavation via routine daily inspections. See Photograph 8.</p> <p>7. Continue to monitor stability of east slope Phase 10 excavation (currently being backfilled), numerous circular slips have occurred. Currently there is adequate stand-off behind the crest of the slope to the quarry boundary. See Photograph 9.</p>	<p>weekly inspections</p> <p>Immediately</p> <p>Immediately</p> <p>Immediately</p> <p>Monitor stability via routine daily inspections</p>

Photo 6. Electric pylon, seepage at toe of batter slope.

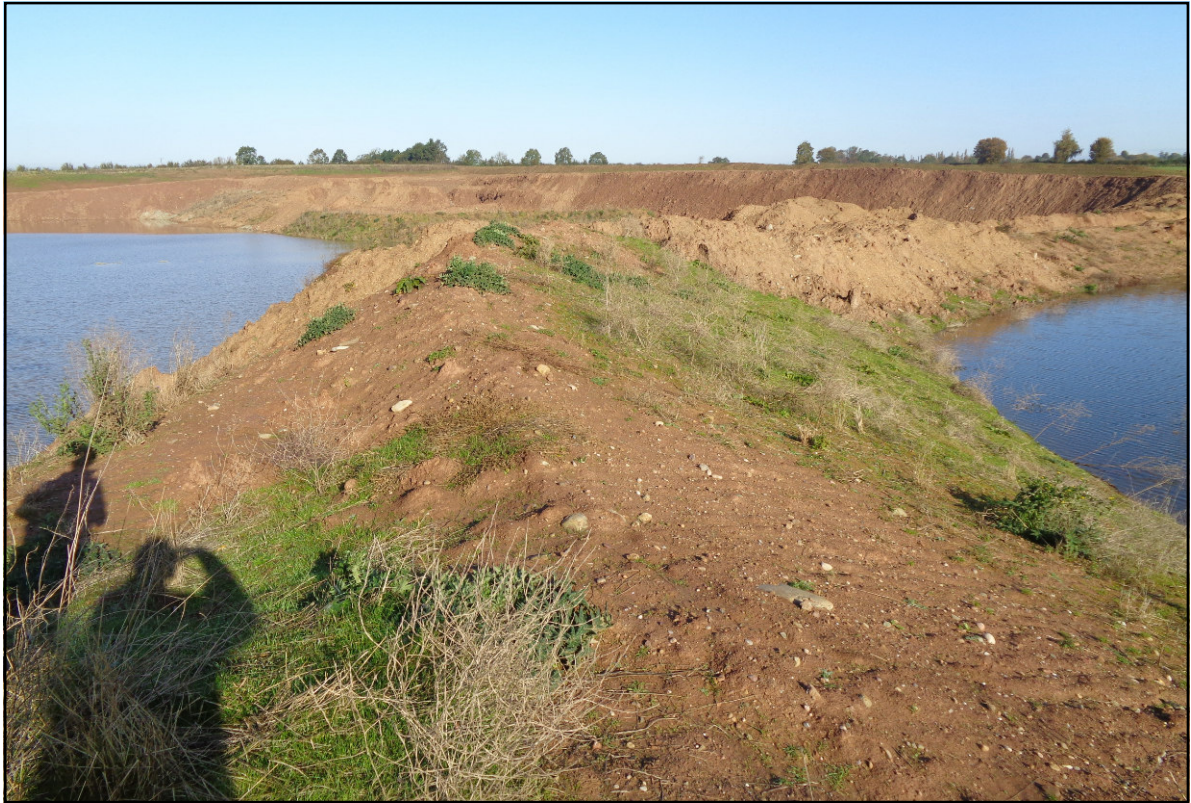
Photo 7. Differential head across dividing bund between flooded Phases 12/13
Excavation and restoration lake (RHS of photo).

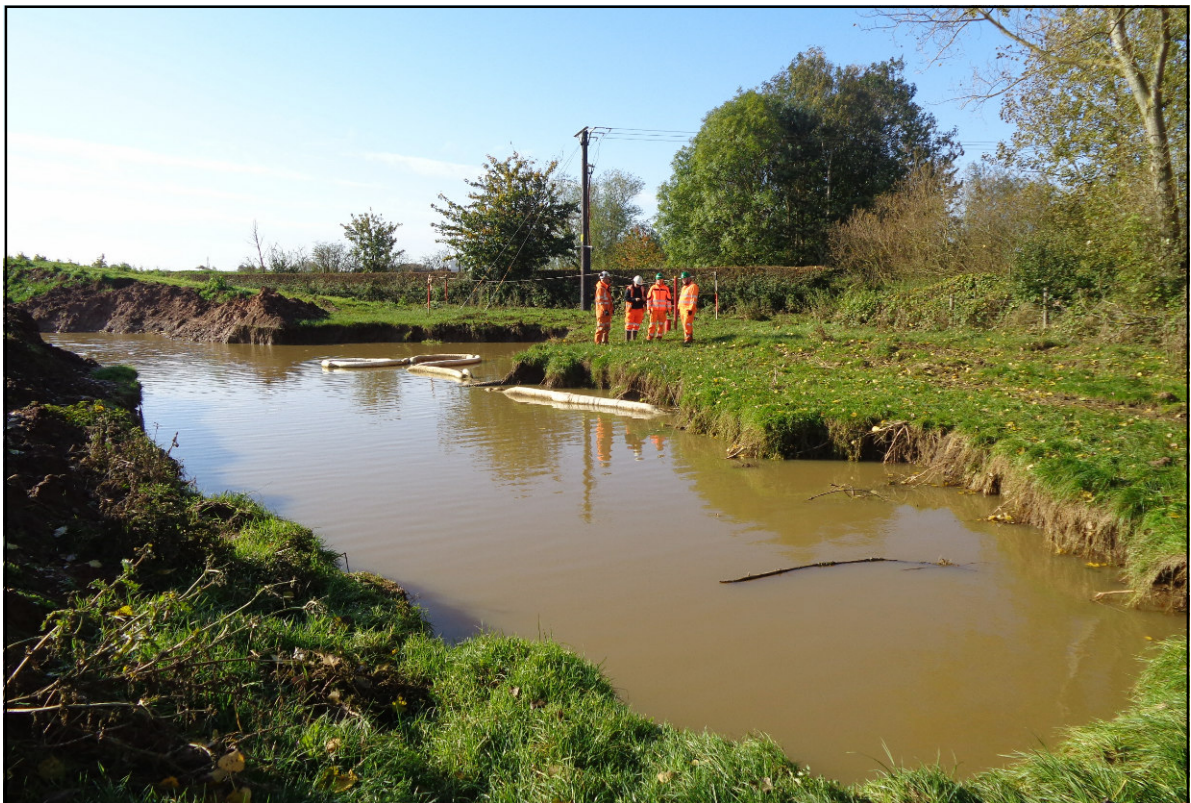
Photo 8. Flooded phase 2 excavation (area in front of personel) washed -out when
brook flooded.

- 4 Active silt lagoons - currently flooded. Sewater to achieve increased
1m freeboard. No lifebuoys or signage. End Jan '20.
Re-instate area of washout with coarse granular rock.
- 5 Phase 2 working - recent erosion following flooding of
brook, adj. to electric post.
Recommend backfill excavation with coarse granular immediately
rock (below water) immediately. Sewater excavation.
- 6 No further remedial works.
- 7 Appraisal for all new features or significant changes for info.
are required.

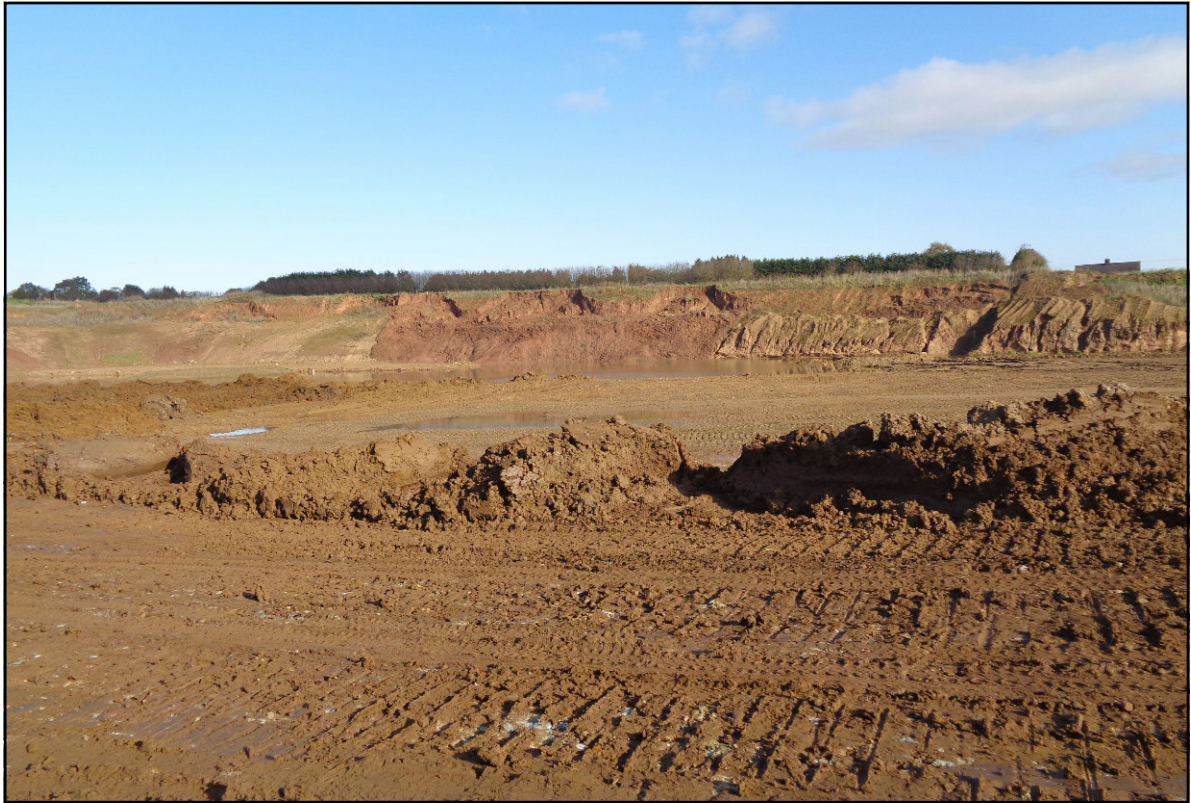
Photo 9. Surface erosion Phase 10 east slope.

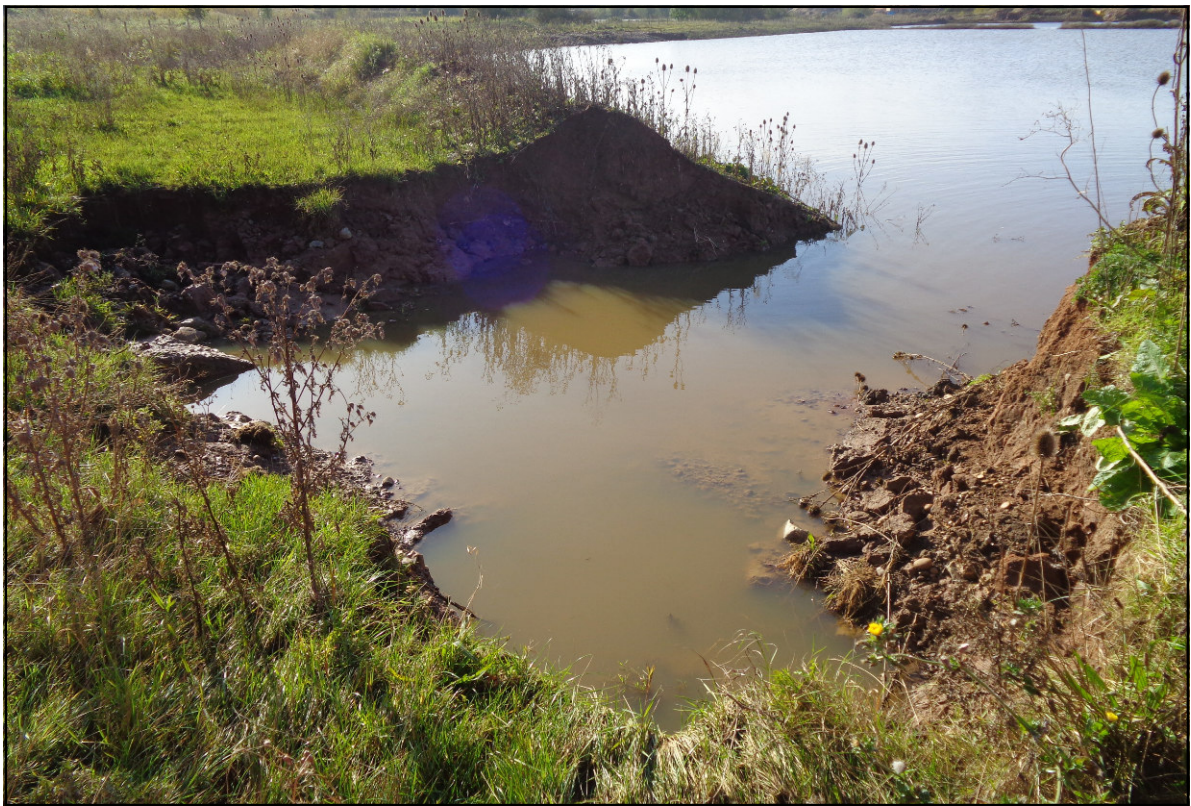
Photo 10. Surface erosion New Silt Lagoons.

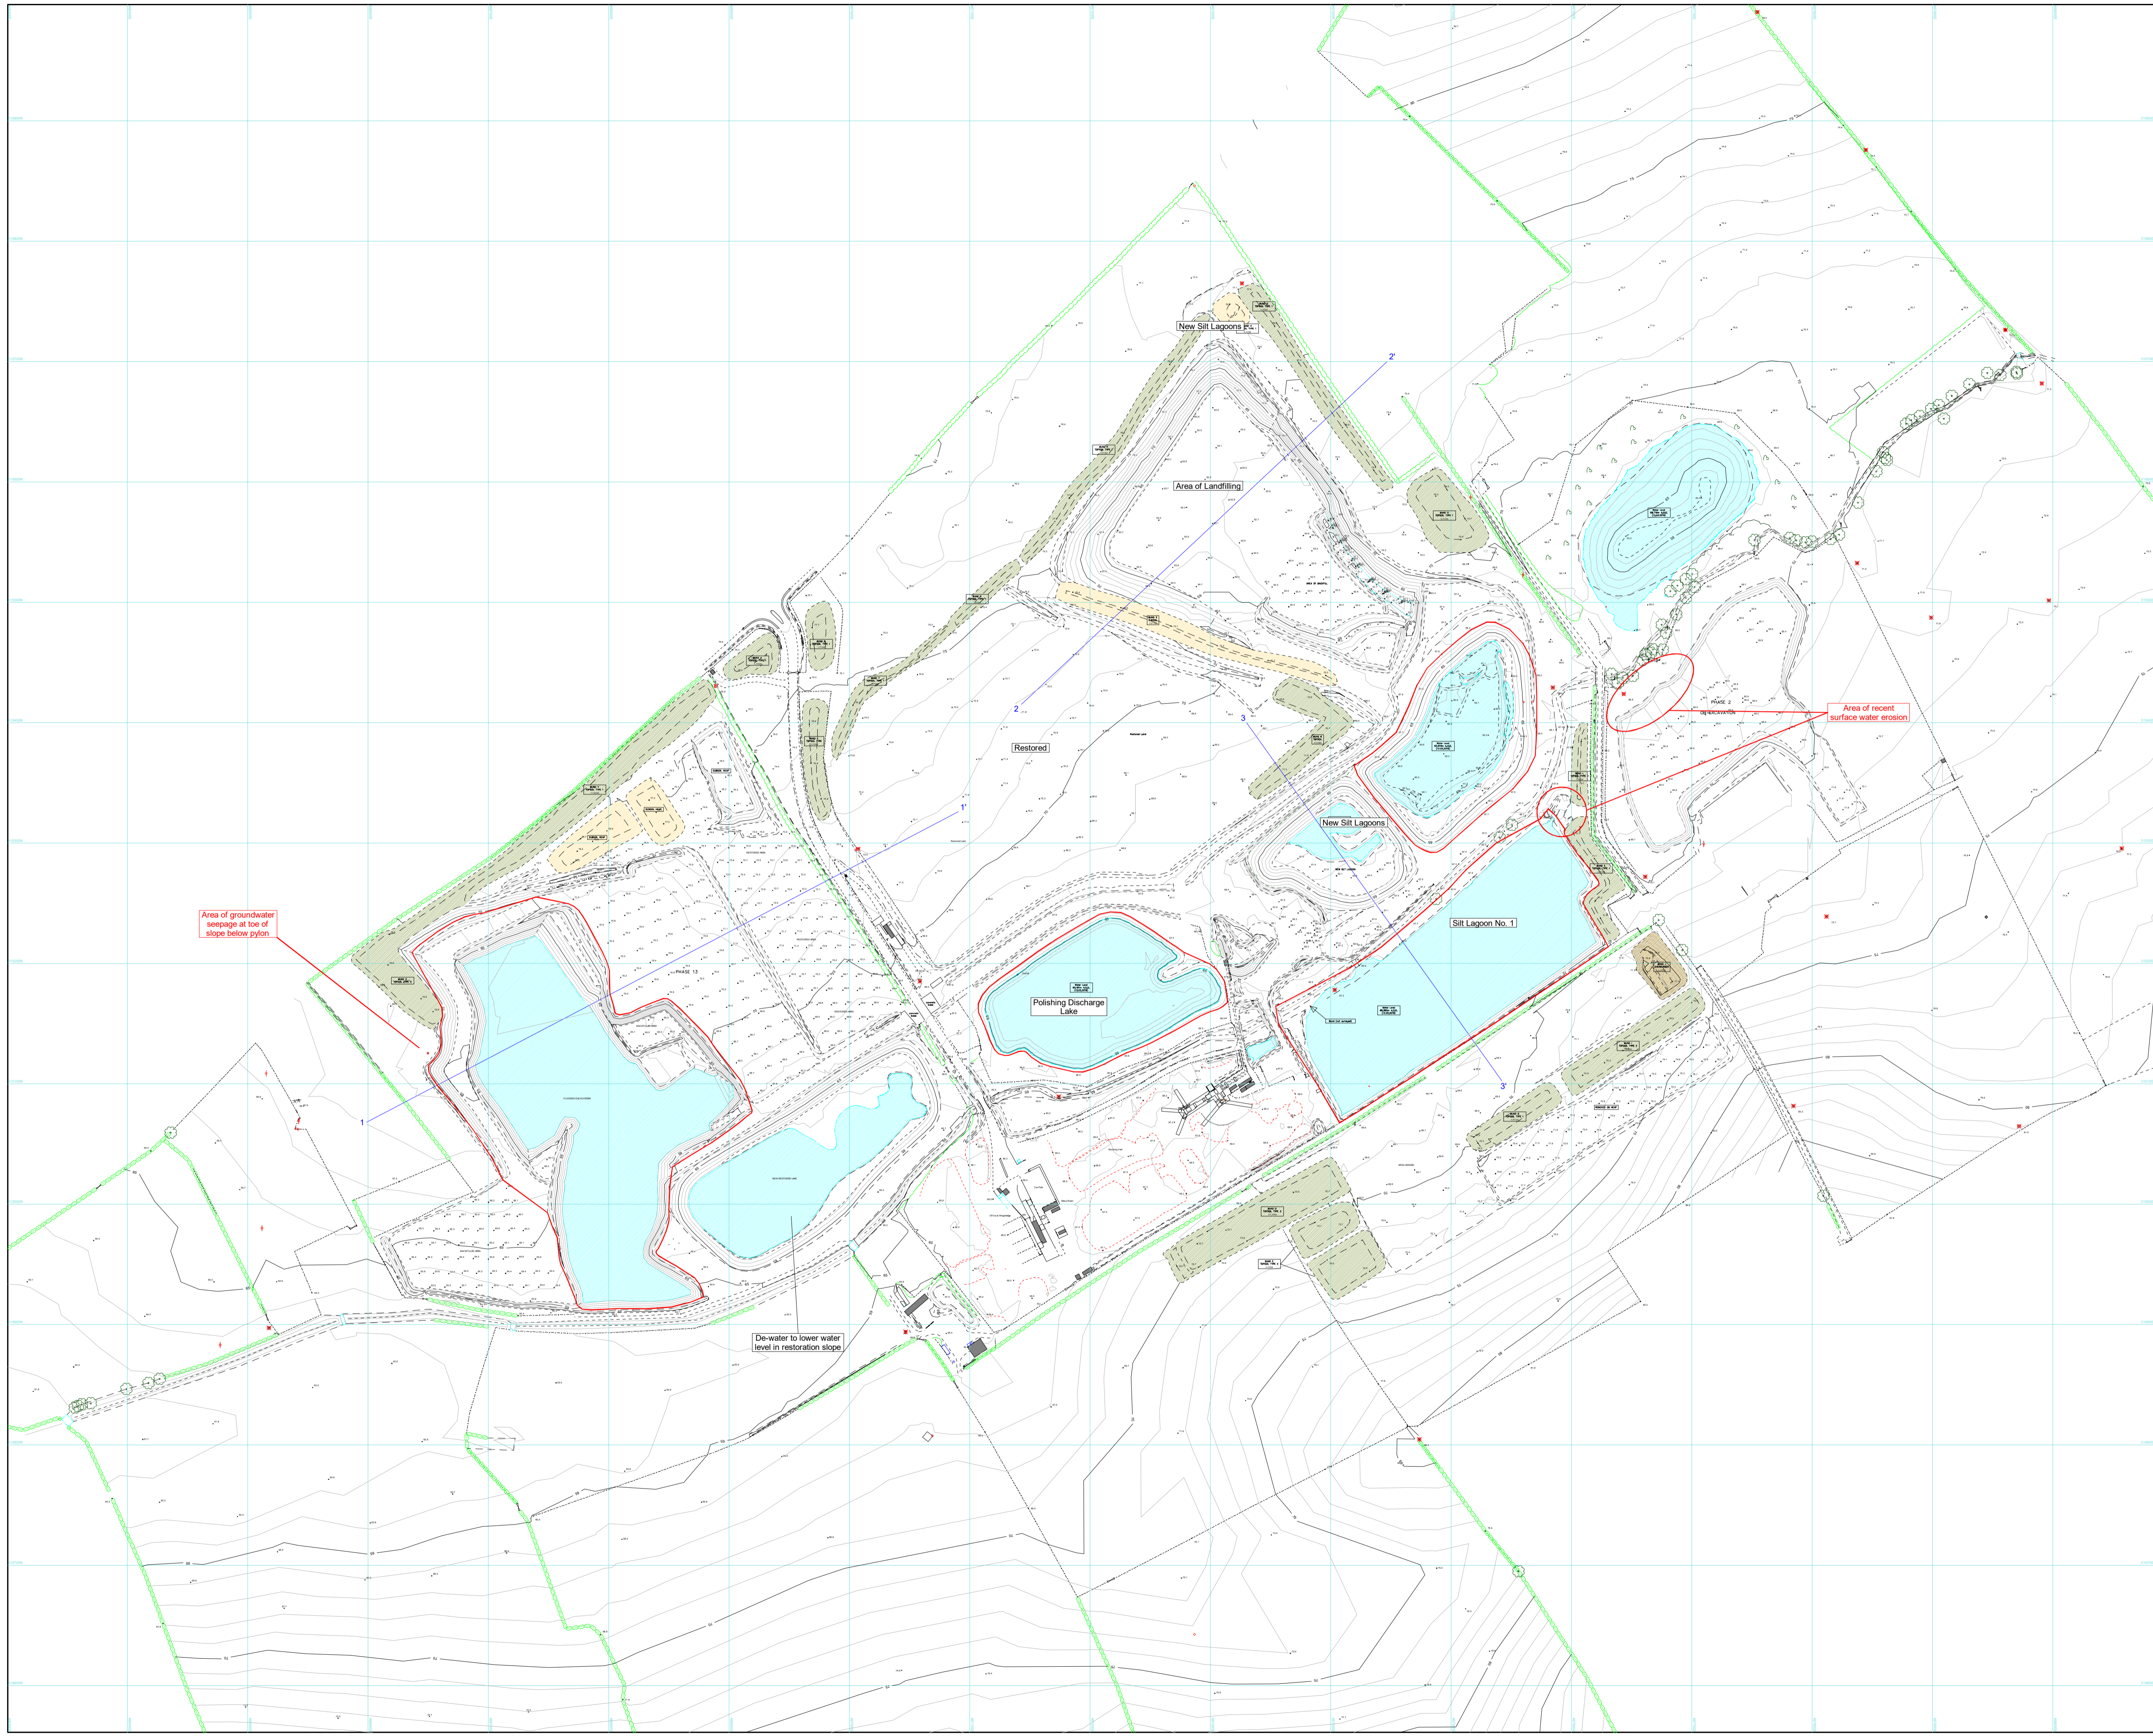
TITLE:
PLAN ON GEOTECHNICAL ASSESSMENT

Area of groundwater seepage at toe of slope below pylon

De-water to lower water level in restoration slope
