Pukka Pies Ltd

Flood Risk Assessment

**Document Number:** FC0194\_051119

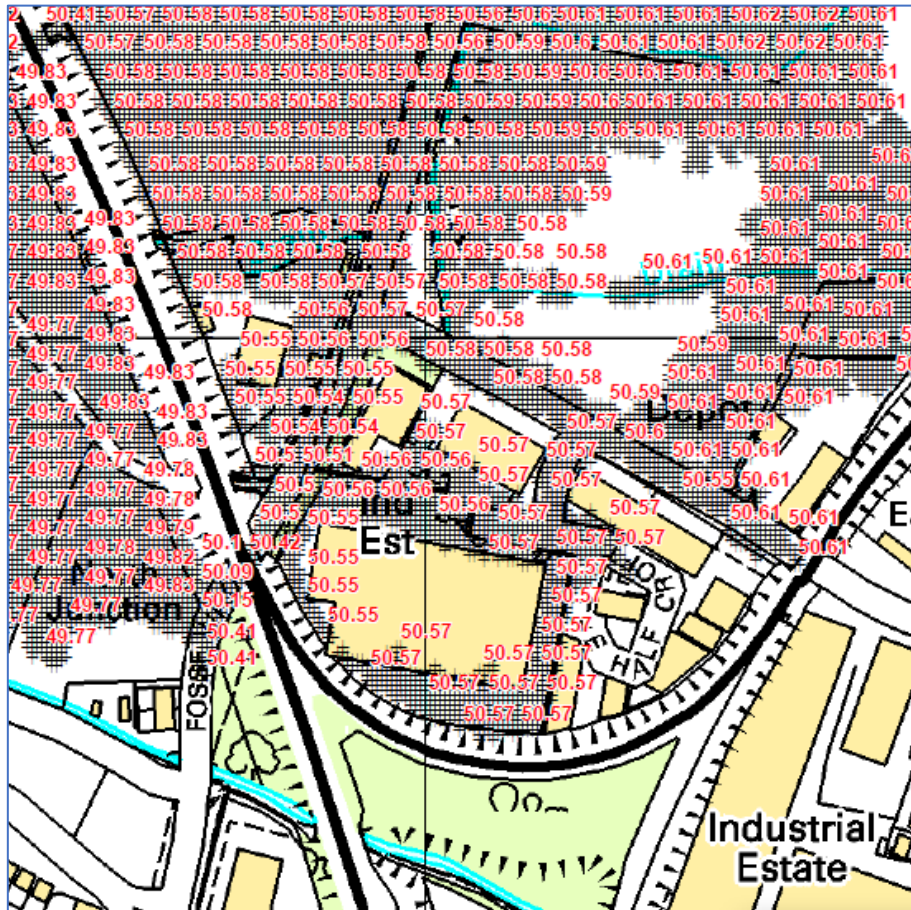
### 4.2.2.1 1% (1 in 100)

The 1% (1 in 100) flood level is deemed to be a maximum of 50.57m AOD as seen on the below extract. When the predicted flood level is projected across site, the maximum predicted flood depth is 0.51m at the lowest topographical point, 50.06m AOD near the site entrance. External ground levels on site generally vary between 50.20m AOD and 50.50m AOD and therefore widespread depths of between 0.07m and 0.37m can be expected.

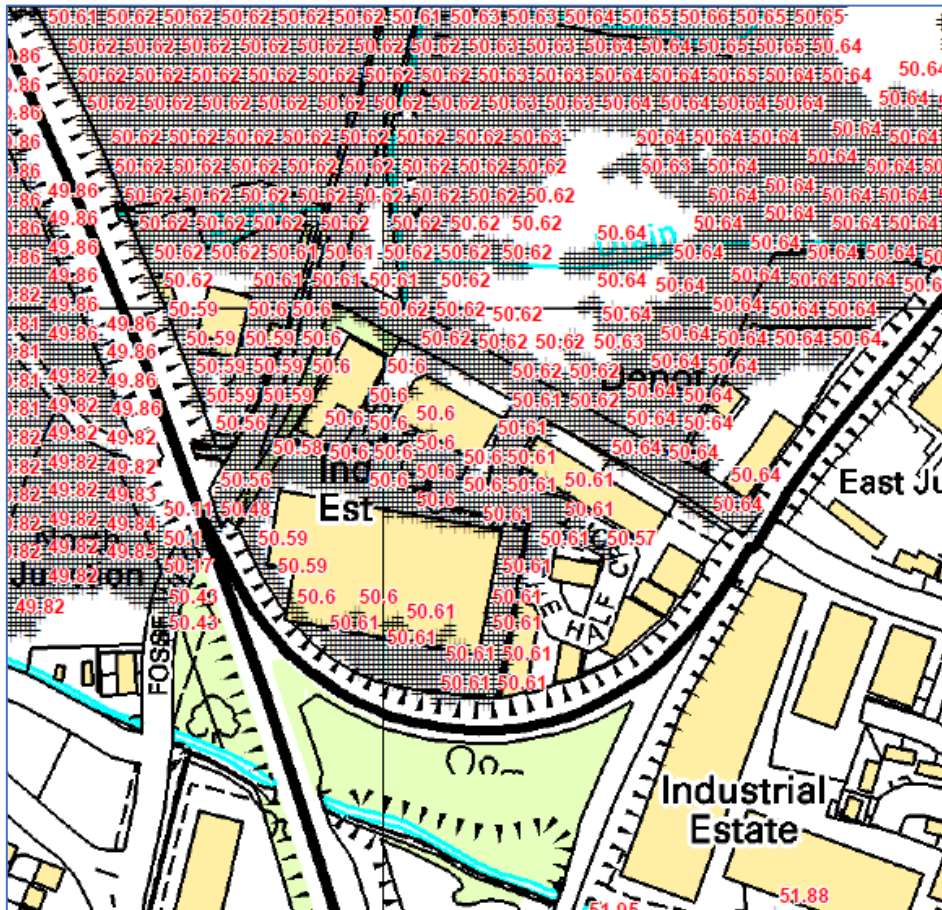
4.2.2.2 1%+20%CC (1 in 100 + 20%CC)

The 1%+20%CC (1 in 100 + 20%CC) flood level is deemed to be a maximum of 50.61m AOD as seen on the below extract. When the predicted flood level is projected across site, the maximum predicted flood depth is 0.55m at the lowest topographical point, 50.06m AOD near the site entrance. External ground levels on site generally vary between 50.20m AOD and 50.50m AOD and therefore widespread depths of between 0.11m and 0.41m can be expected.

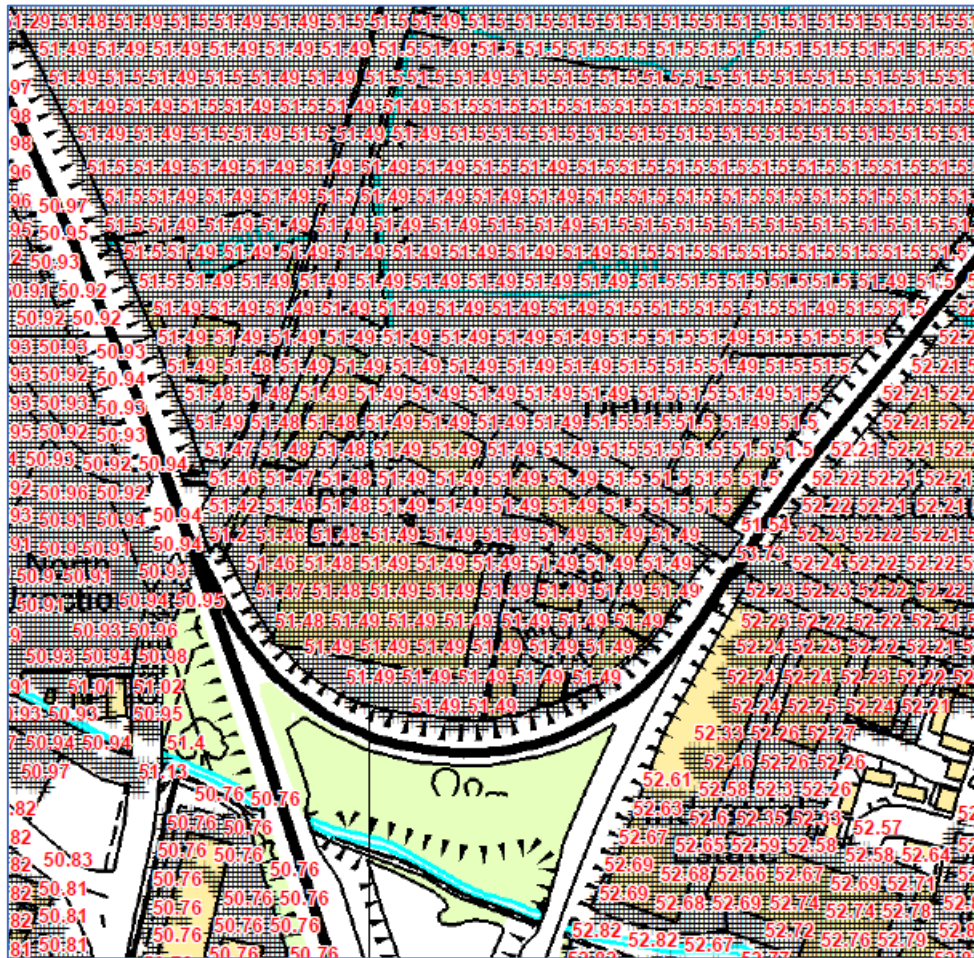
### 4.2.2.3 0.1% (1 in 1000)

The extreme 0.1% (1 in 1000) flood level is deemed to be a maximum of 51.49m AOD as seen on the below extract. When the predicted flood level is projected across site, the maximum predicted flood depth is 1.43m at the lowest topographical point, 50.06m AOD near the site entrance. External ground levels on site generally vary between 50.20m AOD and 50.50m AOD and therefore widespread depths of between 0.99m and 1.29m can be expected.

As noted in section 4.2.2.3 of this report the flood levels within the site boundary to drastically increase during a 0.1% (1 in 1000) to the point where all buildings and assets would suffer inundation. However, the 0.1% (1 in 1000) return period is considered to be an extreme occurrence and is only utilised when considering sites of critical national infrastructure (electricity substations, nuclear power plants etc.). Therefore, as the site location is utilised for commercial/industrial purposes, detailed evaluation to the 0.1% (1 in 1000) is not considered justified and is noted for information purposes.

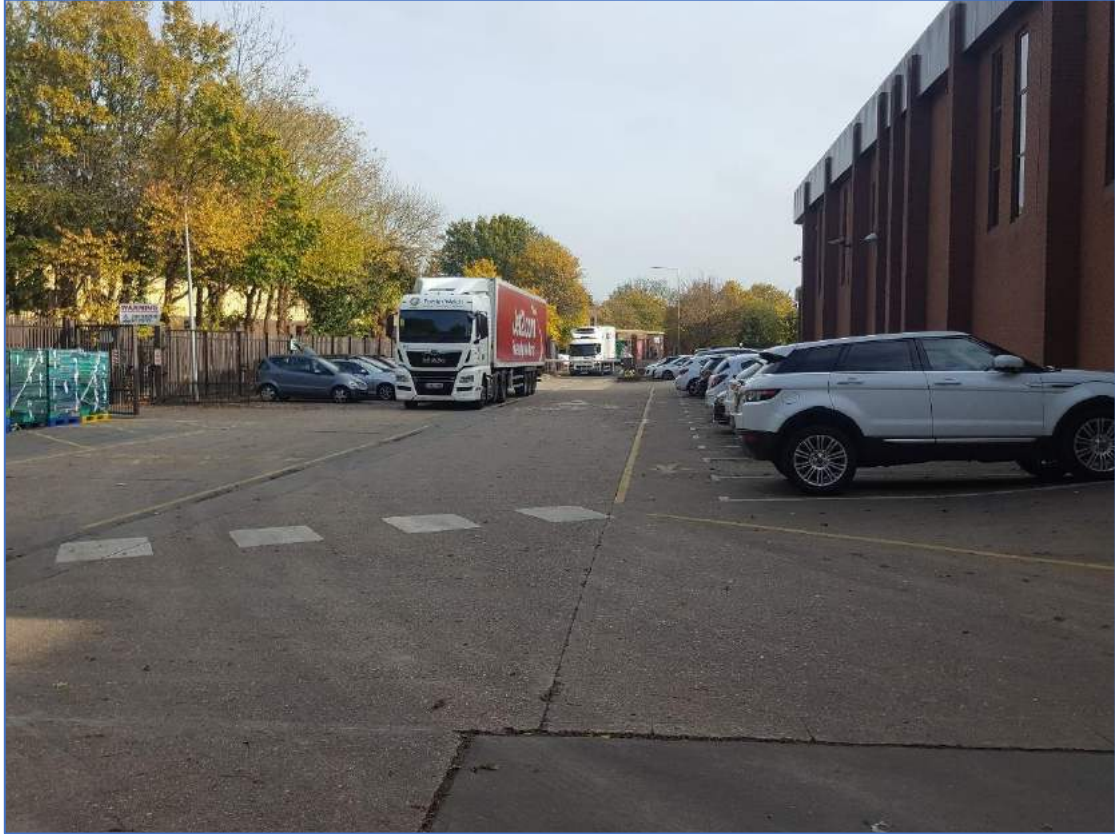
Cars are mainly parked on the northern perimeter of the main building and southern perimeter of the packaging warehouse where predicted flood depths of between 0.2 and 0.5m are expected. Depths of flooding of up to 0.5m are likely to cause mechanical and aesthetical damage to all cars parked onsite.

Photo 7 – Car park area on the northern perimeter of the production building

Given that the access roads to the site are lower and will flood first, in the event of a flood warning being issued in the locality, all employees should be informed to evacuate site as quickly as possible to ensure vehicles can be safely driven offsite and to an area out of the predicted flood risk before flooding occurs at the site.

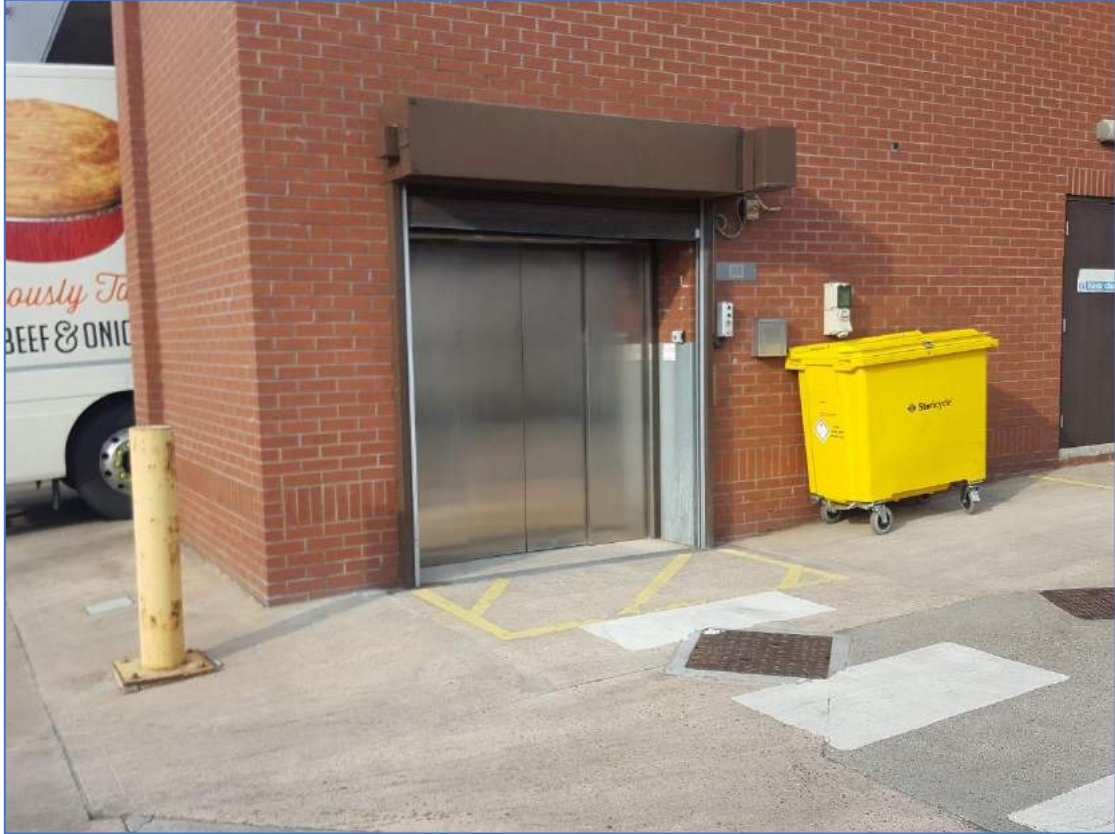
The lowest threshold level into the building in a lift shaft in the south eastern corner at a level of 50.35mAOD. When compared to the predicted flood level of 50.61mAOD, a maximum flood depth of 0.26m could be expected internally. Discussions with the client during the site survey confirmed that inundation to this area would not adversely affect the lift mechanism or motors which are located at high level and only a clean-up operation would be required.

As discussed above the only point of the main building considered susceptible to inundation is a lift in the south eastern corner up to a maximum depth of 0.26m.

Photo 15 – Lower level lift shaft in the south eastern corner of the production building

Although this is considered by the client to not cause any significant damage or impaired operation, it is recommended that in the event of a flood warning being issued in the local area that the lift is raised above the level of the ground floor so that any clean-up operation is minimised.

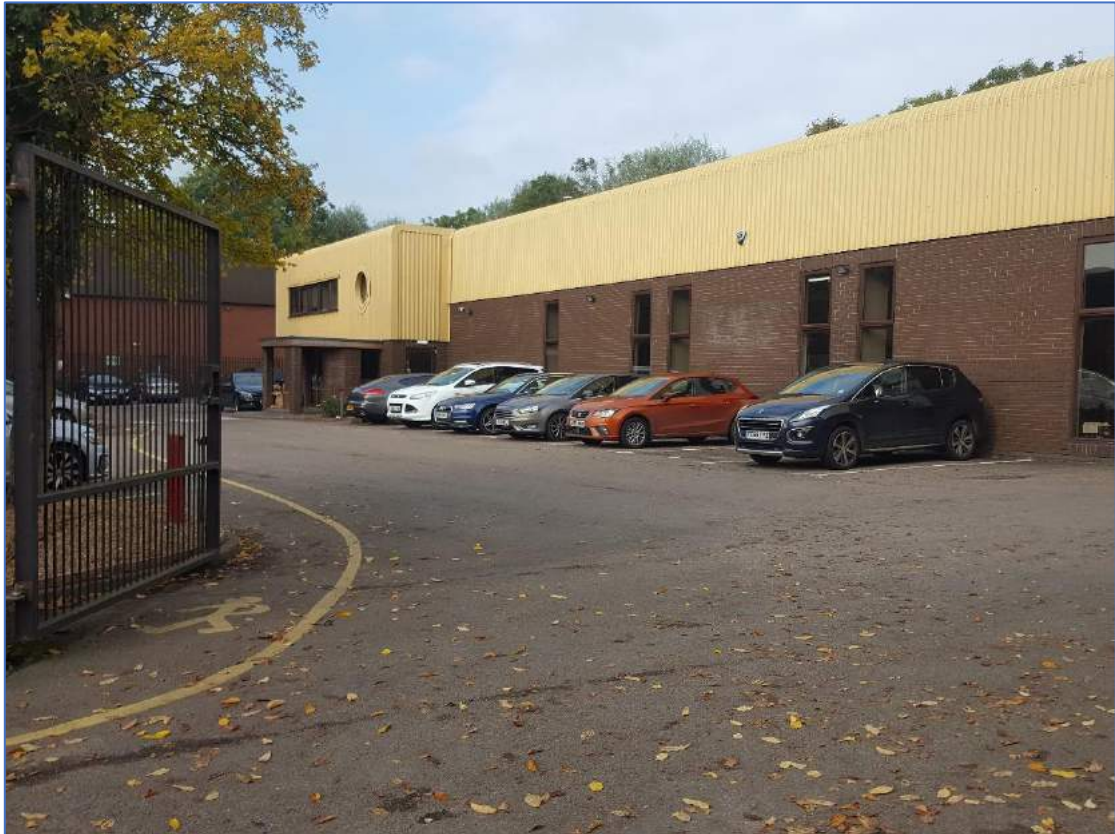
The building floor level has a minimum threshold level of 50.74mAOD which is a minimum of 0.13m above the predicted 1%+20%CC (1 in 100 + 20%CC) flood level of 50.61mAOD. It is therefore considered that inundation to the packaging warehouse is unlikely up to the 1%+20%CC (1 in 100 + 20%CC) return period.

Photo 16 – South western face of the packaging warehouse

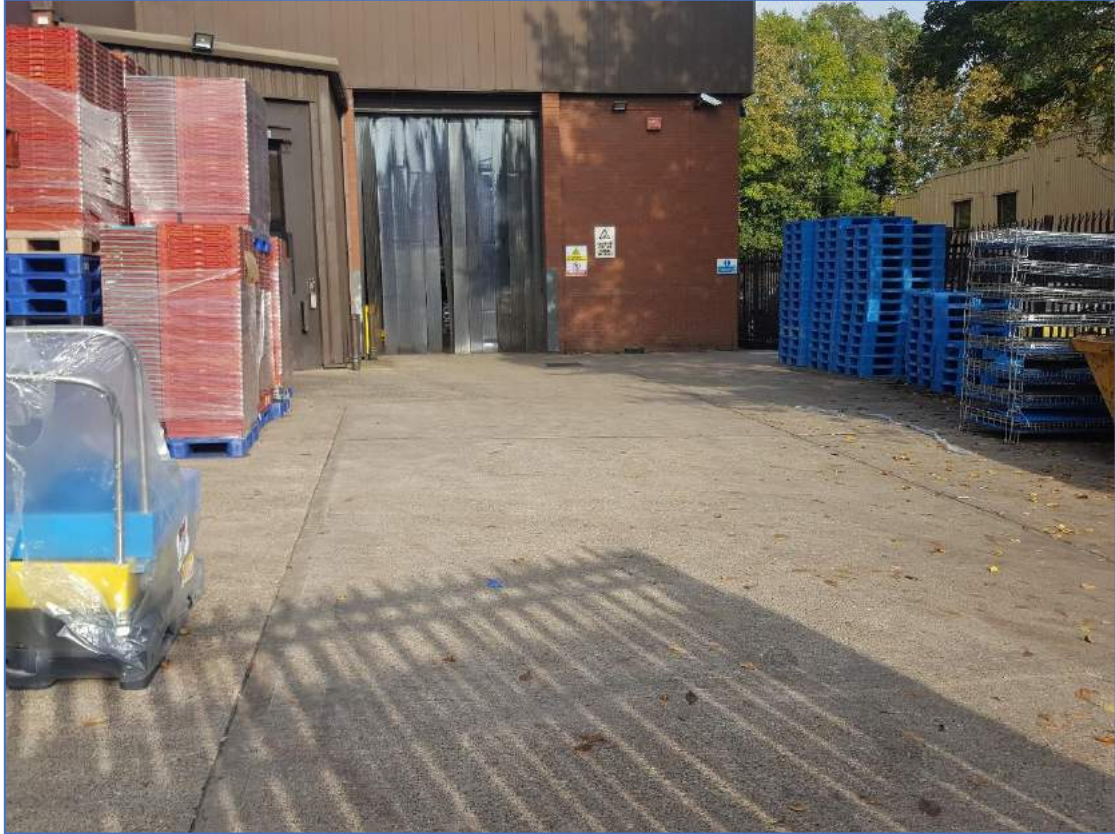
The building floor level has a minimum threshold level of 50.72mAOD which when compared to the predicted flood level of 50.61mOD is 0.11m greater. Therefore, inundation to the building is considered unlikely.

Photo 19 – Roller shutter doorway entrance to the raw materials warehouse

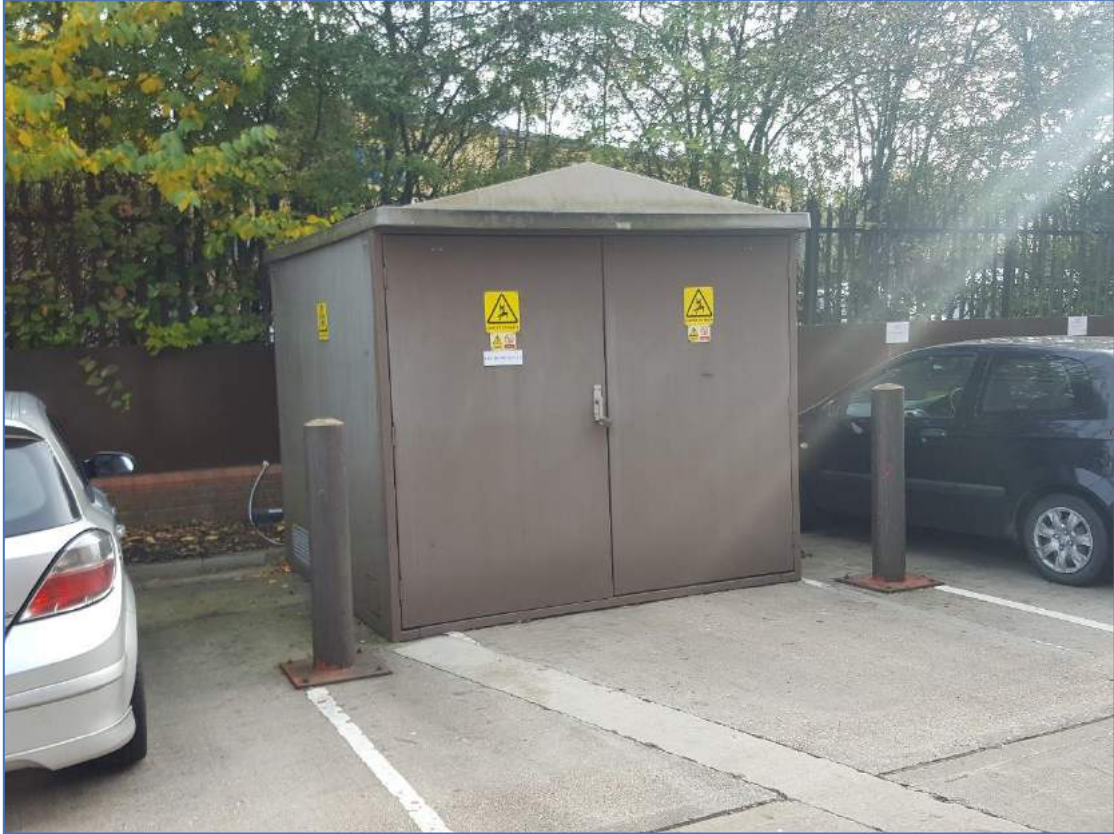
There is a package substation located to the east of the main building which is owner by Western Power Distribution where the floor level is 50.30mAOD. The floor level of the substation is 0.31m lower than the predicted flood level of 50.61mAOD and therefore is considered susceptible to inundation, however, the lowest point of vulnerability of the internal equipment is a minimum of 0.5m above ground level, circa 50.80mAOD, and therefore damage to the equipment is not expected.

Photo 21 – Substation on the eastern perimeter of the production building

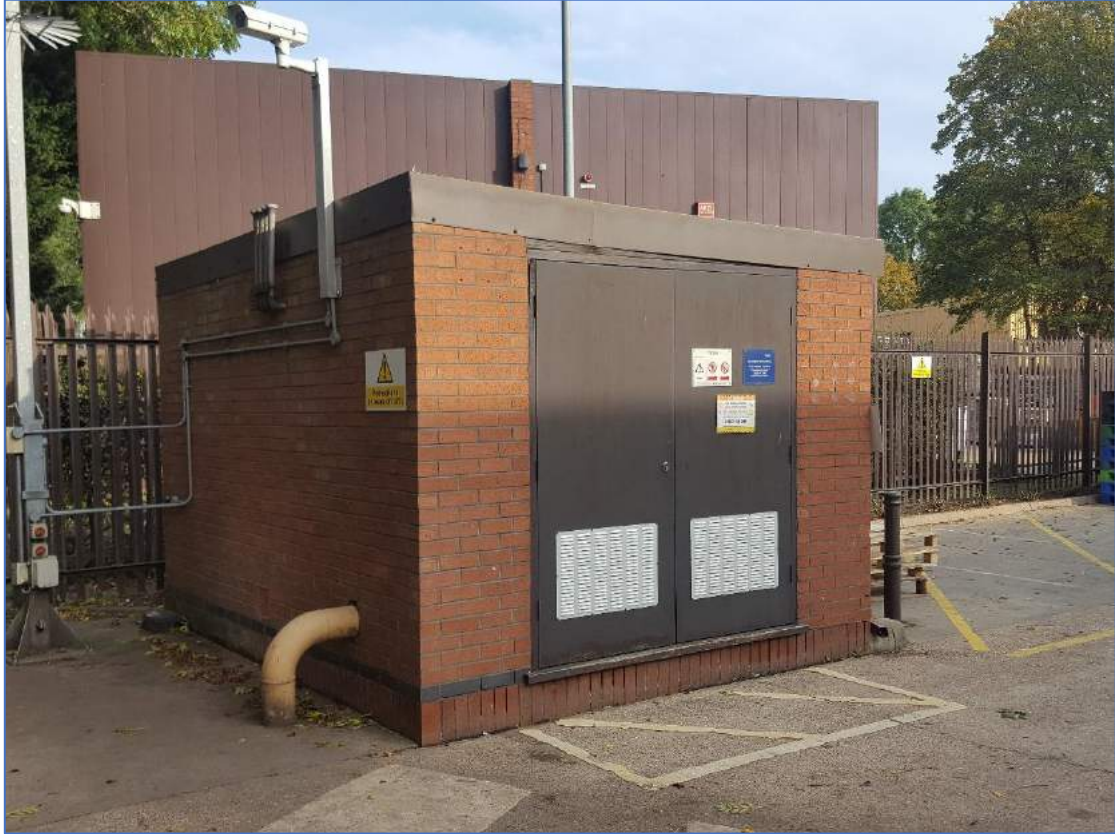
The incoming gas supply to the site is housed within a small brick building between the main building and raw materials warehouse. The building has a minimum threshold level of 50.54mAOD and therefore could be inundated up to 0.07m in depth during a 1%+20%CC (1 in 100 + 20%CC) flood scenario. Most of the content of the building is sealed gas pipework with a telemetry box situated at 1.0m above floor level, circa 51.54mAOD, which is 0.93m greater than the predicted flood level. Therefore, damage as a result of inundation up to 0.07m in depth is not expected.

Photo 23 – Gas supply building

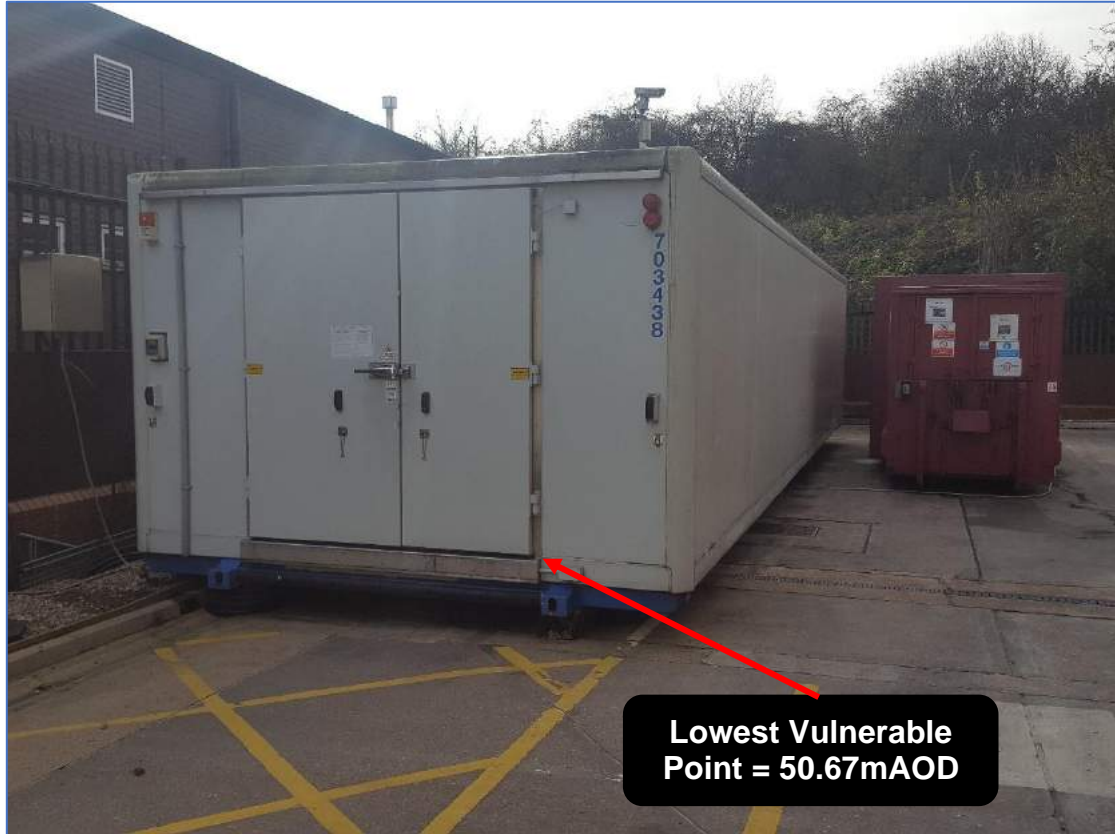
There are two refrigeration containers located on the eastern perimeter of the main building where ground levels are 50.25mAOD as a minimum. When compared to the predicted flood level of 50.61mAOD a maximum flood depth of 0.36m is forecast.

The floor level of the refrigeration containers was measured to be 0.42m above external ground level, circa 50.67mAOD, which is 0.06m greater than the predicted flood level and therefore inundation is considered unlikely.

Photo 25 – External refrigeration container

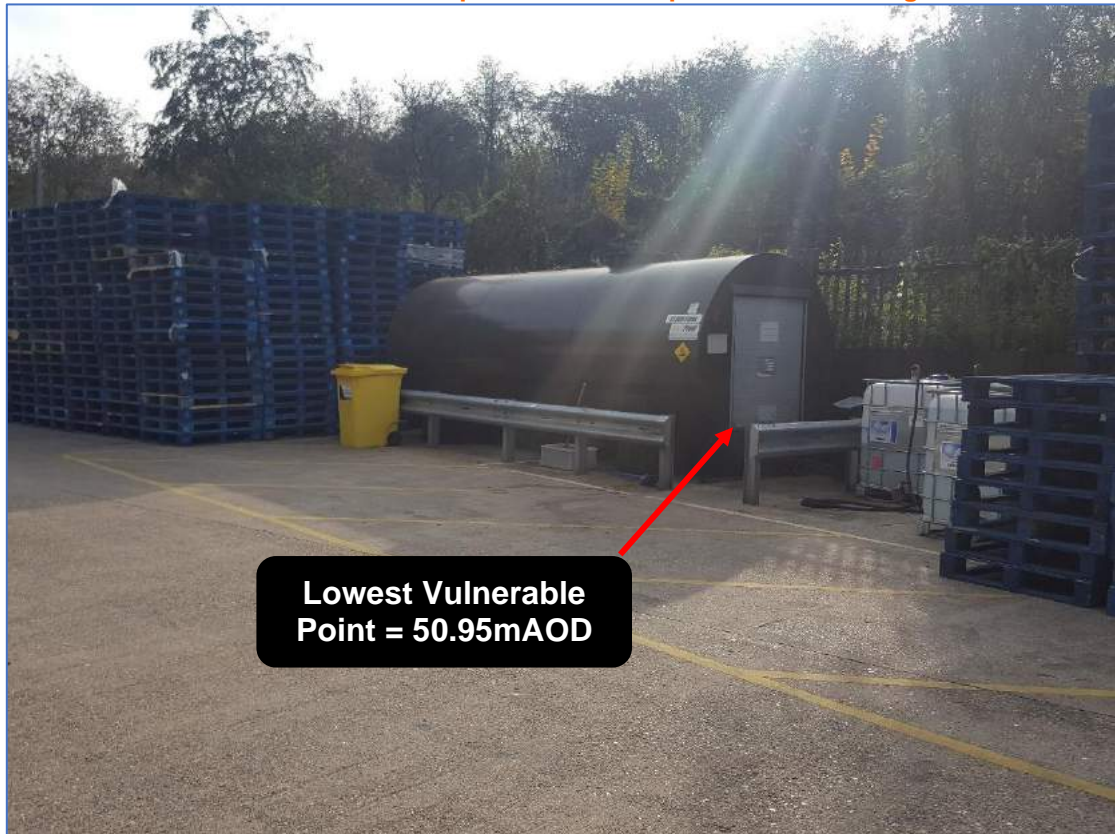
There is a diesel tank situated on the southern perimeter of the site where ground levels are around 50.34mAOD. Based on the predicted flood level of 50.61mAOD, flood depths of up to 0.27m are expected in this area. The lowest point of vulnerability of the diesel tank was measured to be 0.61m above ground level, circa 50.95mAOD, which is 0.34m greater than the predicted flood level, therefore damage as a result of flooding is not expected.

Photo 26 – Diesel tank on the southern perimeter of the production building
