Wrotham Quarry

Annual Report for Western Slope Monitoring

April 2019

Project N° : 190410

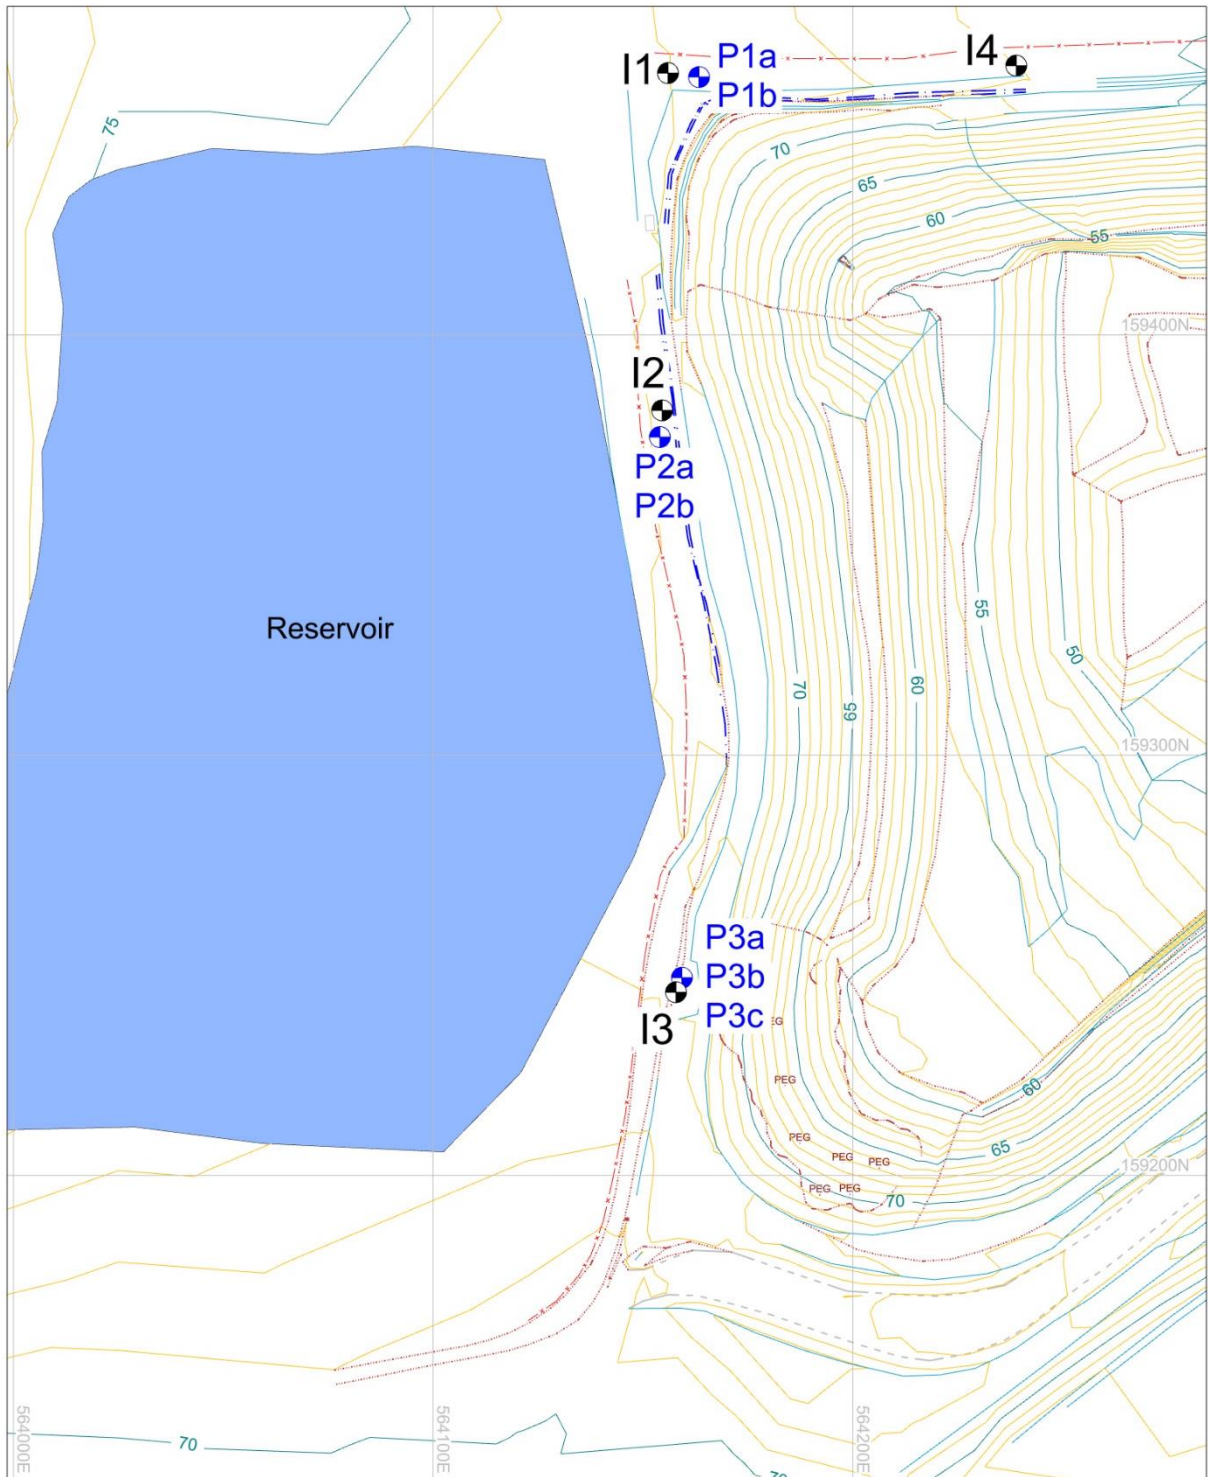
Excavation Diagram 1: Plan showing instrumentation in the Western Slope (topographic survey is from QuarryDesign 2015 UAV survey which includes more detail than the 2016 survey in this area)

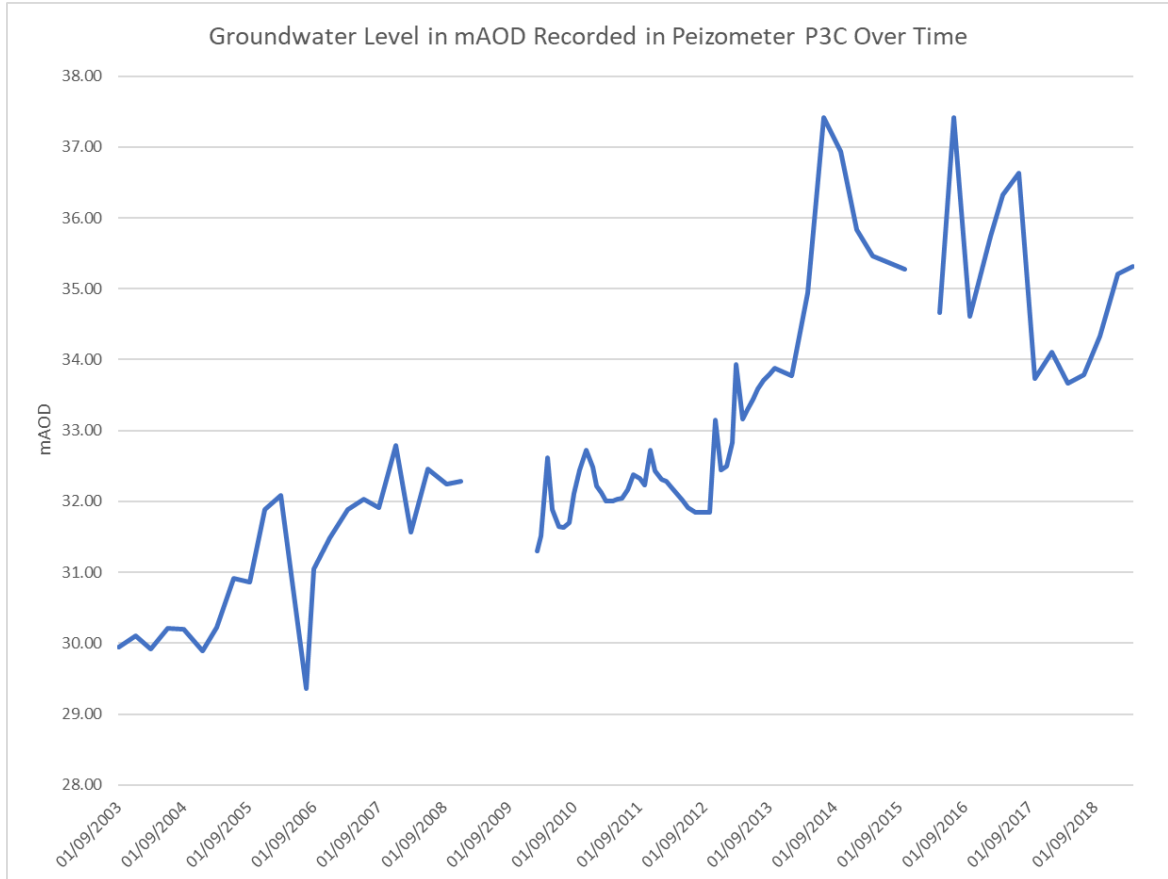
Chart 1: Plot of ground water levels (m AOD) over time in P3C

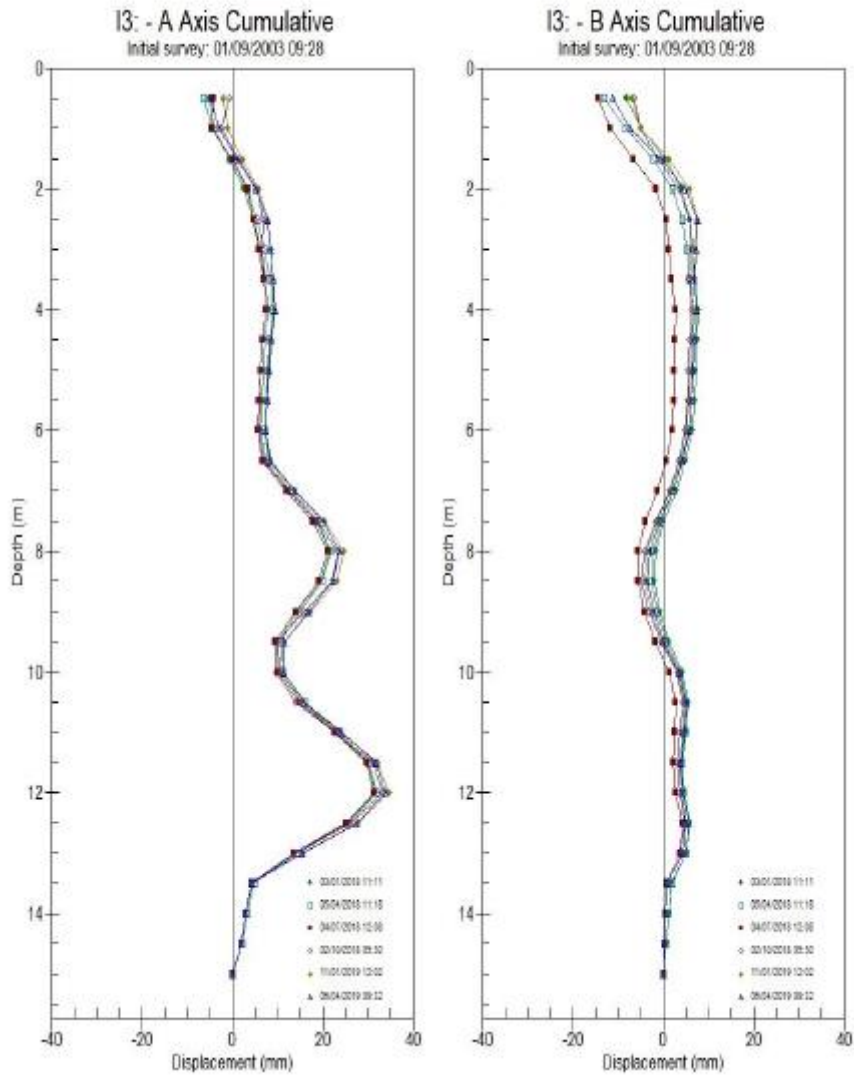
4.1.3 An example of the ITM data is shown in Chart 2 (overleaf), data from one particular inclinometer (I3) in the southwestern corner of the slope for an 18 month period. The cumulative data plot shows deflections of around 10mm to 30mm, relative to the original 2003 installation datum, at depths of ~8m and ~12m.

Chart 2: Data plot from April 2019 ITM report for inclinometer I3

- 4.3.7 **Inclinometer I3:** There appears to be little change in displacement since 2012 at any depth in the 'A' Plane (northeast/southwest) of movement. The only observation is a slight trend for displacement in the A+ direction (northeast/downslope) since February 2015 for all levels of the inclinometer above 13.0m. This trend is very slight, only in the order of 5mm. However, it should be noted when reviewing future data, as it may be a precursor for a more significant movement towards the north east. In the last few months there has been approximately 4mm movement towards the A- direction (southwest).

- 4.3.8 In the 'B' Plane (northwest/southeast) there is very little relative displacement at any level since 2010, with the exception of a very slight movement in the B- plane (north west) for the upper 12.5m in July 2018 amounting to only around 5mm to 2mm in movement. This has since moved back in the B+ direction to previous levels apart from in the top 1.5m where it is continuing to fluctuate in the last few months with up to 10mm.

- 4.3.9 Overall in the I3 location, the results equate to a slight movement at shallow depth to the north east and, at both shallow and at depth in the north west direction.

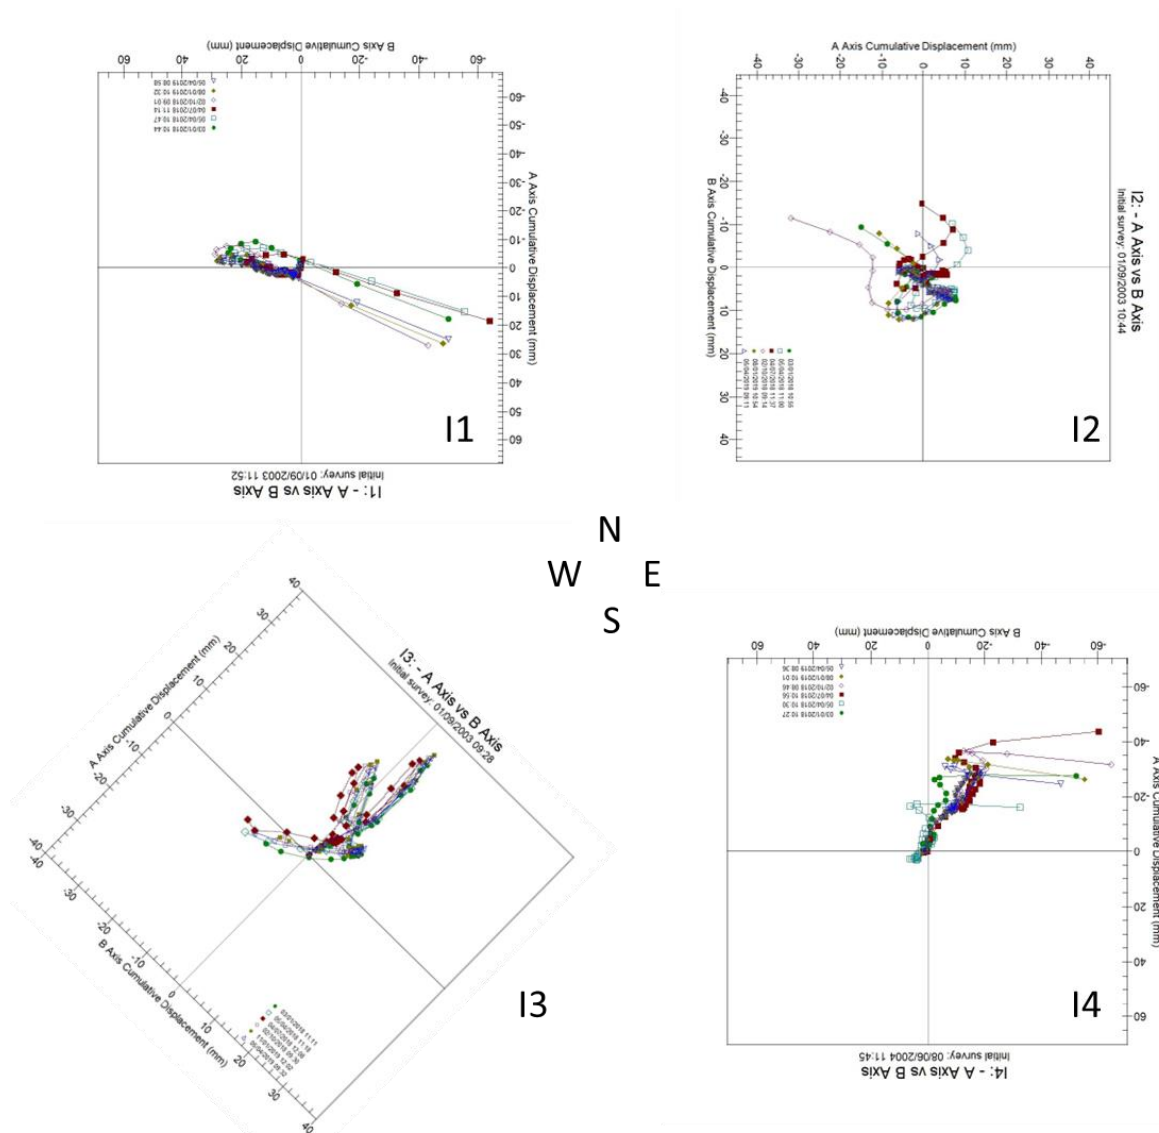
Chart 3: A Axis vs B Axis plots for Cumulative direction of movement from April 2019 ITM report

- 4.1.4 The plots in Chart 3 show the cumulative movement of the inclinometers relative to their installation in 2003, for an 18-month period from the April 2019 ITM report.
- 4.1.5 From the raw ITM data, QuarryDesign have created charts that show the displacement at selected depths for each inclinometer over the full period of data available. These charts are presented in Appendix I.
- 4.1.6 In the following Sections, QuarryDesign present the available data for each inclinometer, both as a summary from the previous report and detail from the current analysis.

- 4.3.13 Overall in the I4 location, there are seasonal fluctuations in displacements at shallow depths. There has been significant and uncharacteristic movement ($\sim 20\text{mm}$) in the last year in towards the north and east directions at depth.

- 4.3.14 This data shows that the northern slope around I4 is moving with the most significant movements at a depth which seems to correspond to the base of the Gault Clay (Although no direct geological data is available from boreholes for this slope the strata is estimated from visual surveys and a nearby BGS borehole record. Although not affecting the reservoir, if this slope were to move significantly, it could fail outside the site boundary into the neighbouring field to the north. From the most recent survey (February 2019, undertaken by quarry design), these overburden slopes beneath I4 are considered to be too steep for long term stability ($1\text{v}:1.8\text{h}$, 29°) especially considering that the upper approximately 15m of the slope will comprise Gault Clay.

- 4.3.15 As this northern slope is showing signs of movement, it is recommended that the slope is buttressed to create an overall angle at or shallower than $1\text{v}:3\text{h}$ ($\sim 18^\circ$). A quick volume calculation has been undertaken and this possible configuration would need approximately $55,000\text{m}^3$ of material (Appendix III). This buttress would need to be constructed with the inclusion of adequate drainage to the crest and toe. Reinstating the original French Drains on the slope and adding new drains where necessary to connect into the existing system. If the slope is not buttressed it is recommended that the northern slope is closely monitored and inspected for signs of large-scale instability such as bulging of the middle or toe of the slope or tension cracks at the top of the slope.

- Due to this recent motion, QuarryDesign recommend that consideration should be given to the buttressing of the northern slopes below I4. An overall slope angle of shallower than 1v:3h is recommended, including adequate drainage or this slope should be closely monitored for large scale movement; and

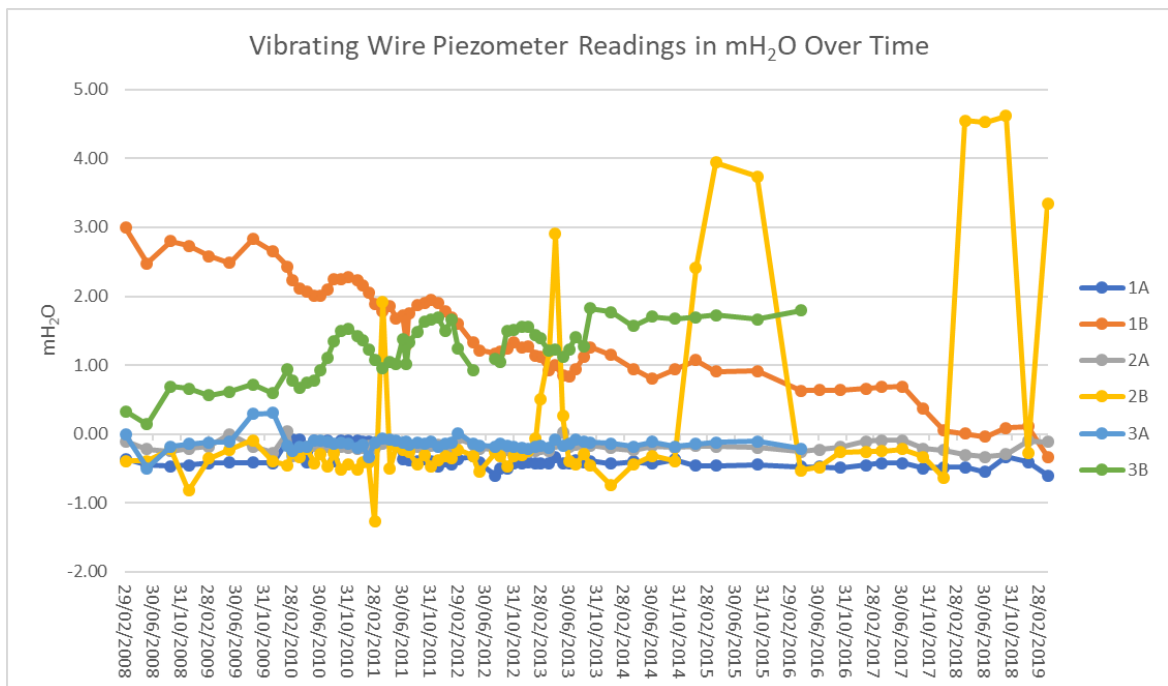
Chart 4: Vibrating Wire Piezometer Data

- The tips at the deeper levels (1A, 2A and 3A) in the VWP's show consistent, near zero or slightly negative pore water pressures;
- VWP 1B continues to show a decrease in pore water pressure over time;
- 2B shows fluctuating behaviour, with high pore water pressures over the last year, decreasing in January 2019 then rising again in the most recent readings from 5th April 2019. Although these readings are high it is still generally in line with what has been recorded previously.
- 3B has shown a general increase in pore water pressure since 2008 however, this has remained steady since October 2010 until it was buried in 2016.

4.4.4 An increase in pore water pressure can lead to a reduction in shear strength in cohesive soils, increasing the likelihood of a failure. Therefore, continued monitoring of these installations is recommended.

- VWP P3 has been reported as being unable to be monitored due to the headworks being buried. An additional recommendation is therefore for the site to undertake the necessary remedial works as soon as possible to relocate the headworks and enable VWP P3 to continue to be monitored.
