# Project Wind

## Maw Burn and Cow Gut Dye Tests

Job No: 1043152  
Doc ref: NCL1-DCZZ-STE-UG-RP-C-00-06  
Revision: —  
Revision date: 08 October 2025

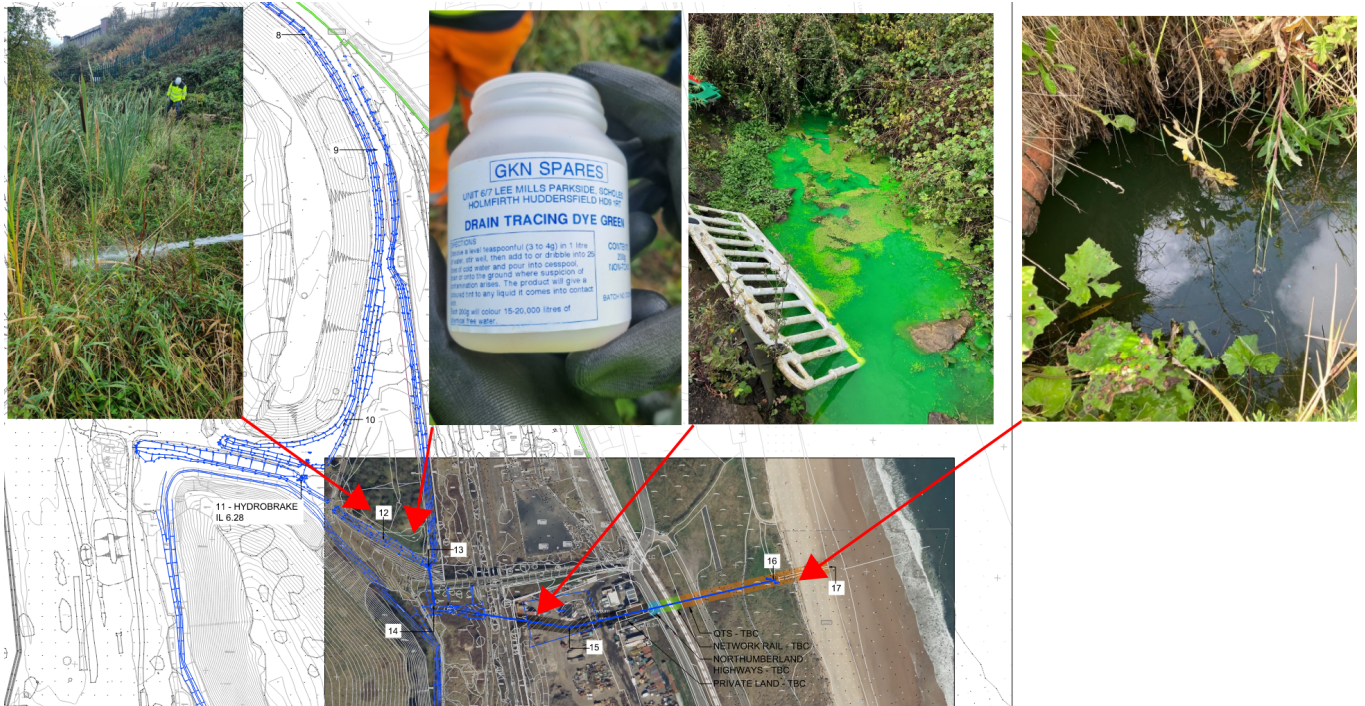
- **Test Location:** Open Maw Burn watercourse within the site development area.
- **Dye Application:** Two tubs of drain tracing dye were introduced to enhance visibility and traceability.
- **Flow Assistance:** A 10,000-litre tanker of clean water was discharged into the Maw Burn to assist dye movement.
- **Weather Conditions:** The test followed a rainfall event on the previous day, resulting in steady and sustained flow within the Maw Burn.

- The increased flow conditions improved dye dispersion and visibility.
- The test confirmed consistent conveyance of dye through the watercourse.

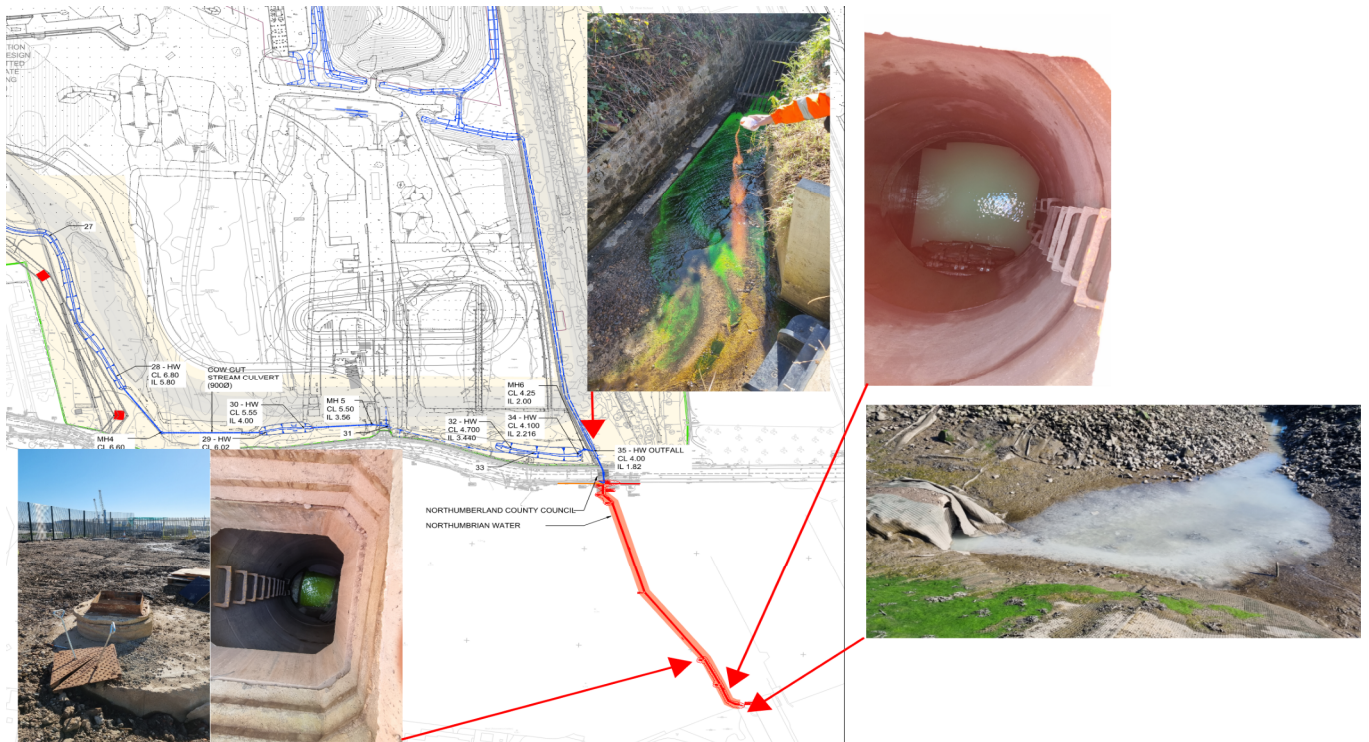
- **Test Location:** Cow Gut Open watercourse within the proposed development.
- **Dye Application:** Two tubs of drain tracing dye were introduced into the Cow Gut watercourse to ensure sufficient visibility and traceability.
- **Flow Assistance:** Two 10,000-litre tankers of clean water were discharged into the channel to replicate moderate flow conditions and assist dye transport.
- **Weather Conditions:** The test followed a heavy rainfall event over the preceding weekend, resulting in steady and sustained flow within the watercourse.
- The increased flow conditions were ideal for observing dye movement and confirming connectivity.
- **Tidal Conditions:**
  - The test was timed to coincide with a spring tide, during which the outfall to the River Blyth was fully exposed.
  - This ensured optimal visibility and minimised tidal backflow interference.

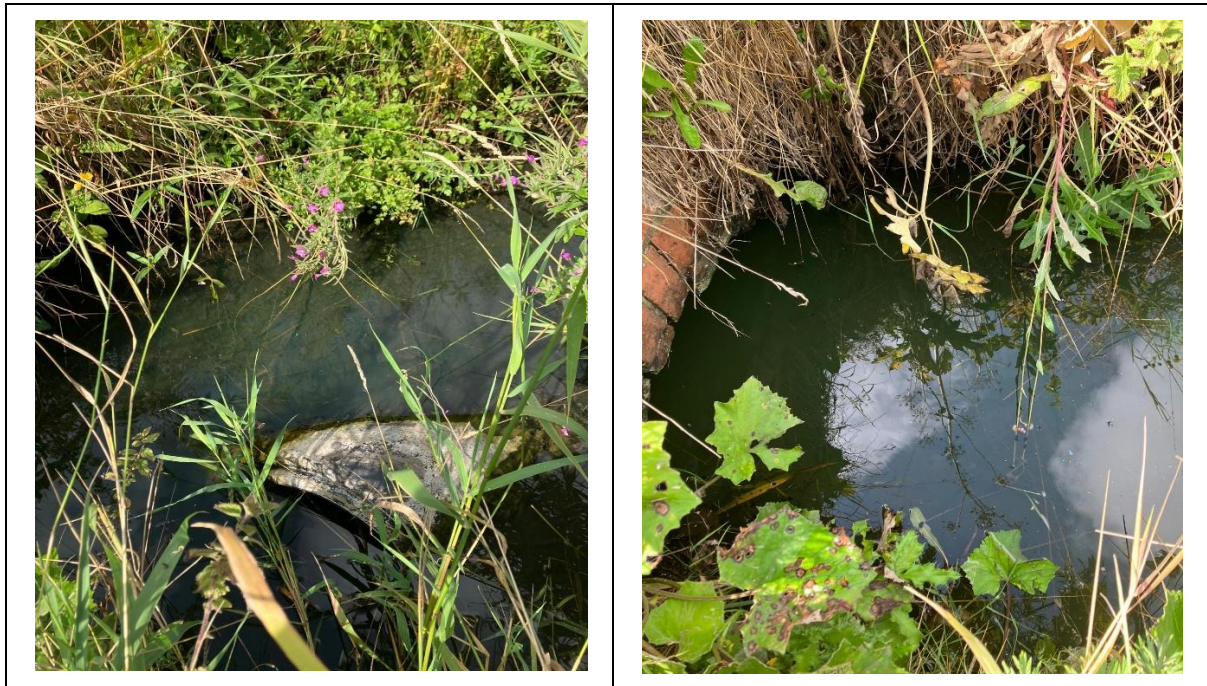
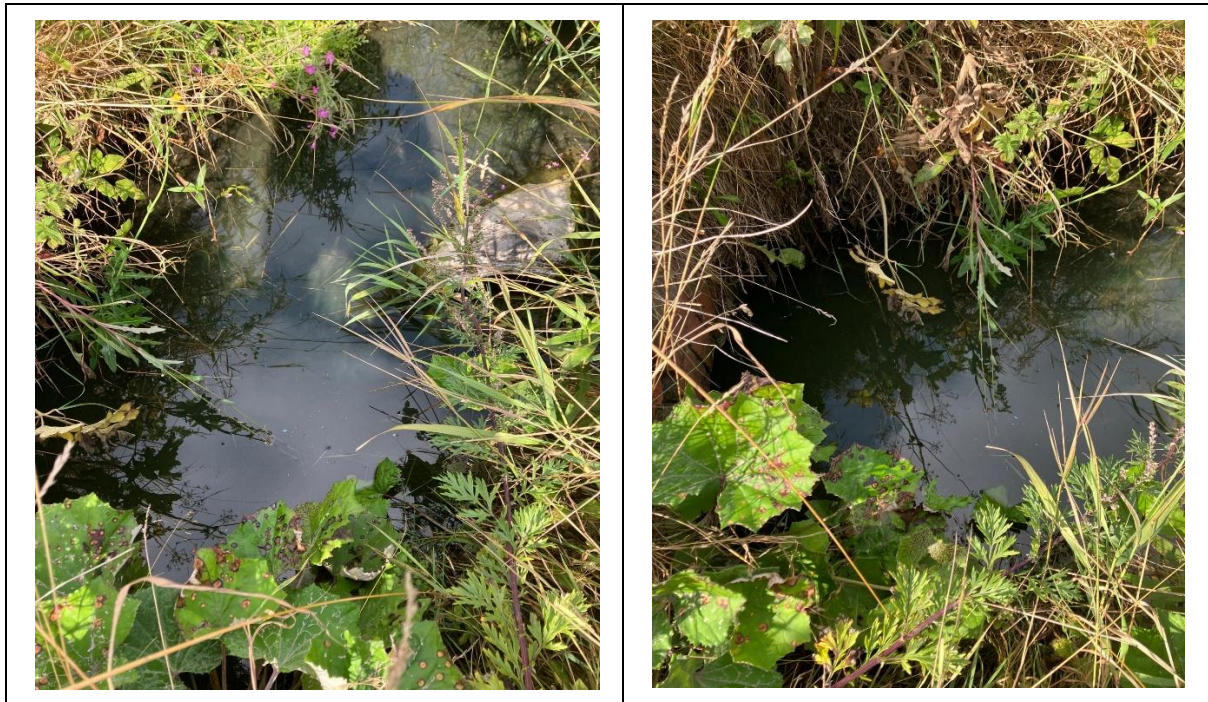
We have been out to the culvert and have attempted to clean the culvert using a High-Pressure Water jetting unit, we have been unable to get the jet to travel and we suspect we have gone up into a chamber, access point to the culverts.

We then attended site a few days later to check the outlet on the beach and it was clear to us that there was green dye showing in the water at the culvert, I have attached a photo I took whilst I was on site of the outlet of the culvert, this shows the water is dyed green.

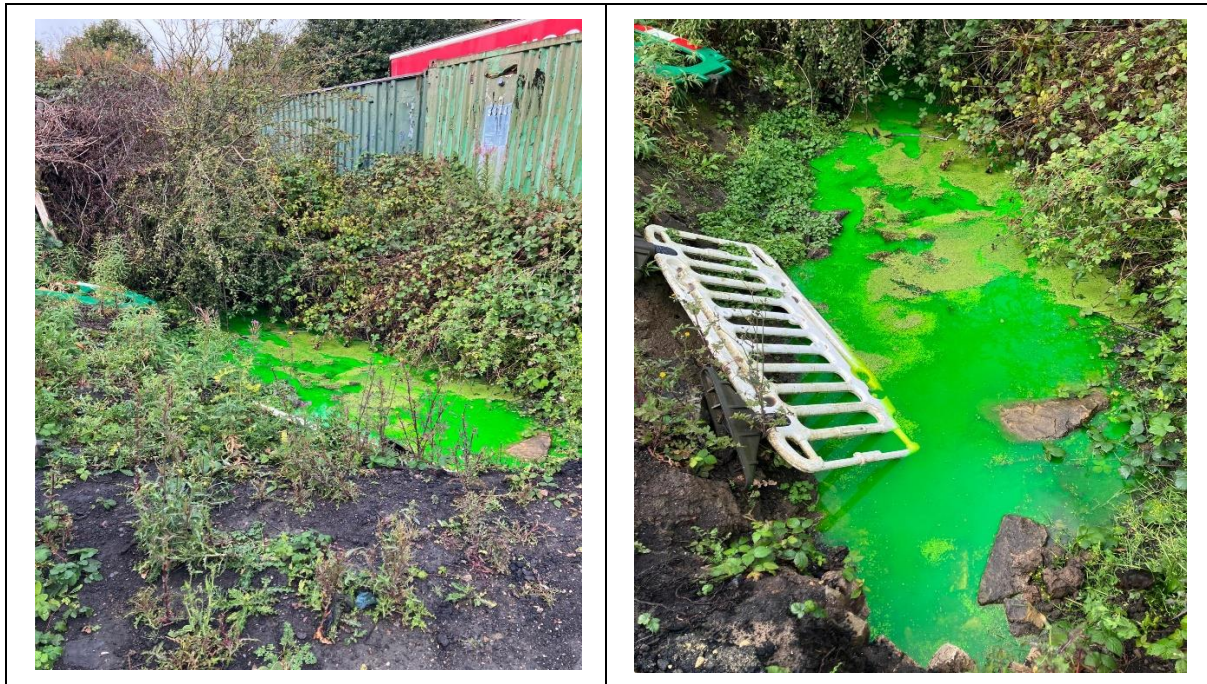
We have been back to the upstream section of the burn and we have put down 10,000 litres of water and a bright green drain tracing dye, after a few hours this drain dye has pushed through to the access point inside of the plant hire company and we have added the photos below.

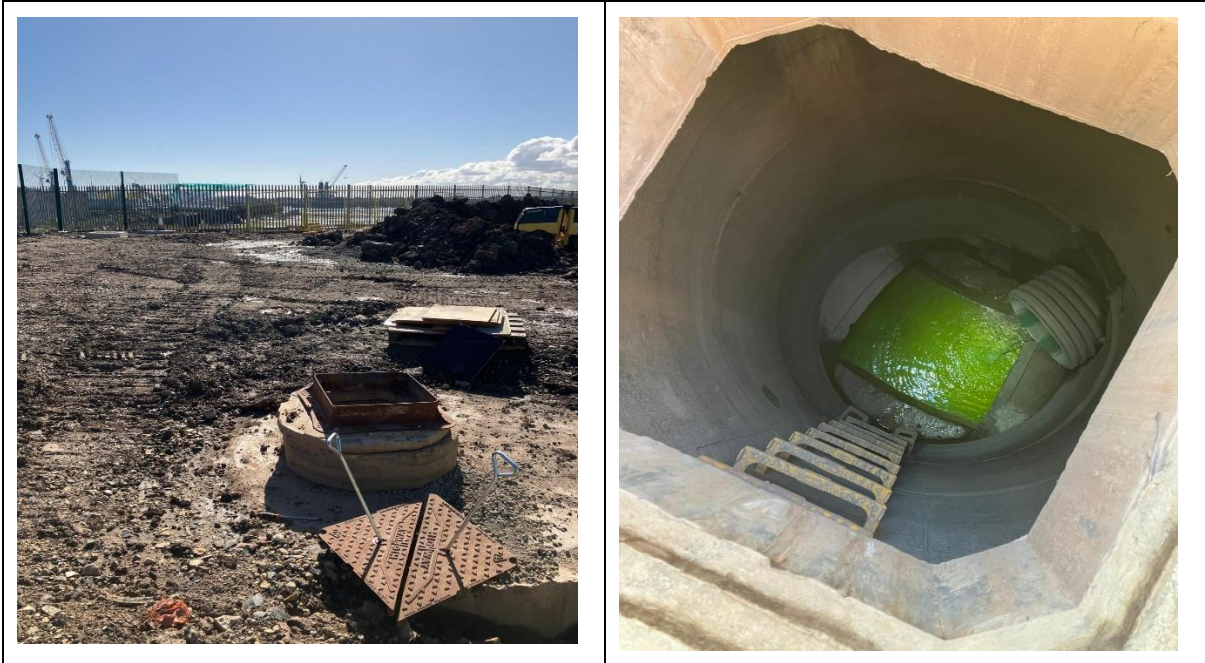
We have also been back to the cow gut and we have added 20,000 litres of water with bright green drain tracing dye and we have then with permission we have entered the building site opposite (JDR Cables) and after a couple of hours we have identified the drain dye in the manhole chamber seen in the photos below.

We believe this then runs into the river and we have lifted a manhole chamber which is off the construction site and near the side of the river, this has a very large gate valve and we believe the silt in the drain is affecting the dye reaching this manhole chamber, we have looked down this drain for a number of hours and the water running through a dirty colour.
