Site Conditioning Report Mack Contracts Ltd

Wallsend Research Station

November 2021

SITE CONDITION REPORT TEMPLATE

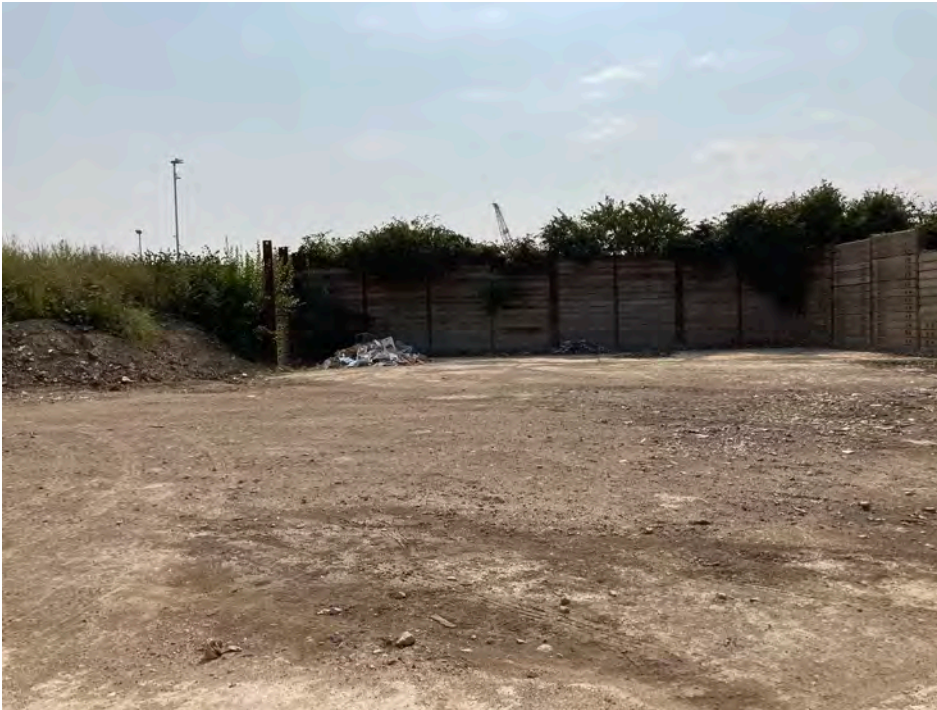
Photo 1

Taken towards South of site looking at middle bay 2. Site surface is concrete covered with loose materials.

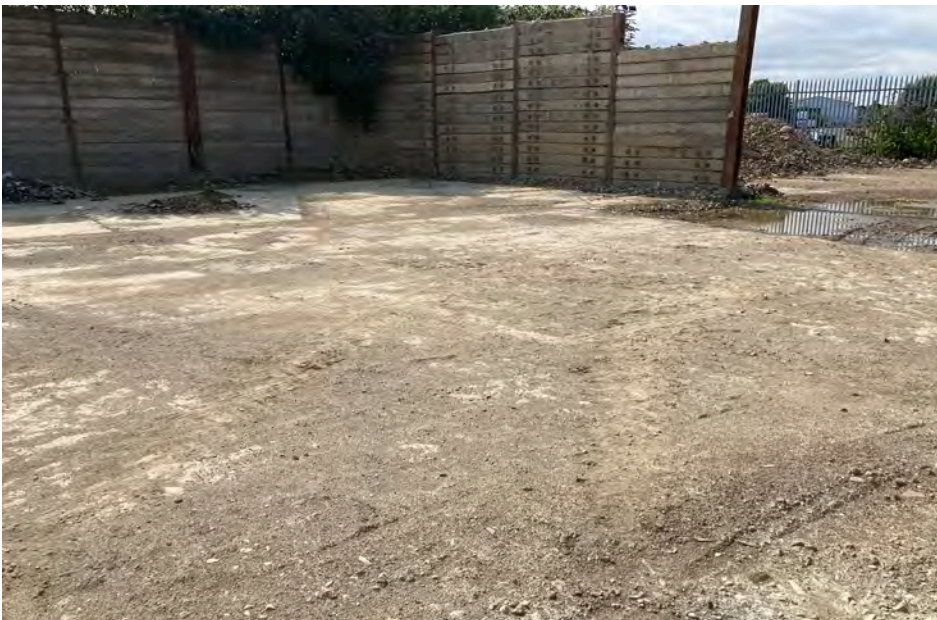
Photo 2

Taken towards South west portion of the site looking at some stone left in the far bay1 approx 20t of material. Site surface is concrete covered with loose materials.

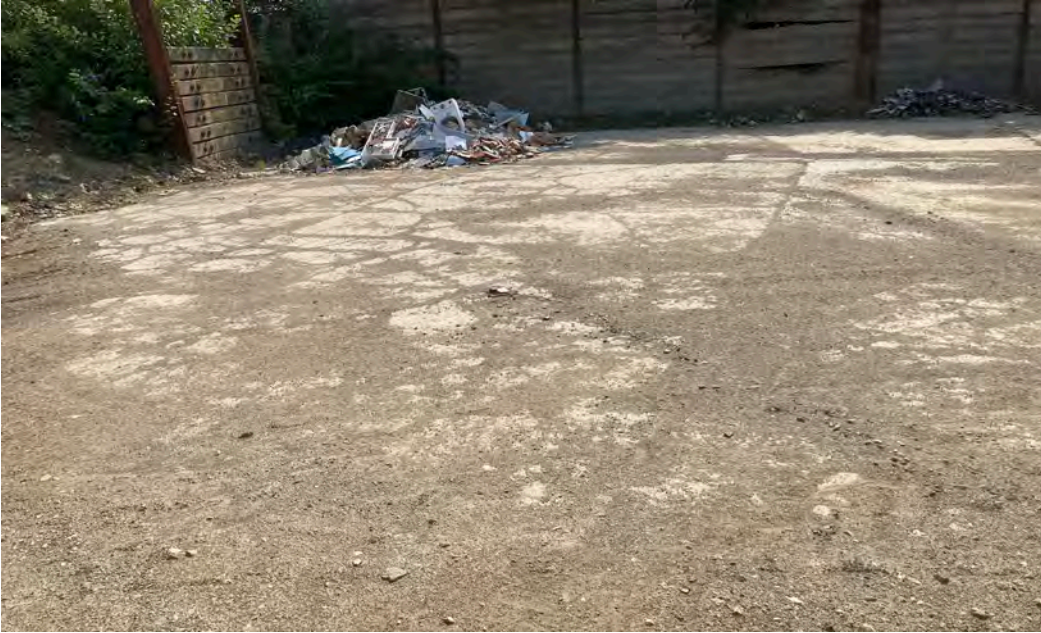
Photo 3

Taken towards South portion of the site looking at some ceramics and stone left in the far left corner of bay 3 approx 2T of material. Site surface is concrete covered with loose materials.

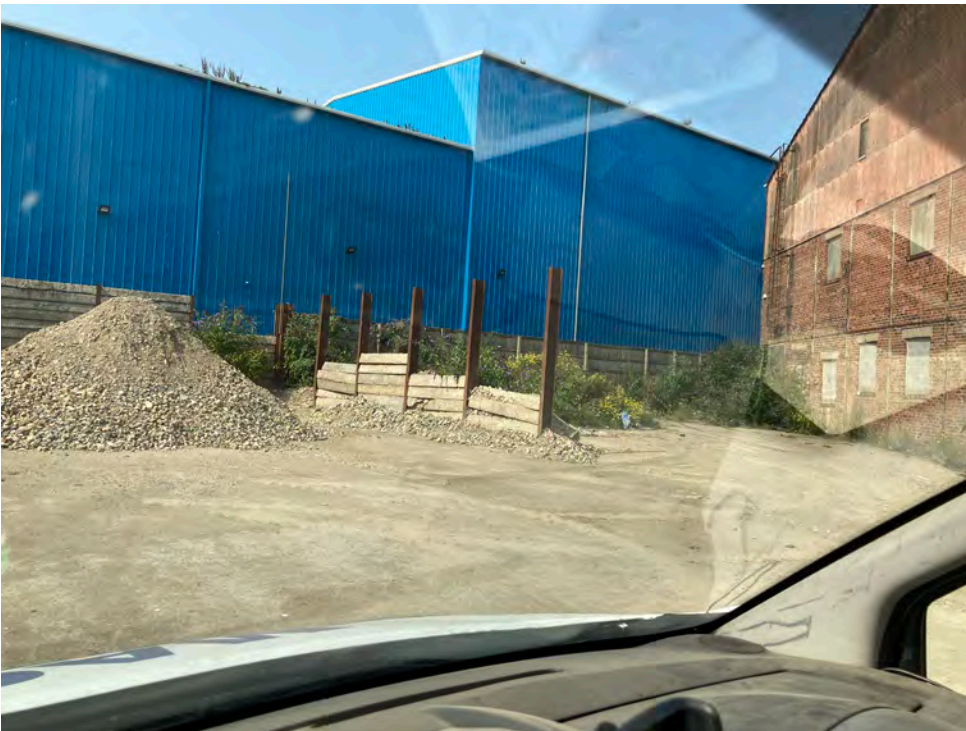
Photo 4

Taken towards North west corner of the site looking at some stone left in the bay approx 1.5T of material. Site surface is concrete covered with loose materials.

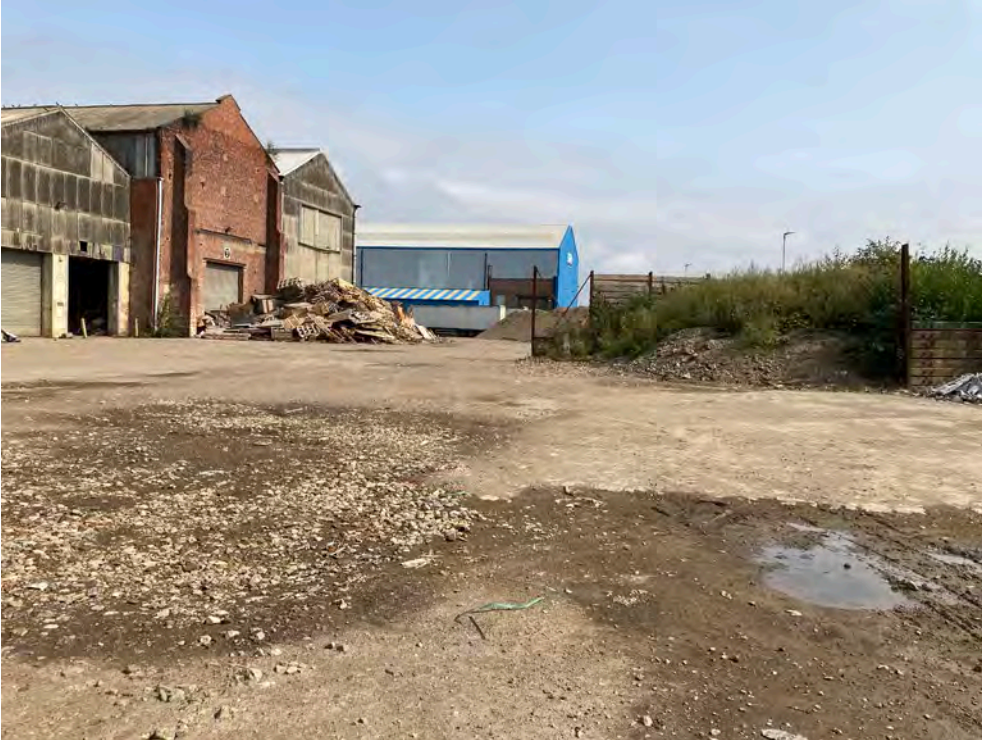
Photo 5

Taken towards North east towards entrance to site. Site surface is concrete covered with loose materials where the low point of the yard is and surface rain water collects (due to no formal drainage). At the top rear of the photo large stockpile of wood can be seen it belongs to the adjacent west wood processor operating in the building.

In the rear of the picture soils can be seen in the bay.

The existing onsite materials will be tested and removed off site by the landlord or processed by arrangement once the permit is issued.
