## Ground Stability Report

Proposed Commercial Development

Land off Napier Road, Rockingham

Document no.: STT1234-R01 Rev A

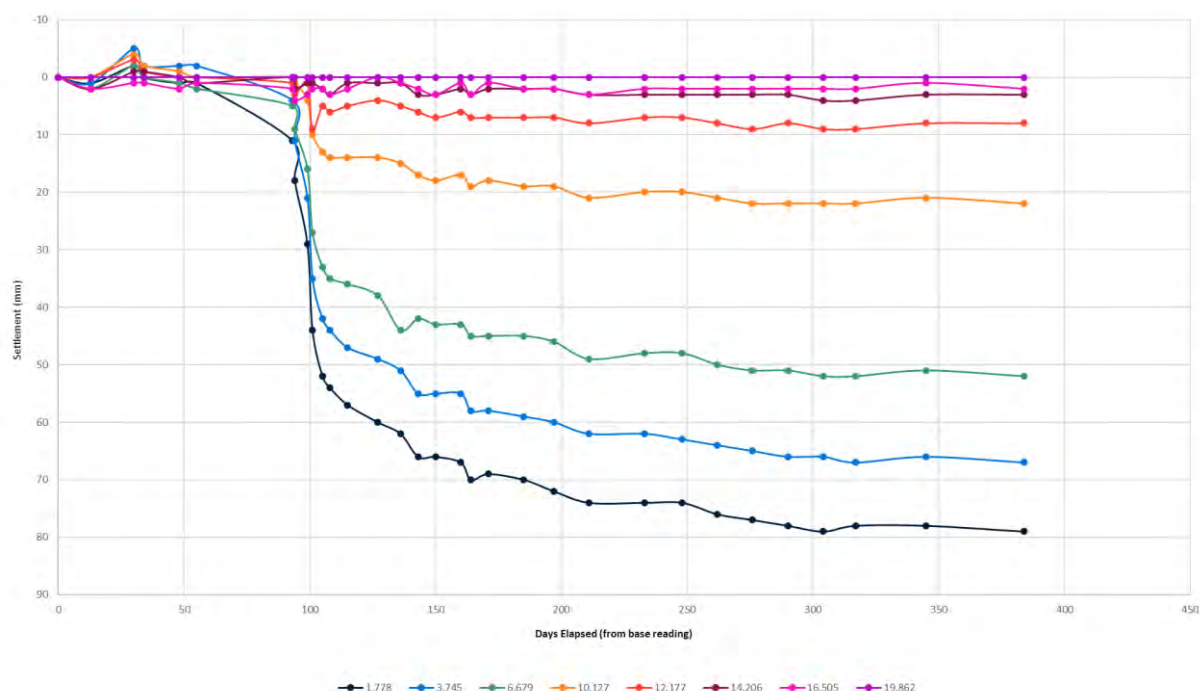
Figure 3-A: Extract of extensometer monitoring results (BH101)

- 3.3.3 The effect of construction of the trial embankment is clearly visible at circa Day 95. By Day 100 the settlement of the uppermost magnet (black) has already reached 40mm. It is estimated that immediate settlement is complete by circa Day 108 where approximately 55mm of settlement has occurred. Approximately 20mm of consolidation settlement is estimated to occur and be complete by circa Day 300. Creep settlement continues beyond this time but is <5mm and therefore considered negligible.

- 3.3.4 The interpretation from the extensometers BH103 and BH106 is summarised below alongside BH101 for completeness. It should be noted that settlement values quoted are for the uppermost magnet which is considered to be representative of original ground level.

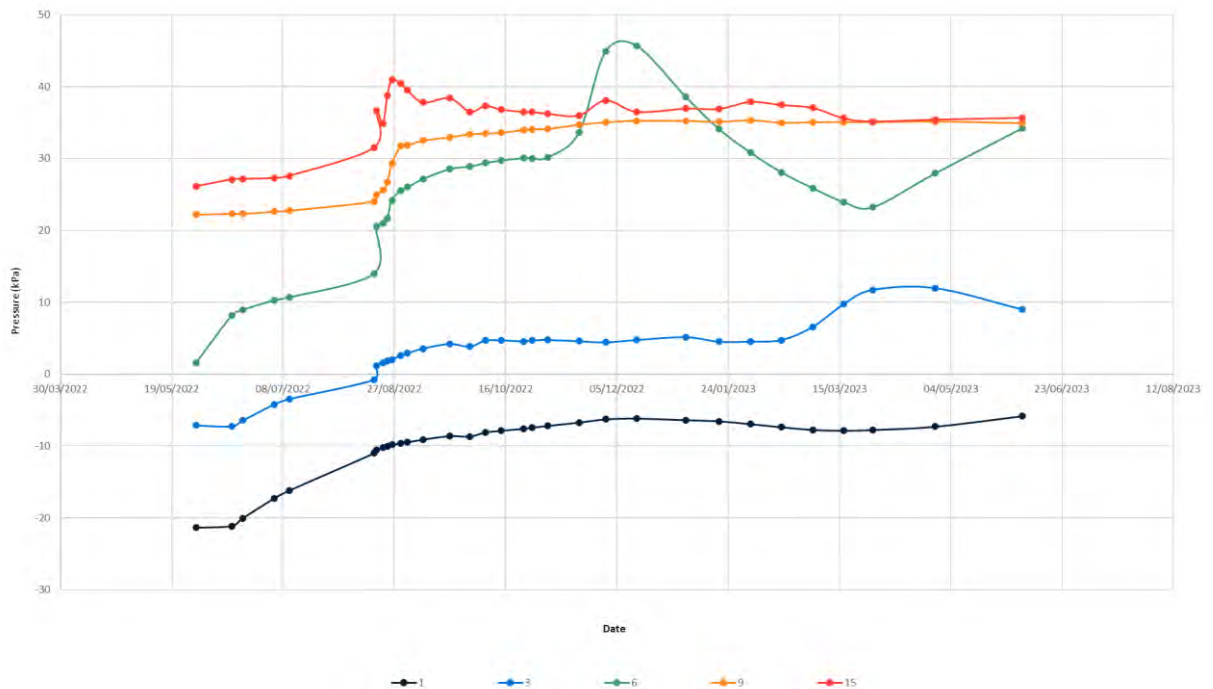
Figure 3-B: Extract of vibrating wire piezometer monitoring results (BH102)

- 3.4.4 In the above results the response to embankment construction can be seen by the rises in the individual piezometer lines just before 27<sup>th</sup> August 2023. This is most evident in the deeper piezometers represented by the green, orange, and red lines. It is noted that in this borehole there is no decay following construction.

- 3.4.5 The piezometer at 6m depth (green line) showed a second rise, peaking on 5<sup>th</sup> December 2022 and subsequently decaying over a period of 3 months. It is suspected that this is evidence of localised collapse settlement below this depth leading to a sudden rise in pressure. It is noted that such sudden movement has not been recorded in extensometer BH101 circa 2.3m away. The collapse has then migrated upward which possibly explains the corresponding rise seen in the light blue line (3m depth) towards the end of the monitoring period.

- 3.4.6 The other two vibrating wire piezometers showed limited response to the embankment construction indicating that drainage is relatively good.

- 4.2.1 The monitoring results from the vibrating wire piezometers showed a limited response to application of load. On this basis no special measures are anticipated to be required to limit rate of filling. It is recommended that normal good practice be adopted when filling the site and that the site should be filled as uniformly as practicable.
