Refurbishment Survey

Colt Data Centre Services, Unit 9-10, Powergate Business
Park, Park Royal, London, , NW10 6PW
N/A

Report No: J013820

Type of Survey: Refurbishment

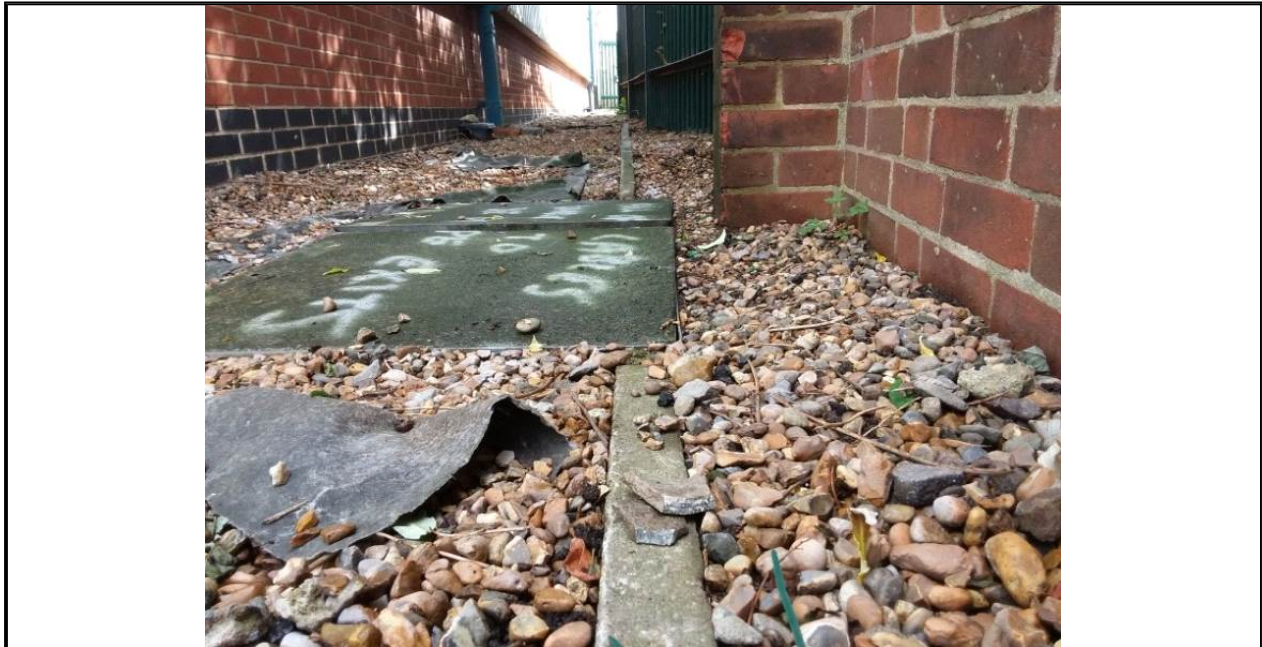
| Item No: | 41 |

| Sample ID | Building | Floor | Description | Room/Position | Extent (m2) | Fixing | Substrate | Asbestos Type Identified | |
|--|--|---|---|--|---|---|---|---|---|
| MH001109 | Colt Data Centre Services, Unit 9-10 Powergate Business Park, London, NW10 6PW | External | Cement | External Elements, Debris to pebbles, walkway between units 9 and 10 | Unknown | Bonded | Concrete | Chrysotile | <p>Picture 41</p> |

| Item No | Sample ID | Building | Floor | Room No | Room Description | Location | Extent in m2 | Substrate | Product type | Condition | Surface treatment | Asbestos type | Accessibility | Total risk assessment score | Risk category |
|--|---|--|---|---|--|--|---|---|---|---|---|---|---|---|---|
| 41 | MH001109 | Colt Data Centre Services, Unit 9-10 Powergate Business Park, London, NW10 6PW | External | 1 | External Elements | Debris to pebbles, walkway between units 9 and 10 - Cement | Unknown | Bonded, Concrete | (1) Asbestos Cement | Medium Damage | 1 | Chrysotile | (1) Occasionally likely to be disturbed | 9 | C |

| Sample No: | MH001109 |

| Recommended Action: | Low risk ACM (bound in matrix) remove, repair or encapsulate under controlled conditions. Work on this material does not require a license. Work on this material may be notifiable to the appropriate enforcing authority. Disposal of asbestos waste by a licensed contractor only. All work must conform to the 'Control of Asbestos Regulations 2012'. |
