# Saxon Pit Southern Buttress

## Waste Recovery Plan

### East Midlands Waste Management Ltd

16 December 2024

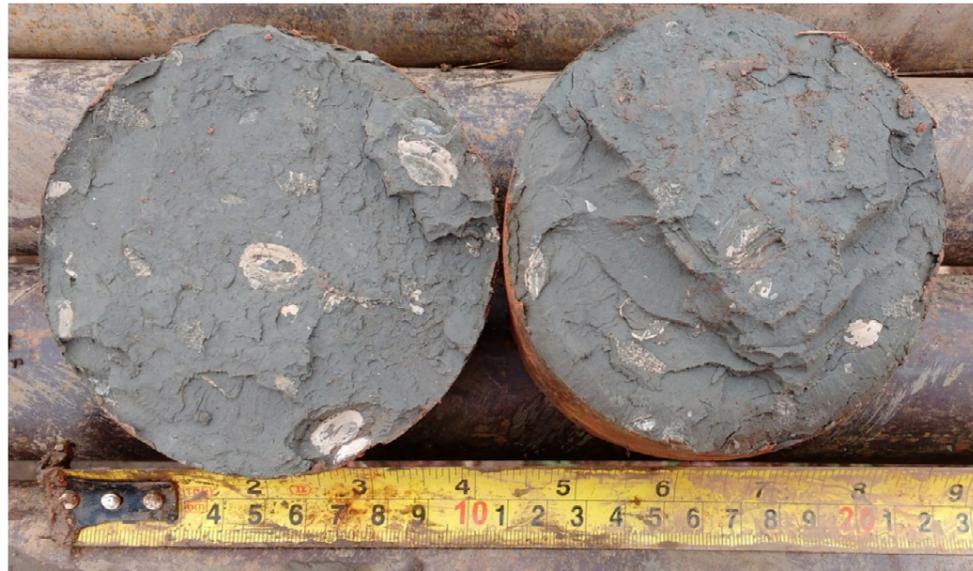
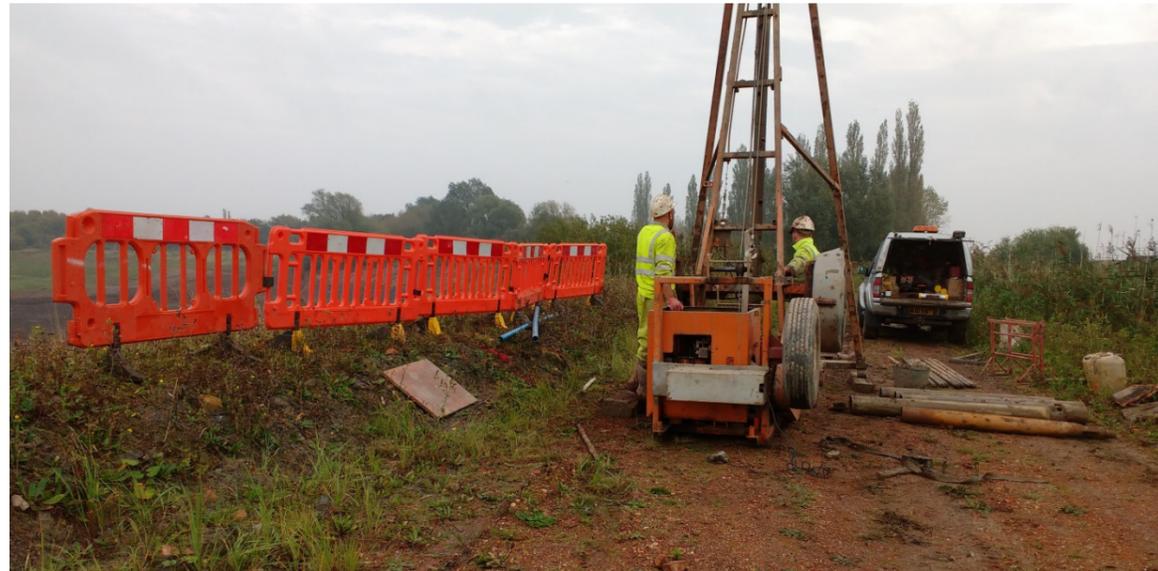
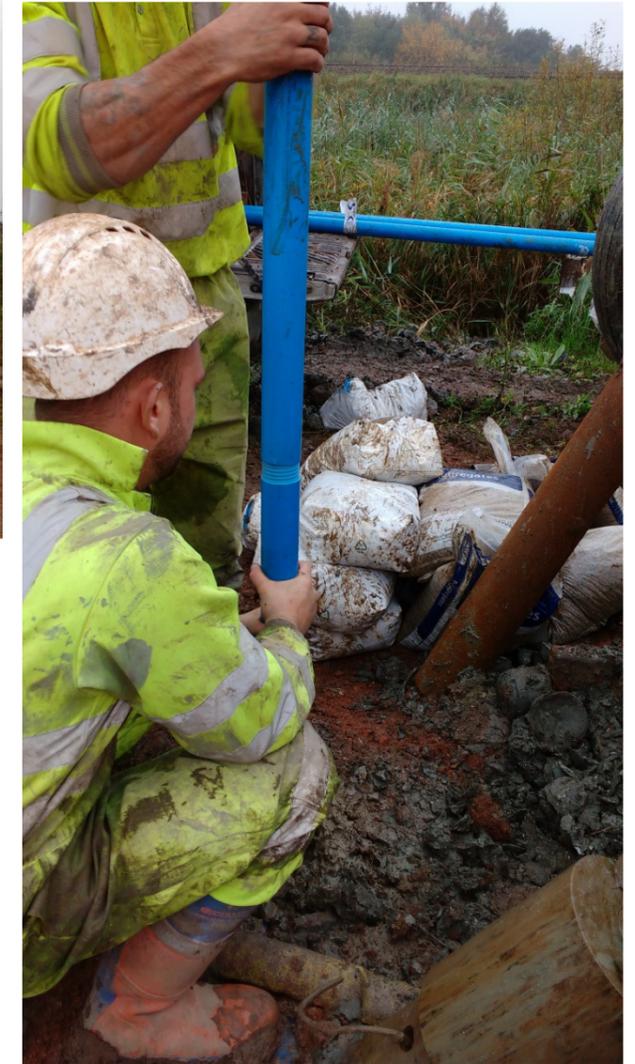
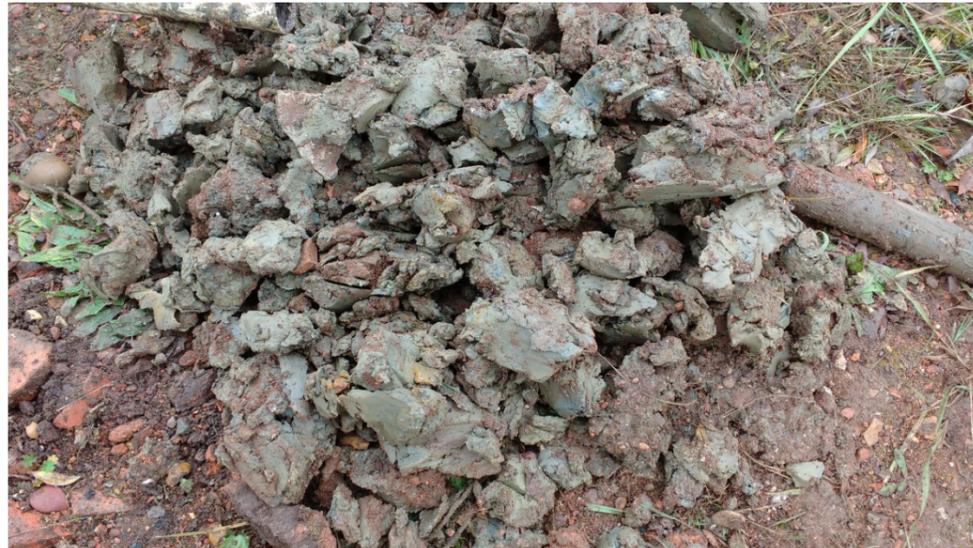
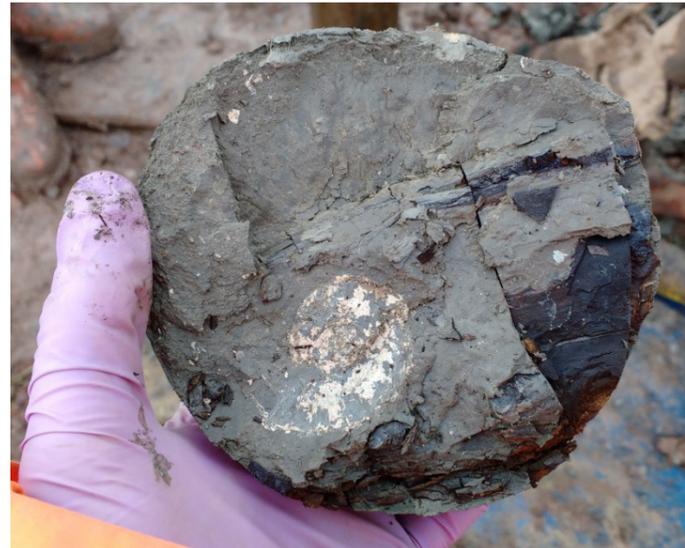
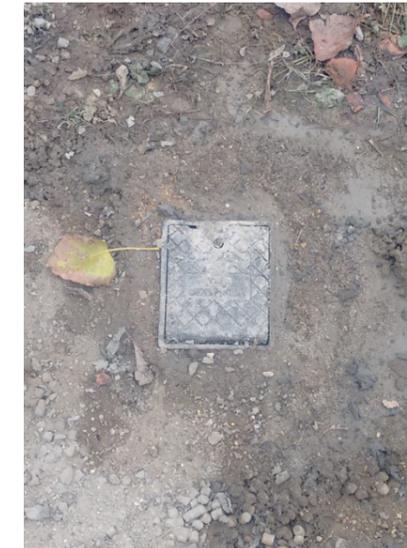
- Top Left: Typical Oxford Clay*
- Top Middle: Typical Set-Up with Safety Barriers*
- Far Right: Installation of Standpipe Piezometer*
- Bottom Left: Weathered Oxford Clay and Fill Material*
- Bottom Middle: Oxford Clay with Organic Matter*
- Bottom Right: Flush Headworks*

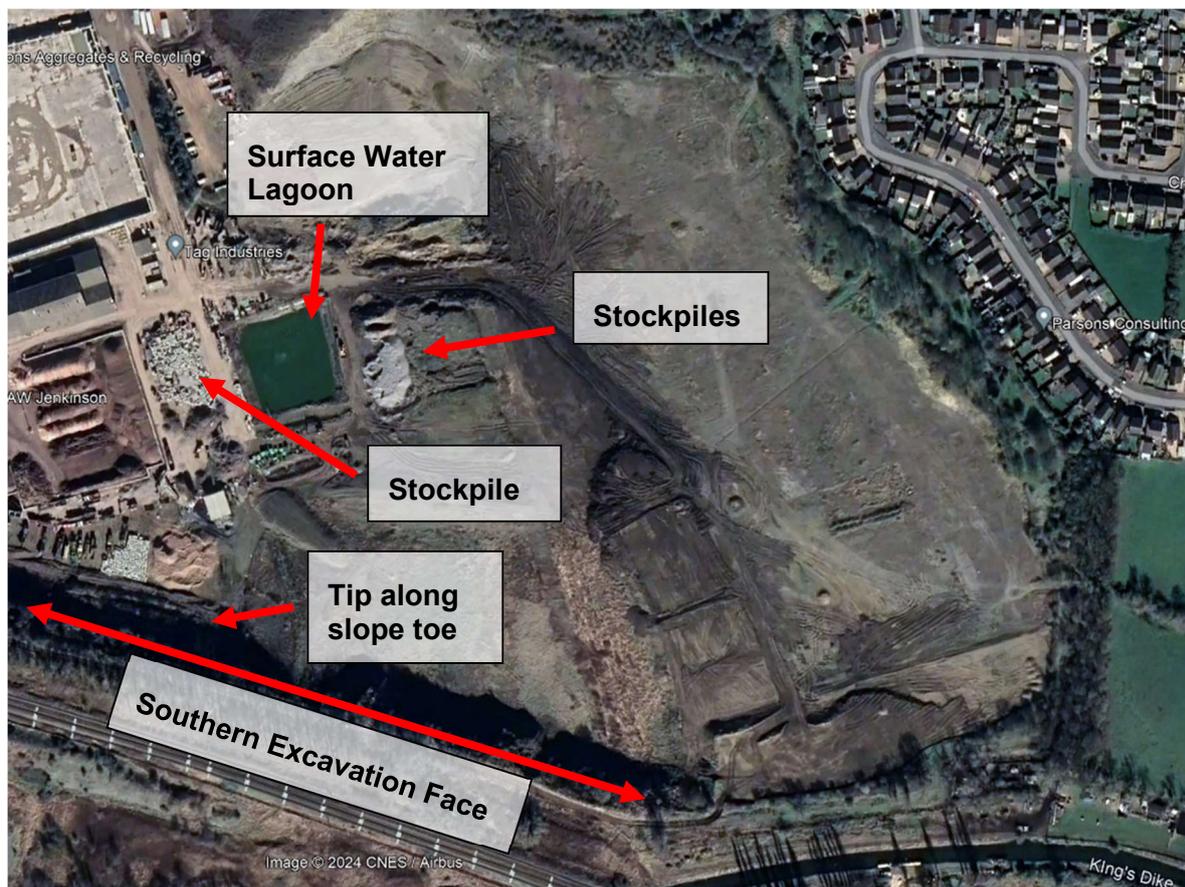
Image 1-1 Key Site Features

The key features observed during the inspection of EMW site at the Saxon Pit quarry are shown in Image 1-1 and summarised in Table 1-1

Feature	Hazard Status	Reason / detail
Southern Excavation Face	Significant Hazard	Vertical height of exceeds 15m in depth and/or the overall slope angle exceeds 1V:1H
Tips	Not a Significant Hazard	<10,000m <sup>2</sup> in plan area, <15m in height.
Surface Water Lagoon	Not a Significant Hazard	<10,000m <sup>2</sup> in volume.
Stockpiles	Not a Significant Hazard	<10,000m <sup>2</sup> in plan area, <15m in height.

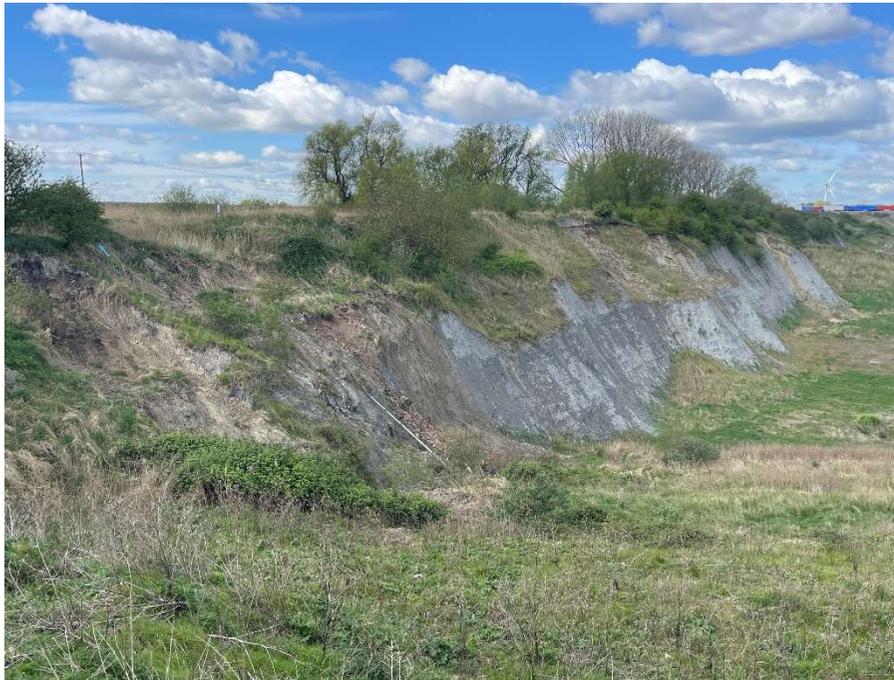
**Photo 1: Undulating slope face - facing west**

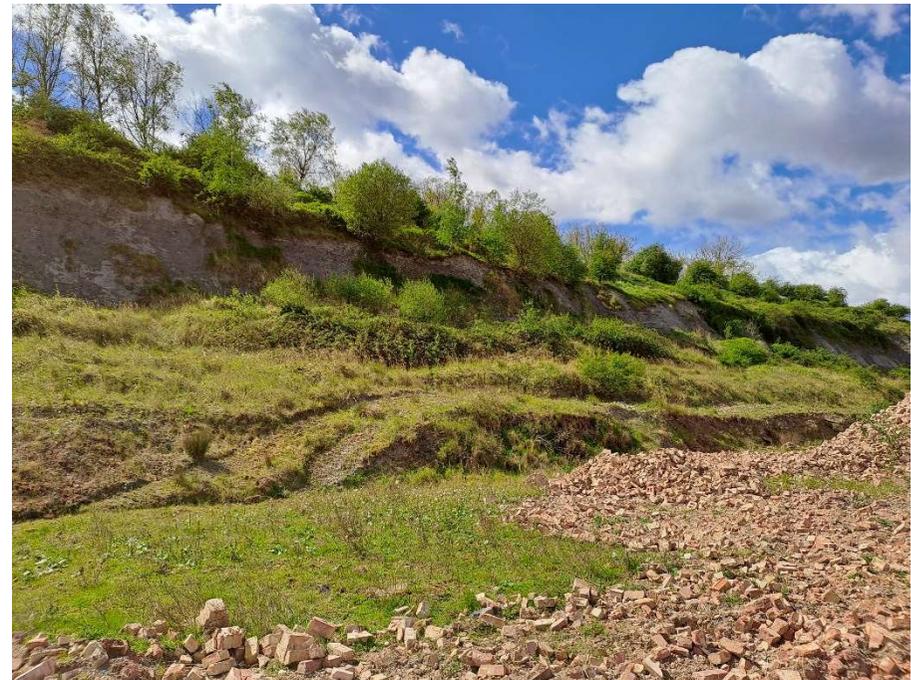
**Photo 2: Buttress to slope face on west of ramp - facing southwest**

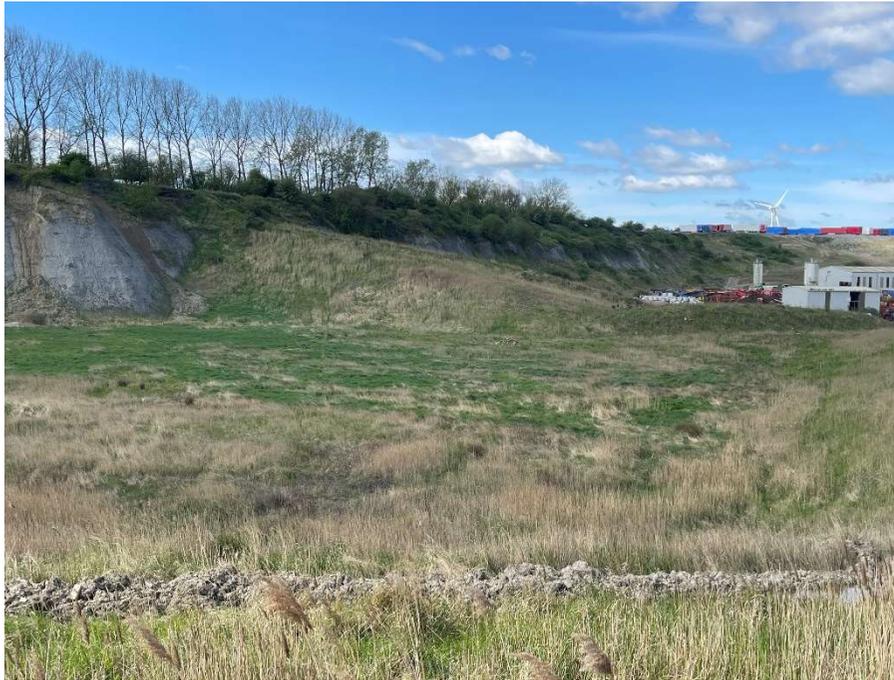
**Photo 3: Central buttress and access ramp - facing southwest**

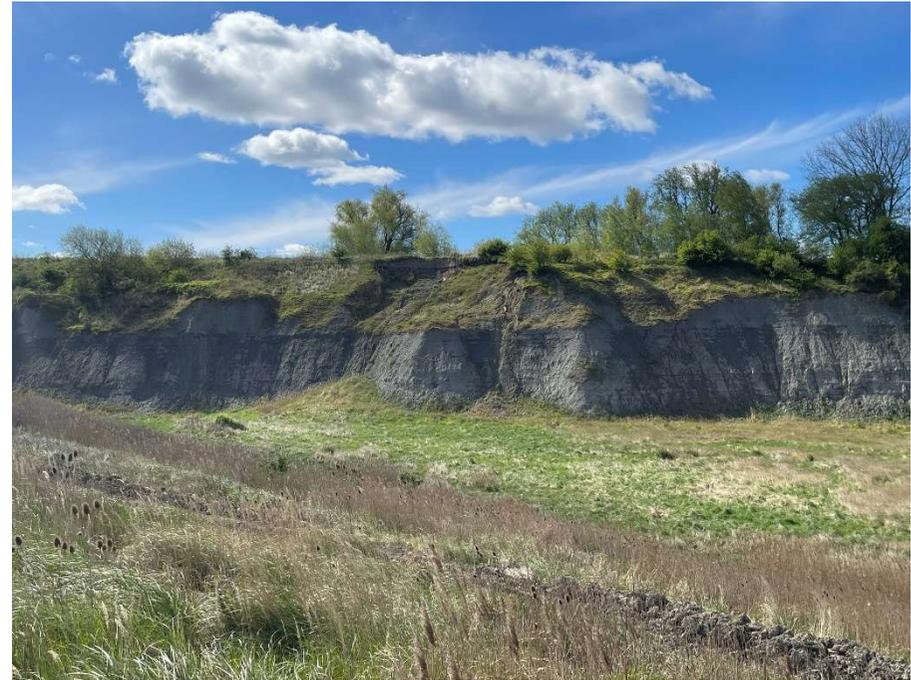
**Photo 4: Series of failures in upper section - facing south**

The Geotechnical Assessment carried out under Regulation 33 of the Quarries Regulations concludes that the exposed southern quarry face represents a significant hazard and that remedial works are required to stabilise/buttress the face to avoid risk to health and safety. The report recommends that steps to improve the situation following necessary regulatory processes must begin within 2 years and be monitored regularly in the interim and when works start.

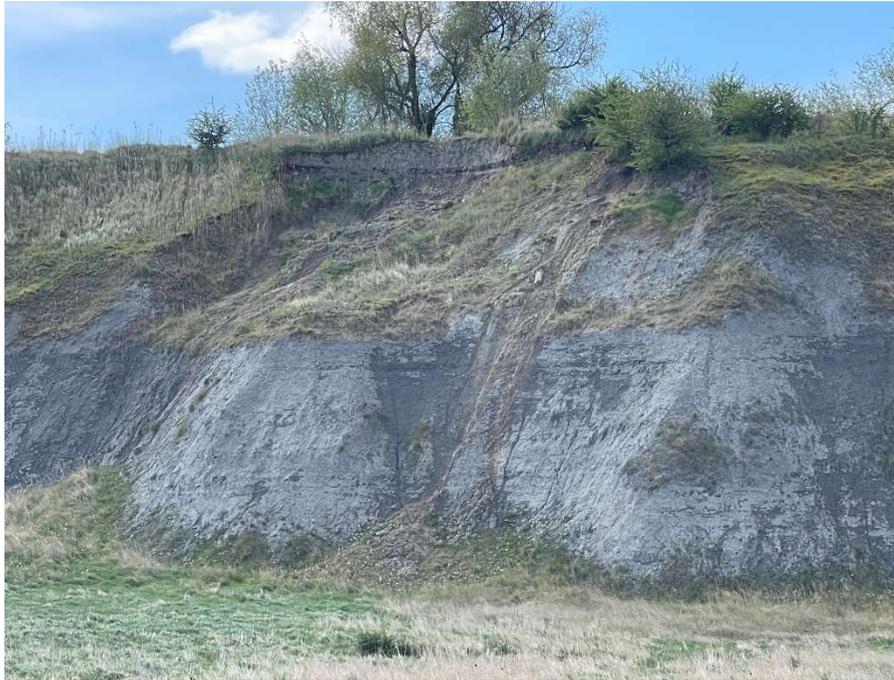
**Photo 5: Significant backscarp and exposed lithology - facing south**

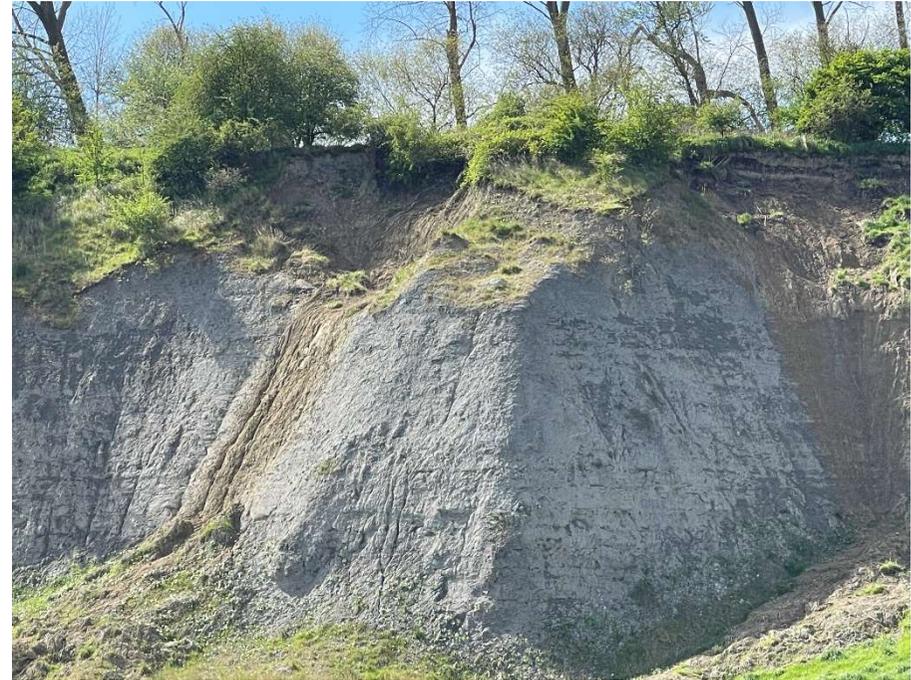
**Photo 6: Failed section with debris flow on slope face & exposed lithology - facing south**

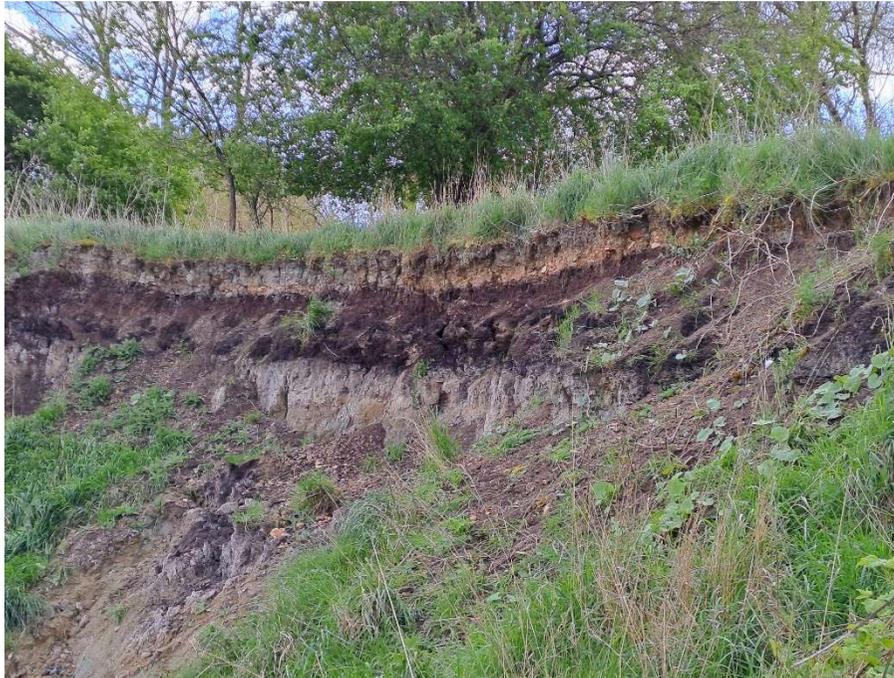
**Photo 7: Exposed upper lithology immediately east of ramp – facing southeast**

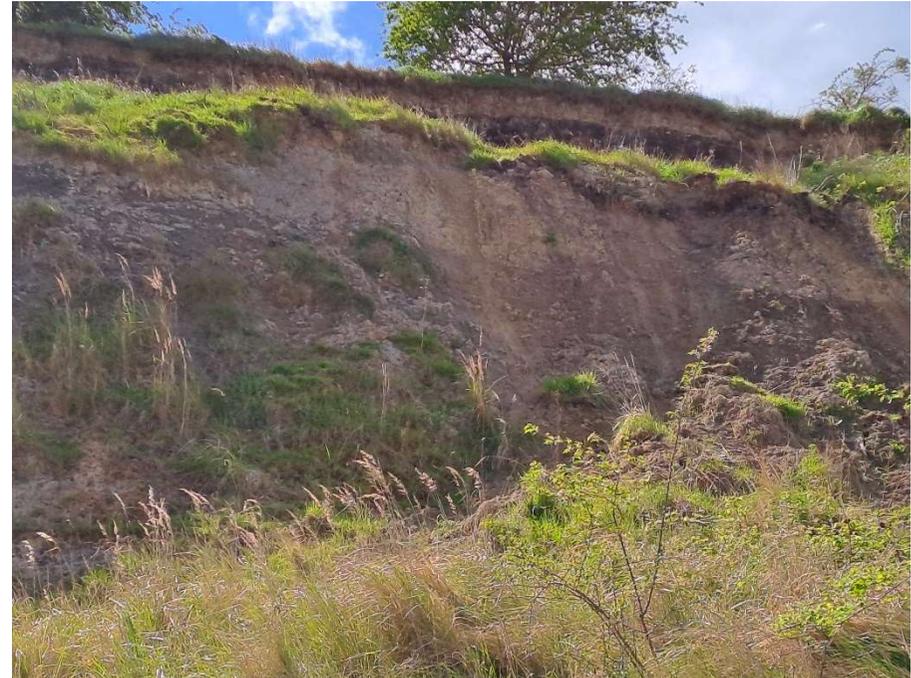
**Photo 8: Exposed upper lithology facing southwest**

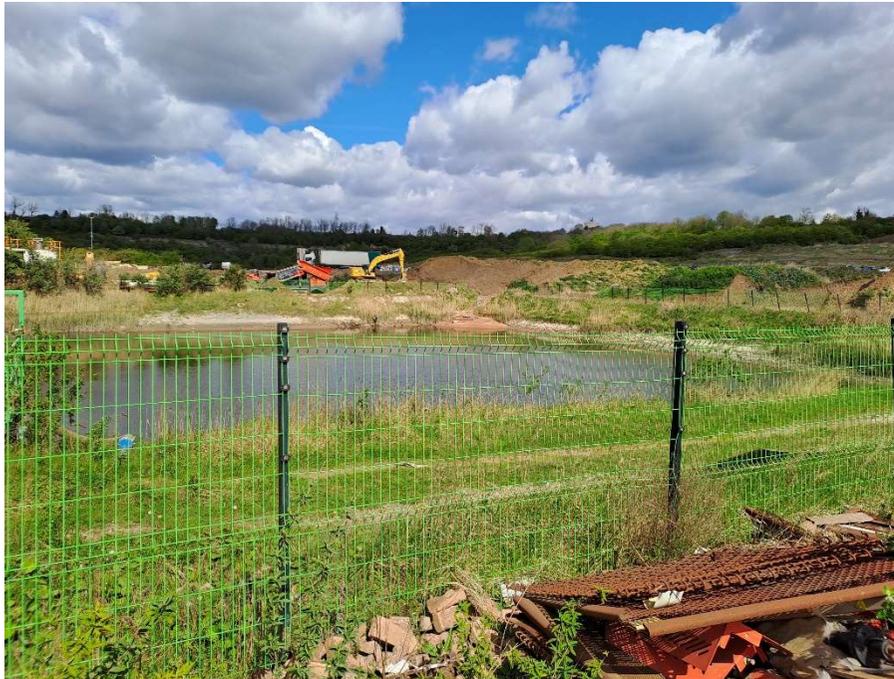
**Photo 9: Fenced off lagoon facing northeast**

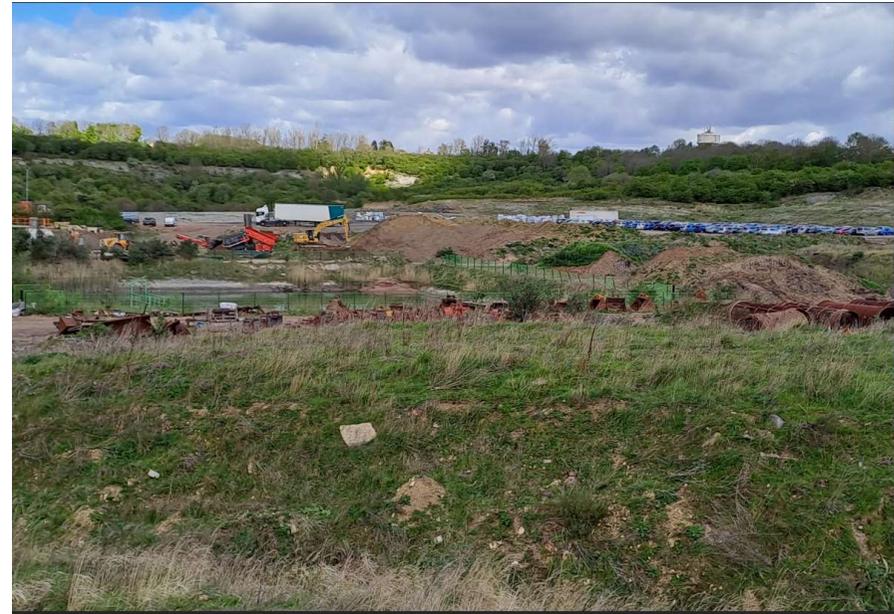
**Photo 10: Stockpiles around lagoon area – facing northeast**

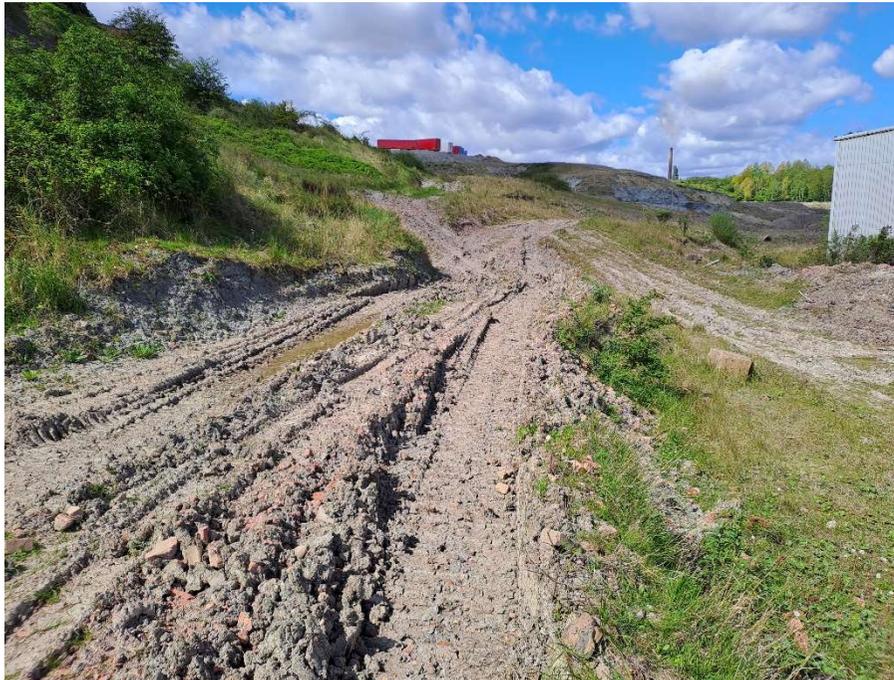
**Photo 11: Haul Road/track at slope toe – facing west**
