Rev:	Date:	Desc:	Client:	Job no.:
0	October 2022	Original	Biomass No.4 UK Limited Plymouth EfW Facility	SOL_21_P024_COG October 2022
			Annex Title:	
			Site Photographs

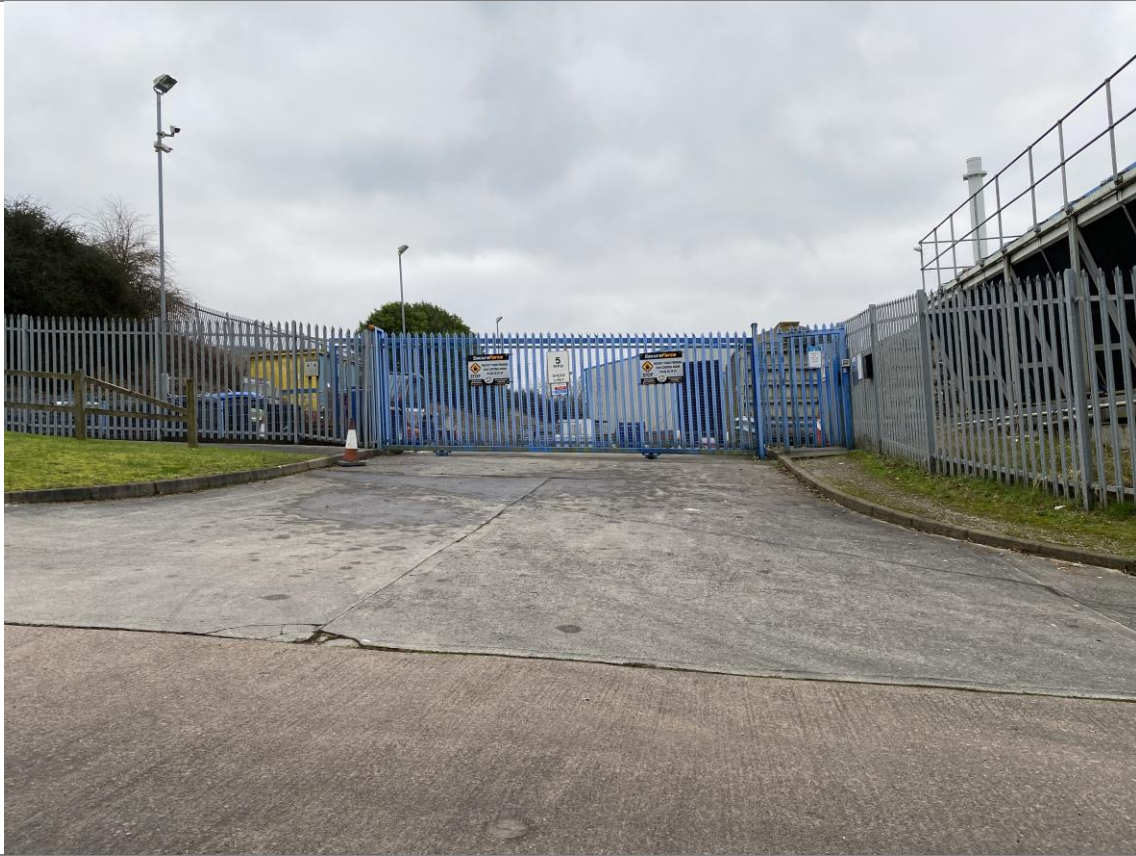
Photograph 1: Site entrance with motorised gate and palisade fencing.

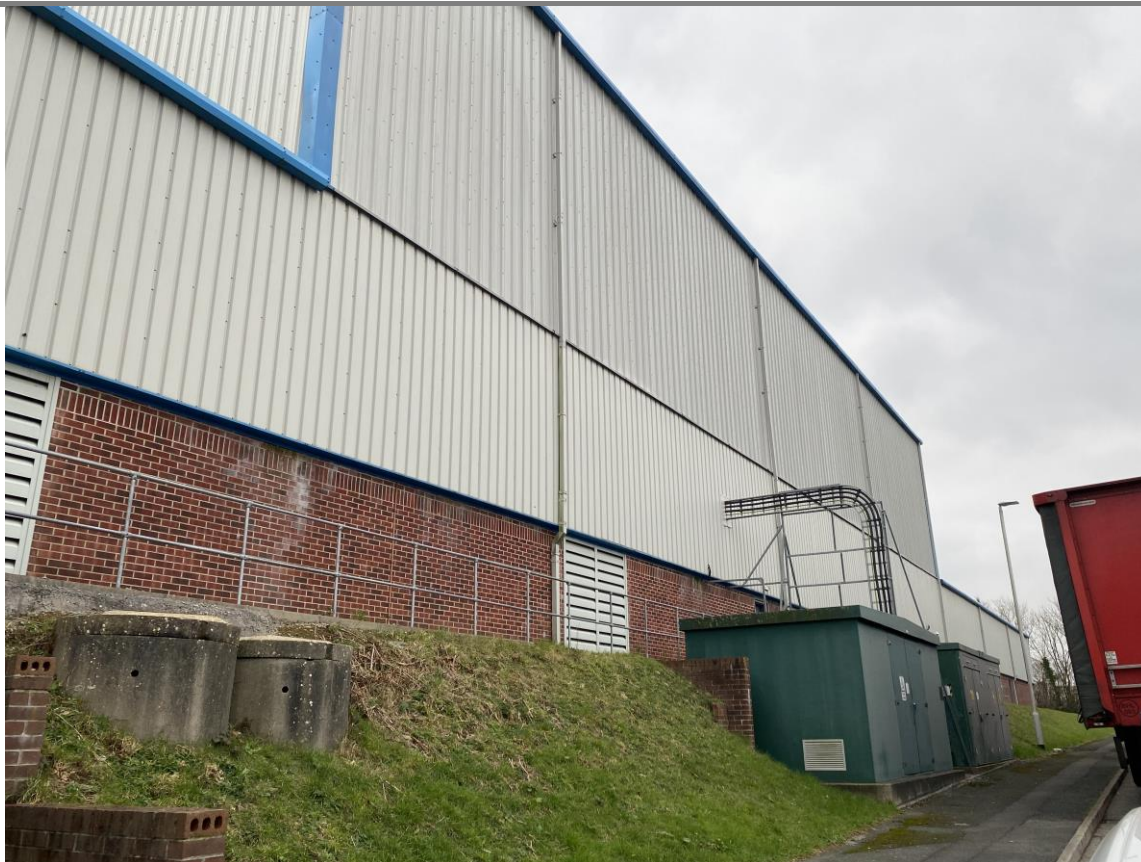
Photograph 2: Southwest façade, with electricity substations to right of image and S1 emission monitoring point to left of image.

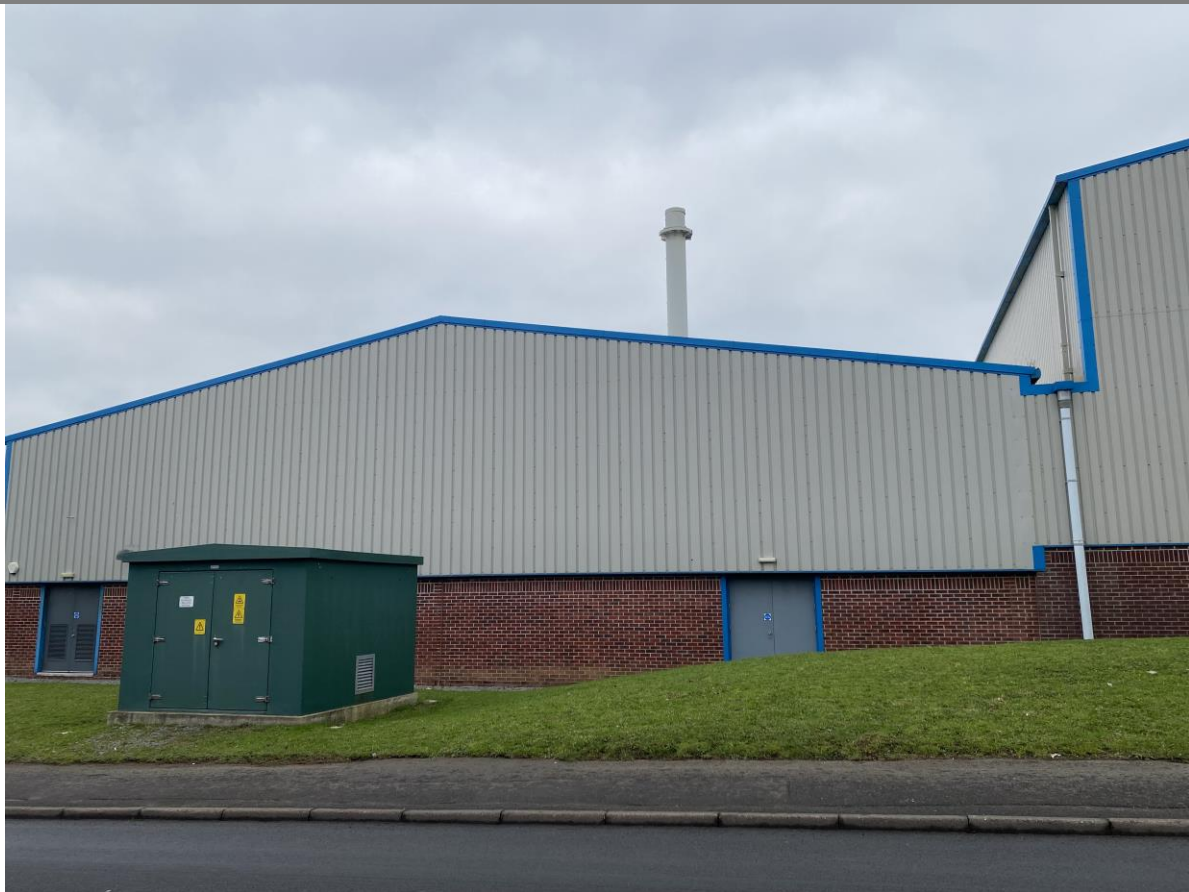
Photograph 3: Southeast façade with electricity substation in front of building and emissions stack A1 visible.

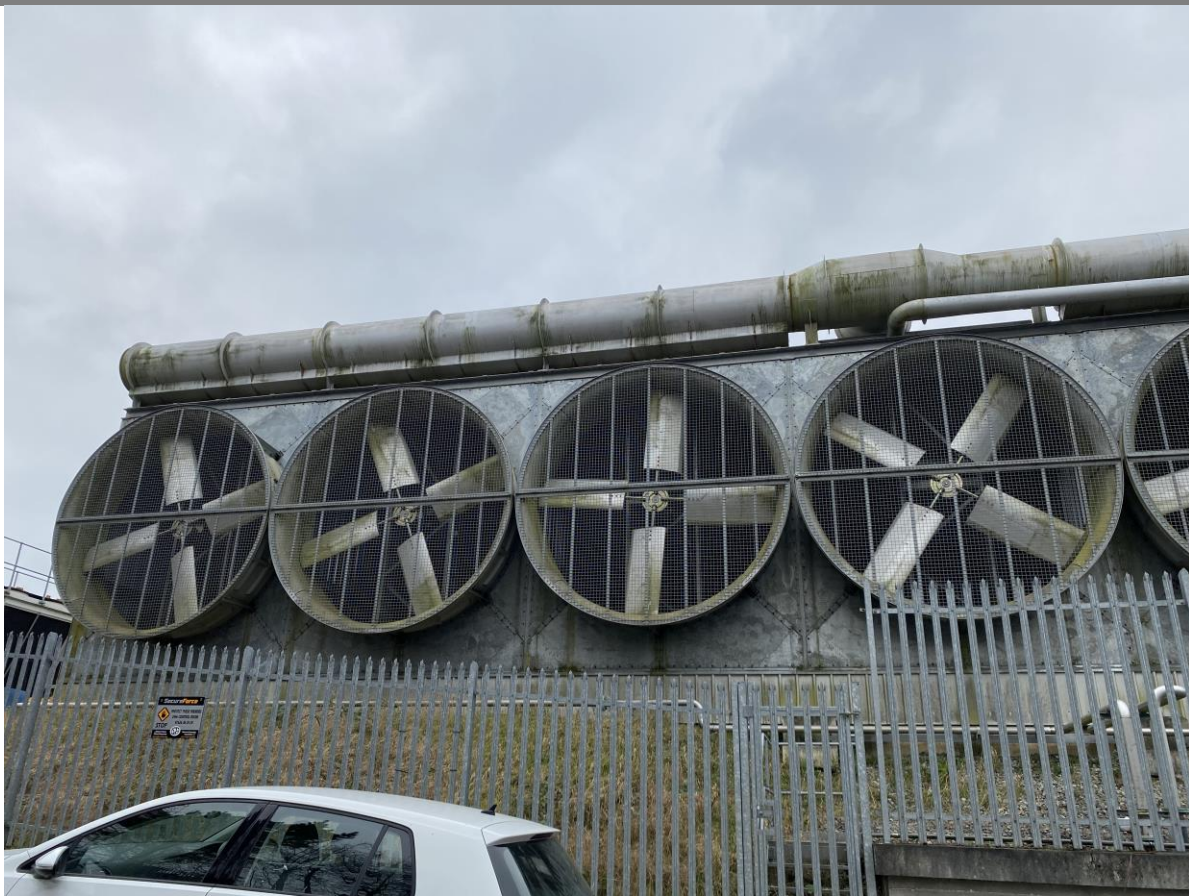
Photograph 4: Coolers at northeast end of the site.

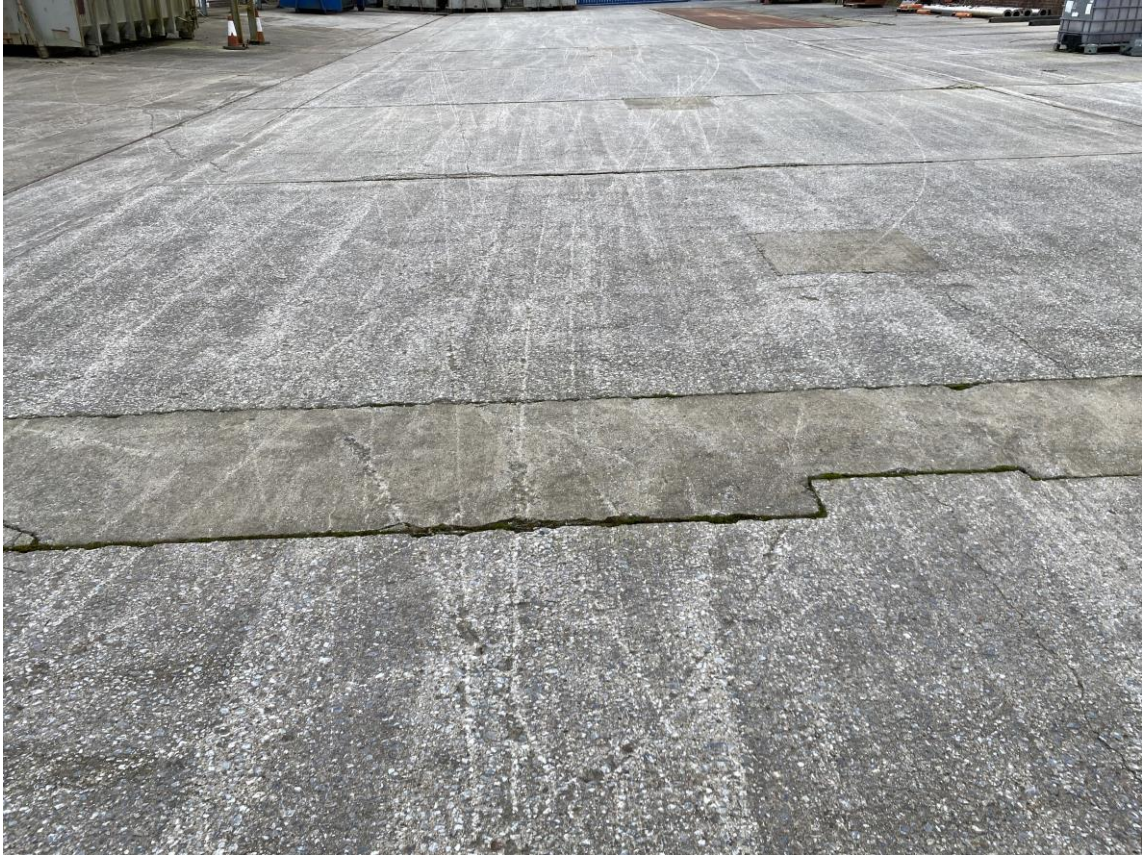
Photograph 5: Concrete pad in main yard. Existing weighbridge is visible at the top right hand side of the image.

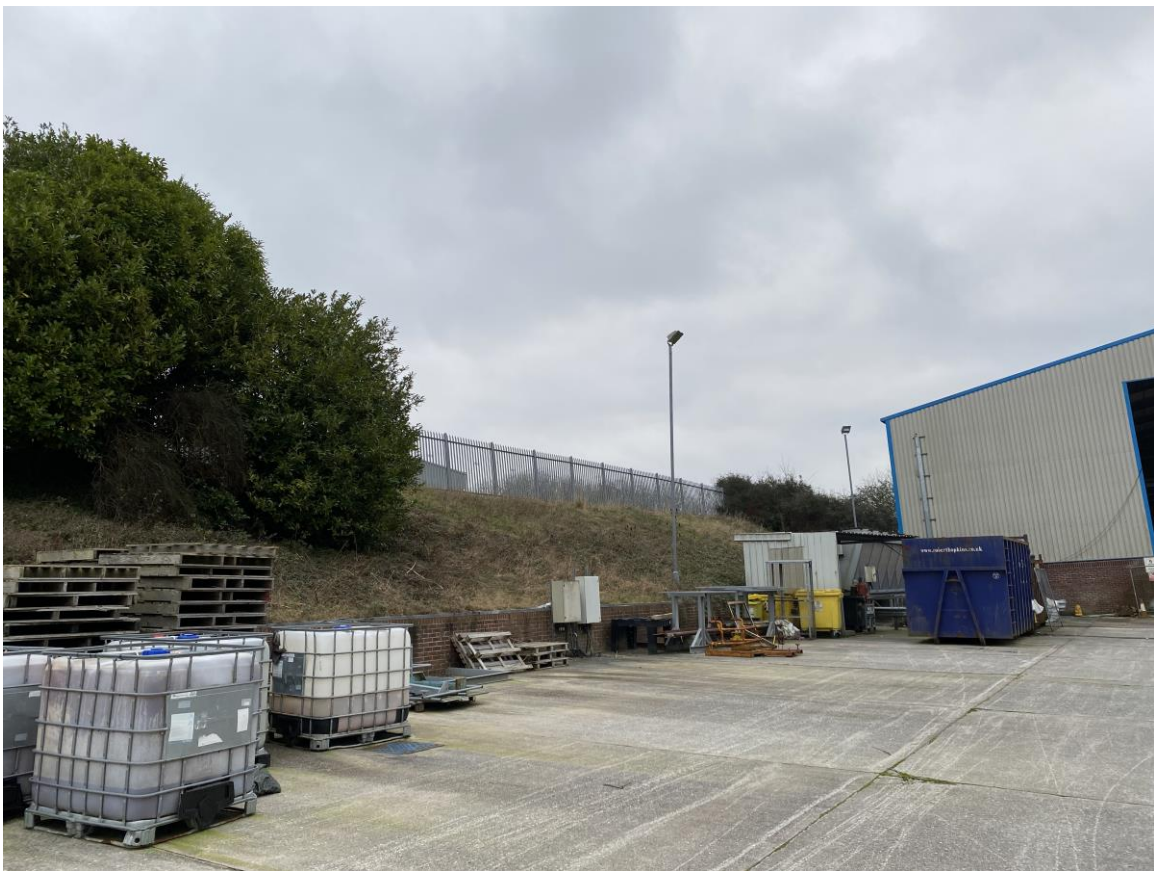
Photograph 6: Northeastern edge of main yard with bank and site boundary palisade fence in background.

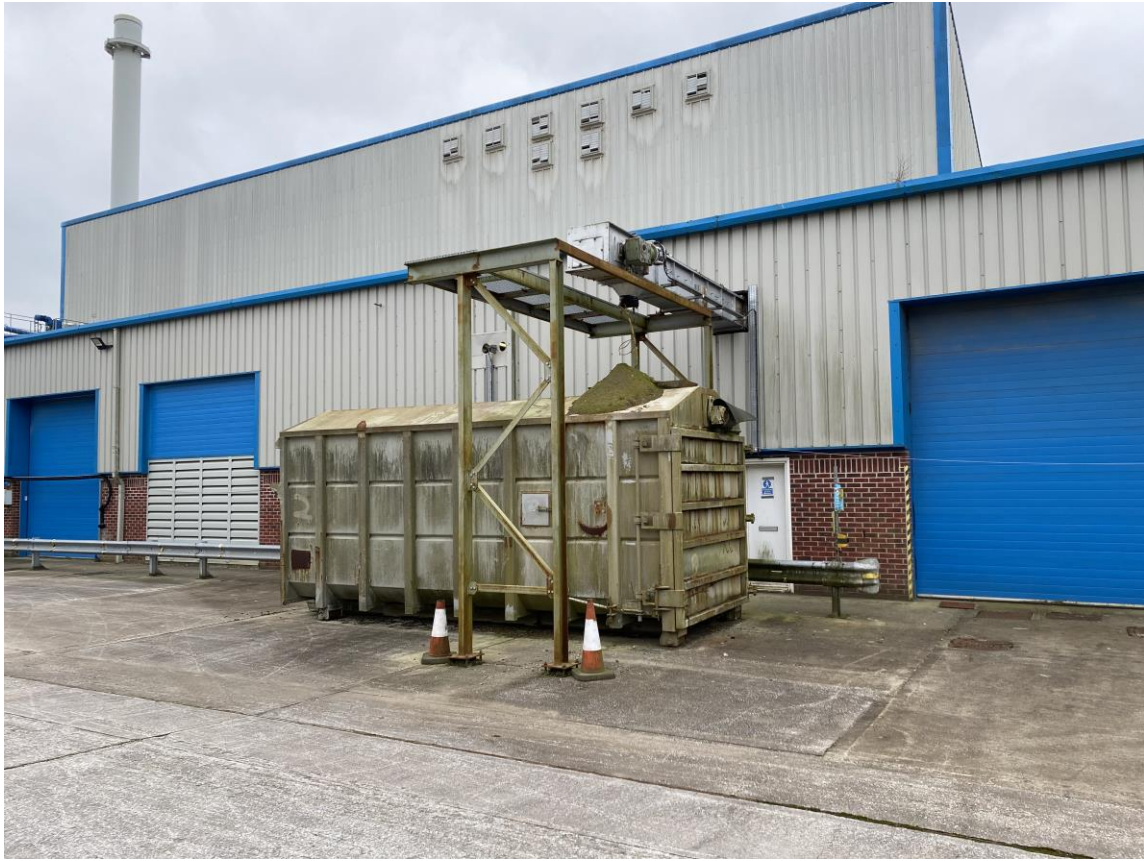
Photograph 7: View of northeast side of the building from main yard.

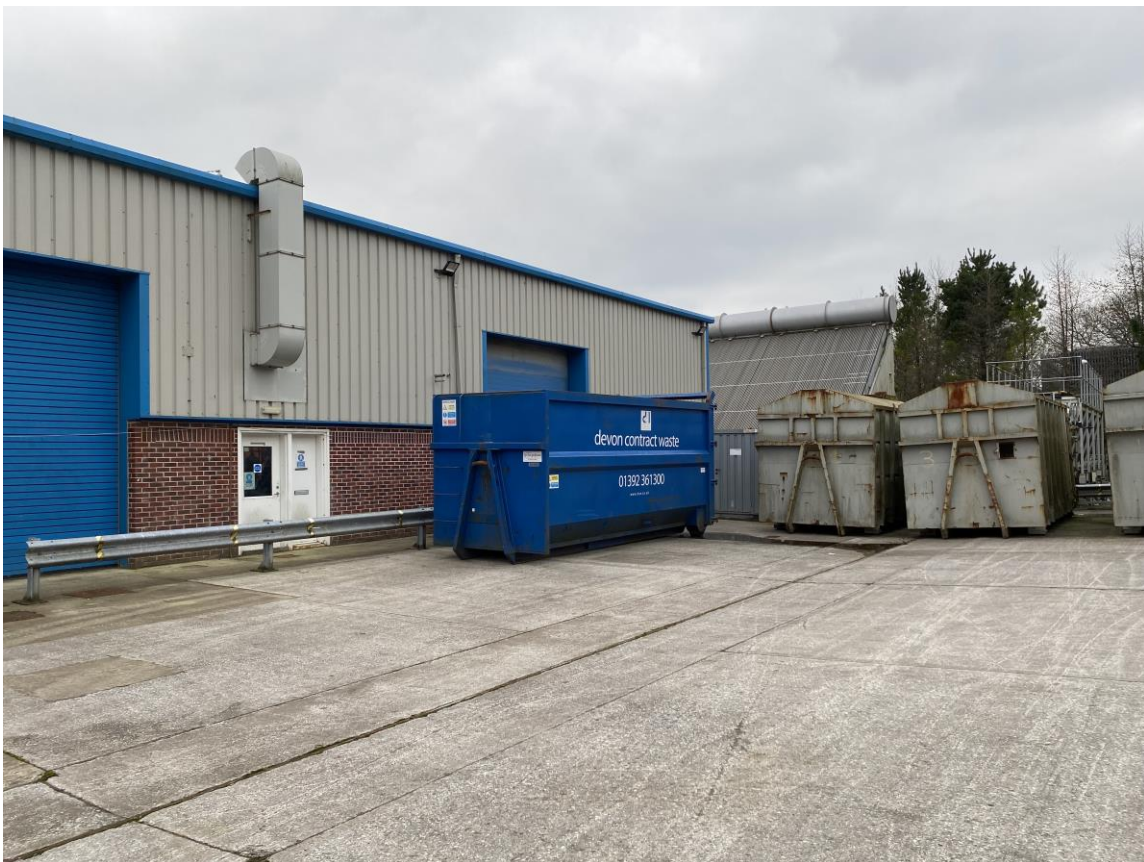
Photograph 8: View of northwest corner of the site from the main yard.

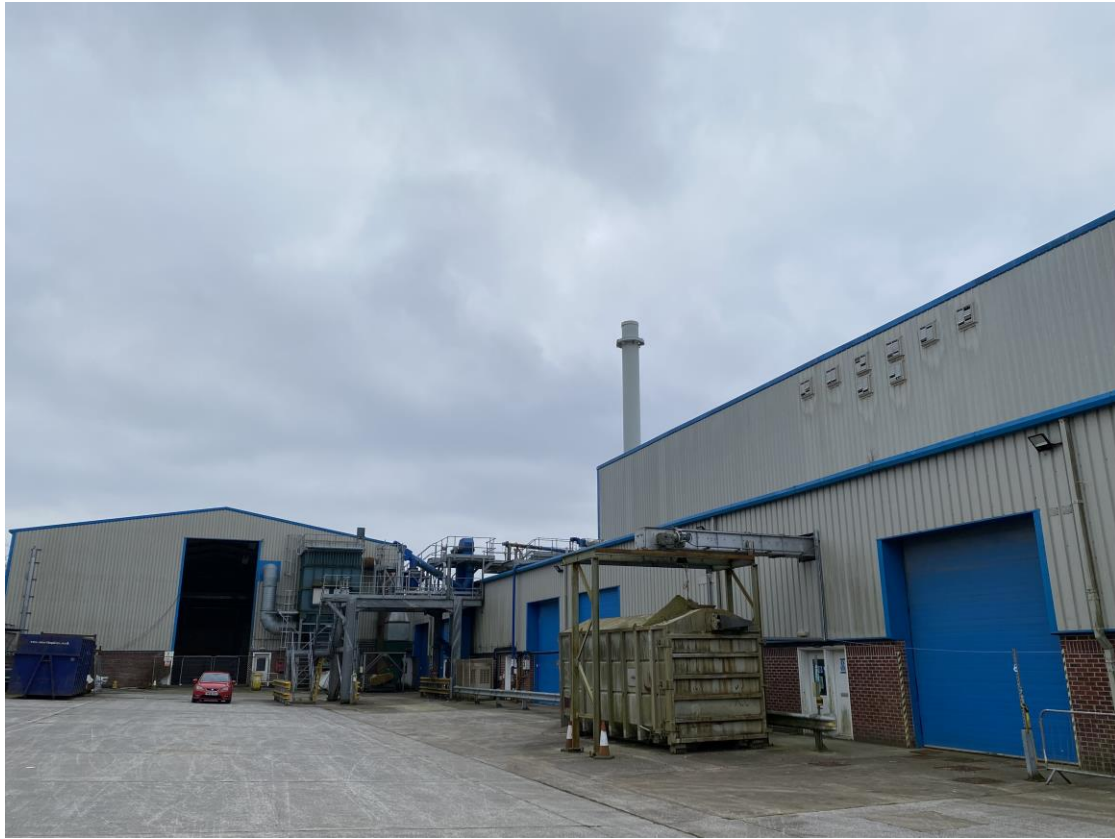
Photograph 9: View of facility looking south from the main yard. Reception hall is to the left of the image and stack visible in background.

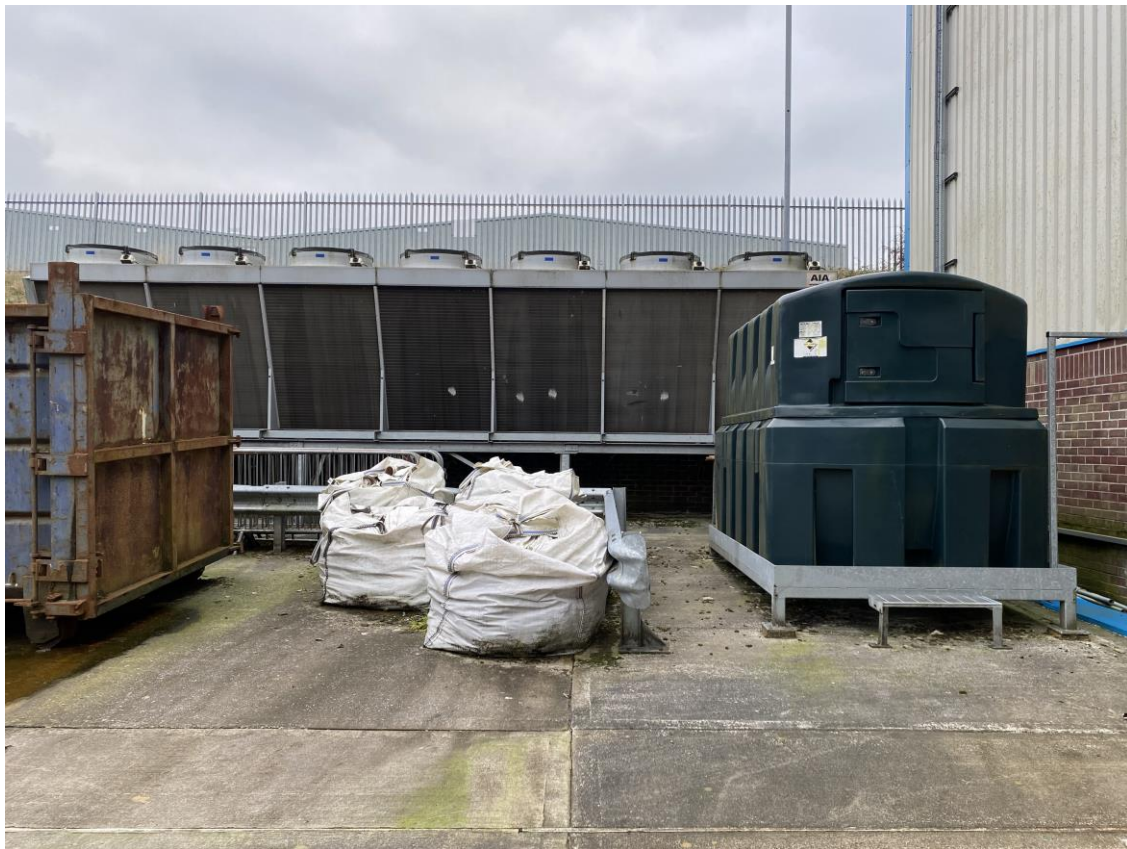
Photograph 10: Southeast corner of yard. Diesel tank on right hand side of image.

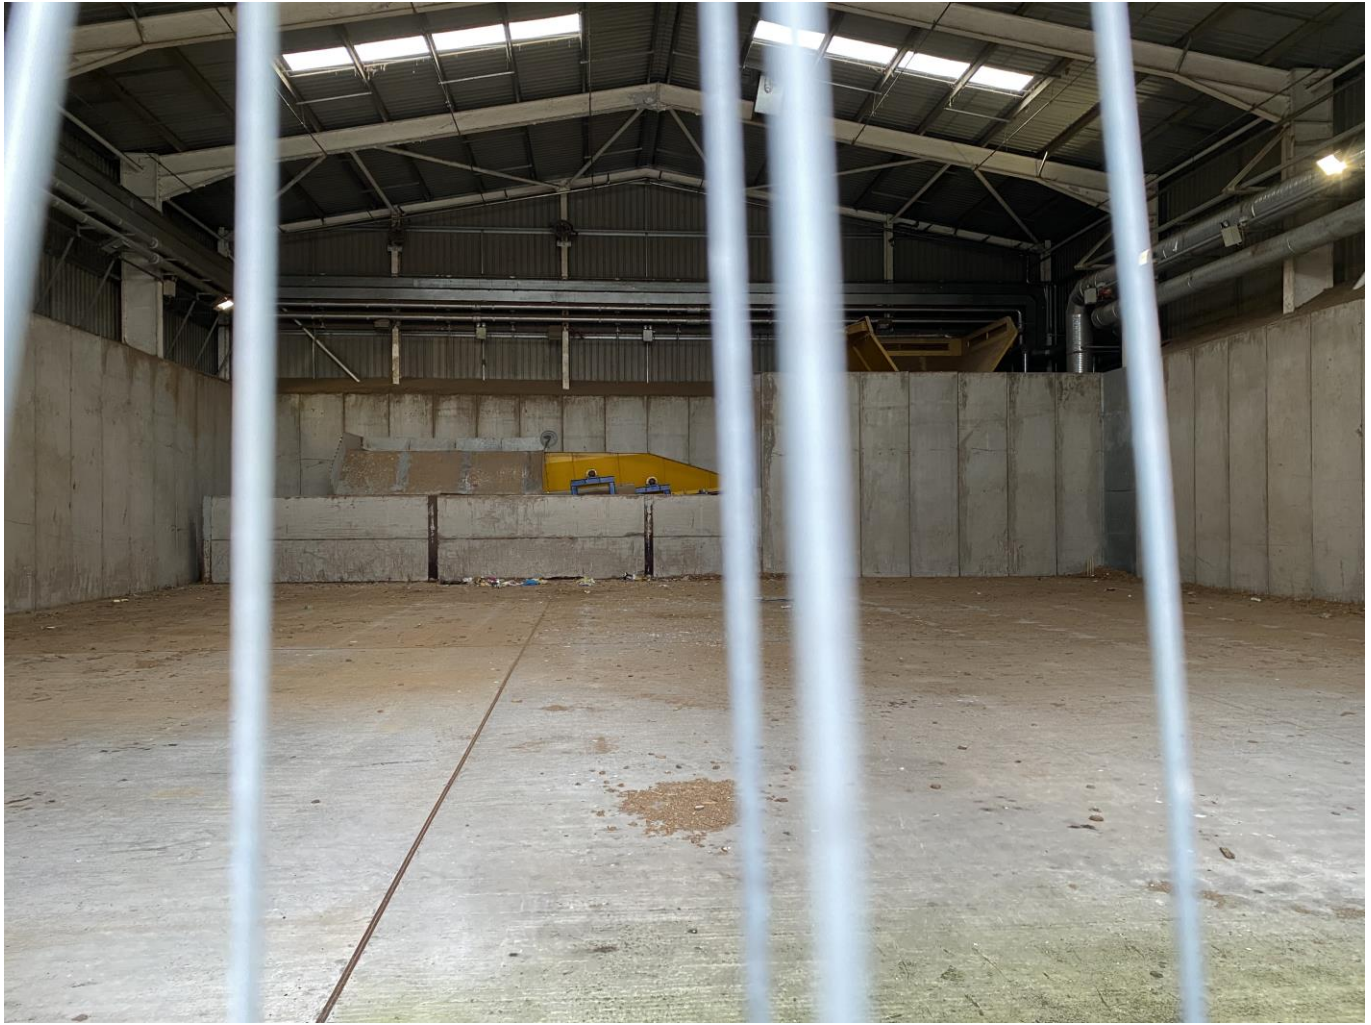
Photograph 11: Fuel reception hall.

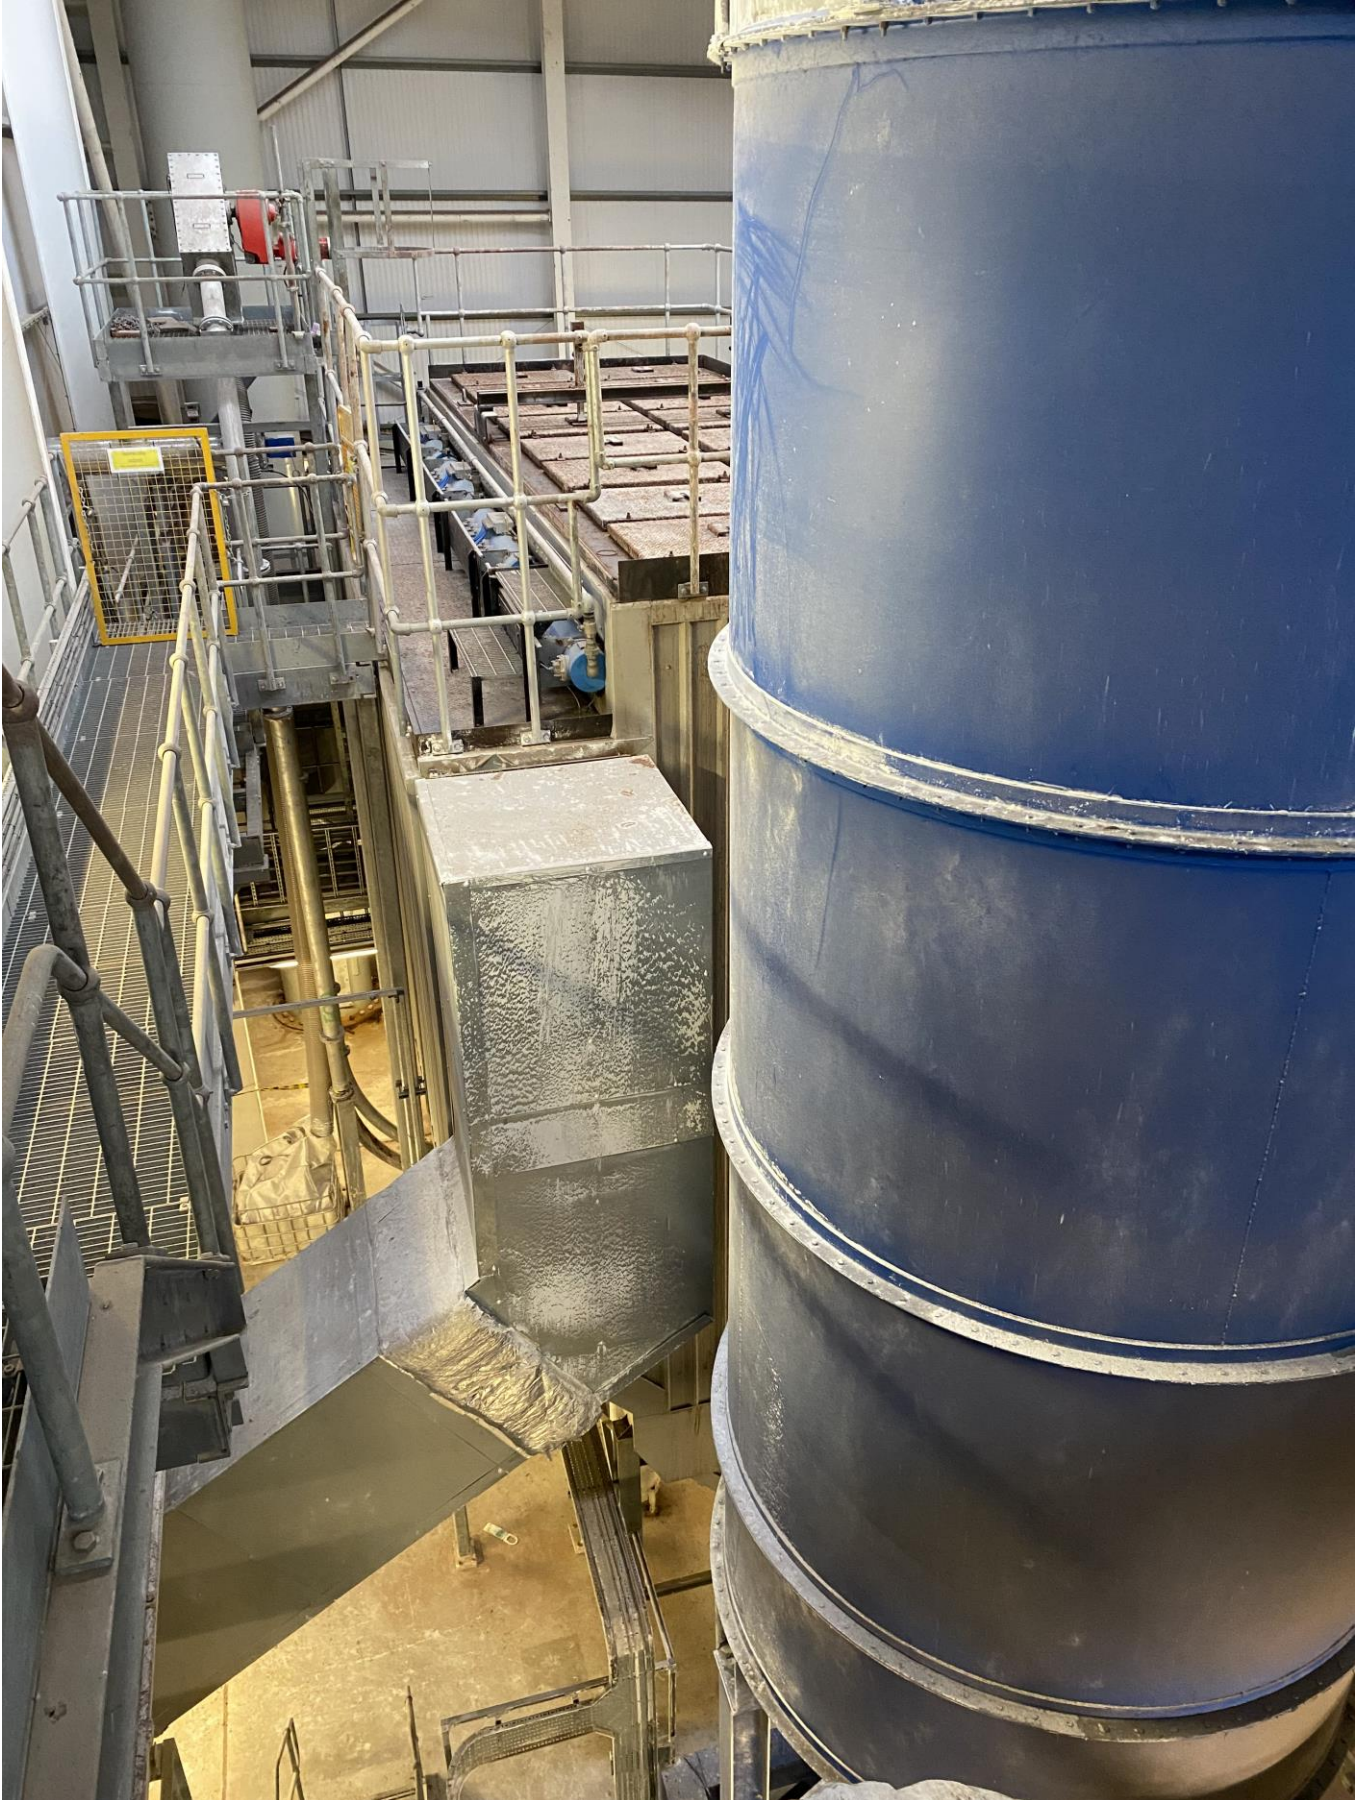
Photograph 12: Existing equipment inside processing building.

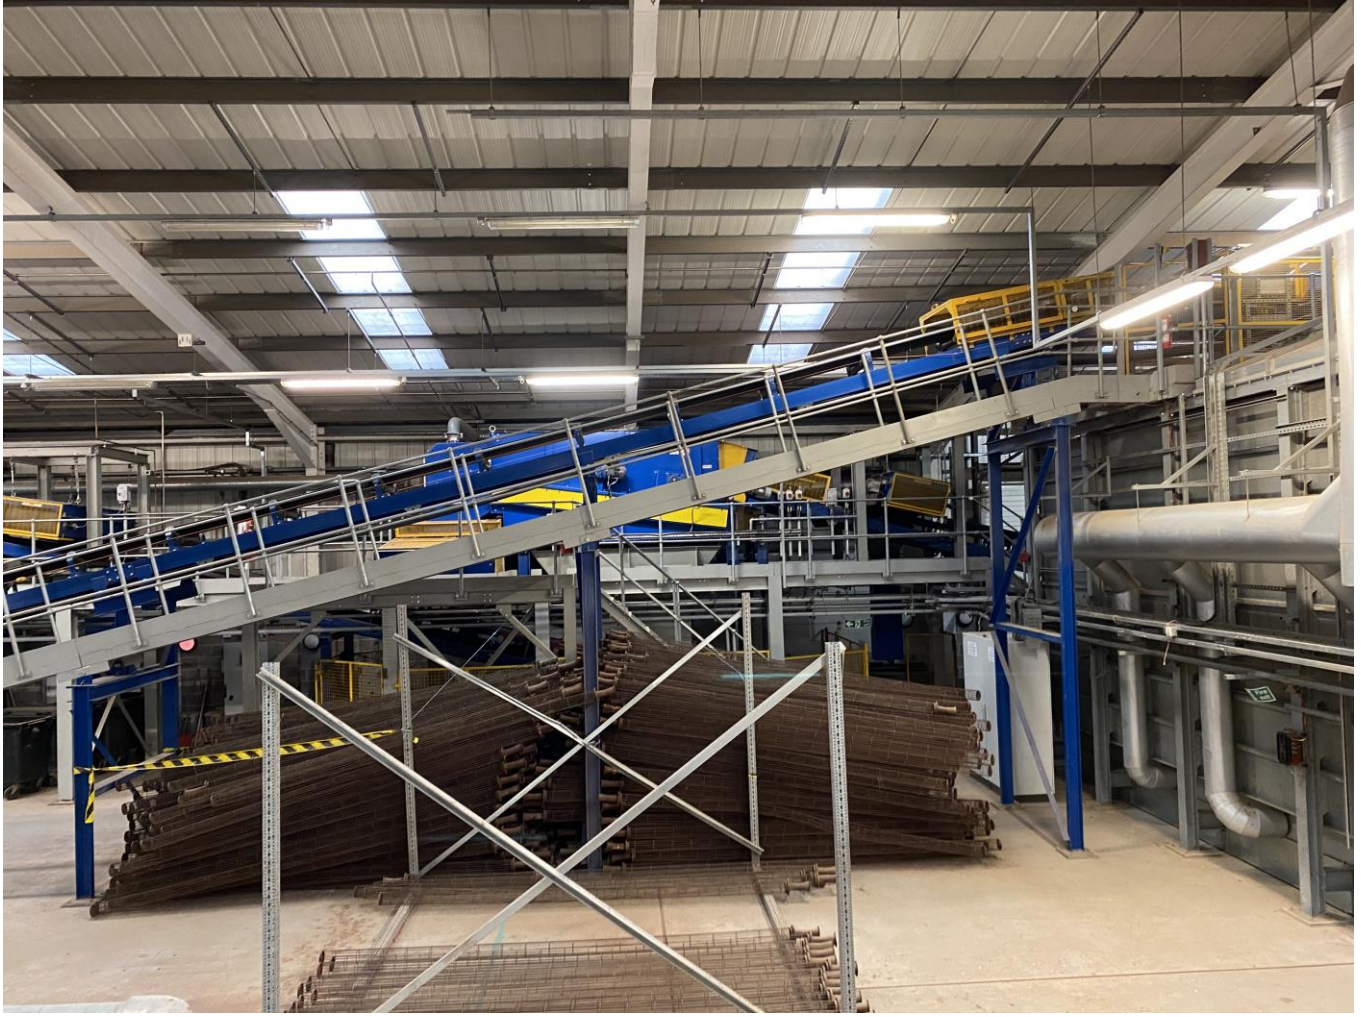
Photograph 13: Conveyors inside processing building. Hard standing in good condition.

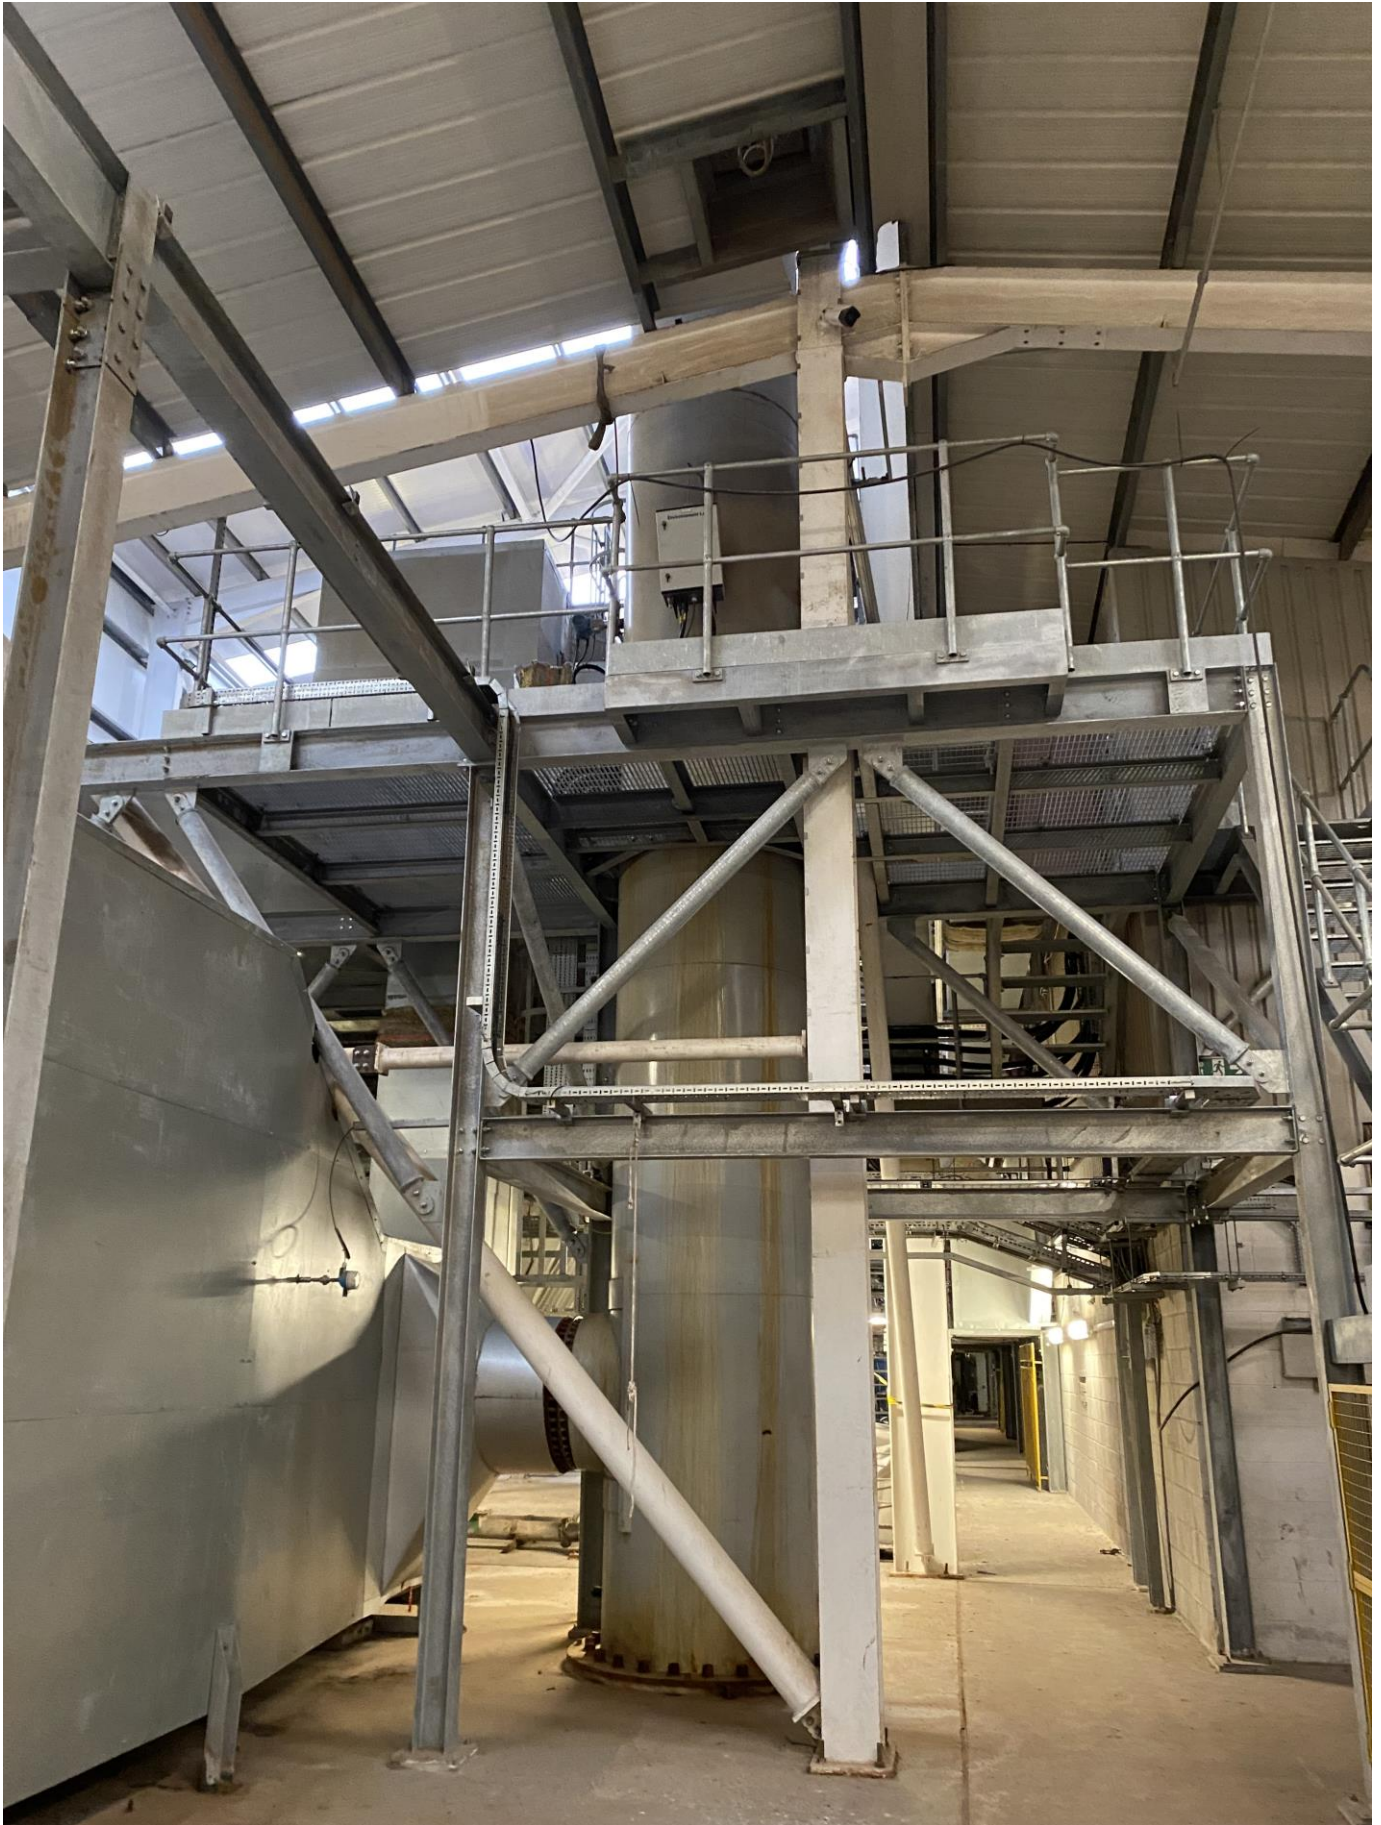
Photograph 14: View of stack from inside the building.

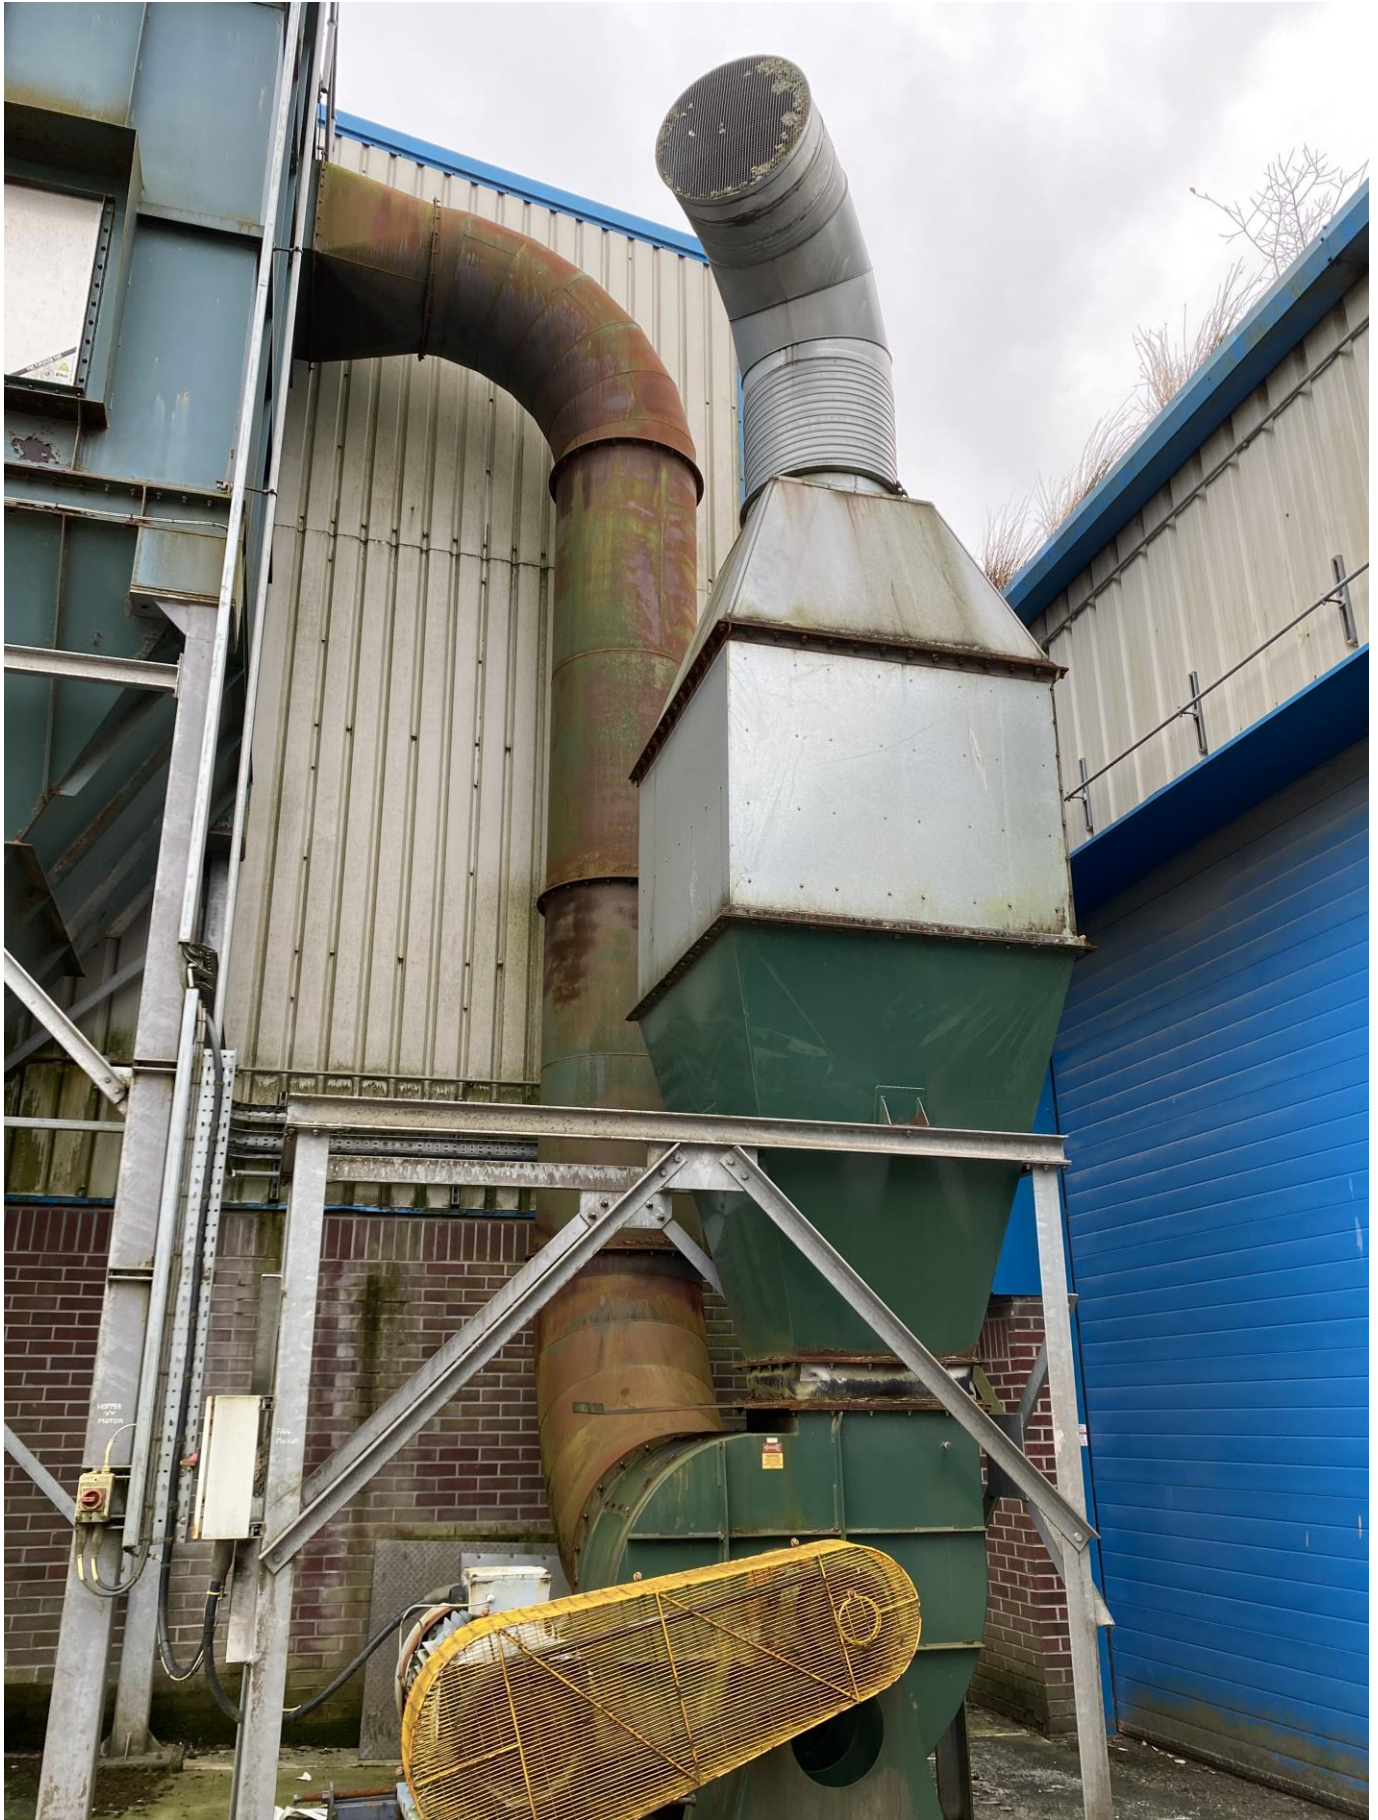
Photograph 15: Existing extraction point.
