Inspection Report
On-stream inspection
Vector Aerospace

Tank No.: Tank 33 – ACID WASTE OFF HAUL

Report No: 187_T33

Date of Inspection: 12th May 2022

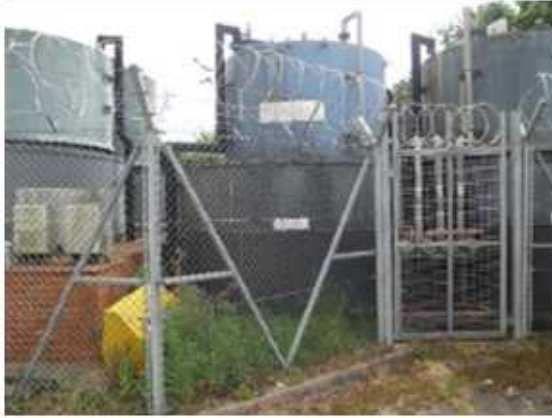
Photograph 1: Tank is on stream with no permanent access.

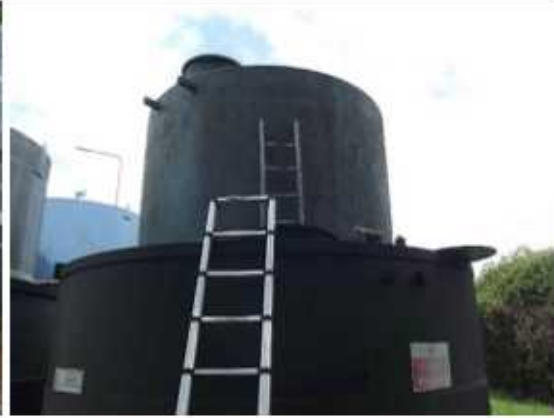
Photograph 2: Manway is in the bund lid. Temporary ladder access.

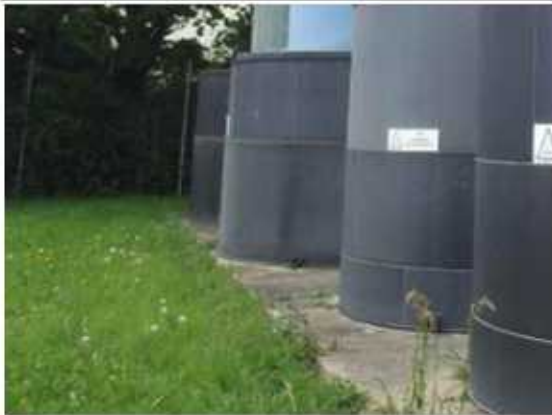
Photograph 3: Tank foundation is cast concrete slab construction.

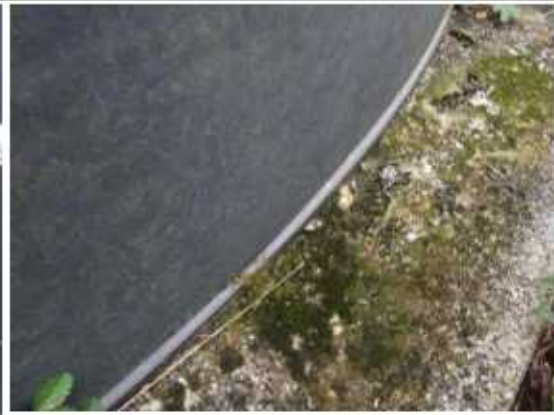
Photograph 4: Tank bund is installed directly on top of the foundation.

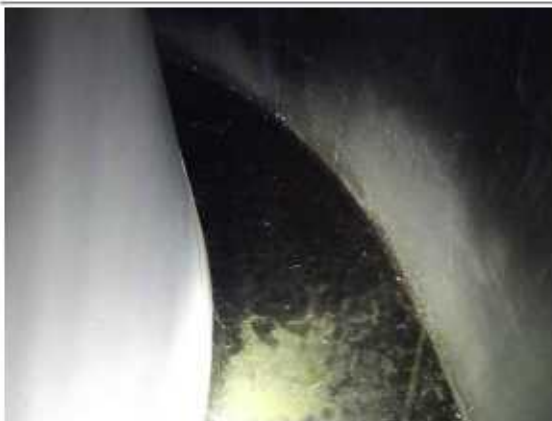
Photograph 5: Internal bund is clean and dry.

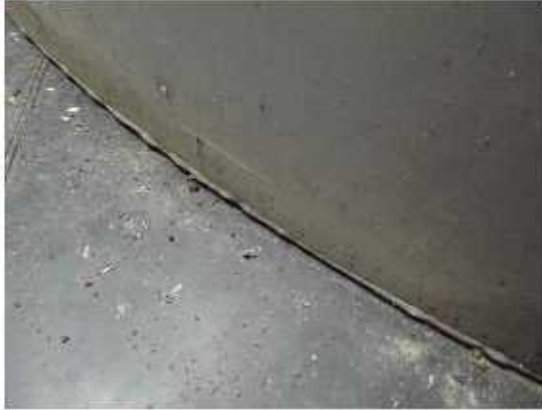
Photograph 6: The tank is installed directly above the plastic bund floor, above a concrete base.

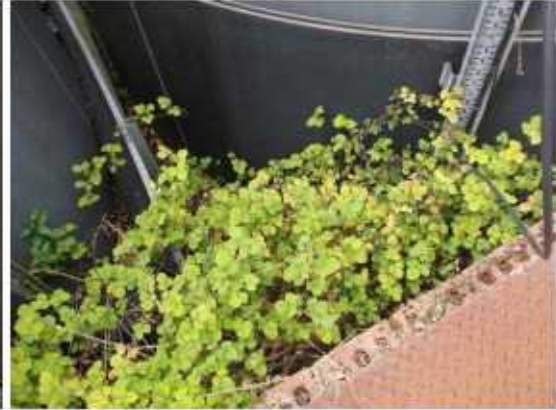
Photograph 7: Significant vegetation in and around tank bunds.

1. Consider installing a simple valved outlet in the lower bund shell to allow draining (after analysis) of any rainwater.
2. Clearly identify the tank with Tank No, Duty and Volume.
3. Remove the vegetation from the concrete foundation and in particular the growth emanating from under the bund floor.
4. Review the firefighting system by engaging a competent authority experienced in storage tank farm fire safety and protection.

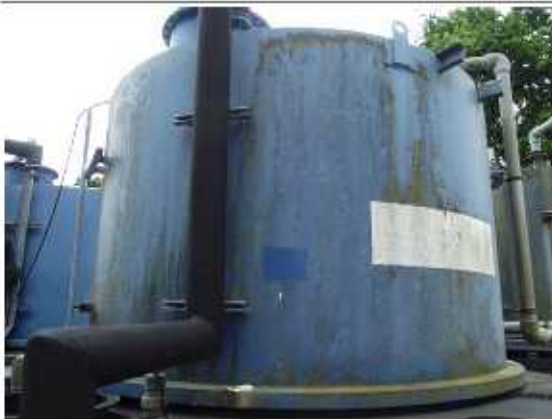
Photograph 8: The tank shell above the bund is in good condition – painted blue..

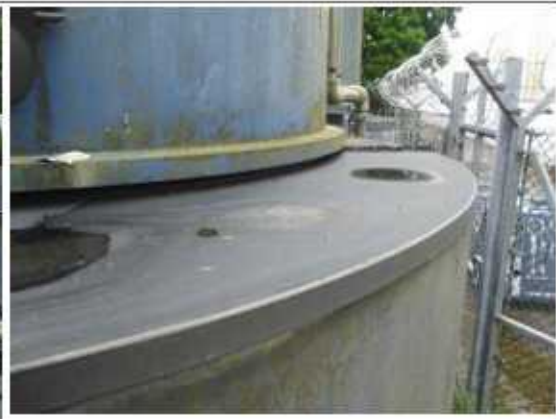
Photograph 9; Mild-steel rain-deflector skirt above bund lid.

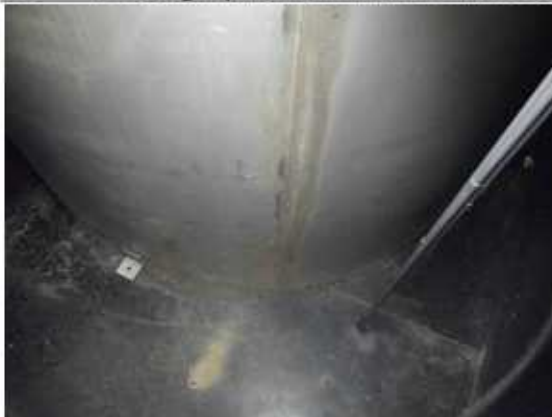
Photograph 10: The external shell below the bund is in good condition and unpainted.

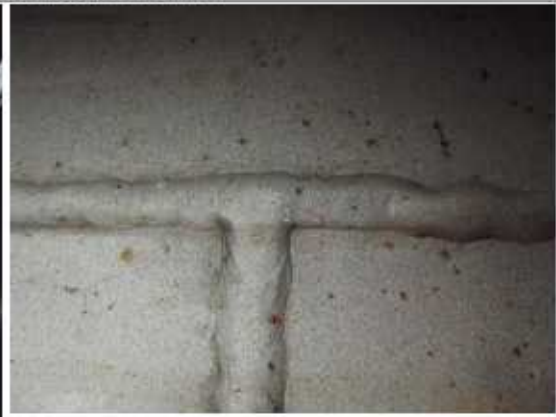
Photograph 11: single horizontal and vertical weld over two courses.

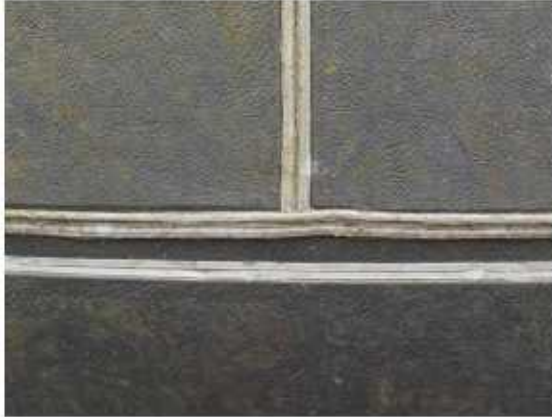
Photograph 12: External bund is in good condition. Welds all good.

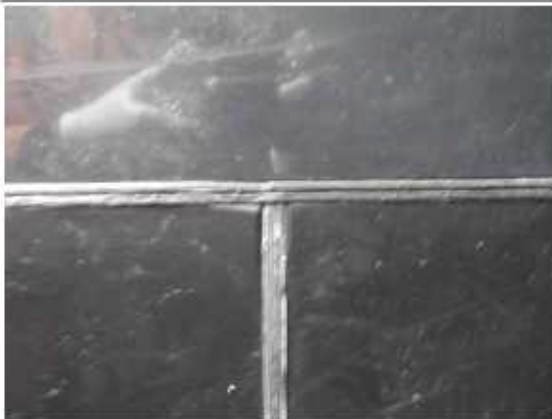
Photograph 13: The internal tank bund shell is in good condition with all welds well made.

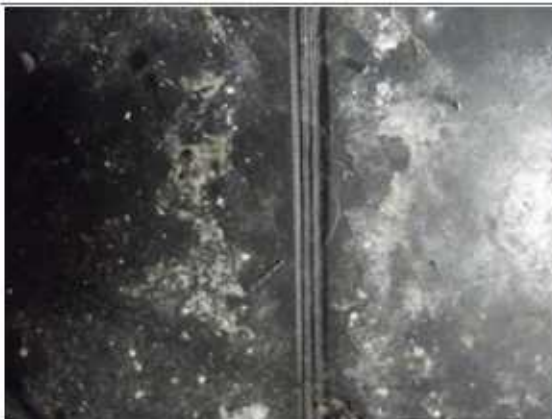
Photograph 14: The tank bund bottom is clean and dry. Welds all well made.

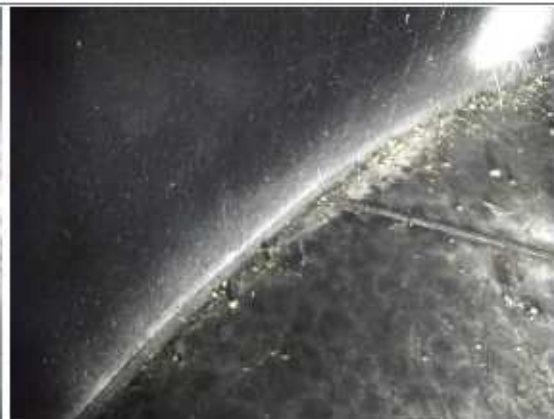
Photograph 15: Bund floor to shell internal corner weld in good condition.

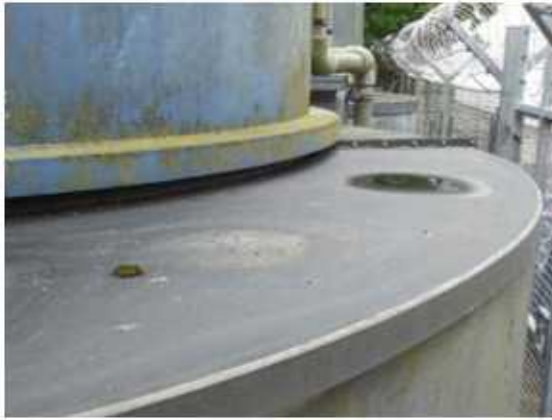
Bund Lid	4	No	Rainwater could enter the bund – from penetrations in the bund lid.
Appurtenances	2	Yes	There is currently no way to easily drain the bund of rainwater – fit a drain valve.
Anchor bolts	0	N/A	None present

Photograph 15: Bund lid below steel rainwater deflector skirt.

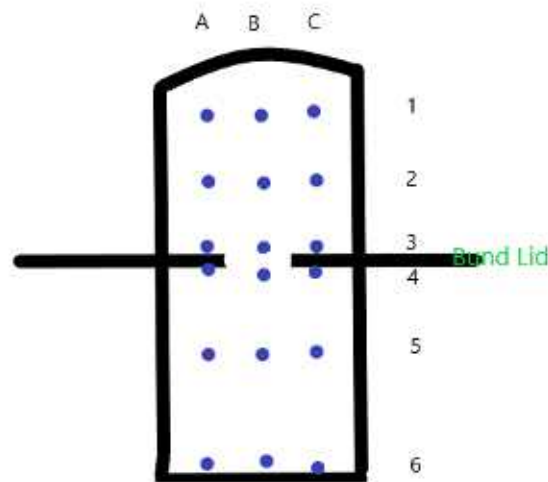
T33 UT measurements (mm)

1	2	3	4	5	6
A	4.1	3.9	4	3.9	4	4
B	4	3.9	4	4.1	4	4
C	3.9	4.1	3.9	4	4.1	3.9

Average Tank Shell thickness – 4 mm 316 Stainless Steel
