**Inspection Report**  
**On-stream inspection**  
**Vector Aerospace**

**Tank No.:** Tank 34 – ALKALI WASTE OFF HAUL

**Location:** Vector Aerospace, Fareham Road, Gosport,  
Hampshire, PO13 0AA

**Report No:** 187\_T34

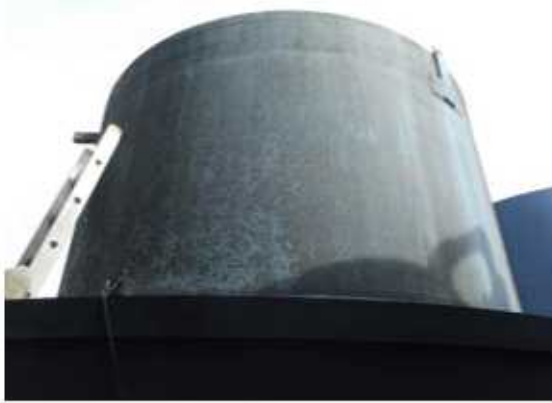
Photograph 1: Tank is on stream with no permanent access.

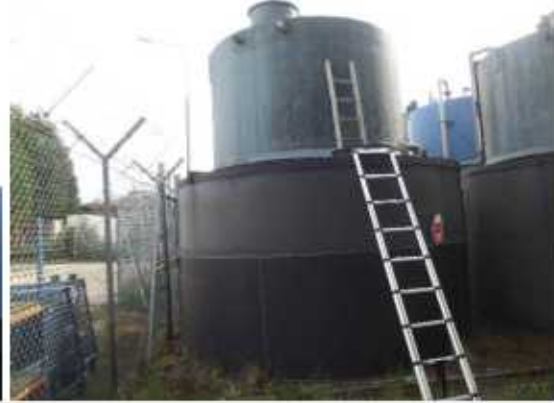
Photograph 2: Manway is in the bund lid. Temporary ladder access.

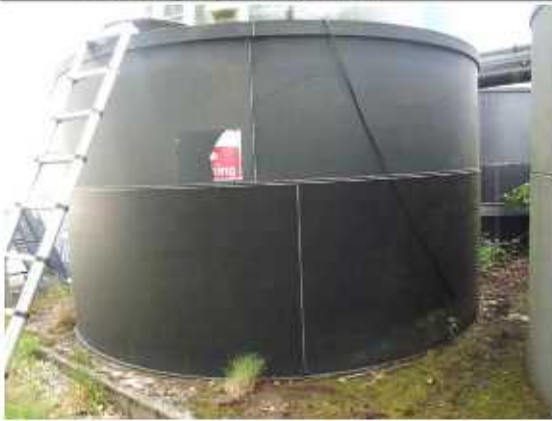
Photograph 3: Tank foundation is cast concrete slab construction.

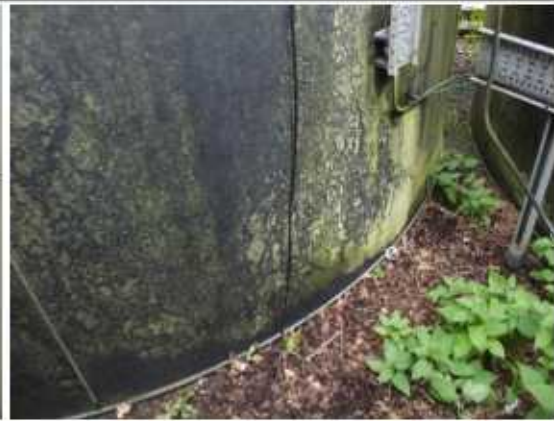
Photograph 4: Tank bund is installed directly on top of the foundation.

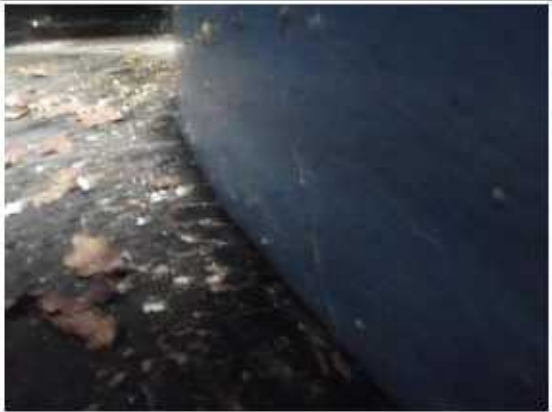
Photograph 7: The tank is installed directly above the plastic bund floor, above a concrete base.

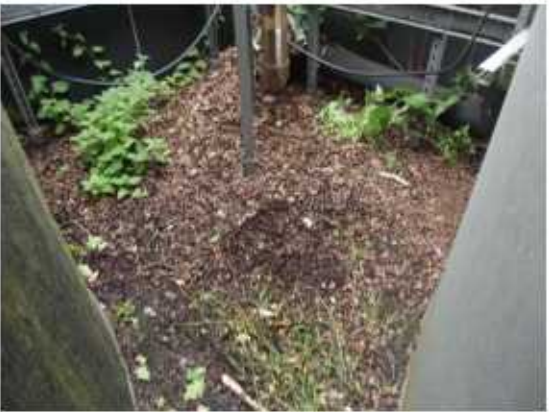
Photograph 8: Significant vegetation in and around tank bunds.

1. Consider installing a simple valved outlet in the lower bund shell to allow draining (after analysis) of any rainwater.
2. Clearly identify the tank with Tank No, Duty and Volume.
3. Remove the vegetation from the concrete foundation and in particular the growth emanating from under the bund floor.
4. Review the firefighting system by engaging a competent authority experienced in storage tank farm fire safety and protection.

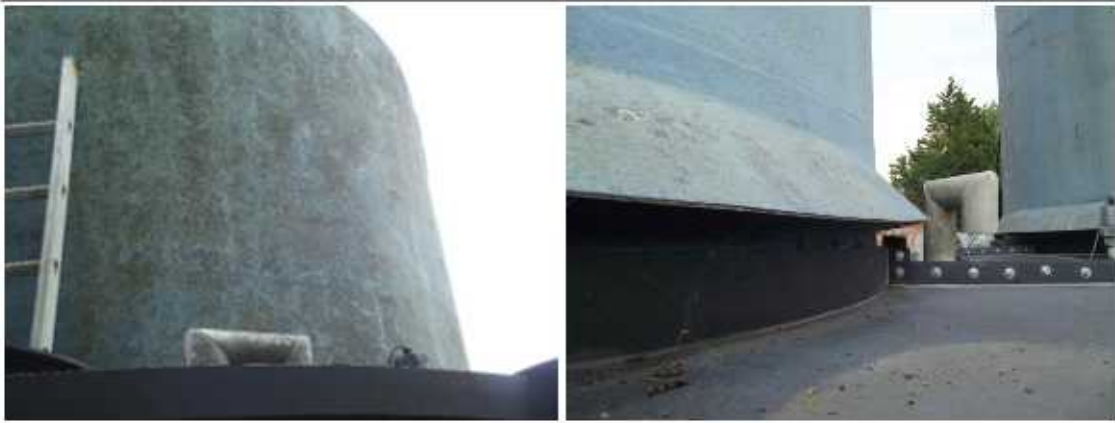
- The tank shell above the bund lid was observed from ground level with binoculars, and, where accessible, from a ladder – some evidence of fungal growth.
- See DVI data in Appendix 1.

Photograph 9: The tank shell above the bund is in good condition – note fungal growth. Photograph 10; Fibre glass rain-deflector skirt is in good condition – note fungal growth.

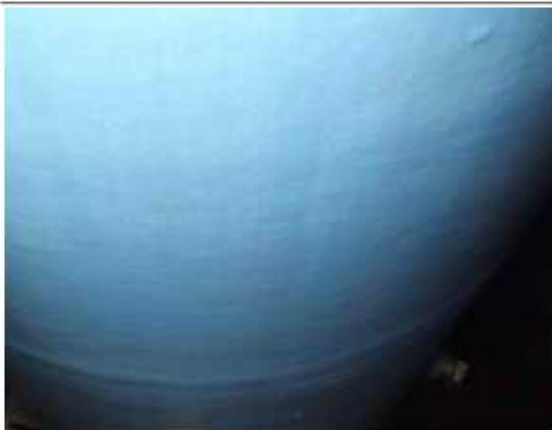
Photograph 11: The external shell below the bund is in good condition.

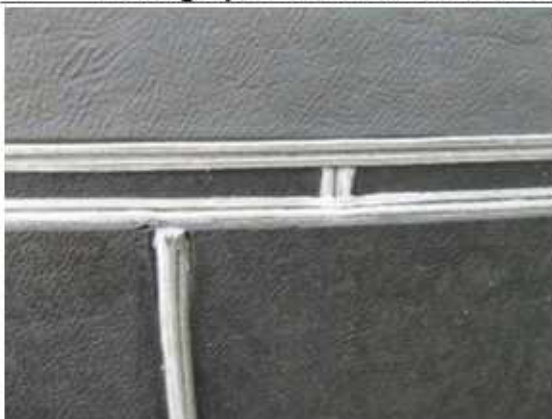
- The tank bund external shell is plastic in self-coloured dark grey. There are horizontal and vertical welds on the external tank bund shell, all are well made with no evidence of separation/leakage.

Photograph 12: External bund is in good condition. Welds all good.

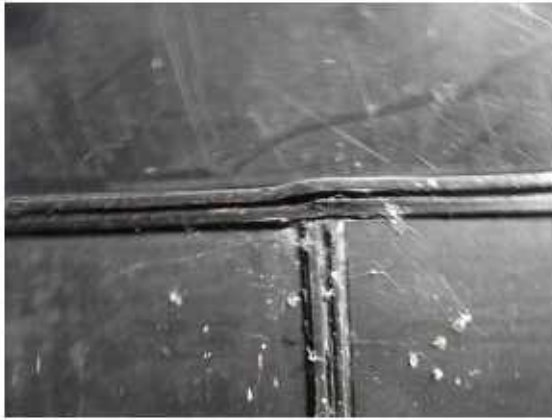
- The tank bund shell is plastic in self-coloured black. There are horizontal and vertical welds on the internal tank bund shell, all are well made with no evidence of separation/leakage.

Photograph 13: The internal tank bund shell is in good condition with all welds well made.

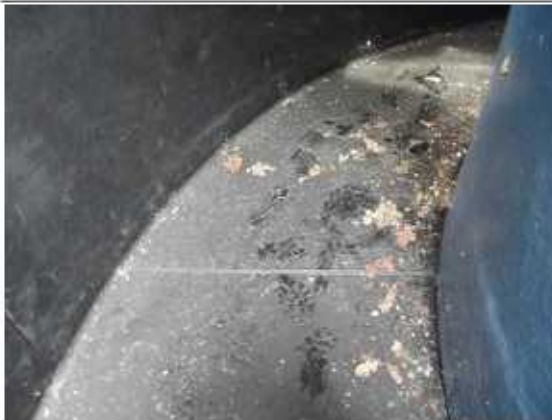
Photograph 14: The tank bund bottom was relatively clean and dry.

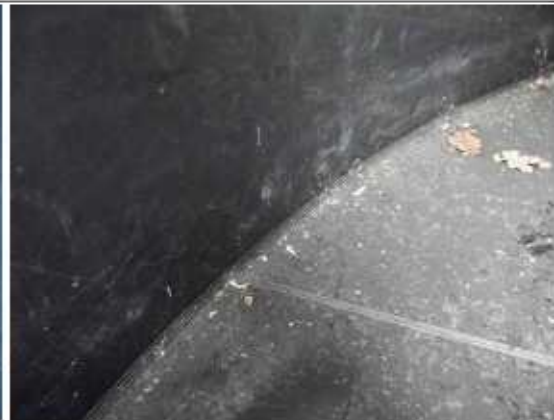
- The tank bund floor is self-coloured black plastic and extends approximately 15 mm beyond the diameter of the tank bund shell, creating an external bottom projection.
- The tank bund shell is connected internally and externally to the tank bottom with a corner weld.

Photograph 15: Bund floor to shell internal corner weld in good condition

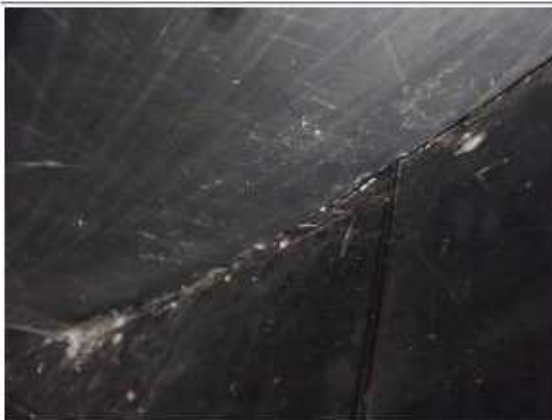
Photograph 15: Underside of bund lid.

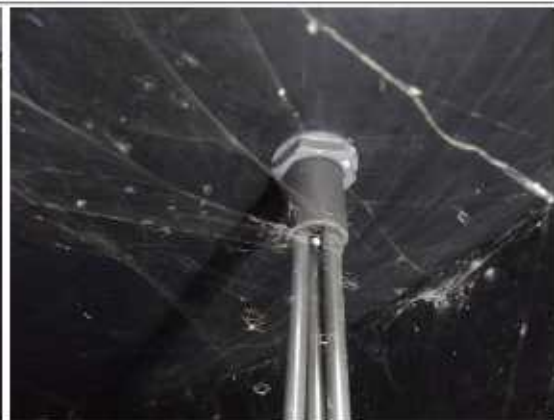
- Tank 34 is individually bunded. The tank is eccentrically located in the bund to allow the installation of manway in the bund lid. The bund is constructed of plastic panels welded to form a closed cylinder and lidded to prevent the ingress of rainwater. There is currently no means of emptying the bund. At the time of the inspection, the bund floor was clean and dry. The bund floor welds and shell to floor corner welds were inspected and there was no evidence of leakage to the tank foundation, implying that the bund floor and corner welds are in good condition. Internal and external shell plates and welded joints are in good visual condition with no signs of failure/leakage. The plastic lid incorporates the bund manway. All sections and welds are in good visual condition with no evidence of leakage. Note that rainwater could be seen to have ponded on the bund lid topside – these penetrations could be the source of a rainwater leak.

Bund Floor	4	No	Good condition - no evidence of leakage.
Bund Lid	3	Yes	Rainwater is entering the bund – probably from leaking penetrations in the bund lid.
Appurtenances	2	Yes	There is currently no way to easily drain the bund of rainwater – fit a drain valve.
Anchor bolts	0	N/A	None present

Photograph 16: Bund lid penetration – potential source of rainwater ingress.
