**Site: Wincombe lane,  
Shaftesbury,  
SP7 8QD.**

# Visual Tank Inspection Report

## **Digester Tank**

**Report Number:** 23-004

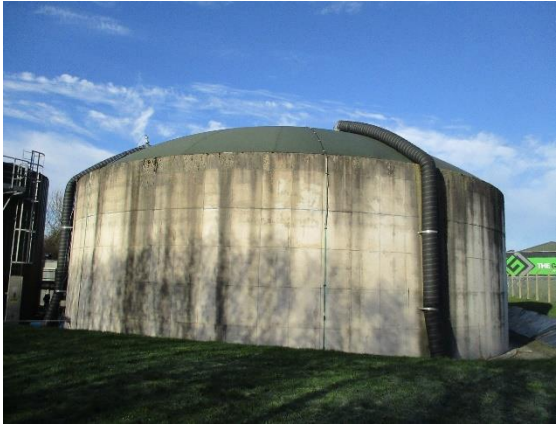
| Photo 1<br>Shell<br>General View | Photo 2<br>Concrete Outstand<br>No cracking to Base |

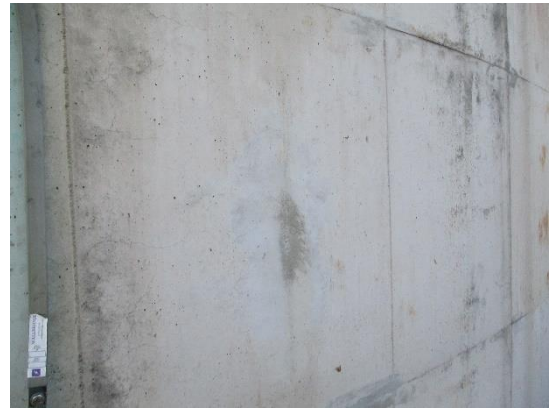
| Feature | Comments | Action Status | | |
|---|---|---|---|---|
| External Condition | The external concrete shell is in good condition with no cracking, spalling or displacement observed. | √ | | |

| Photo 3<br>Concrete Shell<br>No cracking or spalling to concrete | Photo 4<br>Roof<br>General overview of blower pipework + roof |

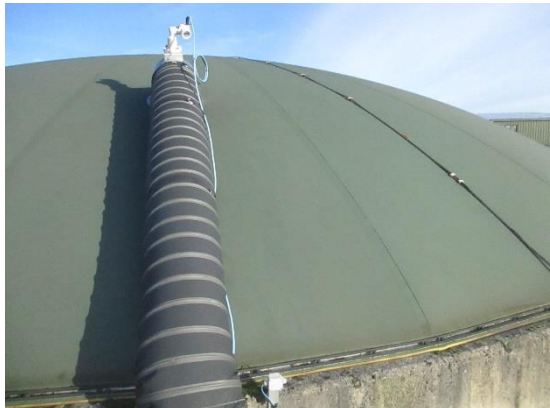
| Feature | Comments | Action Status | | |
|---|---|---|---|---|
| External Nozzles & Pipework Connections | The blower ducting attachment points visually look to be in good condition | √ | | |

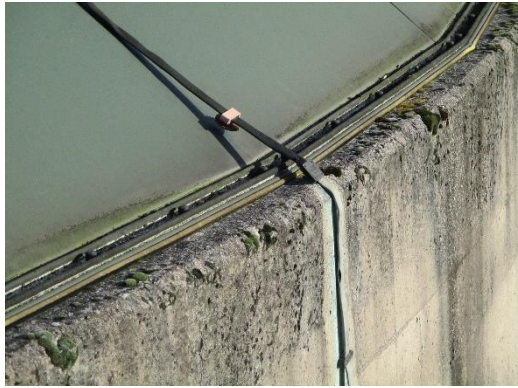
| Feature | Comments | Action Status | | |
|---|---|---|---|---|
| Lightening conductor | The calibration certification has expired. | | √ | |

| Photo 5<br>Venting /Overflow<br>Catch pot not secure. | Photo 6<br>Lightening Conductor<br>General Overview |

| Feature | Action | Time Frame | Page Reference |
|---|---|---|---|
| Calibration | Re-calibrate the lightening conductors | ASAP | 13 |
