**Site: Wincombe lane,  
Shaftesbury,  
SP7 8QD.**

# Visual Tank Inspection Report

## Permeate Tank

**Report Number:** 23-004

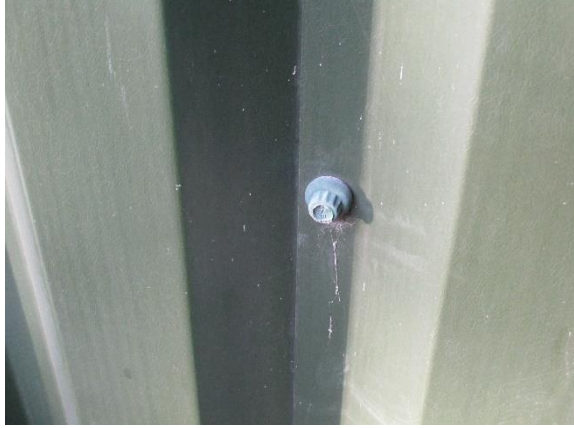
The tank shell was externally lagged so a visual inspection was not possible, however the lagging is all tight and secure with no signs of water ingress.

| Shell | External jacketing |
| General View | All lagging is secure with no water ingress |

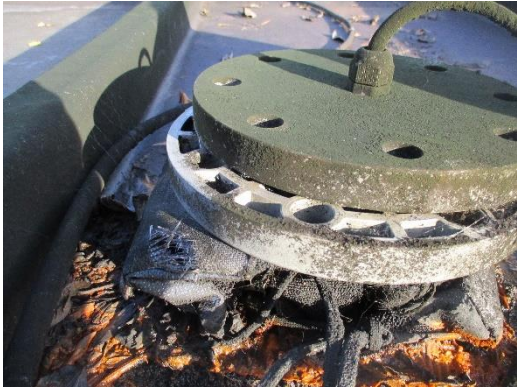
A flange belonging to an 80mm roof nozzle has missing bolts that require installing.

| Feature | Comments | Action Status | | |
|---|---|---|---|---|
| External Nozzles & Pipework Connections | Missing bolts noted to 80mm nozzle.<br>(See photo 5)<br><br>Vent pipework is out breathing product on to roof.<br>(See photo 3) | | √ | |

| Roof Nozzles | Access Ladder |
| No bolts fitted to nozzle, | General View |

| Feature | Action | Time Frame | Page Reference |
|---|---|---|---|
| Missing bolts | Replace Missing bolts to nozzle. | 6 months | 13 |
