Site: Wincombe lane,  
Shaftesbury,  
SP7 8QD.

## Visual Tank Inspection Report

# Effluent Tank

**Report Number:** 23-004

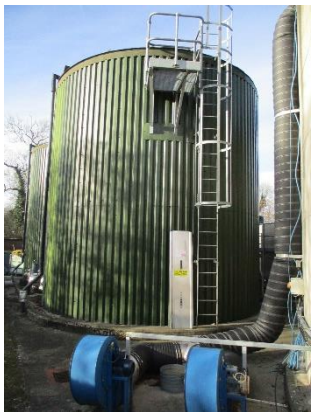
The tank shell was externally lagged so a visual inspection was not possible, however the lagging is all tight and secure with no signs of water ingress.

| Photo 1<br>Shell<br>General View | Photo 2<br>Steel Jacketing<br>General View |

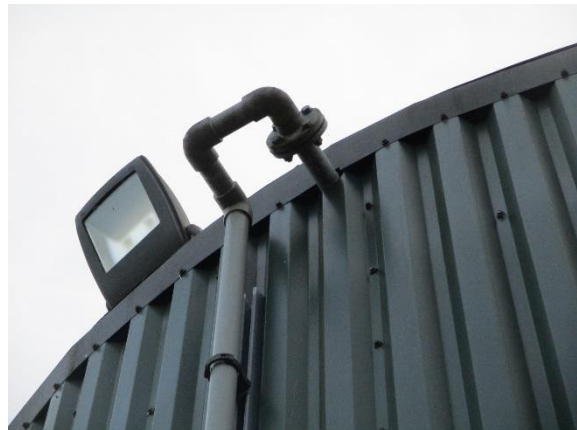
| Feature | Comments | Action Status | | |
|---|---|---|---|---|
| External Condition | Steel jacketing visually in good condition | √ | | |

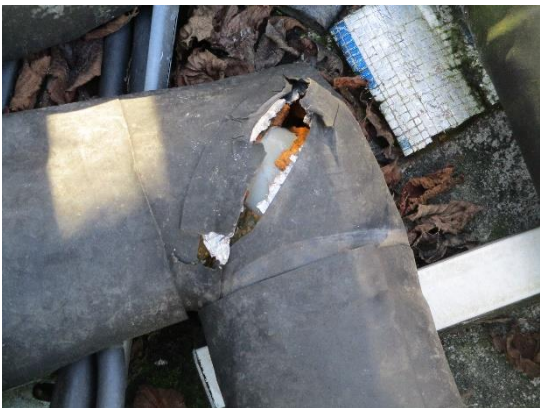
Lagging to pipework is starting to deteriorate. This requires replacement.

| Feature | Comments | Action Status | | |
|---|---|---|---|---|
| Lagging to pipework | Areas of failed lagging to external pipework (See photo 3) | | √ | |

| Photo 3<br>Pipework Lagging<br>Lagging showing signs of deterioration | Photo 4<br>Roof<br>General overview |

| Feature | Action | Time Frame | Page Reference |
|---|---|---|---|
| Failed lagging | Replace areas where lagging has failed | 6 months | 12 |

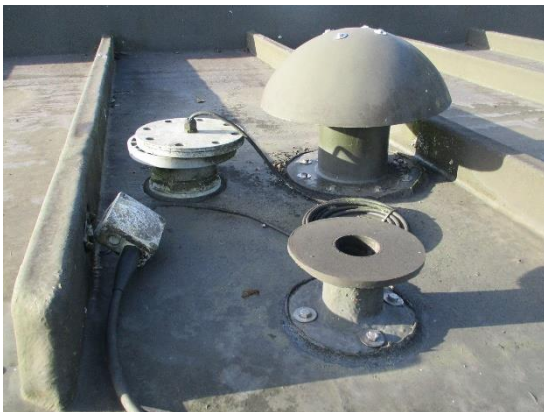
| Feature | Comments | Action Status | | |
|---|---|---|---|---|
| External Condition | The GRP roof is in good condition with no cracking or delamination noted. | √ | | |

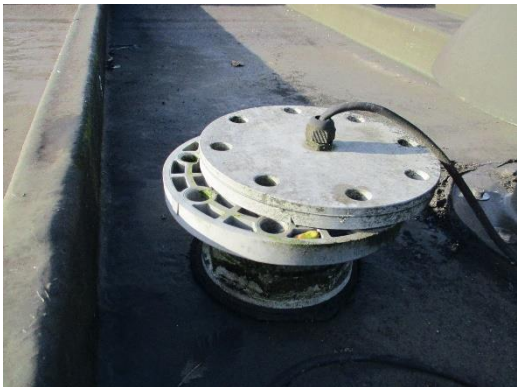
A flange belonging to an 80mm roof nozzle has missing bolts that require installing

| Feature | Comments | Action Status | | |
|---|---|---|---|---|
| External Nozzles & Pipework Connections | Missing bolts noted to 80mm nozzle. (See photo 5) | | √ | |

| Photo 5<br>Roof Nozzles<br>Missing bolts to roof nozzle, | Photo 6<br>Access ladder<br>General overview |

| Feature | Action | Time Frame | Page Reference |
|---|---|---|---|
| Missing bolts | Replace missing bolts to roof nozzle | 6 months | 13 |

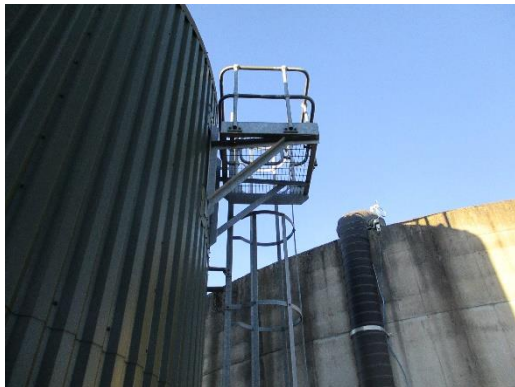
| Feature | Comments | Action Status | | |
|---|---|---|---|---|
| Access Ladder | Access ladders in good condition. | √ | | |
