**Site: Wincombe lane,  
Shaftesbury,  
SP7 8QD.**

## Visual Tank Inspection Report

# Sludge Tank

**Report Number:** 23-004

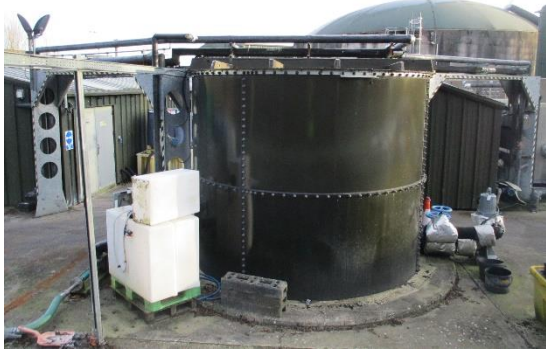
| Photo 1 | Photo 2 |

| Shell | Roof |
| General View | General View |

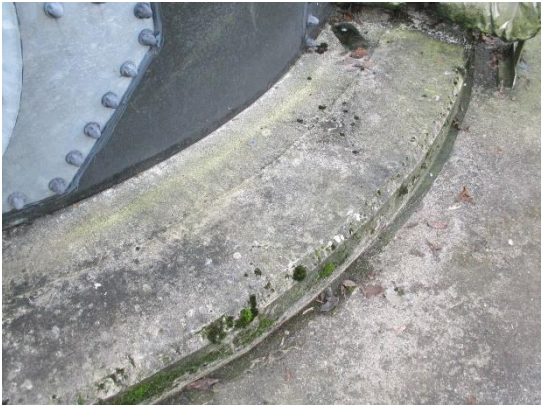
| Photo 3 | Photo 4 |

| Feature | Comments | Action Status | | |
|---|---|---|---|---|
| Cracking/Spalling of Concrete | None. | √ | | |

| No cracking or spalling of concrete around base of tank | Overflow pipework is exhibiting signs of aging & previous repairs to joints |

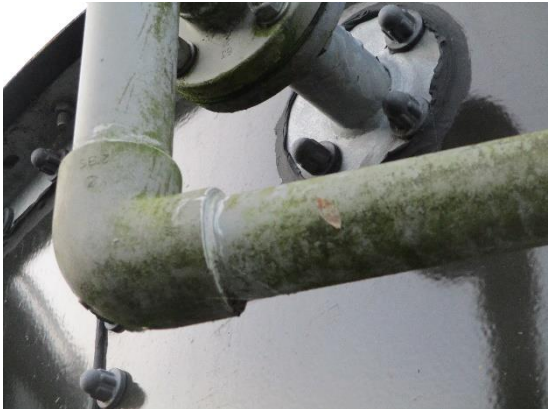
The 50mm overflow pipework from course two is exhibiting signs of age hardening, with fungal growth build-up. This should be replaced within the next 6 months.

| Feature | Comments | Action Status | | |
|---|---|---|---|---|
| Pipework & Pipework connections | The 50 mm overflow pipework is exhibiting sign of age hardening and fungal growth (See Photo 4) | | √ | |

| Feature | Action | Time Frame | Page Reference |
|---|---|---|---|
| Overflow Pipework | Replace age hardened plastic pipework | 6 months | 12 |

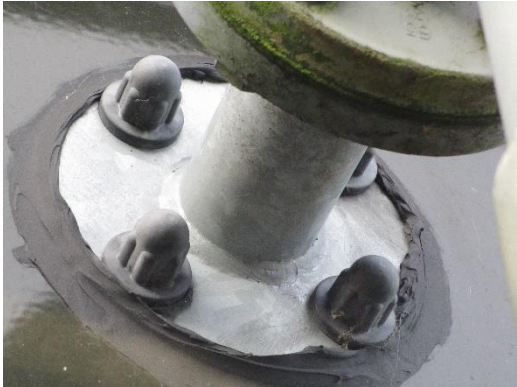
| Photo 5 | Photo 6 |

| Feature | Comments | Action Status | | |
|---|---|---|---|---|
| External Nozzles | All nozzle connections are tight and secure, with no cracking of mastic sealant. | √ | | |

| No signs of leakage with good mastic condition, | Mastic joints free from cracking or deterioration |

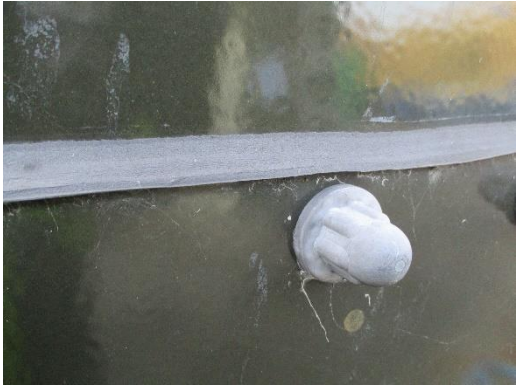
| Feature | Comments | Action Status | | |
|---|---|---|---|---|
| External Joints | The mastic fillets are in good condition with no signs of leakage | √ | | |
