## BV Dairy AD Plant

### Containment System Assessment

Name of client: BV Dairy Limited

Date: March 2023

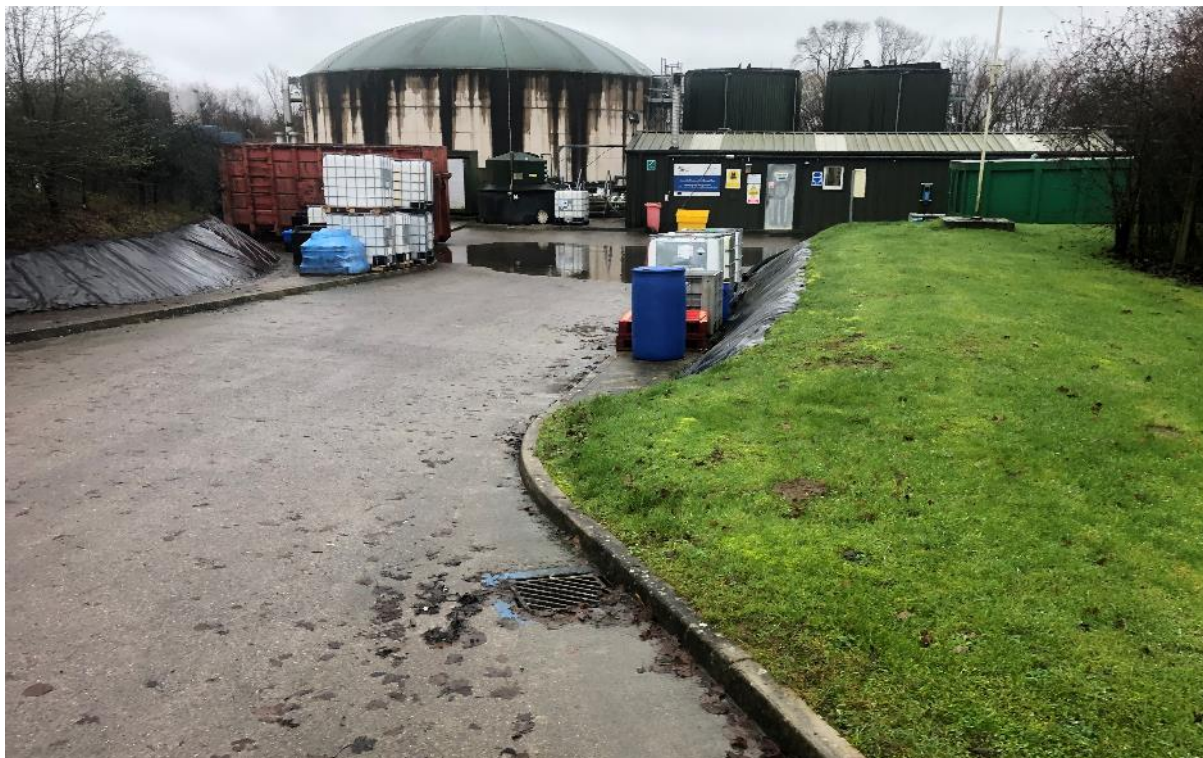
1. View of site looking south at top of access ramp.

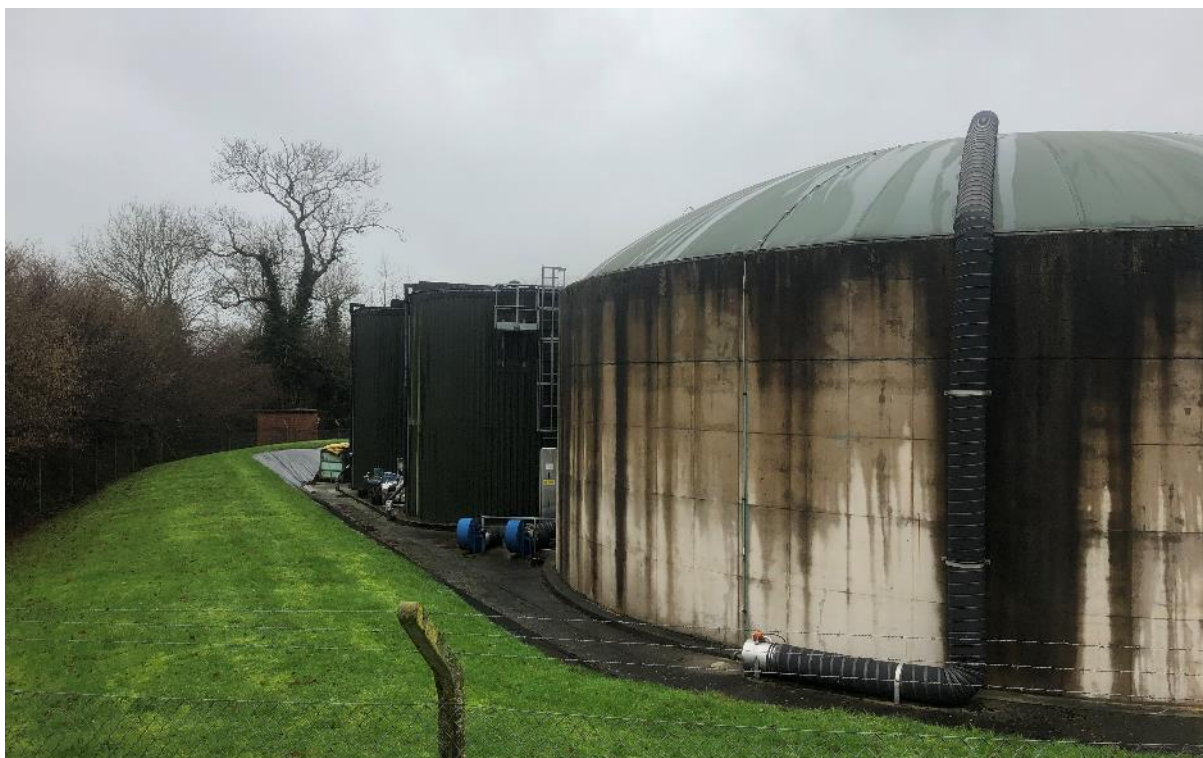
2. Overview of digester and storage tanks.

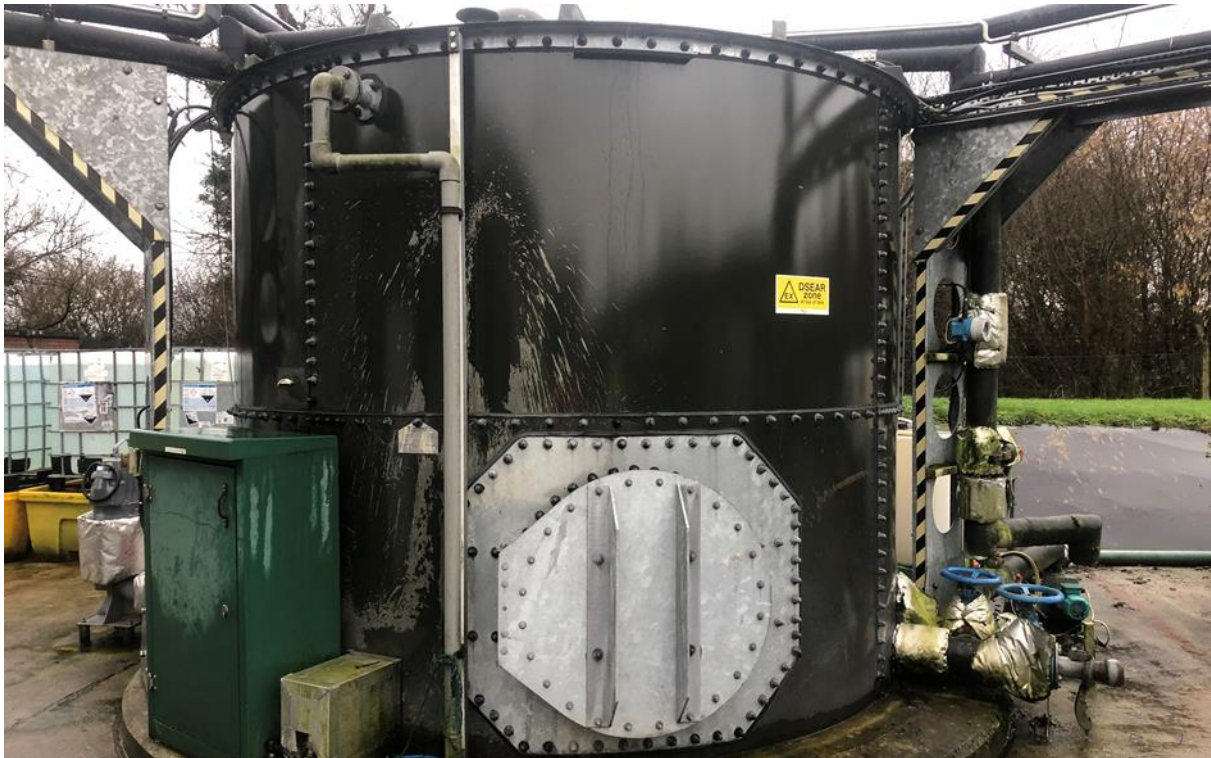
3. Slurry storage tank

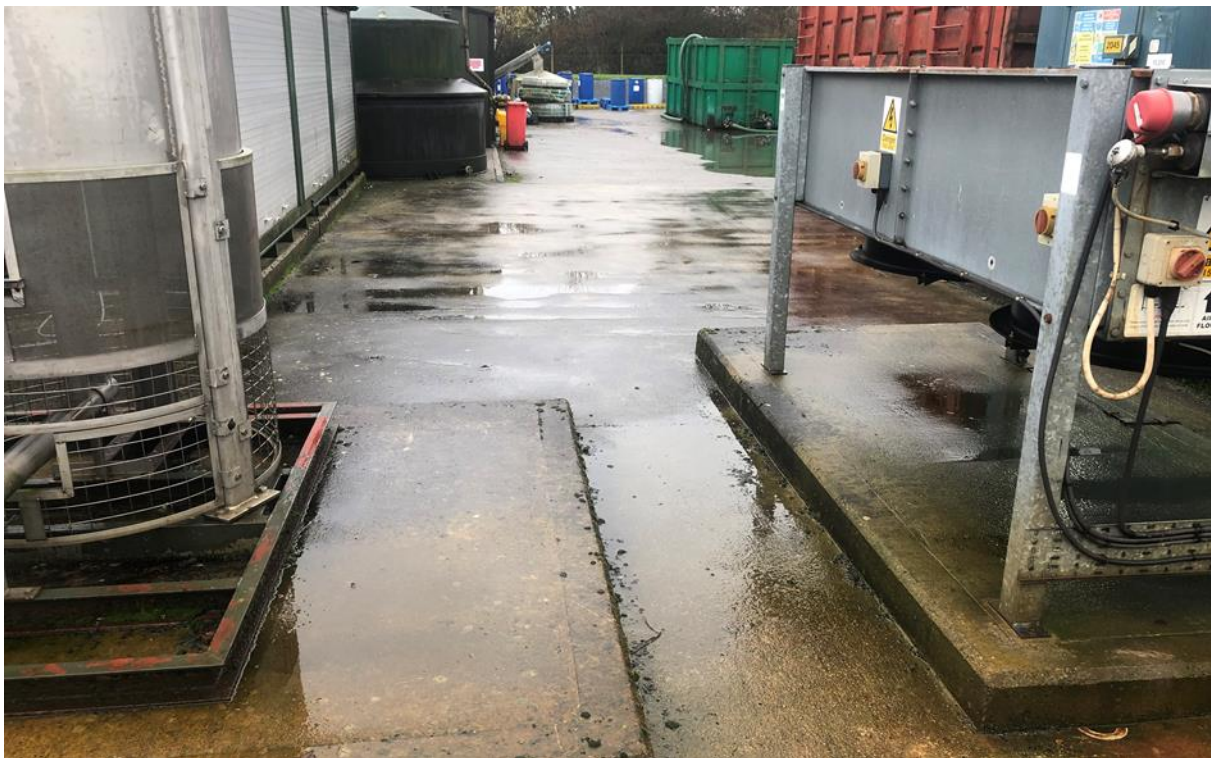
4. General condition of concrete very good,

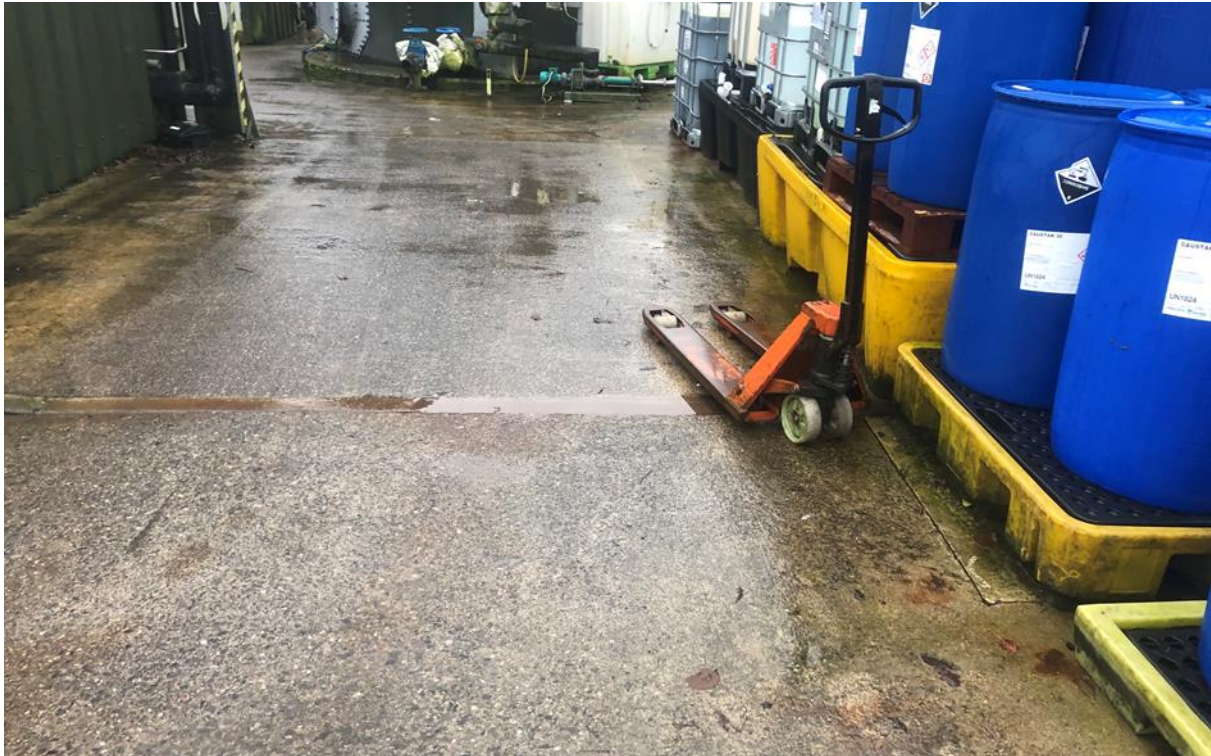
5. Concrete in good condition

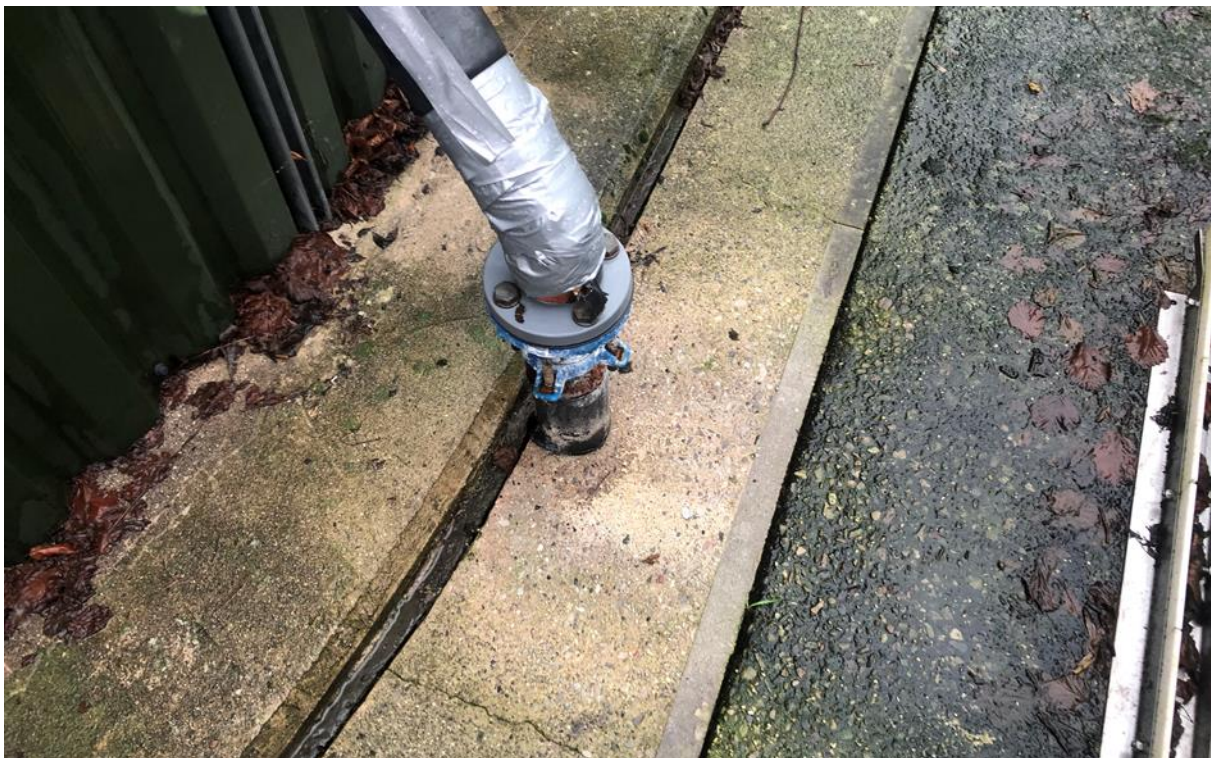
| Table 3 Summary of Site Observations; Secondary Containment | |
|---|---|
| Basal Concrete | <p>The area between the two main tanks, waste input and separator unit is laid to a concrete slab.</p> <p>Concrete slabs generally in good condition.</p> <p>Some joints have mastic/sealant missing or damaged.</p> <p>Concrete appears to have been added to outside of main slabs to fill void between slabs and bund. These were observed to be cracking/lifting in areas.</p> <p>One crack near access ramp needs infilling/sealing.</p> |

6. Concrete joints require sealant.

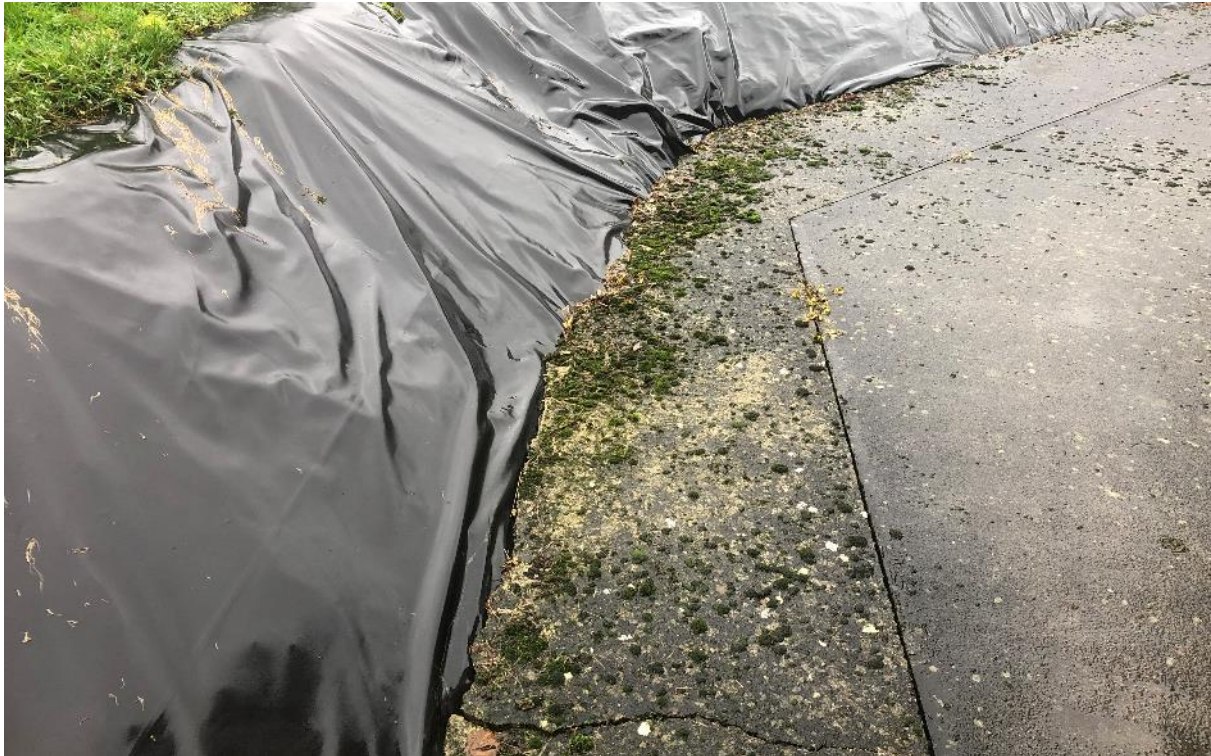
7. Some cracking and lifting of concrete around connection perimeter bund

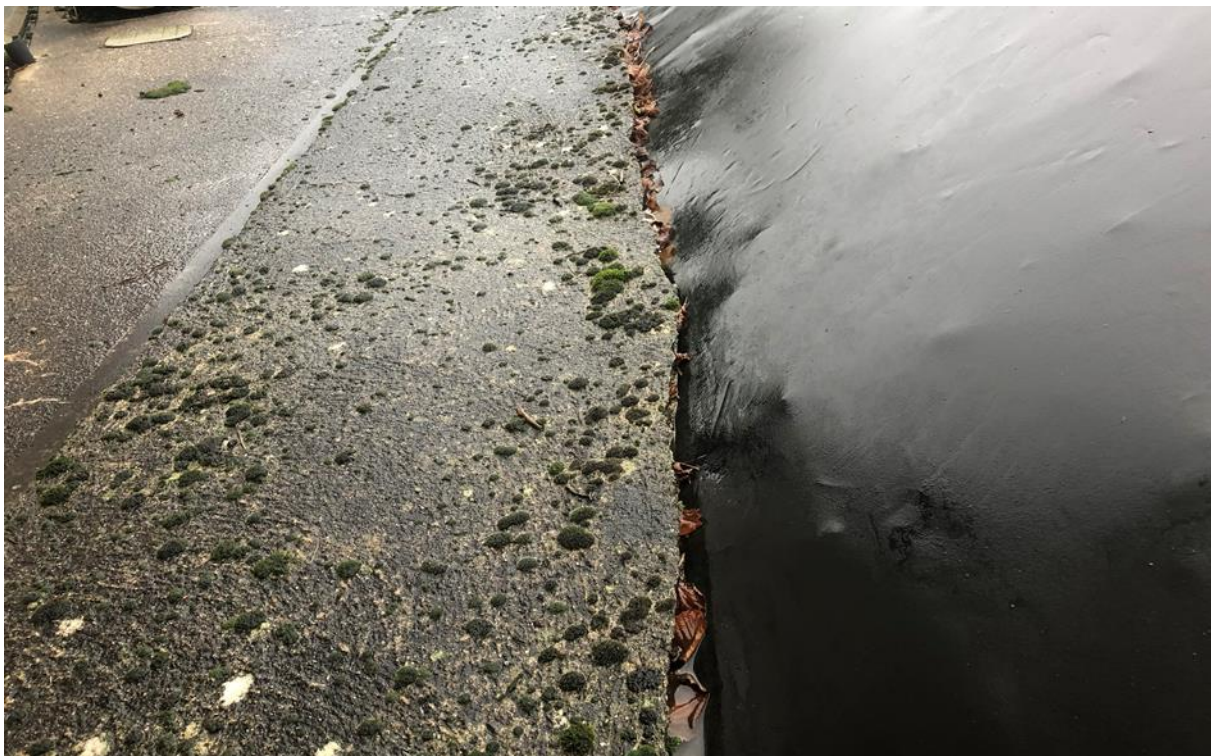
8. Cracking and lifting of concrete around connection perimeter bund

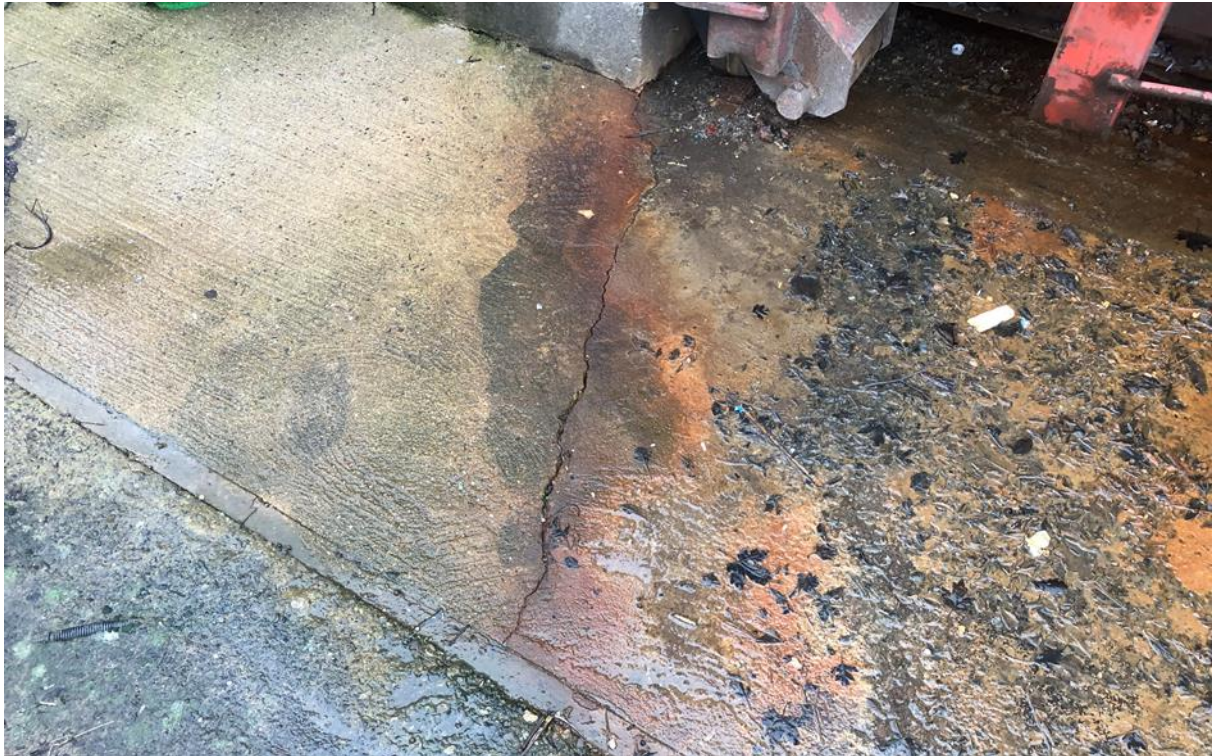
9. Crack in concrete pavement that requires remediation.

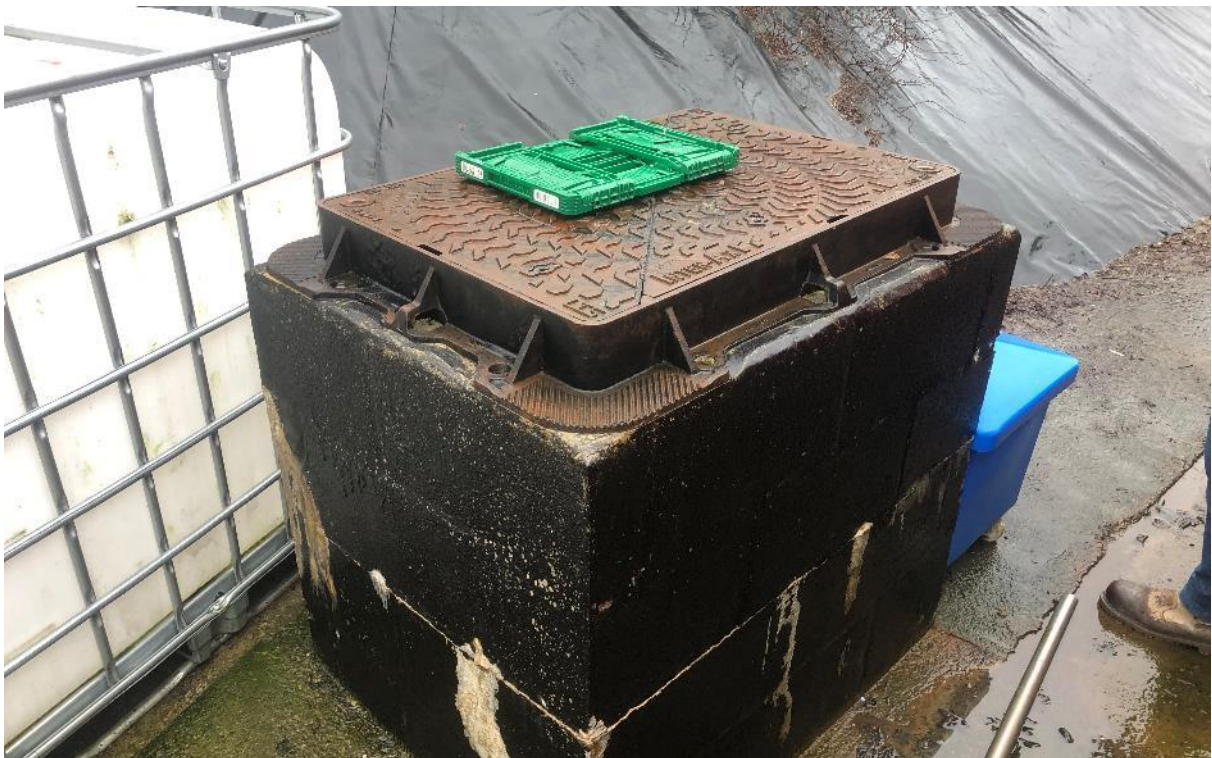
| Table 3 Summary of Site Observations; Secondary Containment | |
|---|---|
| Utility Access/Manholes | <p>Two raised manholes were observed near the base of the access ramp within the containment area for the site. They were rendered and c.1.5m above the surface of the basal concrete slab. Believed to be rendered as there may be a penetration through the basal slab directly below them to access utilities. An internal inspection was not possible.</p> |

10. Rendered raised manholes near base of access ramp.

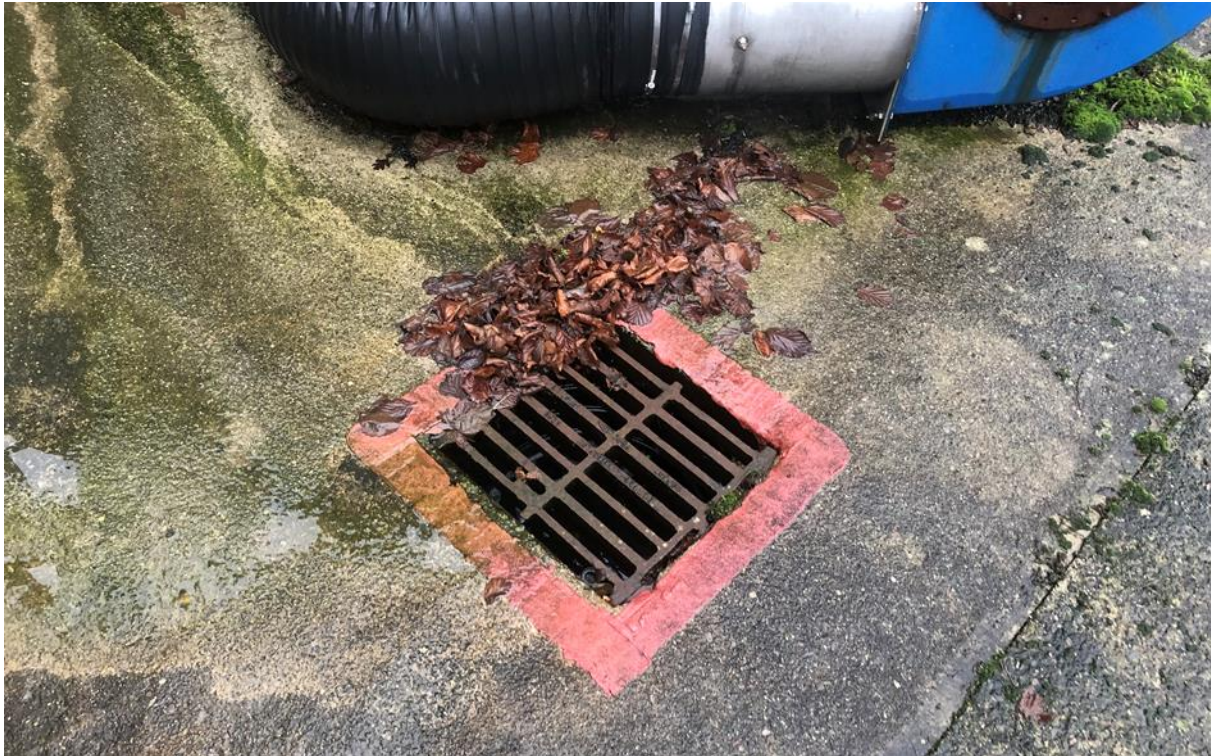
11. Marked dirty water collection drains within the operational area.

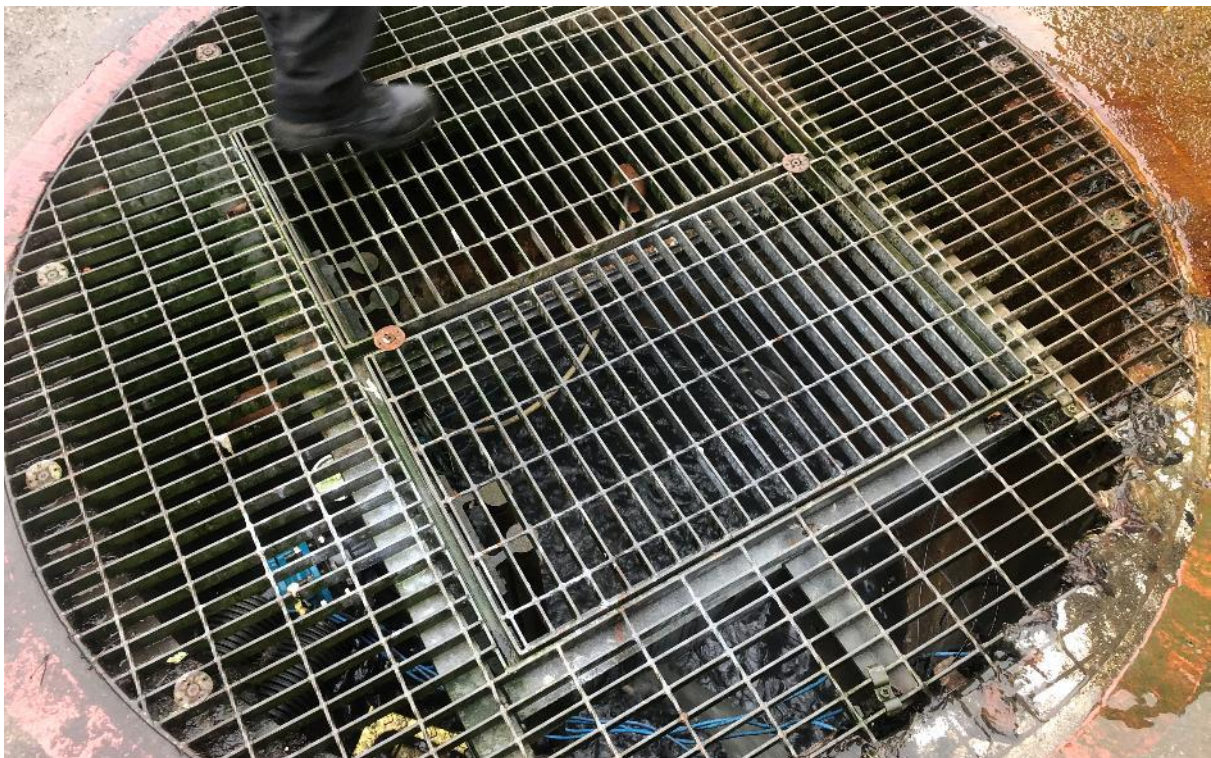
12. Dirty water collection sump.

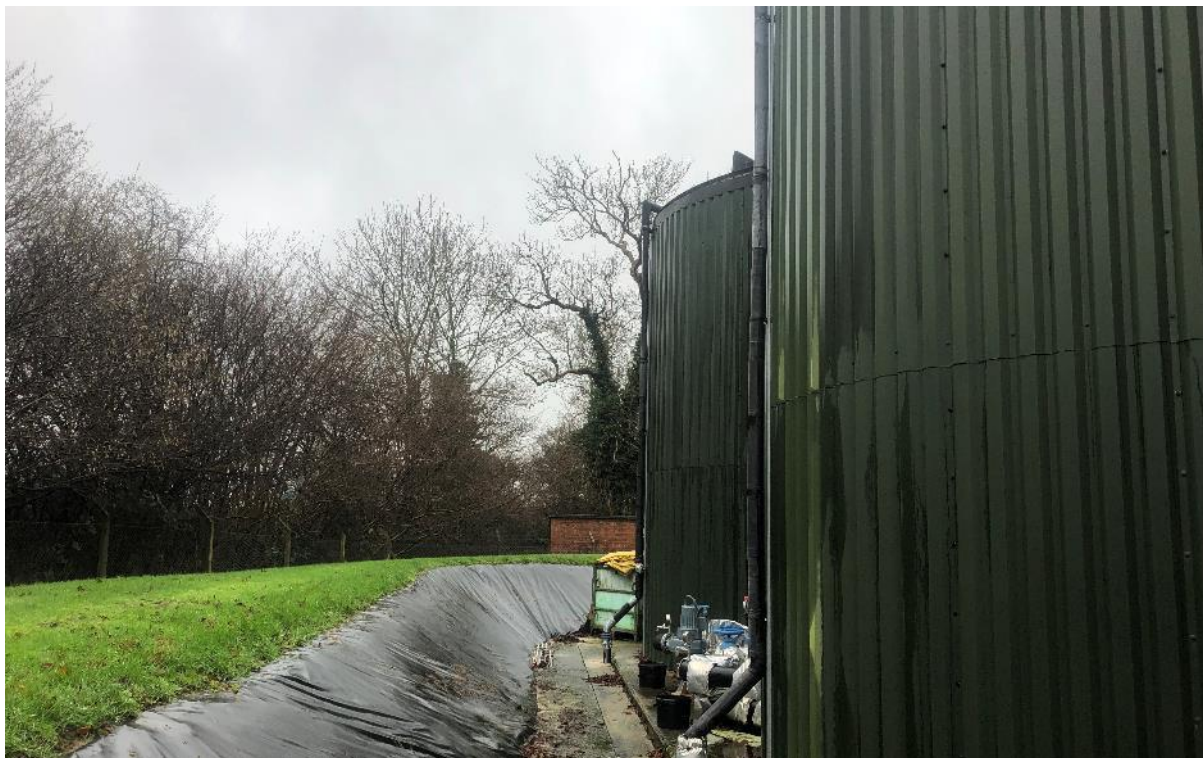
13. Secondary containment bund; South bund looking west

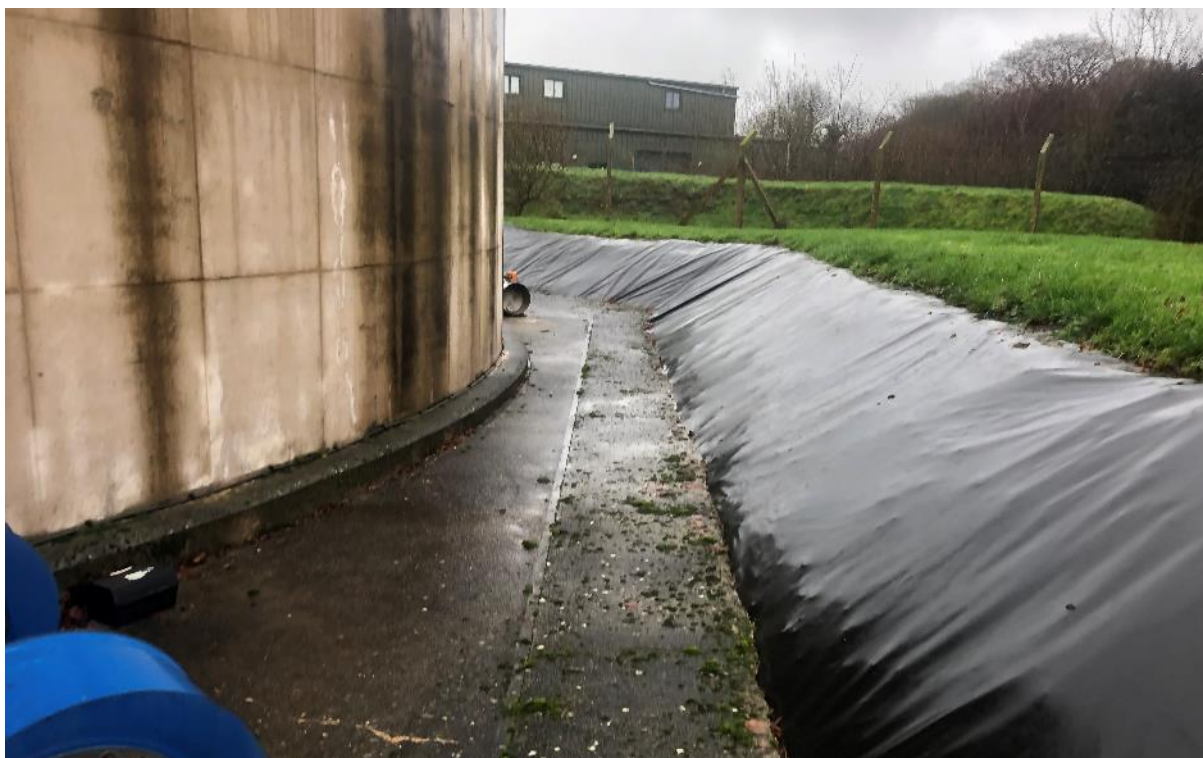
14. Secondary containment bund; South bund looking east

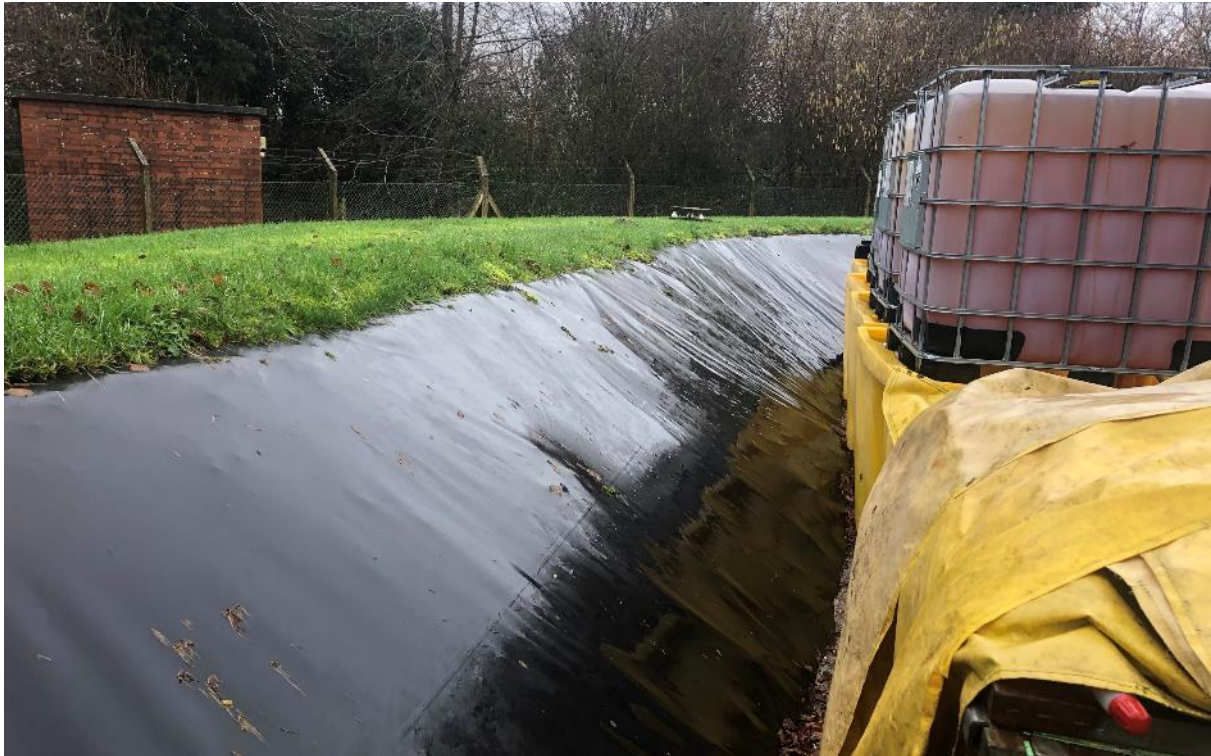
15. Secondary containment bund; South west corner bund looking west

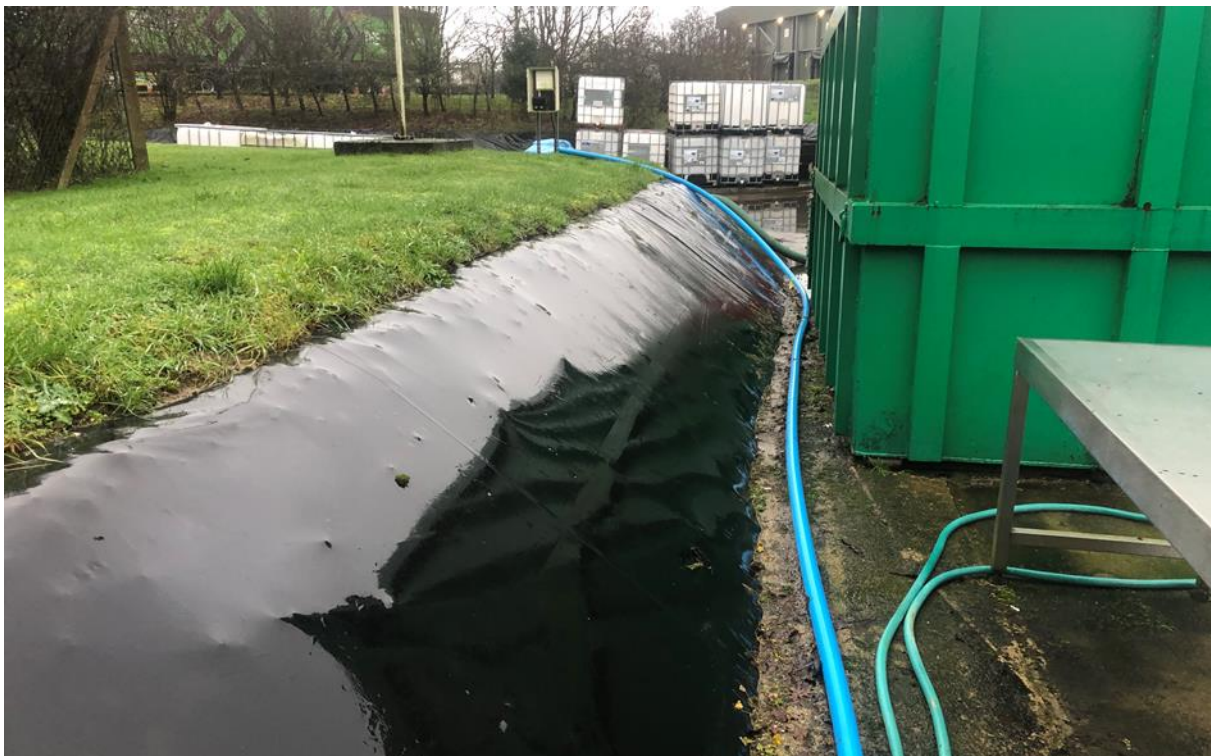
16. Secondary containment bund; North bund looking east

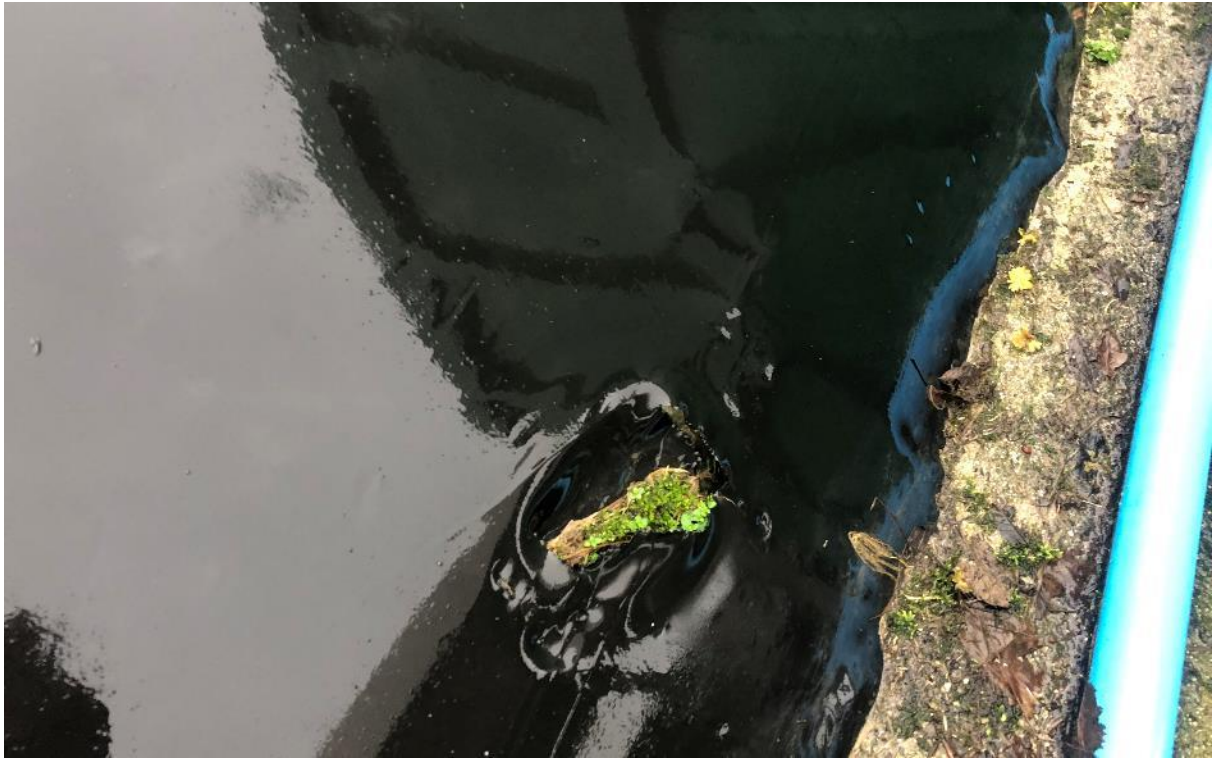
| Table 3 Summary of Site Observations; Secondary Containment | |
|---|---|
| EPDM liner/bunding | <p>Damaged throughout site.</p> <p>Connection detail to basal slabs unconfirmed, however appears to be overlain with concrete only.</p> <p>Site topographical survey exercise advised to confirm containment volume prior to any remedial works being undertaken.</p> <p>EPDM material may be salvageable where intact, however viability of repair versus replacement should be determined when basal tie-in is confirmed and containment volume assessed.</p> <p>Perimeter bunds appeared stable with no slumping noted.</p> <p>Some large clasts behind liner causing tension and damage to EPDM.</p> <p>Where holes were present, these were used to investigate the containment system and it was confirmed that an underlying protective geotextile was present.</p> |

17. Example of damage to EPDM lining system.

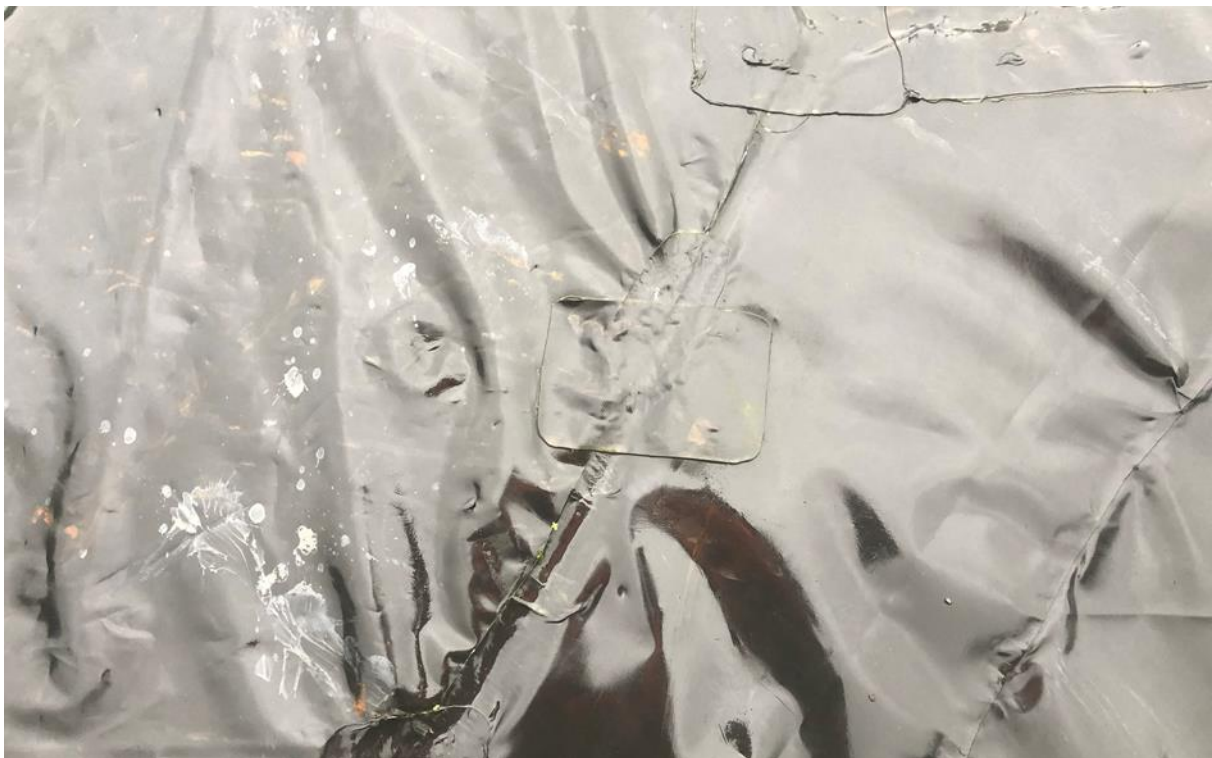
18. Previous repairs undertaken on EPDM liner

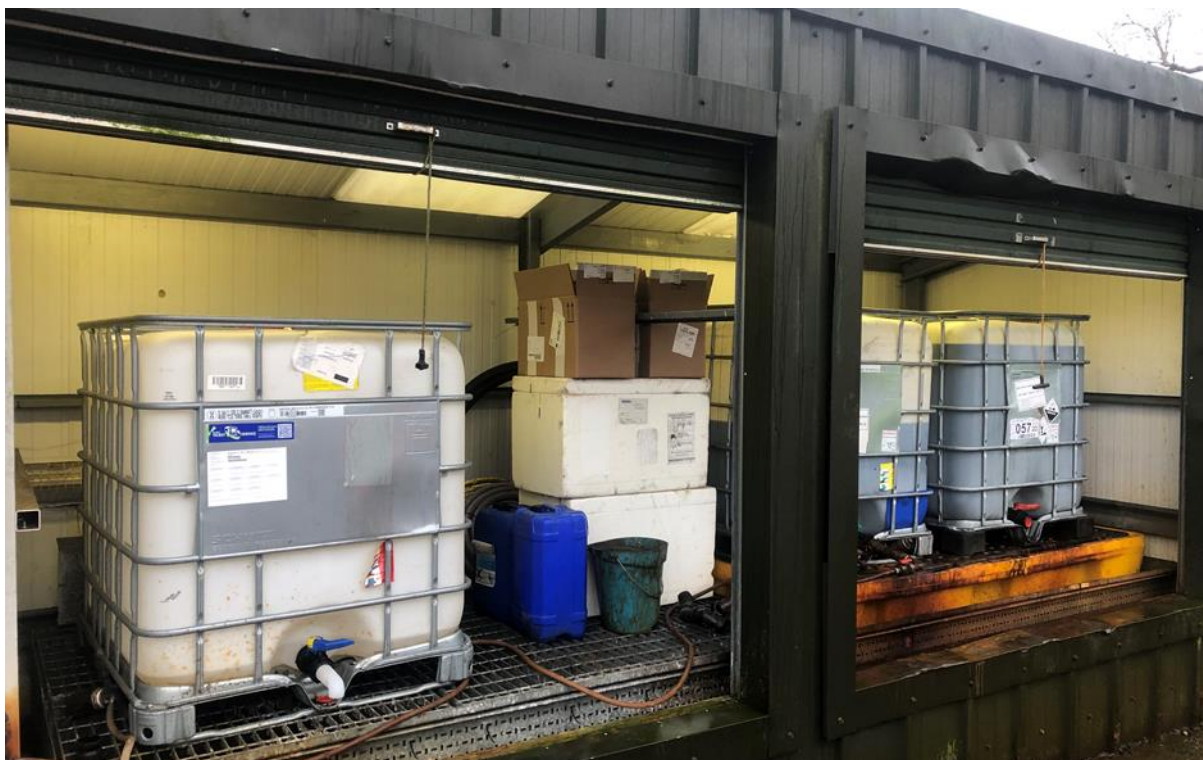
19. Storage of chemicals within locked containers and on bunded bases.

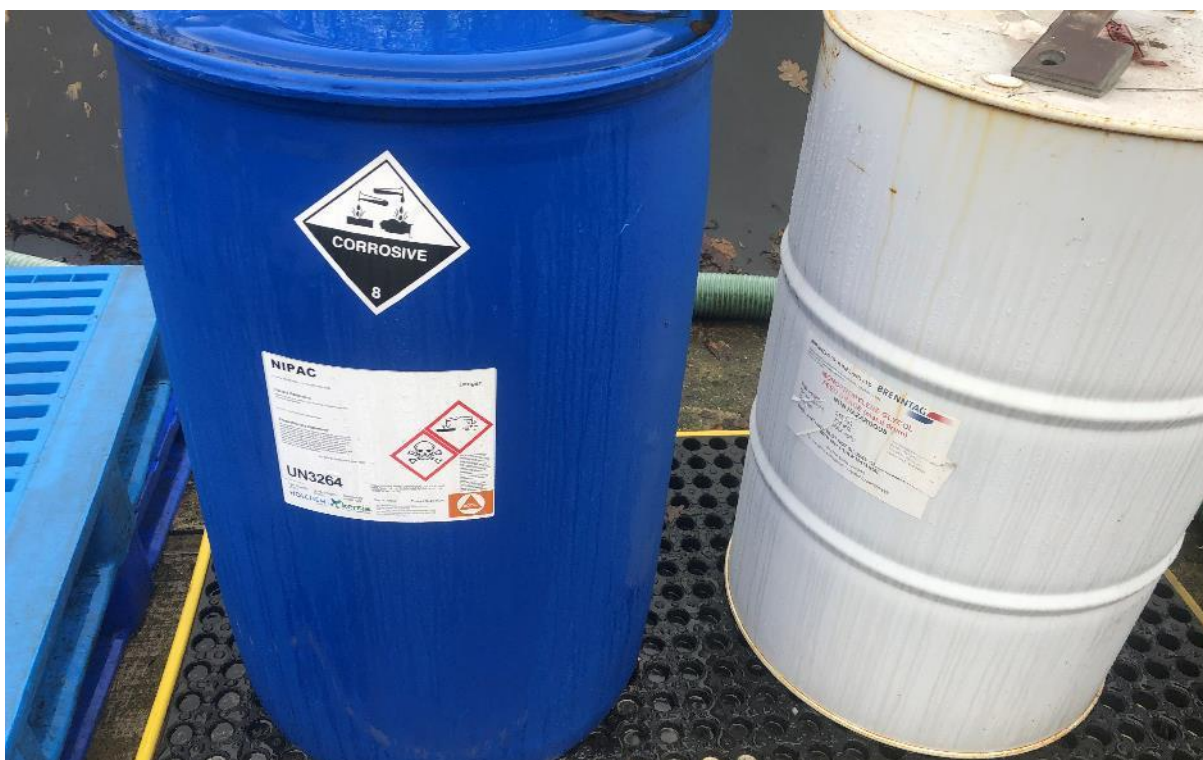
20. Storage of chemicals on bunded bases.

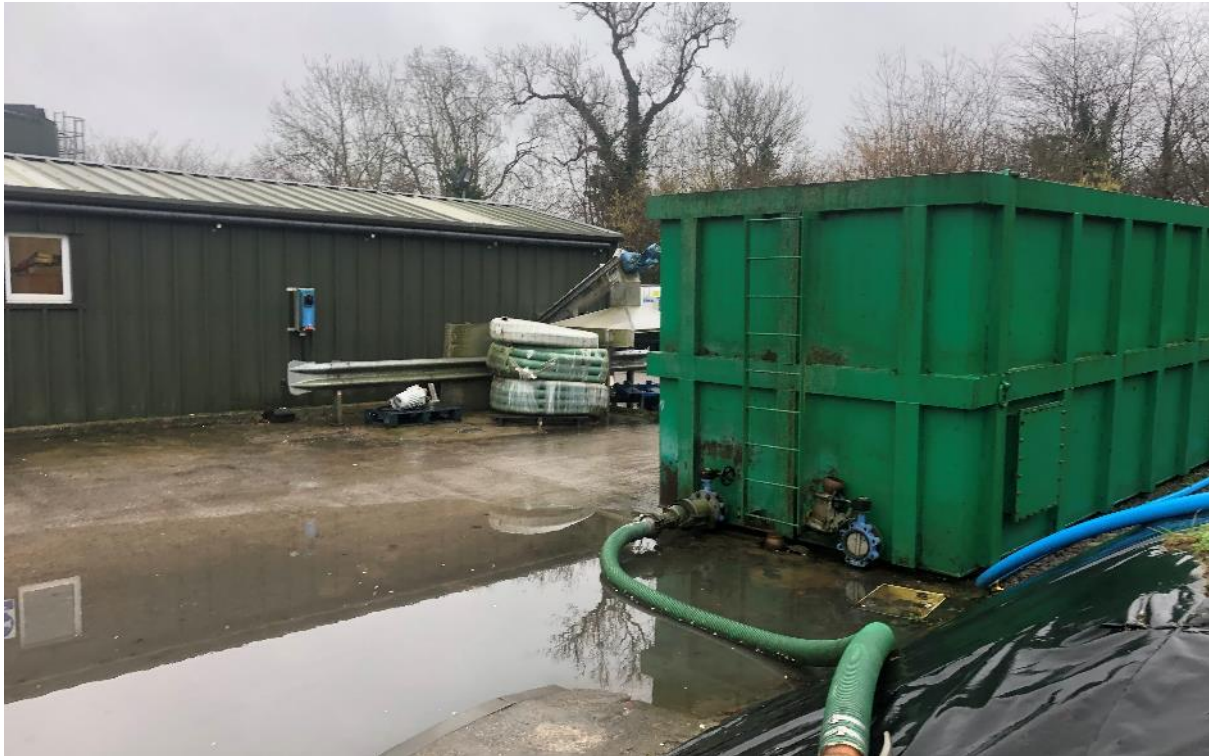
| Table 2 Summary of Site Observations; Primary Containment | |
|---|---|
| Sludge tank (Temporary) | <p>Observed by CQA on 10 January 2023.</p> <p>A temporary sludge storage tank was being used at the time of the inspection. It was observed to be of steel single skin construction. The skip/tank is understood to be emptied twice daily.</p> <p>The current arrangement is understood to be a temporary measure until replacement sludge tank installed.</p> <p>The tank was not inspected by WSG as it did not form part of the sites permanent infrastructure.</p> |

21. Photograph of temporary slurry skip. Note position near to clean water drain.

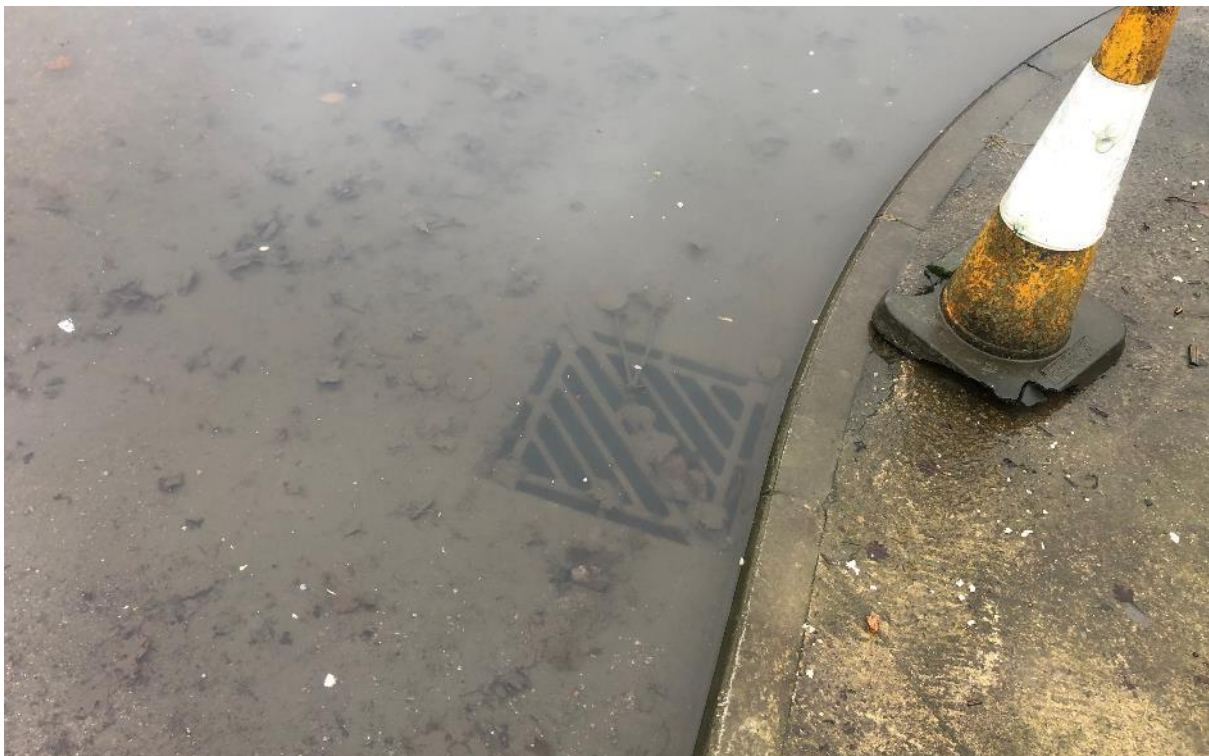
22. Clean water drain at base of access ramp. Note: Drain is within the proposed containment area.

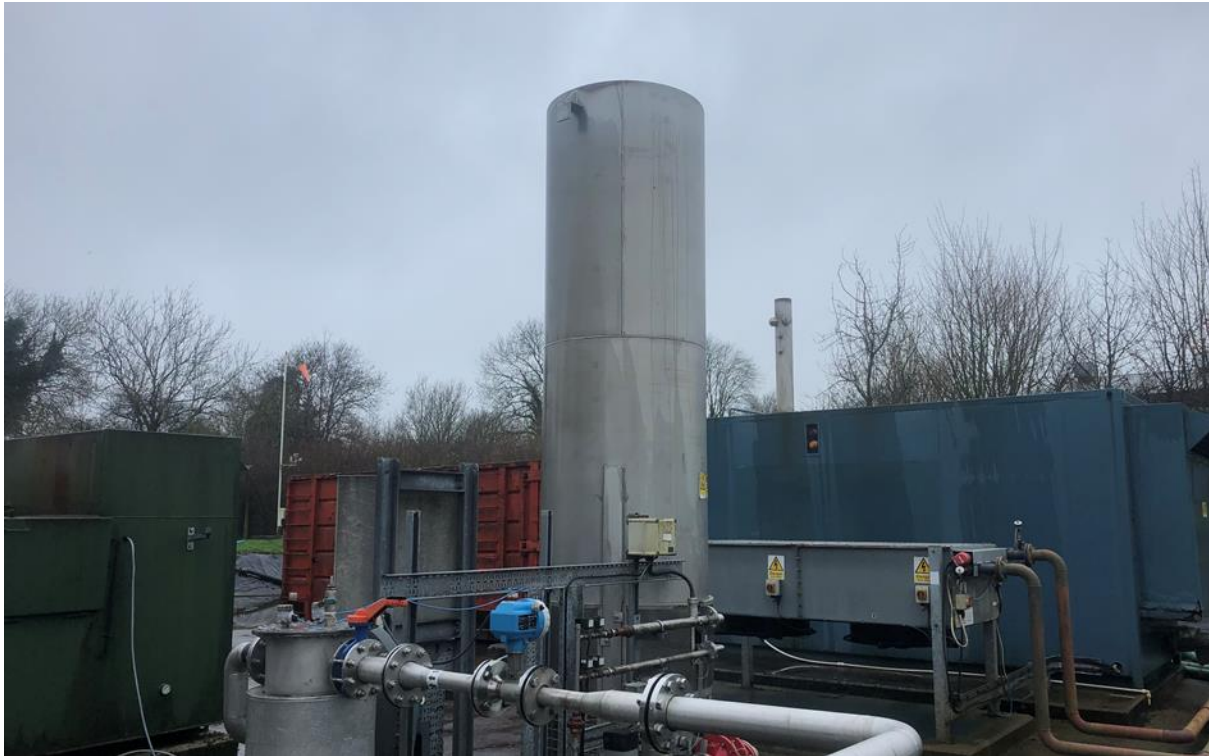
23. Photograph of engine/flare.

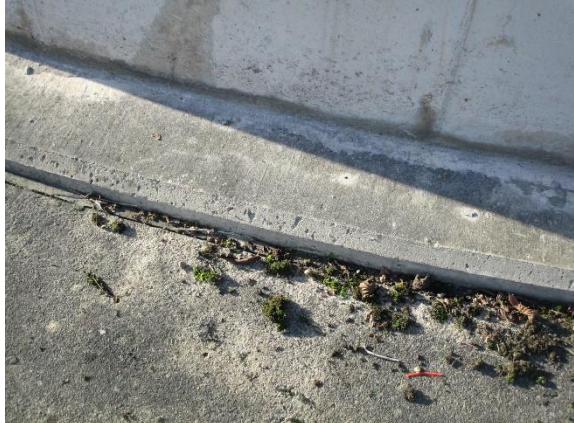
| Photo 1<br>Shell<br>General View | Photo 2<br>Concrete Outstand<br>No cracking to Base |

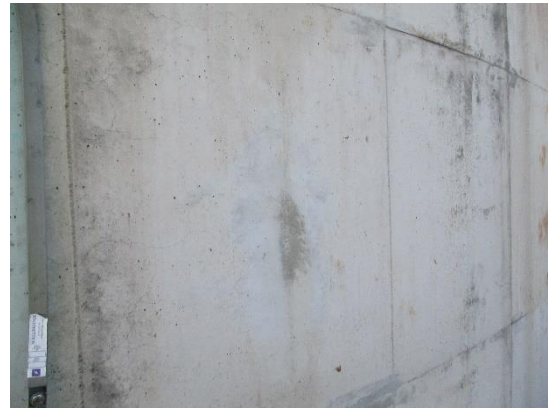
| Photo 3<br>Concrete Shell<br>No cracking or spalling to concrete | Photo 4<br>Roof<br>General overview of blower pipework + roof |

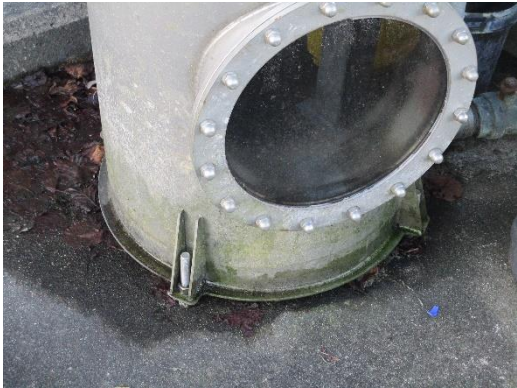
| Photo 5<br>Venting /Overflow<br>Catch pot not secure. | Photo 6<br>Lightening Conductor<br>General Overview |

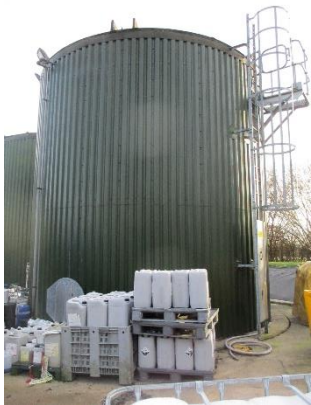
| General View | All lagging is secure with no water ingress |

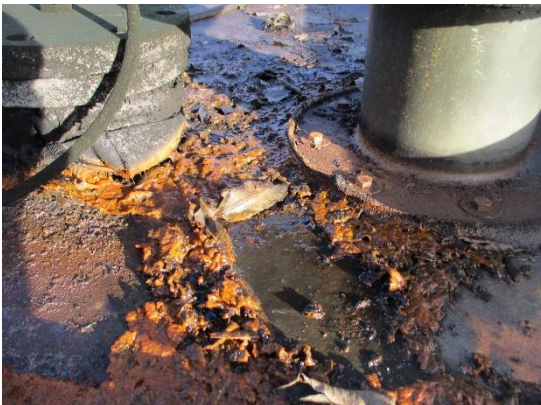
| Product venting onto roof, may be detrimental to mastic seals & GRP roof outer layer. | Corrosion evident to top curb angle. |
