## BV Dairy AD Plant

### Containment System Assessment

Name of client: BV Dairy Limited

Date: March 2023

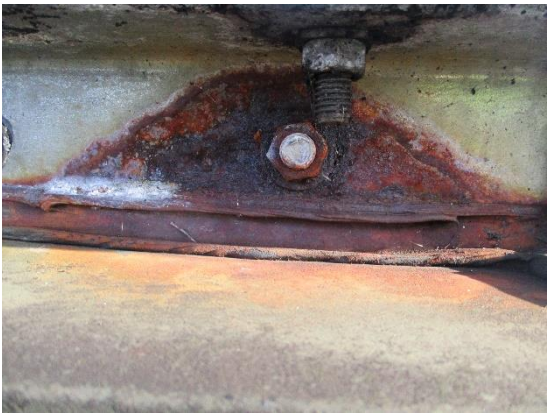
| Product venting onto roof, may be detrimental to mastic seals & GRP roof outer layer. | Corrosion evident to top curb angle. |

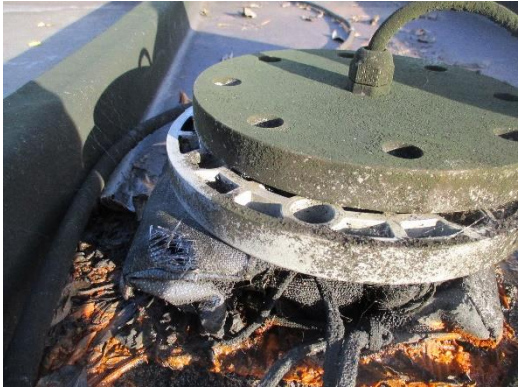
| No bolts fitted to nozzle, | General View |

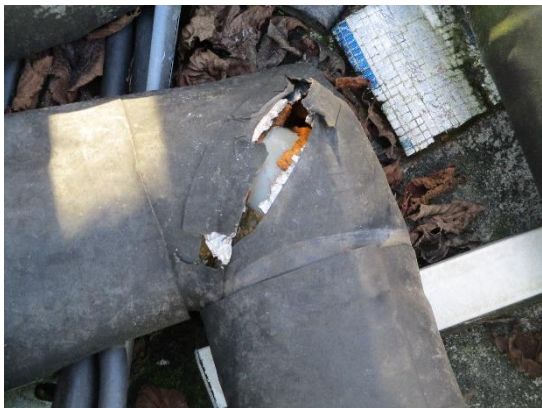
| Photo 3<br>Pipework Lagging<br>Lagging showing signs of deterioration | Photo 4<br>Roof<br>General overview |

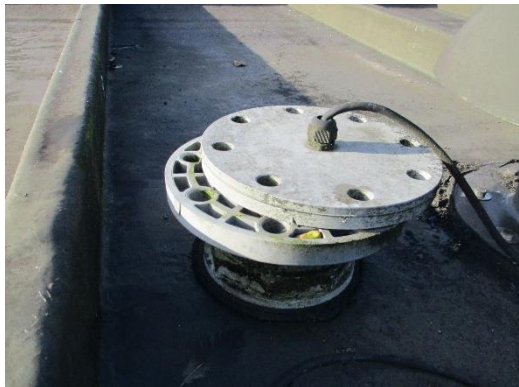
| Photo 5<br>Roof Nozzles<br>Missing bolts to roof nozzle, | Photo 6<br>Access ladder<br>General overview |

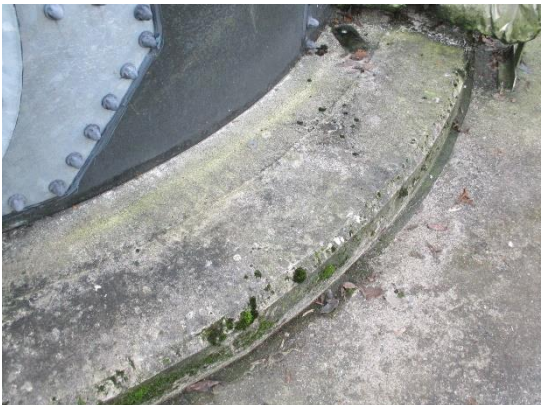
| No cracking or spalling of concrete around base of tank | Overflow pipework is exhibiting signs of aging & previous repairs to joints |

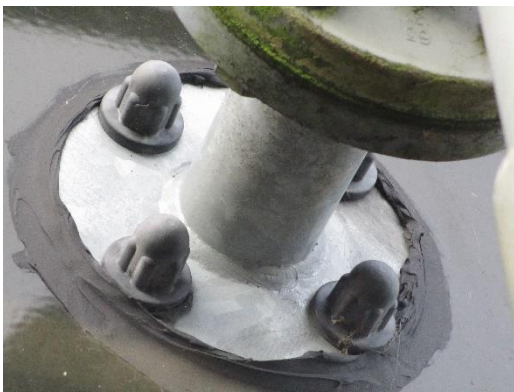
| No signs of leakage with good mastic condition, | Mastic joints free from cracking or deterioration |
