MULLER TELFORD DAIRY

Containment Assessment
Prepared for: **Muller UK & Ireland Group LLP**

SLR Ref: 410.V62639.00001
Version No: Final
January 2023

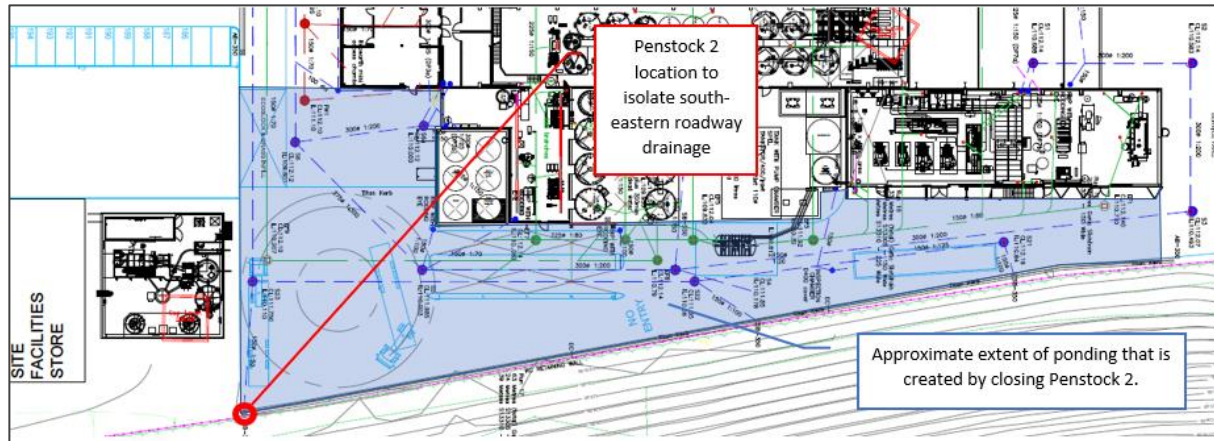
Figure 2-2: Isolation of Drainage at Penstock 2

associated with the access road, tankering area and ETP loading area in the south-west corner of the site can be isolated by closing a penstock at 'Penstock 2' (see Figure 2-2).

Currently, normal operation is for Penstock 2 to be closed and it is only opened after testing of water to demonstrate that it is uncontaminated.

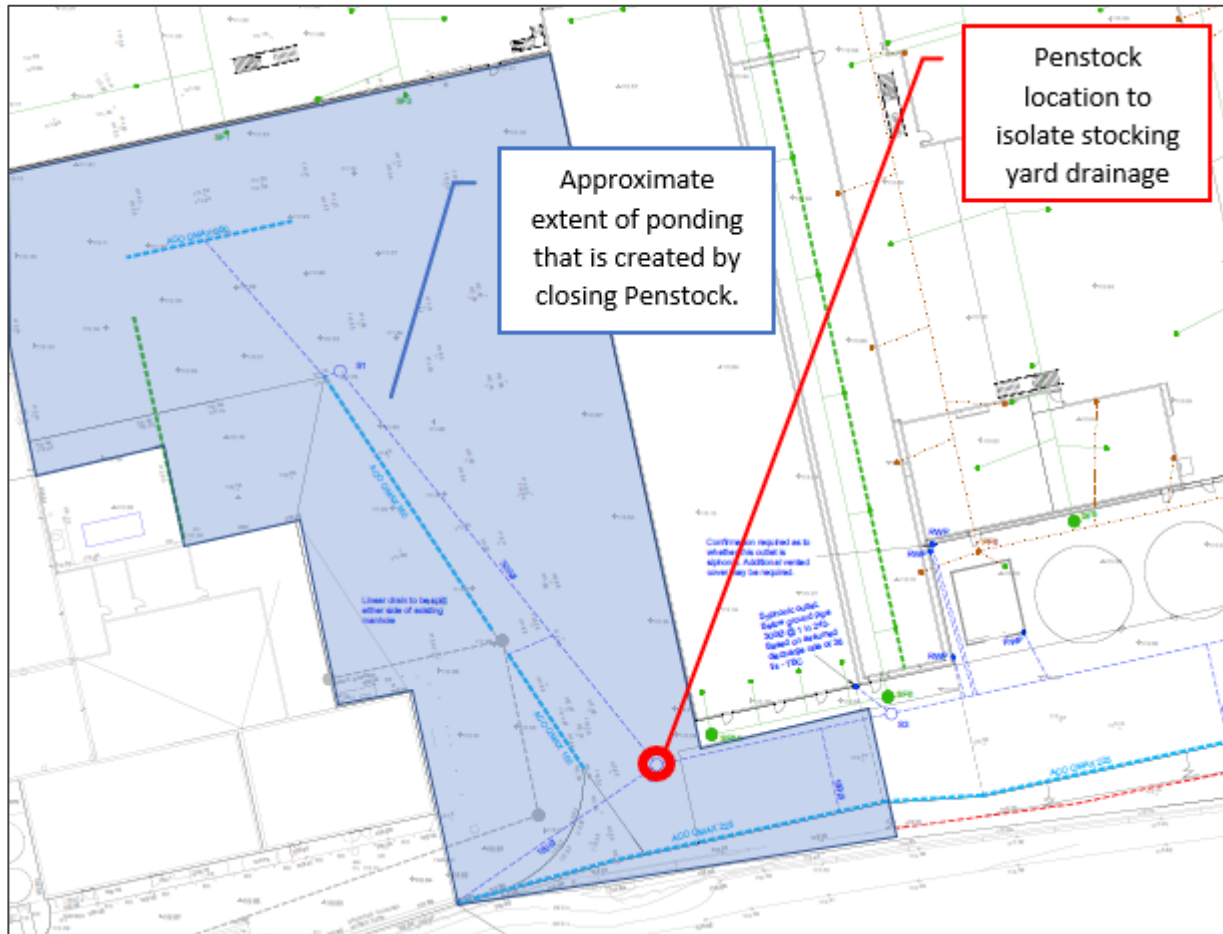
Figure 2-3: Isolation of Drainage in Stocking Yard Area

The slot drain running in a north-westerly direction through the stocking yard that separates the 'old' and 'new' dairy buildings is also fitted with a penstock valve (see Figure 2-3).

This valve is, under normal circumstances, left open and drains water to the 'eastern' system, via the SUDs lagoon. It can however be manually closed to allow drainage to be retained within the stocking yard area.

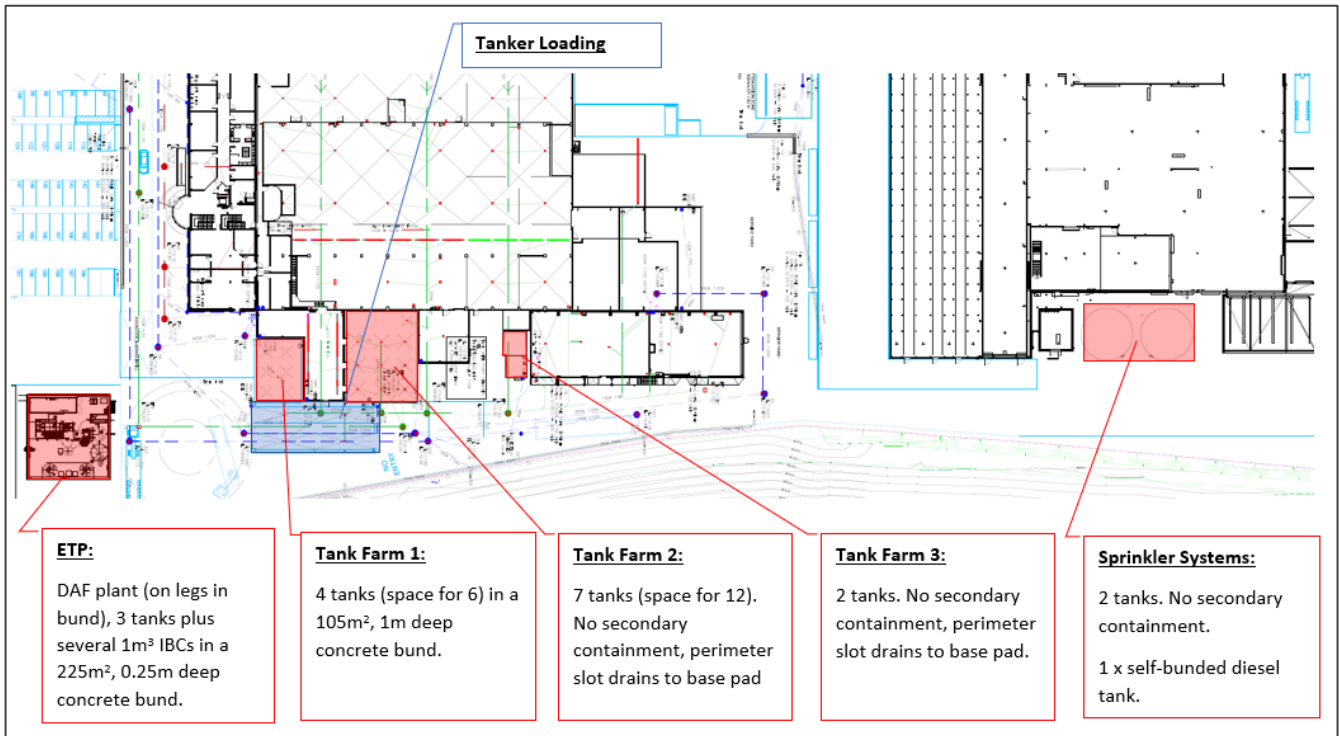
Figure 3-1: Outline External Tanks, Bunds and Tanker Bay Layout

As shown in Figure 3-1, only two areas of the site are provided with secondary containment bunds. These are the ETP and Tank Farm 1. Water and/or spillage within these bunds are held within the sealed bund and are pumped out to treatment and ultimately disposal to sewer via manually operated submersible pumps that discharge to the site effluent systems. Other bunds on site associated with smaller storage vessels (<10m³) are undercover and do not collect rainfall. These smaller bunds are regularly inspected, and any spilt content disposed of via the in-site effluent treatment systems.

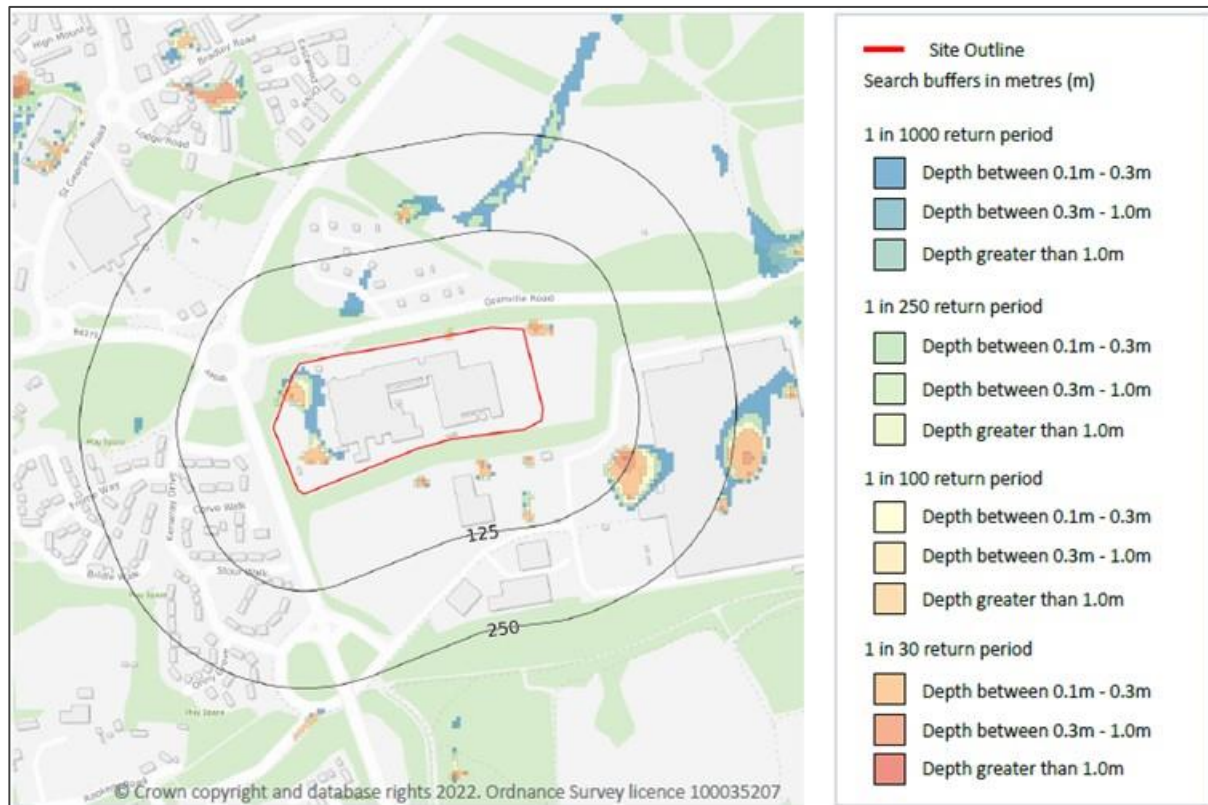
Figure 3-2: Surface Water Flood Risk Map

Other potential transient pathways that may develop relate to the risk of flooding at the site. The information in Appendix O2 indicates that there is little risk of surface water flooding to the main areas of the facility that store liquids. However, the western end of the site is subject to a minor risk from flooding over return period of >30 years (see Figure 3-2). With reference to the *Check your long term flood risk* website², the facility at Telford is at 'very low risk' of flooding by rivers and surface waters and is not in a recognised flood zone.

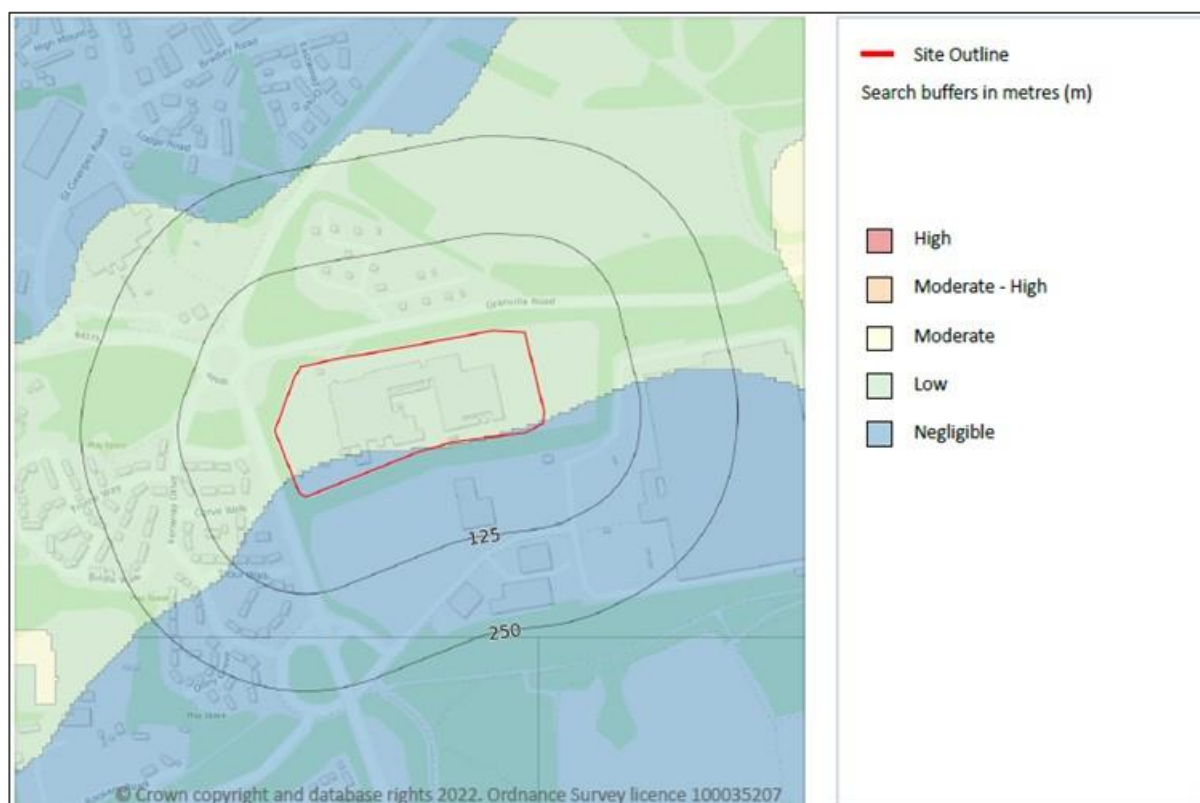
Figure 3-3: Groundwater Flooding Map

Groundwater flooding is caused by unusually high groundwater levels. Data in Appendix O2 indicates that, based on a 1 in 100-year return period, the site is not at risk from groundwater flooding (see Figure 3-3).

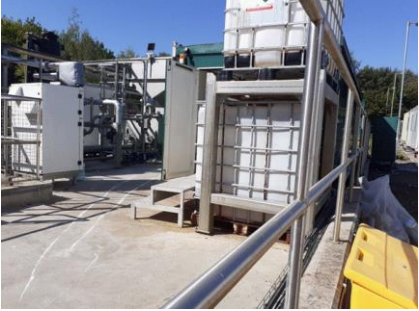
<p><u>Plate 1</u></p> <p>ETP showing good quality concrete bunding containing IBC's of dosing chemicals.</p>

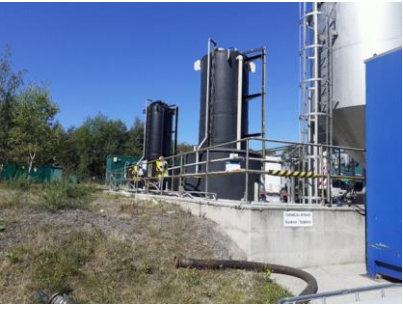
<p><u>Plate 2</u></p> <p>ETP showing DAF tank and bulk chemical storage tanks.</p>

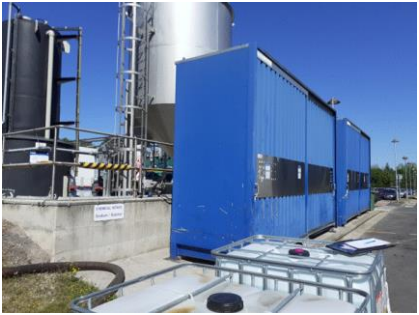
<p><u>Plate 3</u></p> <p>Small packaged chemical stores adjacent to ETP.</p>

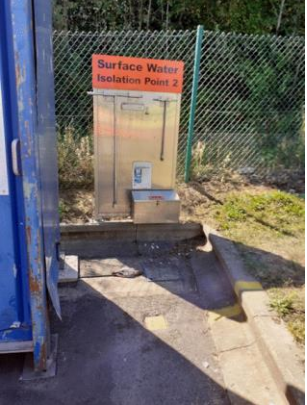
<p><u>Plate 4</u></p> <p>Surface water isolation point (Penstock) 2, southwest corner of storage tank and tanker loading area.</p>

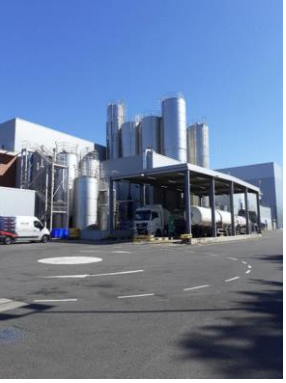
<p><u>Plate 5</u></p> <p>Tanker loading bay also showing tank farm in background and good quality tarmac surface in foreground.</p>

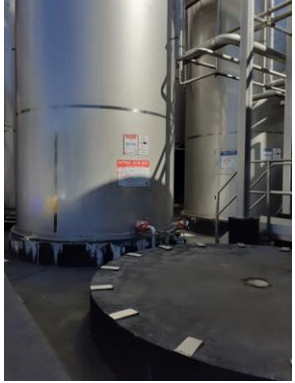
<p><u>Plate 6</u></p> <p>Example bulk chemical storage tank and base for additional tank.</p>
