| PROJECT | Chilmington Green<br>Ashford, Kent | | CLIENT | Hodson Developments | | | |
| TITLE | River Beult Monitoring December 2023 | | REFERENCE | 22074-SVY-TN-03 | | C01 | |

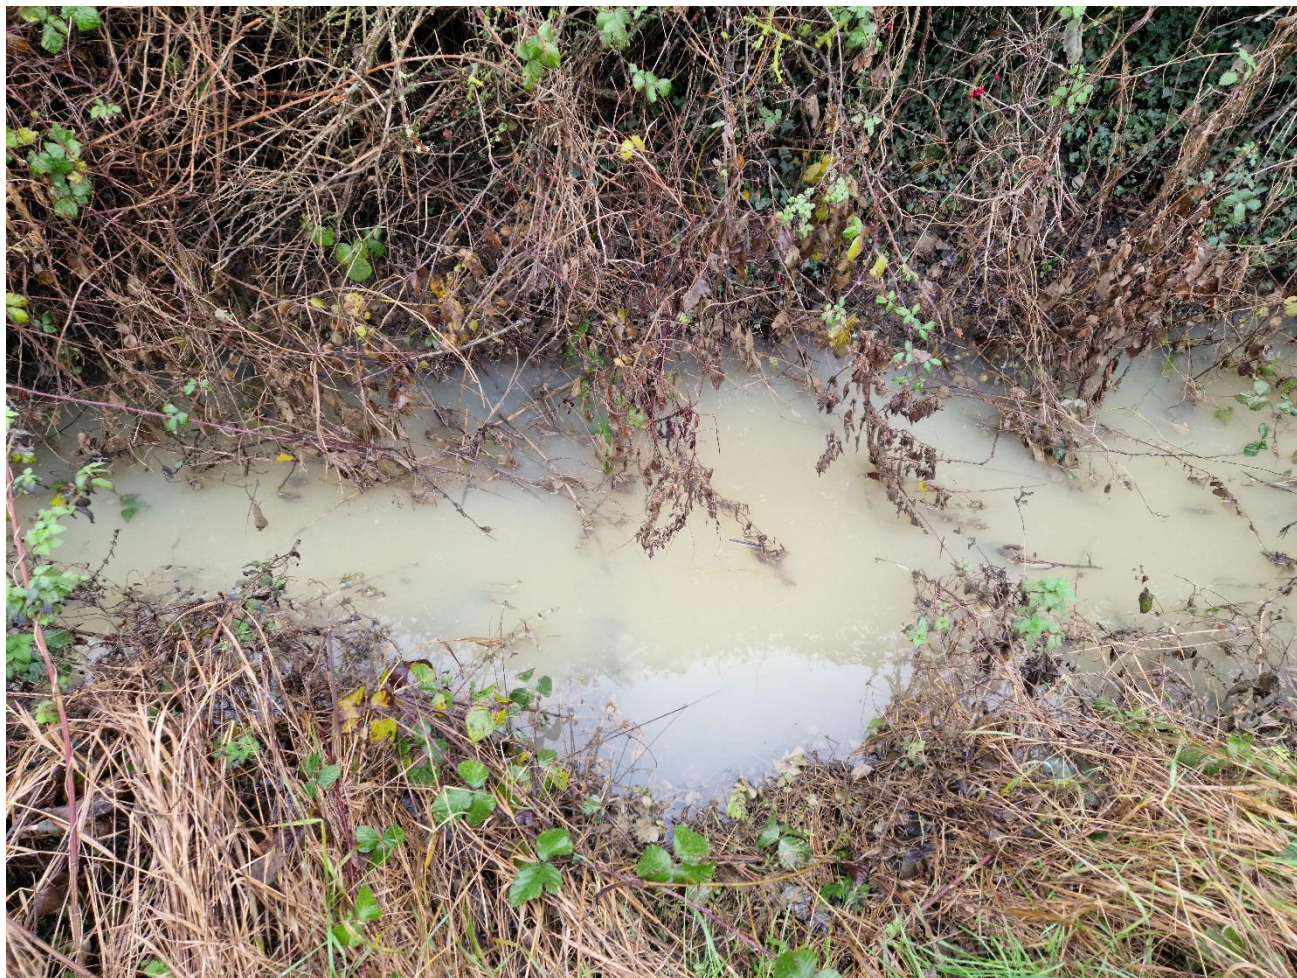
Site 2: Stream next to field hedge row (05/12/23)

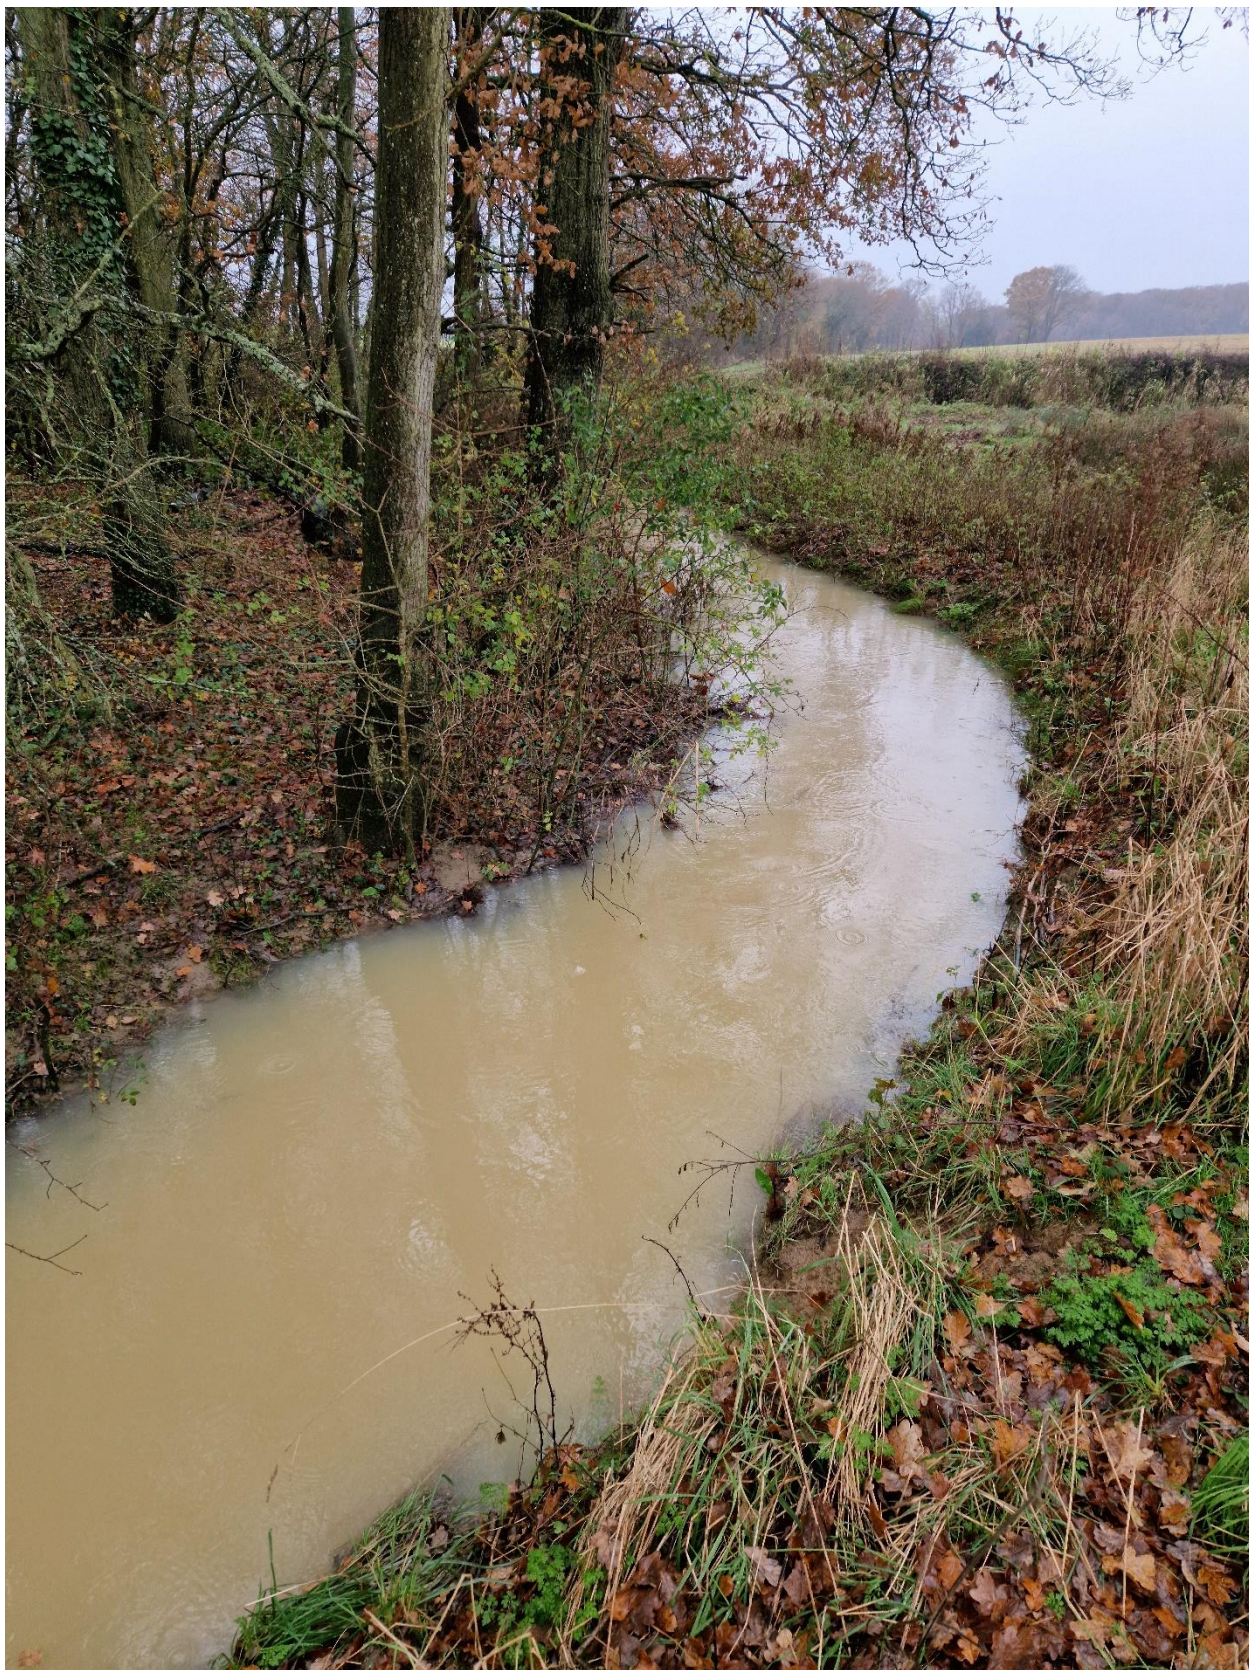
Site 3: Stream prior to joining adjacent River Beult tributary. (05/12/23)

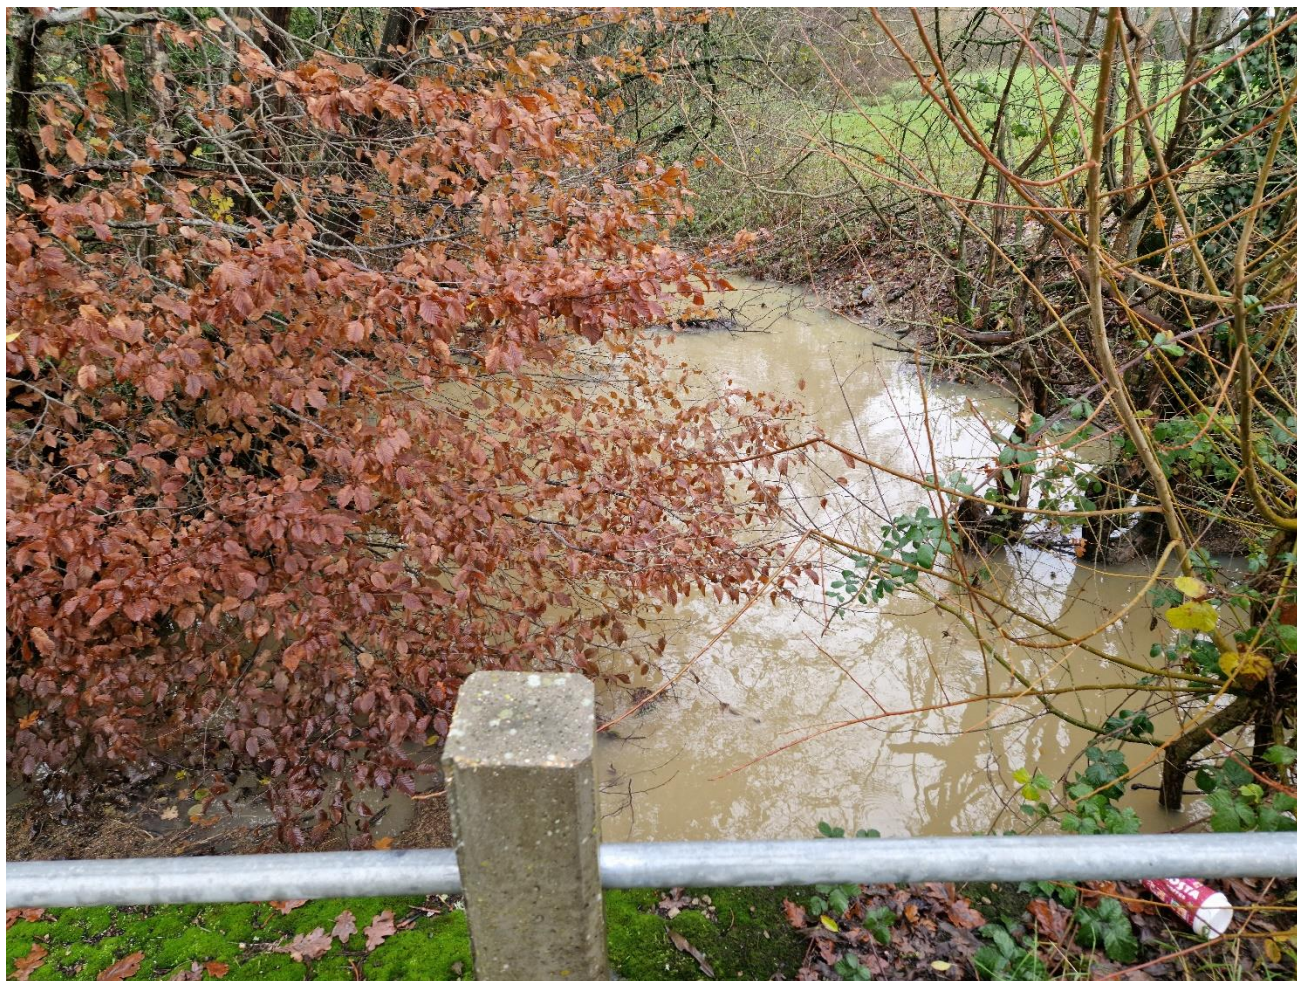
Site 4: Upper River Beult near Bethersden Road (05/12/23)

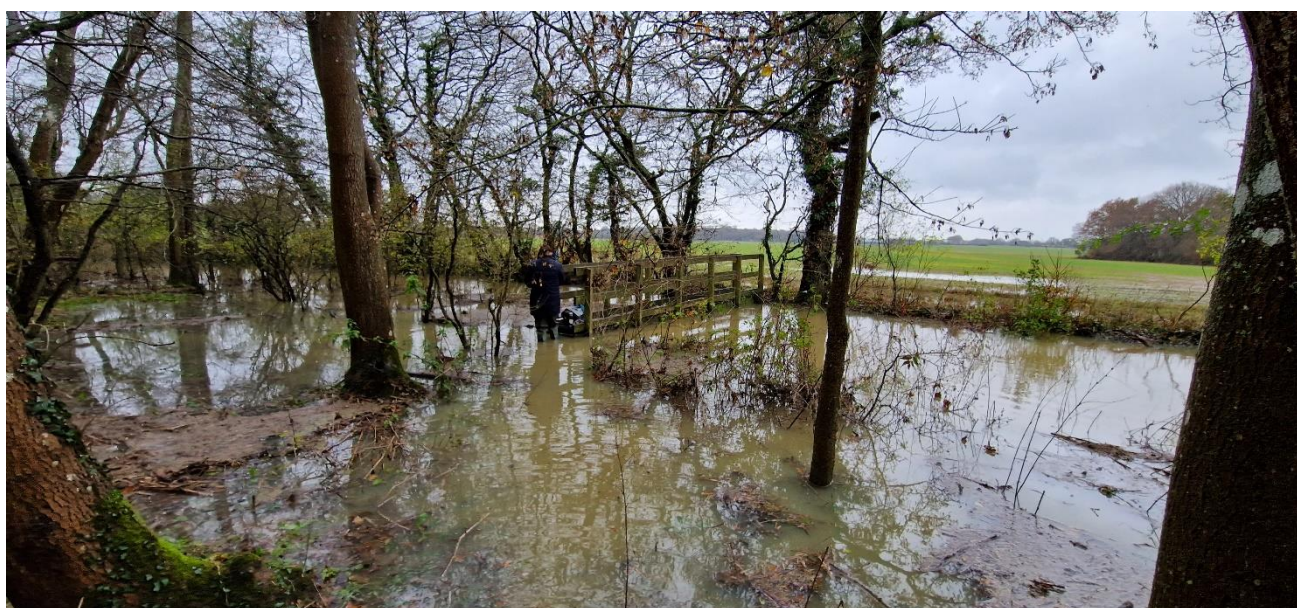
Site 5: Near Kiln Wood Public Right of Way (05/12/23)
