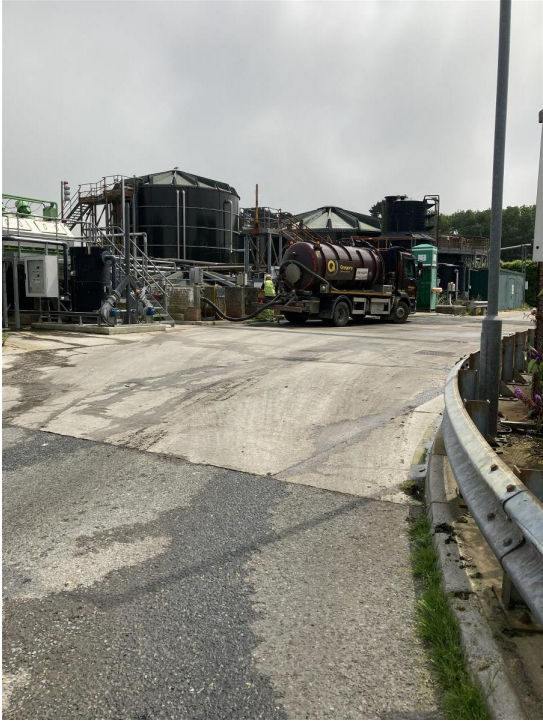
Photo Location:			
Direction: Sludge Reception Area			
Survey Date: 13/07/2021			
Comments:			
Photograph ID: 2

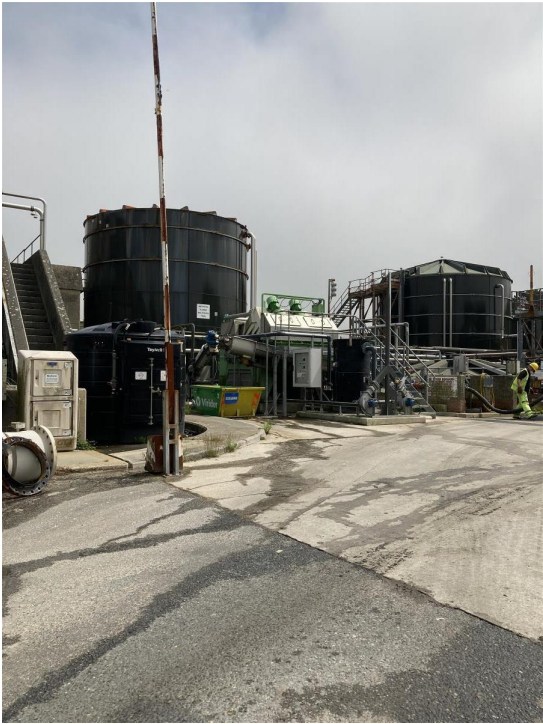
Photo Location:			
Direction: Tanker Delivery Point			
Survey Date: 13/07/2021			
Comments:

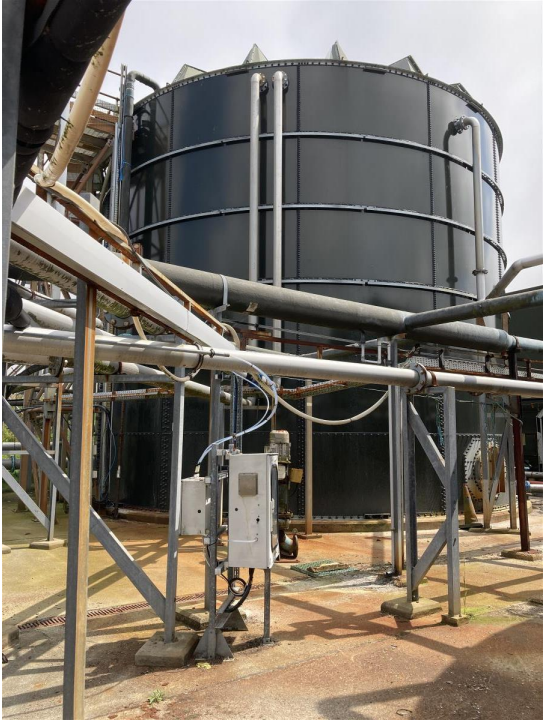
Photo Location:			
Direction: Sludge Balancing Tank			
Survey Date: 13/07/2021			
Comments:			
Photograph ID: 6

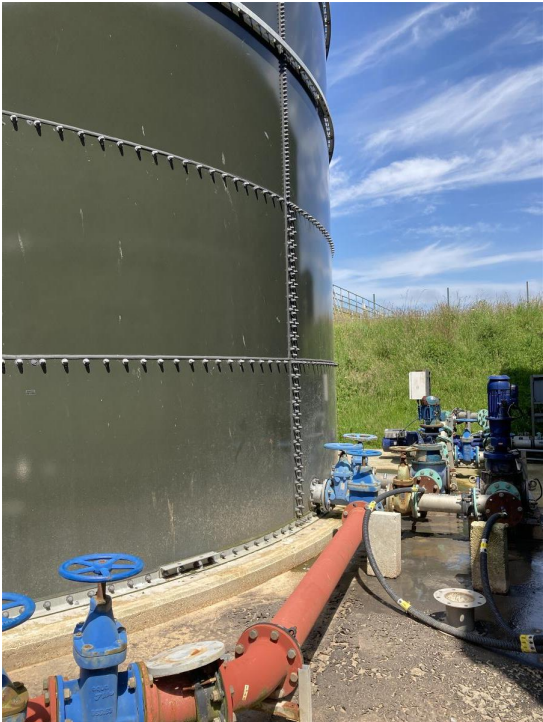
Photo Location:			
Direction: Sludge Blending Tank (close up)			
Survey Date: 13/07/2021			
Comments:

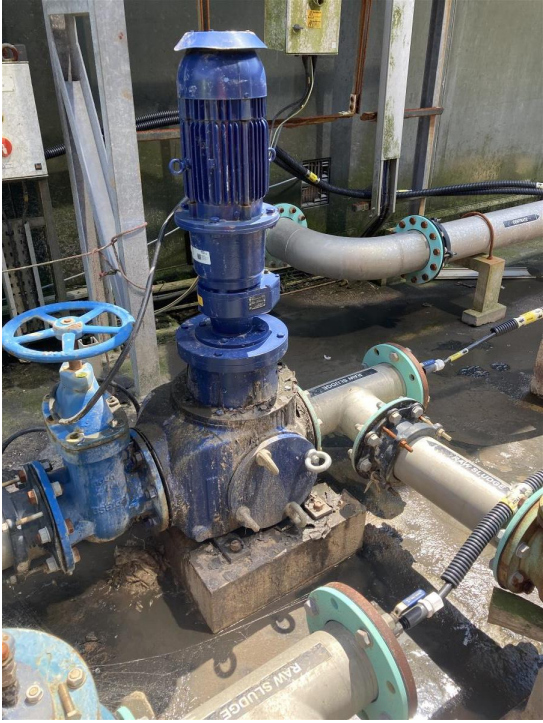
Photo Location:			
Direction: Mascerator Pumps			
Survey Date: 13/07/2021			
Comments:			
Photograph ID: 8

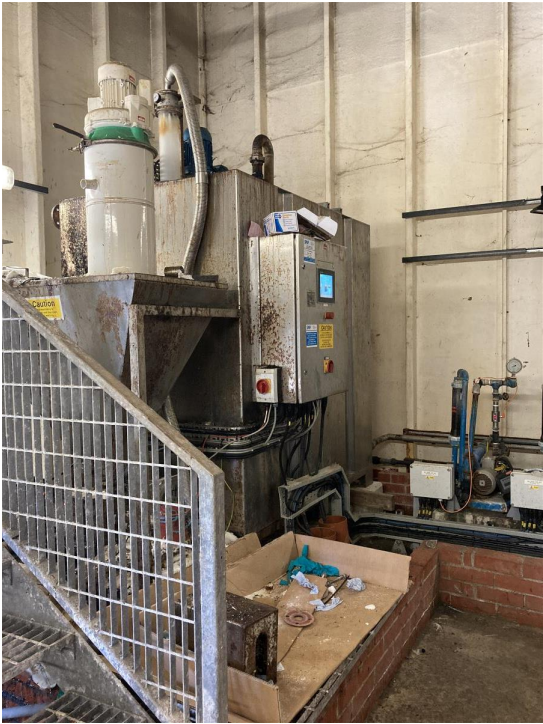
Photo Location:			
Direction: Thickener Polydosing System			
Survey Date: 13/07/2021			
Comments:

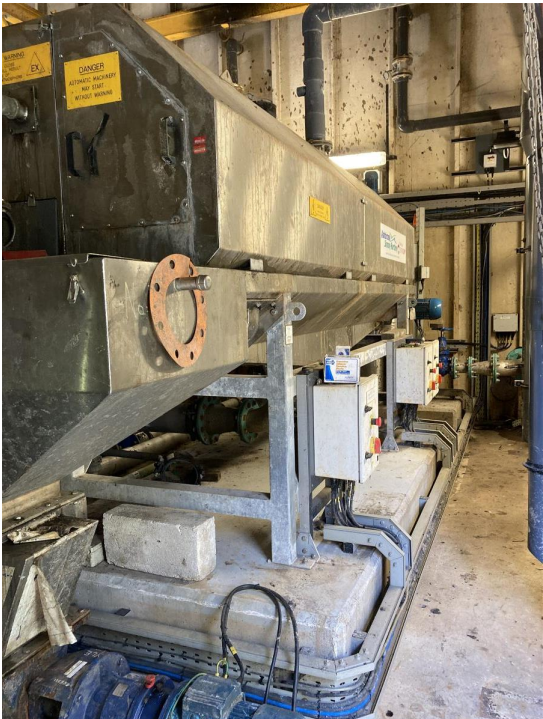
Photograph ID: 10

Photo Location:	
Direction: Thickener 2	
Survey Date: 13/07/2021	
Comments:

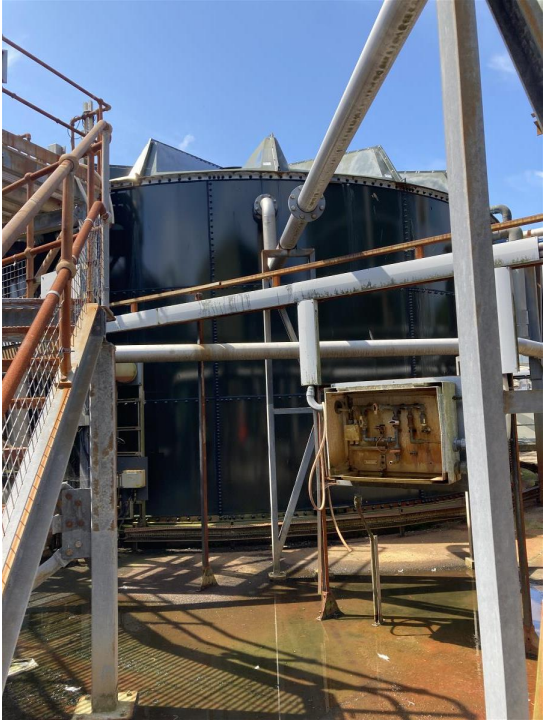
Photo Location:			
Direction: Thickened Sludge Tank			
Survey Date: 13/07/2021			
Comments:			
Photograph ID: 12

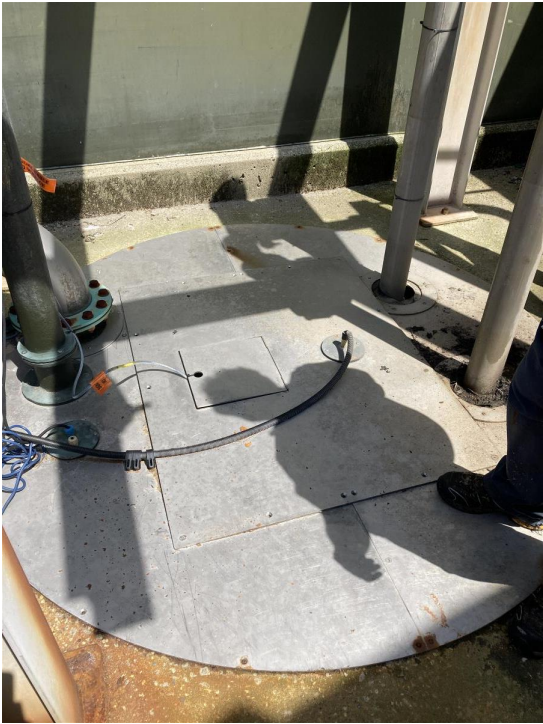
Photo Location:			
Direction: Return liquor pumping station (Thickener)			
Survey Date: 13/07/2021			
Comments:

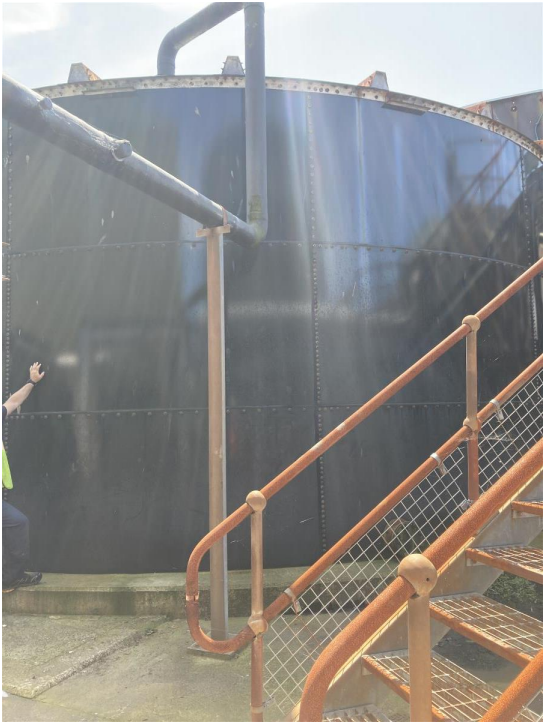
Photo Location:			
Direction: Return Liquor Blancing Tank			
Survey Date: 13/07/2021			
Comments:			
Photograph ID: 14

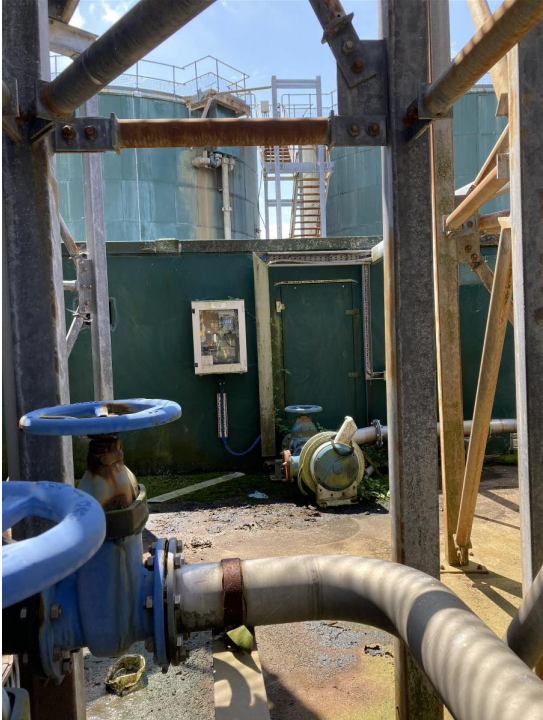
Photo Location:			
Direction: Primary Digester Feed Pumps enclosure			
Survey Date: 13/07/2021			
Comments:

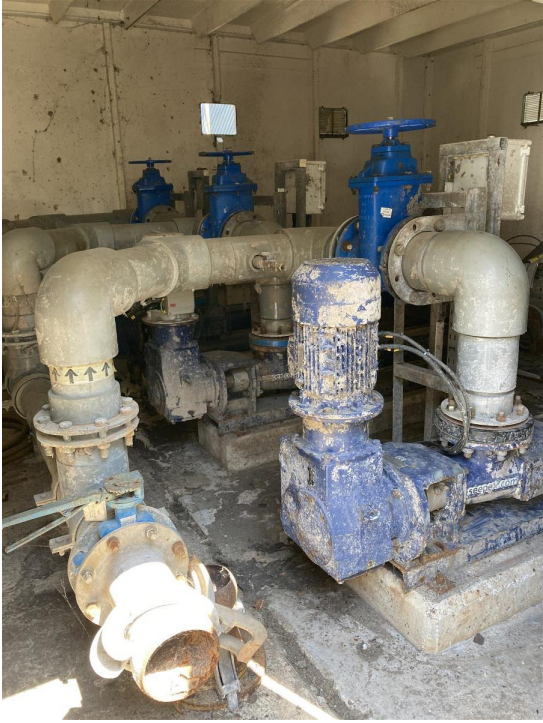
Photo Location:			
Direction: Digester Feed Pumps			
Survey Date: 13/07/2021			
Comments:			
Photograph ID: 16

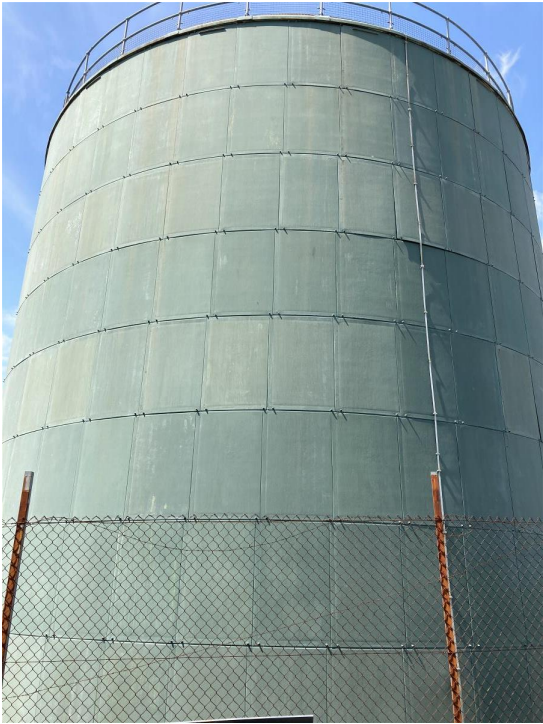
Photo Location:			
Direction: Primary Digester (close up)			
Survey Date: 13/07/2021			
Comments:

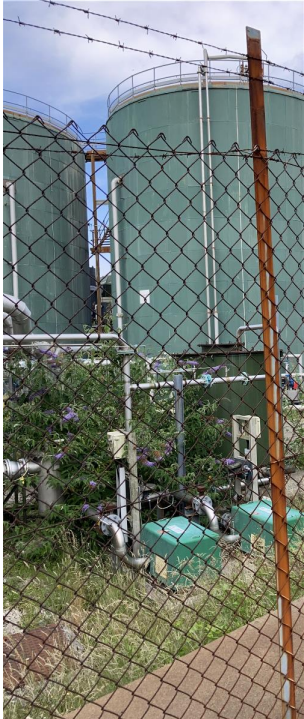
Photo Location:			
Direction: Primary Digesters			
Survey Date: 13/07/2021			
Comments:			
Photograph ID: 18

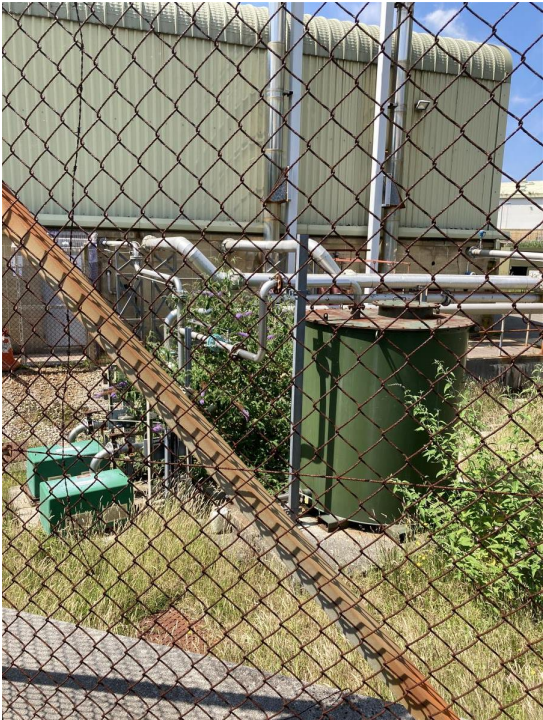
Photo Location:			
Direction: Boiler/CHP house with Boiler Stacks (background). Gasbooster (infront)			
Survey Date: 13/07/2021			
Comments:

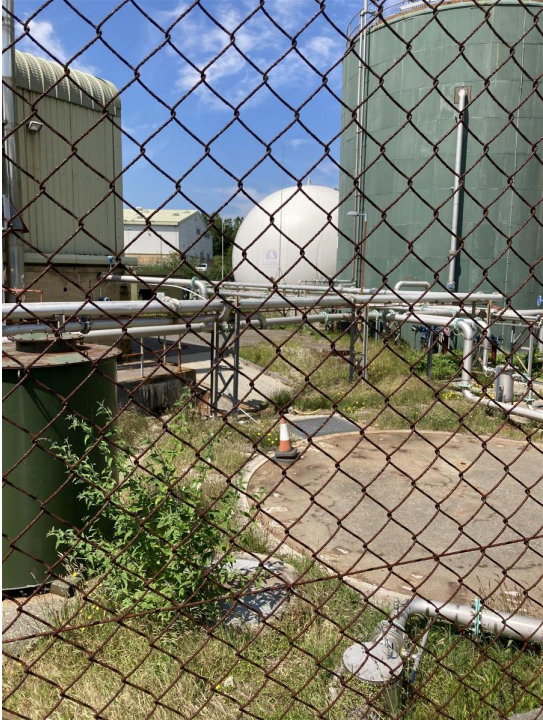
Photo Location:			
Direction: Primary digester Disgester and Gas Bag			
Survey Date: 13/07/2021			
Comments:			
Photograph ID: 20

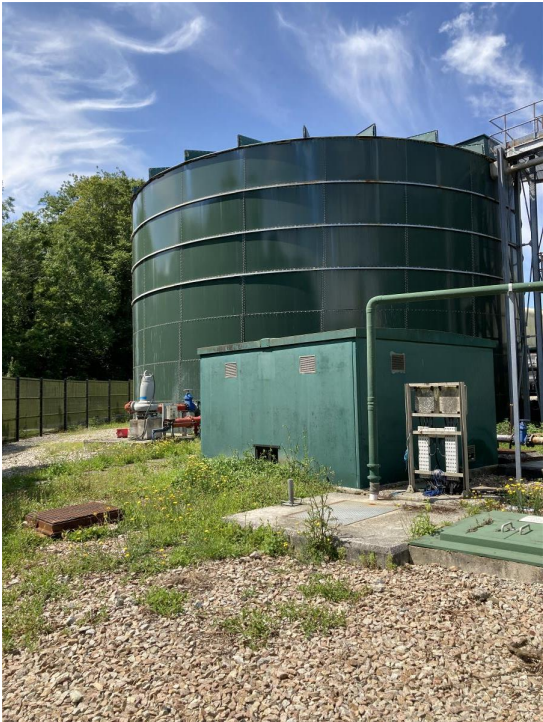
Photo Location:			
Direction: Secondary Digester 1			
Survey Date: 13/07/2021			
Comments:

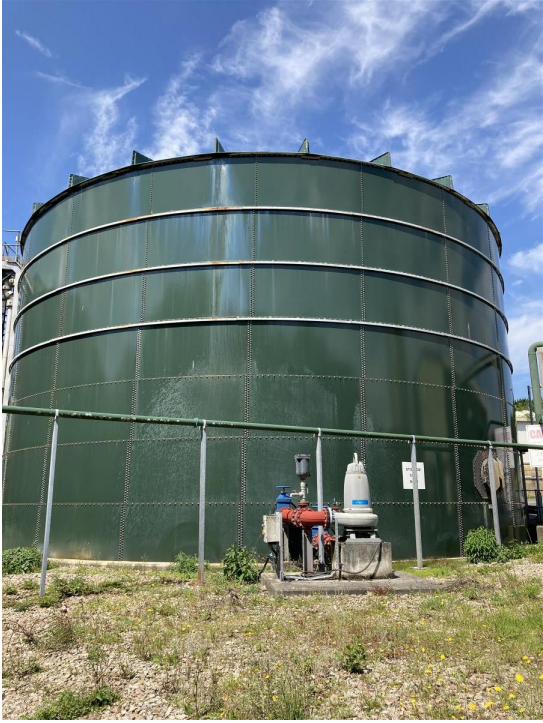
Photo Location:			
Direction: Secondary Digester 2			
Survey Date: 13/07/2021			
Comments:			
Photograph ID: 22

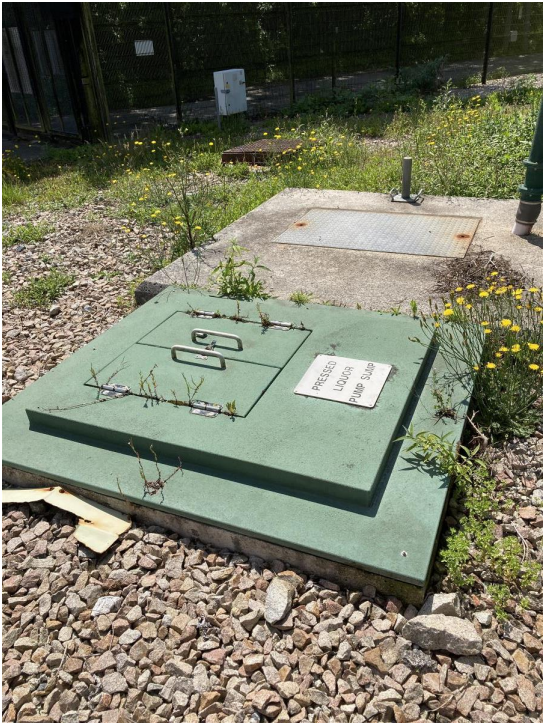
Photo Location:			
Direction: Centrifuge Return Liquor Sump			
Survey Date: 13/07/2021			
Comments:

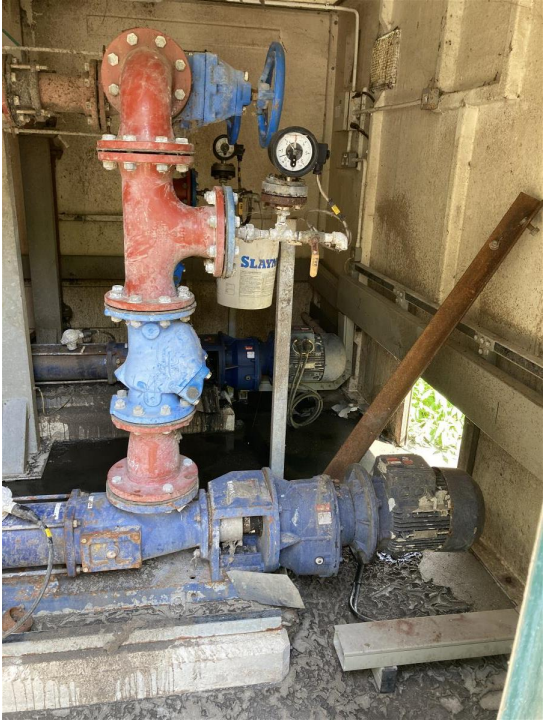
Photo Location:			
Direction: Centrifuge Feed Pumps			
Survey Date: 13/07/2021			
Comments:			
Photograph ID: 26

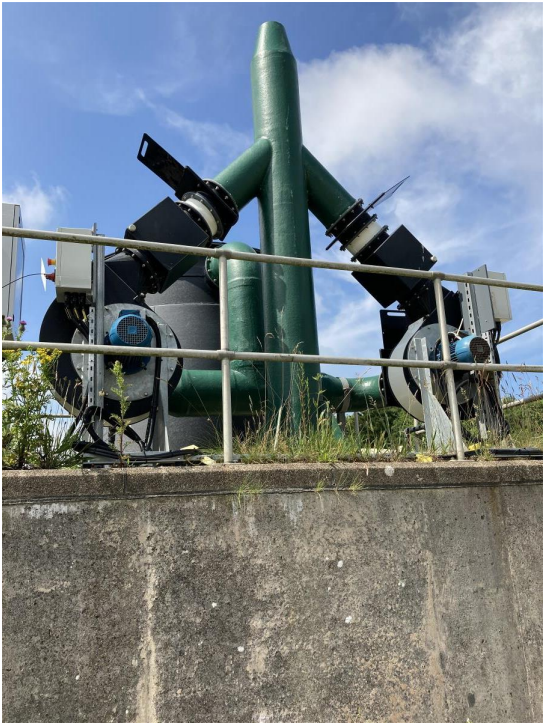
Photo Location:			
Direction: Thickner OCU stack			
Survey Date: 13/07/2021			
Comments:

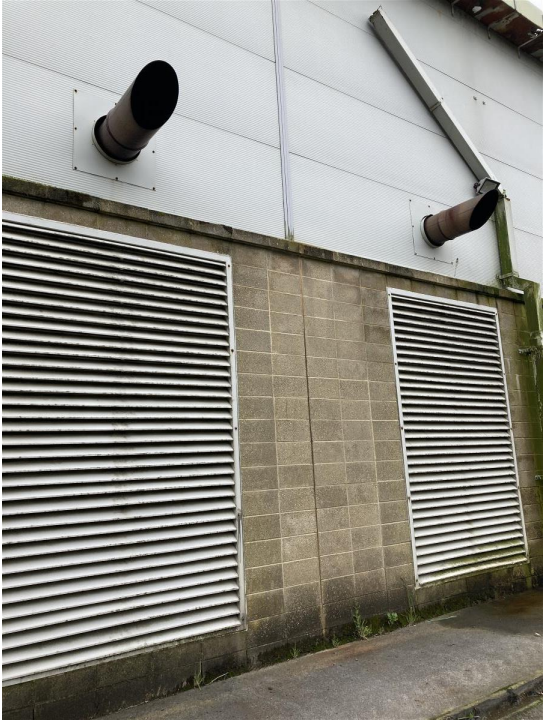
Photo Location:			
Direction: Generator Emmission points			
Survey Date: 13/07/2021			
Comments:			
Photograph ID: 30

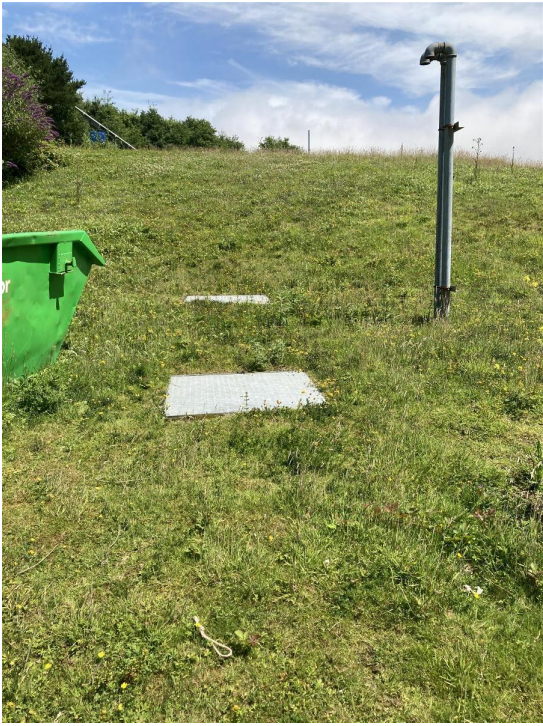
Photo Location:			
Direction: Underground Diesel Storage Tanks			
Survey Date: 13/07/2021			
Comments:
