**Industrial Emissions Directive –  
Hayle Waste Water Treatment  
Works (WWTW)**

Secondary Containment Modelling  
Assessment

05/01/2024

South West Water

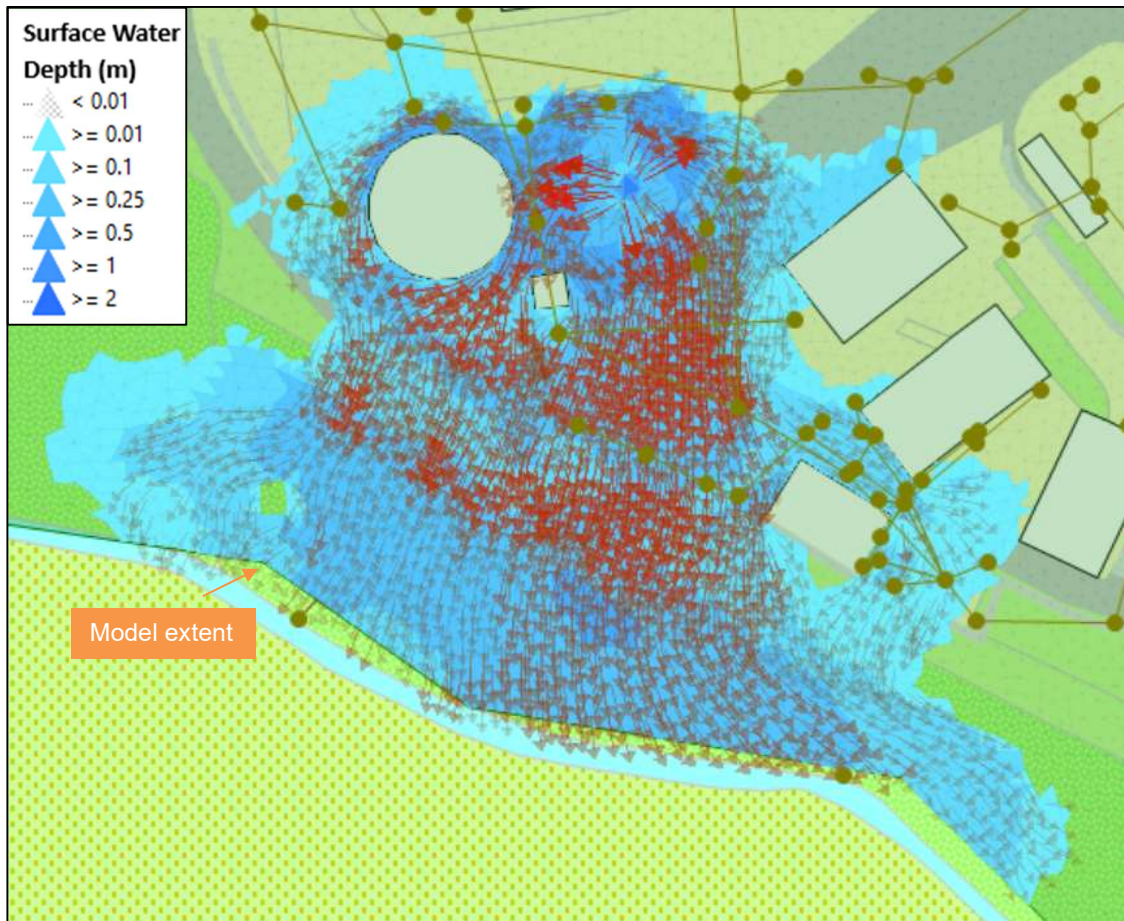
Figure 6: Hayle WwTW predicted flow paths following secondary digester burst

Figure 6 presents the spill results following the burst of secondary digester 2. Blue colour shows the depth of surface water and the red arrows show the direction of overland flow. This shows significant flows extending past both the WwTW site boundary and the modelling extent. Indicating that upon failure of the secondary digester, pollutants will enter the River Hayle and there is minimal containment to mitigate this currently.

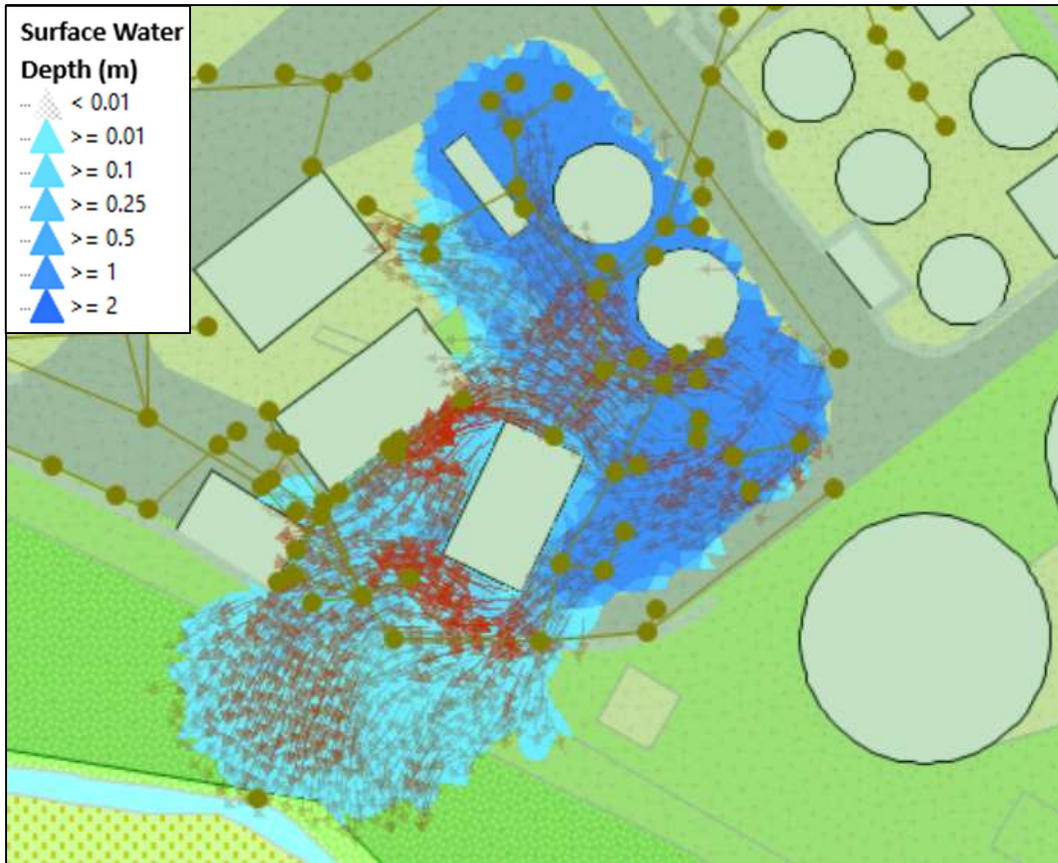
Figure 7: Hayle WWTW predicted flow paths following primary digester burst

A simulation with no added containment was also carried out for primary digester 2 (labelled L2 on Figure 4). An inflow file discharging 1717.1m<sup>3</sup> (110% of the volume) was applied at the tank's center. The results of this simulation predict the flow will reach the ditch and drain to the River Hayle as shown in Figure 7 below.

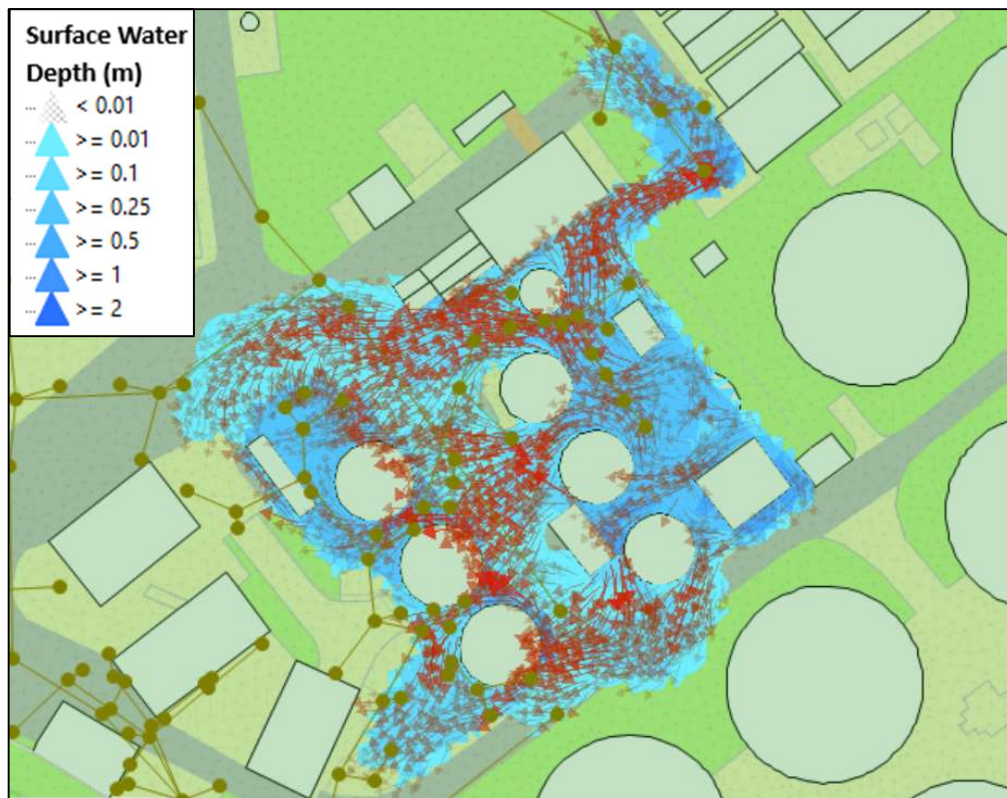
Figure 8: Hayle WwTW predicted flooding extent following sludge balancing tank burst

A simulation with no added containment was also carried out for sludge balancing tank failure (labelled C on Figure 4). An inflow file discharging 768.9m<sup>3</sup> (110% of the volume) was applied at the tank's center. This predicted that spilling would cover a large portion of the WWTW site, but not reach the River Hayle. Figure 8 presents the extent of this spill.

The sludge balancing tank has greater volume and produces a greater extent of spilling than the neighboring imported sludge balancing tank, thickened sludge tank and return liquor balancing tank. Local containment surrounding these tanks is recommended to avoid site flooding in the event of any of their failures.

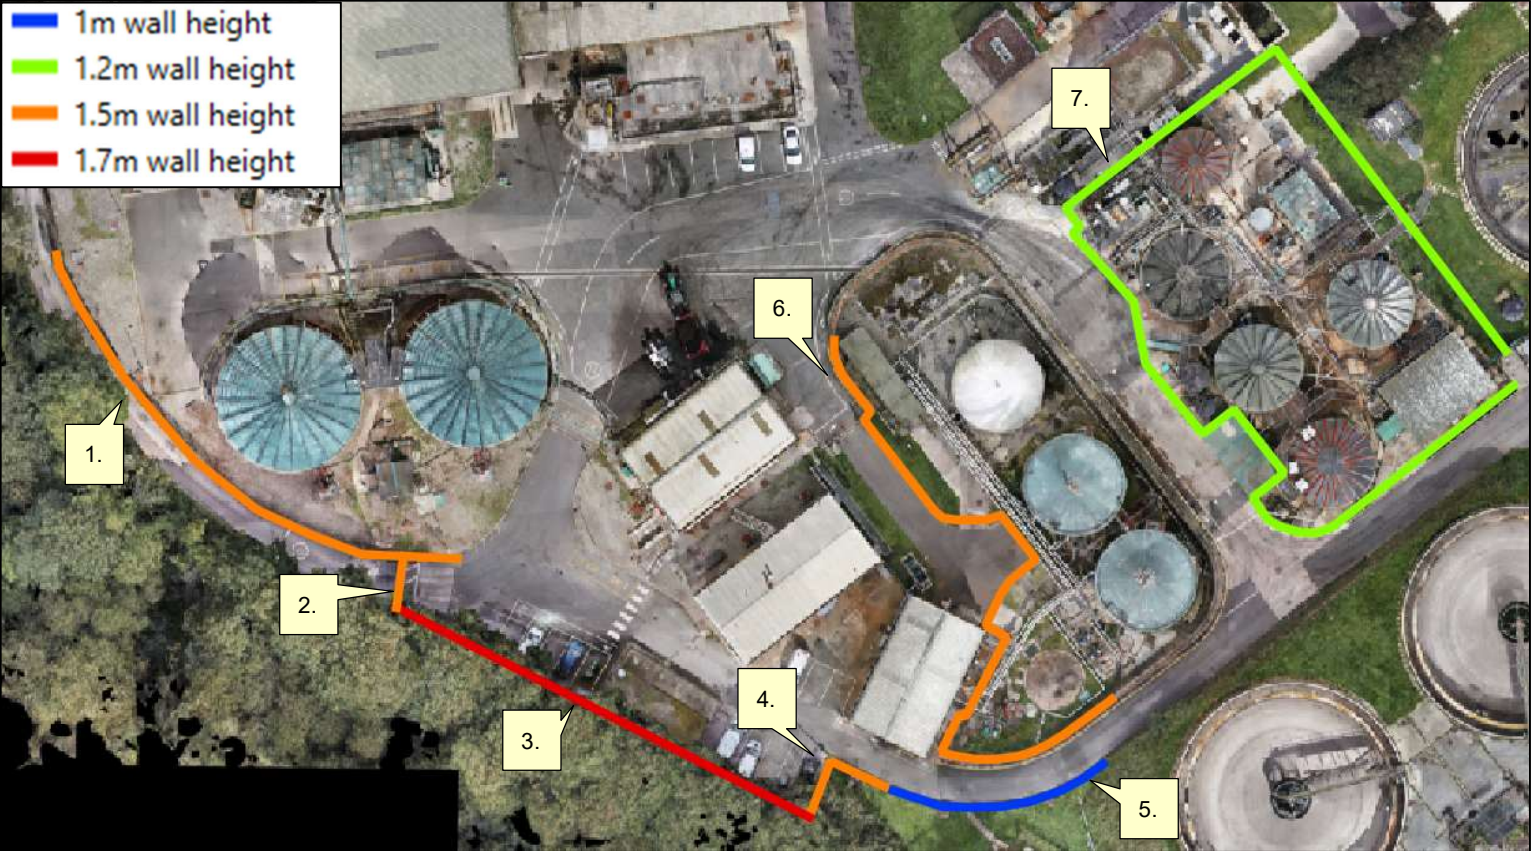
**Figure 9: Hayle WWTW secondary containment solution**

For the Hayle WwTW site, the 1.7m wall proposed along the southern boundary (labelled '3.') is higher than this recommendation. Alternative solutions were investigated to check if this southern wall could be minimized to 1.5m height. For example, pump flowrates were increased from 10 l/s to 50 l/s and 60m<sup>3</sup> additional storage added at the southern carpark. However, an alternative solution was not identified that could avoid watercourse contamination for the secondary digester 2 failure when accommodating for rainfall depth.

CIRIA c736 notes that under some circumstances a wall higher than 1.5m is required. In which case a risk assessment should be conducted. In the simulation of worst-case failure at Hayle WwTW (secondary digester 2 burst) with the proposed solution added, only a small area exceeds 1.5m depth (this can be observed in section 8.1.3). Therefore, the risk of using a 1.7m wall is expected to be mitigatable. If a 1.7m wall is to be constructed a risk assessment will need to be undertaken.

There is also limited confidence in the modelled mesh level at the southern boundary, this is right at the extent of the drone survey. It is recommended that the topography is surveyed further along the proposed wall route.

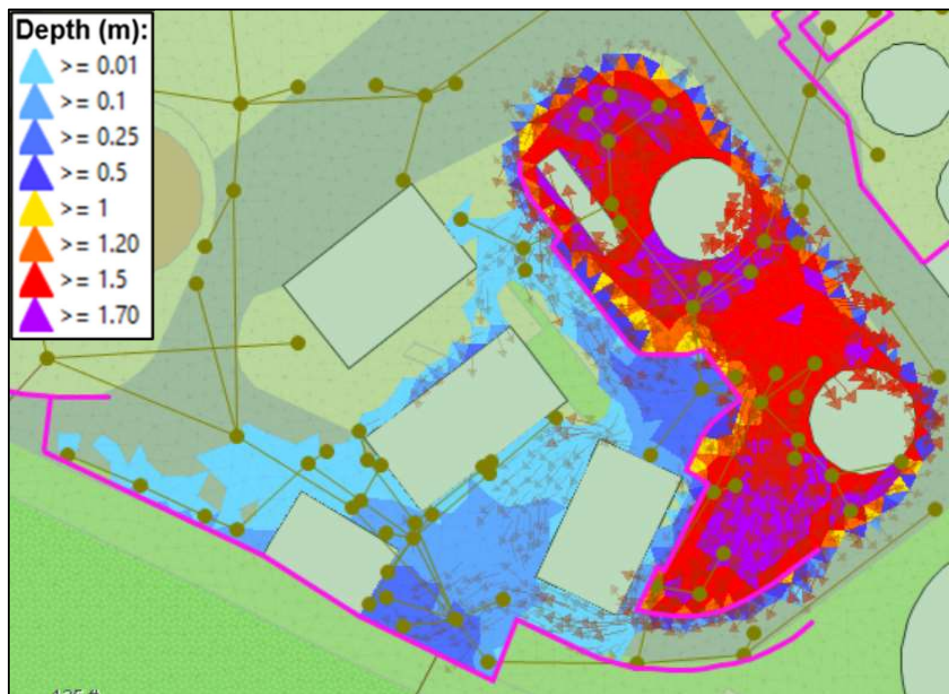
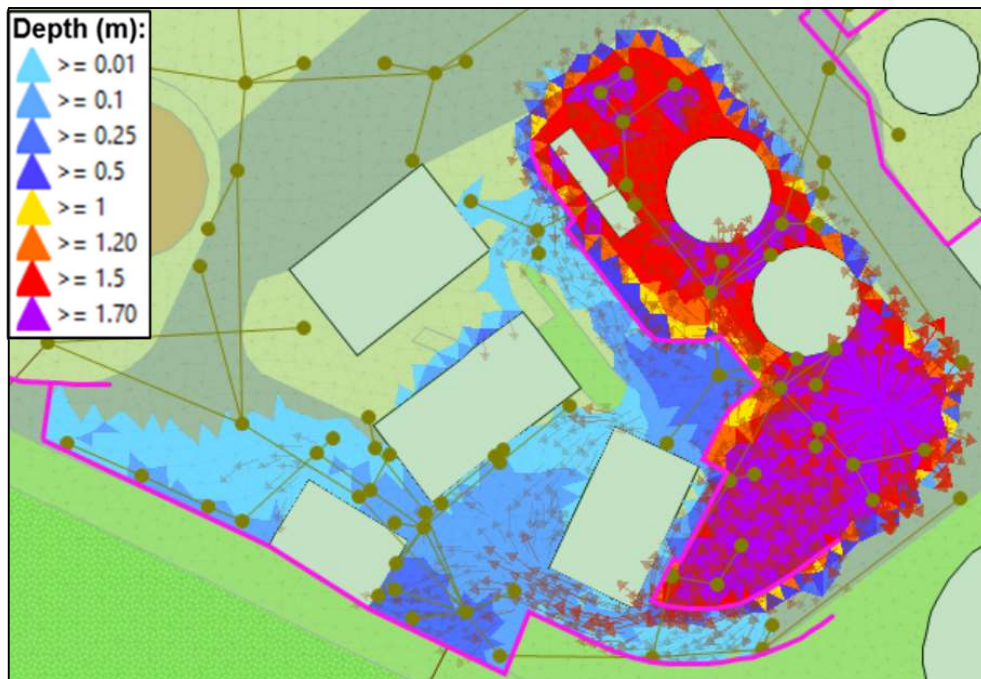
Figure 10 and Figure 11 show the containment solution working for both primary digesters. The 1.5m wall surrounding these digesters is not able to contain the entire volume of a spill, this is predicted to be overtopped. However, the containment solution in conjunction with the additional wall barrier along the southern site boundary is sufficient to stop the spill from entering the surrounding environment.

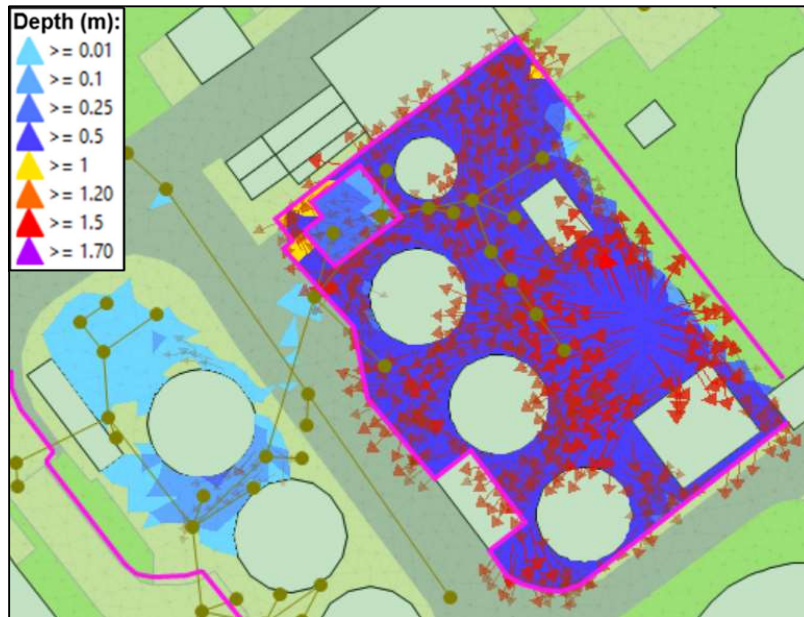
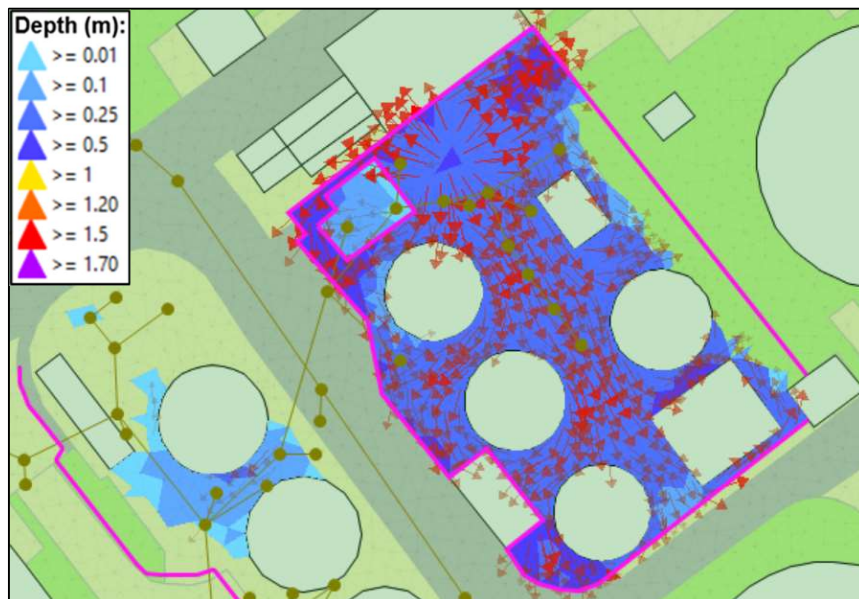
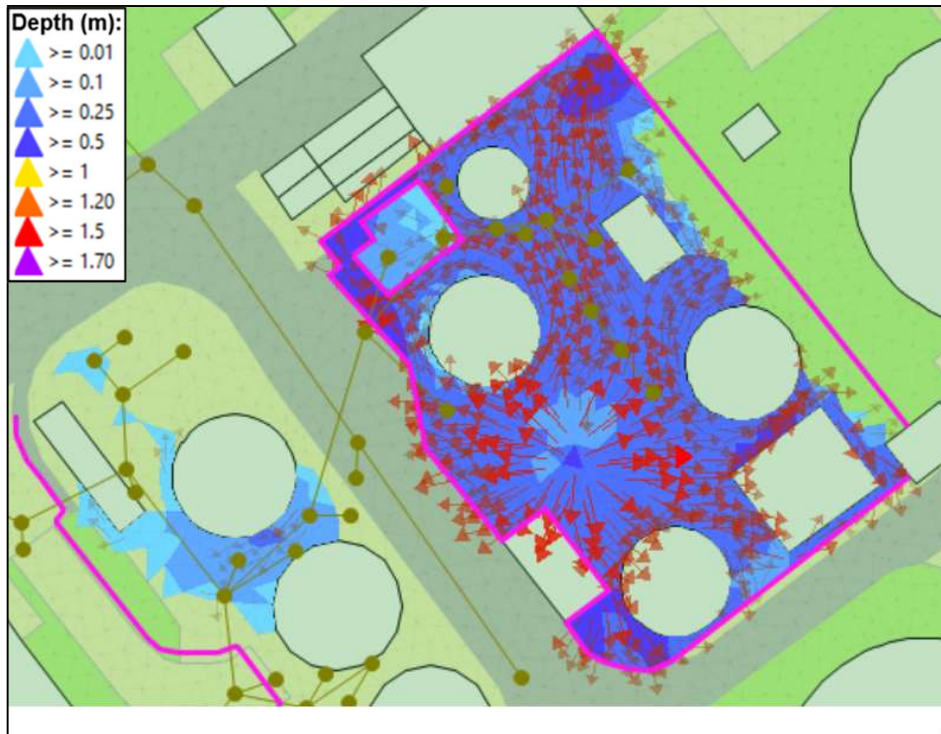
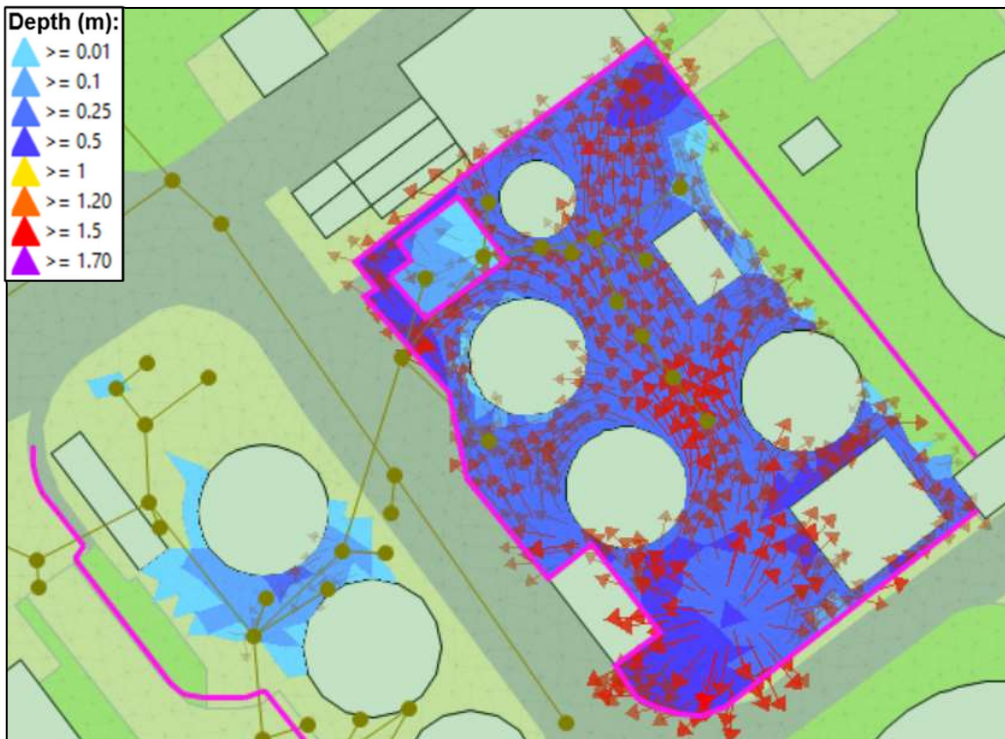
Figure 12, Figure 13, Figure 14 and Figure 15 show that the proposed 1.2m perimeter wall is able to contain the burst spills for the sludge and imported sludge balancing tanks, return liquor balancing tank, and thickened sludge tank. Drainage capacity is overwhelmed, this causes a relatively small volume to spill out by primary digester 1 via the drainage onsite. This is still retained within the site.

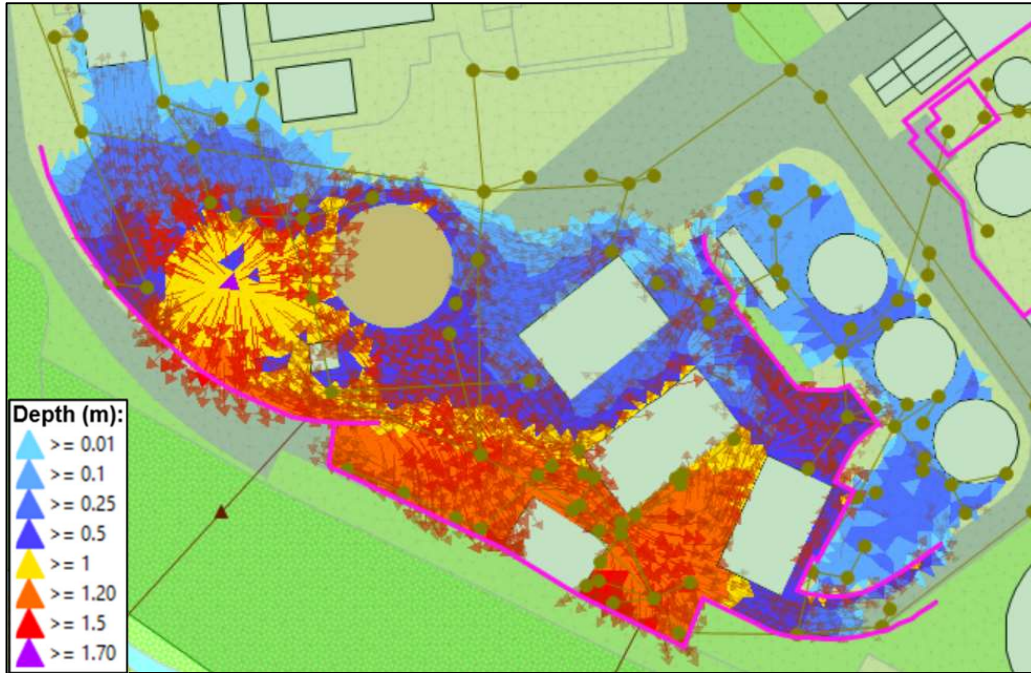
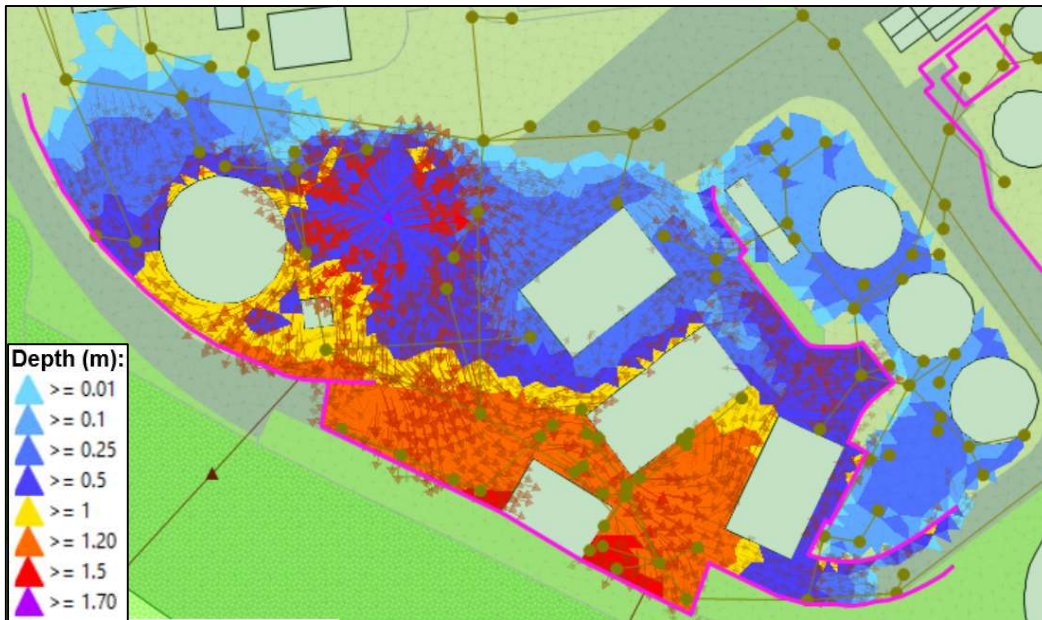
The proposed walls are sufficiently able to contain the secondary digester flow. This can be observed in the maximum spilling depth results presented in Figure 16 and Figure 17.

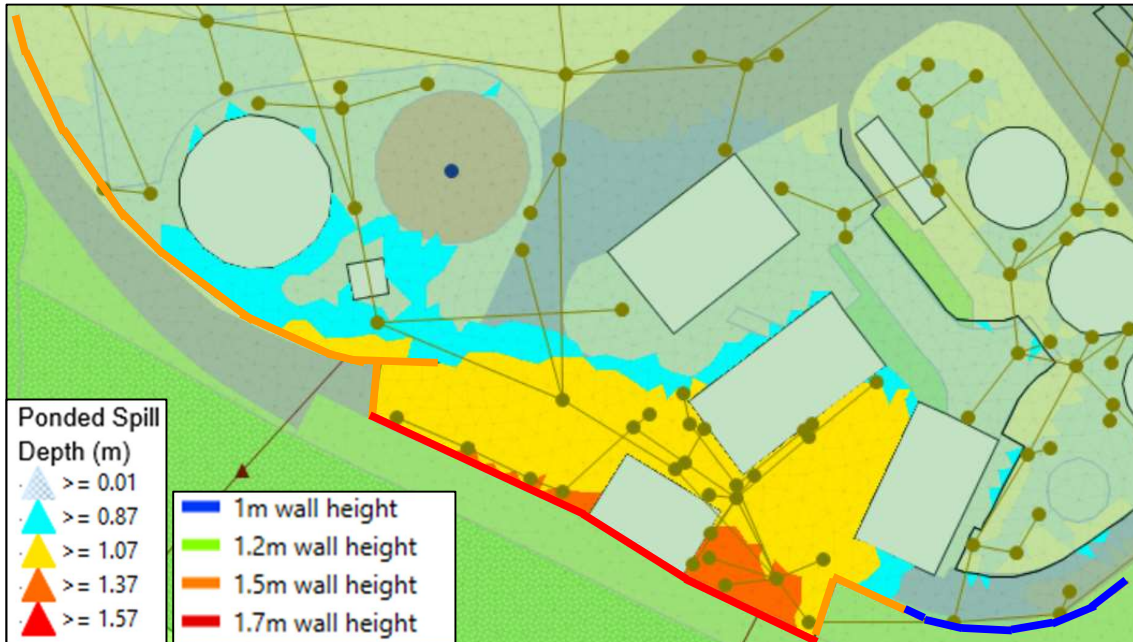
**Figure 18: Assessing wall heights with rainfall considered for secondary digester 2 burst scenario**

Figure 18 below presents the maximum ponded levels after the bursting of secondary digester 2. This shows how a 1.5m wall is sufficient all along the southern wall except for a section by the carpark. This is predicted to be overtopped if 130mm depth of rainfall accumulated following burst. To resolve this a 1.7m wall (solution wall '3.') is proposed along this section as indicated by the red line.

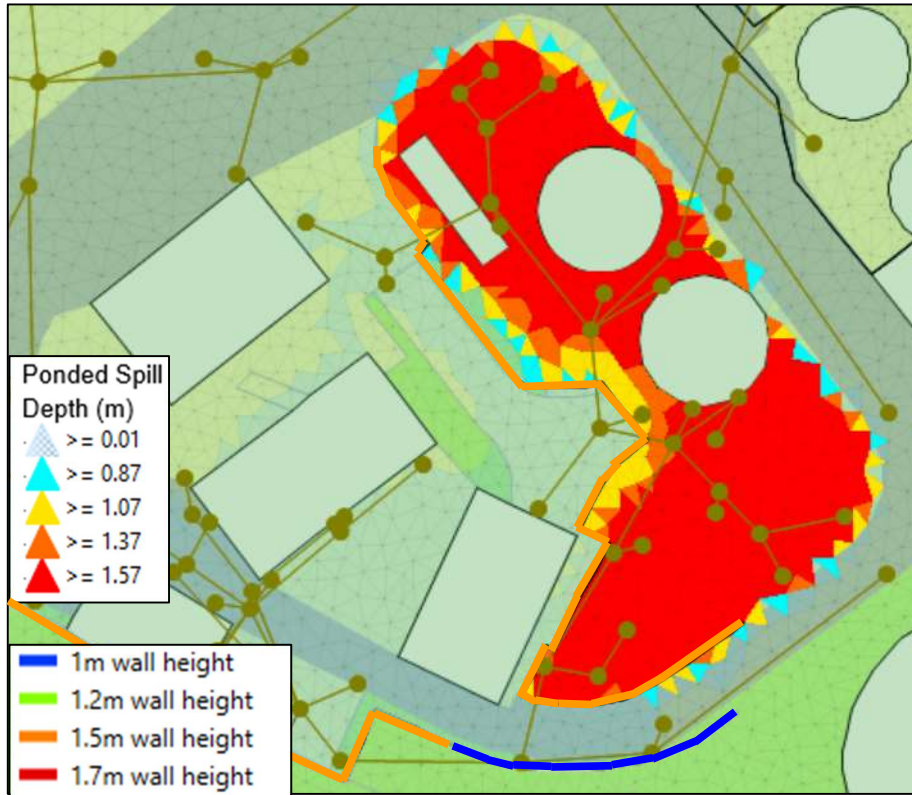
Figure 19: Assessing wall heights with rainfall considered for primary digester 2 burst scenario

Figure 19 presents the maximum ponded levels following primary digester 2 burst. This shows that the 1m height wall on the southern road bend won't be overtopped. With the solution implemented there is no predicted breach to the environment when rainfall is accounted for.

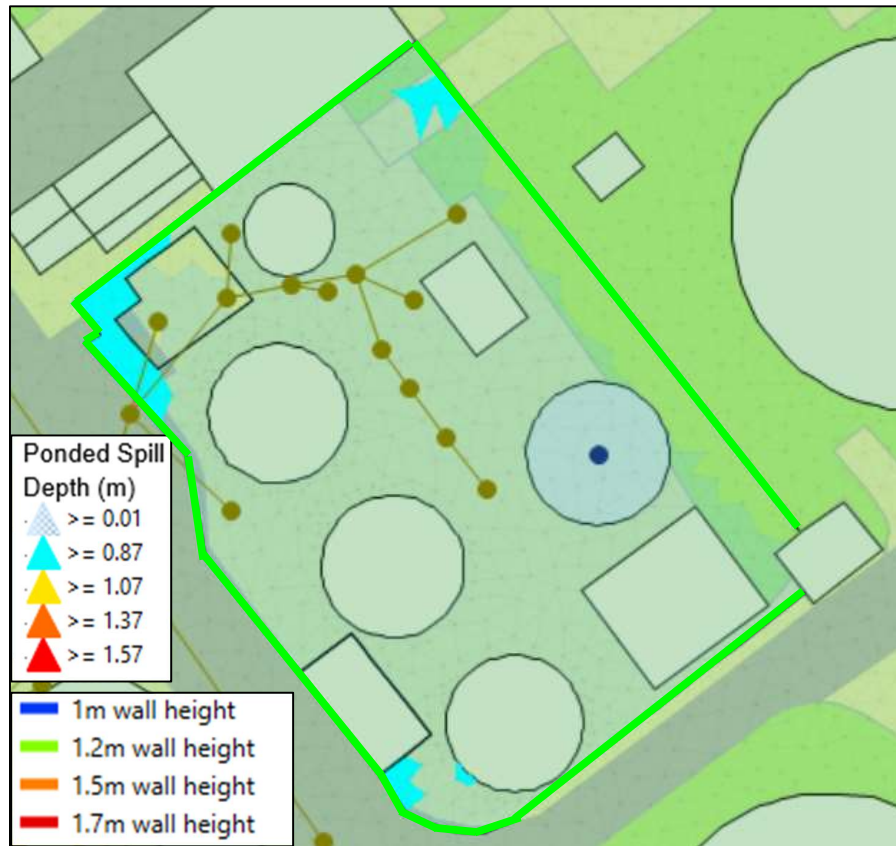
Figure 20: Assessing wall heights with rainfall considered for sludge balancing tank burst scenario

Figure 20 presents the maximum ponded levels following failure of the sludge balancing tank. This shows that at three corners of this perimeter a 1m wall would be overtopped with the addition of the 130mm rainfall depth. A 1.2m wall will be sufficient to contain the spills and mitigate risk to the rest of the WWTW for failure of any of the sludge tanks.
