Newlay Weir Investigation

Independent review into the failure
of Newlay Weir in January 2021

Final Issue

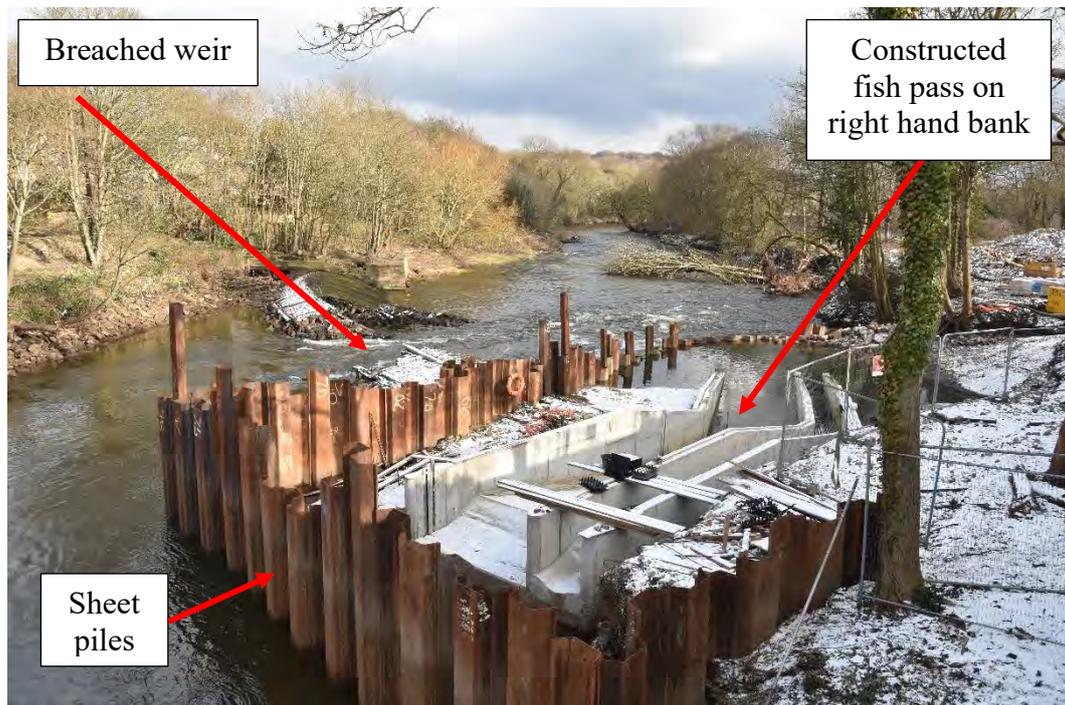
Figure 1 Newlay Weir post failure (12-02-2021)

On Thursday 21st January 2021, after a period of relatively high floodwaters, including Storm Christoph, which peaked on 21st January, a member of the public witnessed failure to the downstream face of the weir. The failure progressed over the next two weeks, resulting in a significant failure and loss of the central portion of the weir (Figure 1).

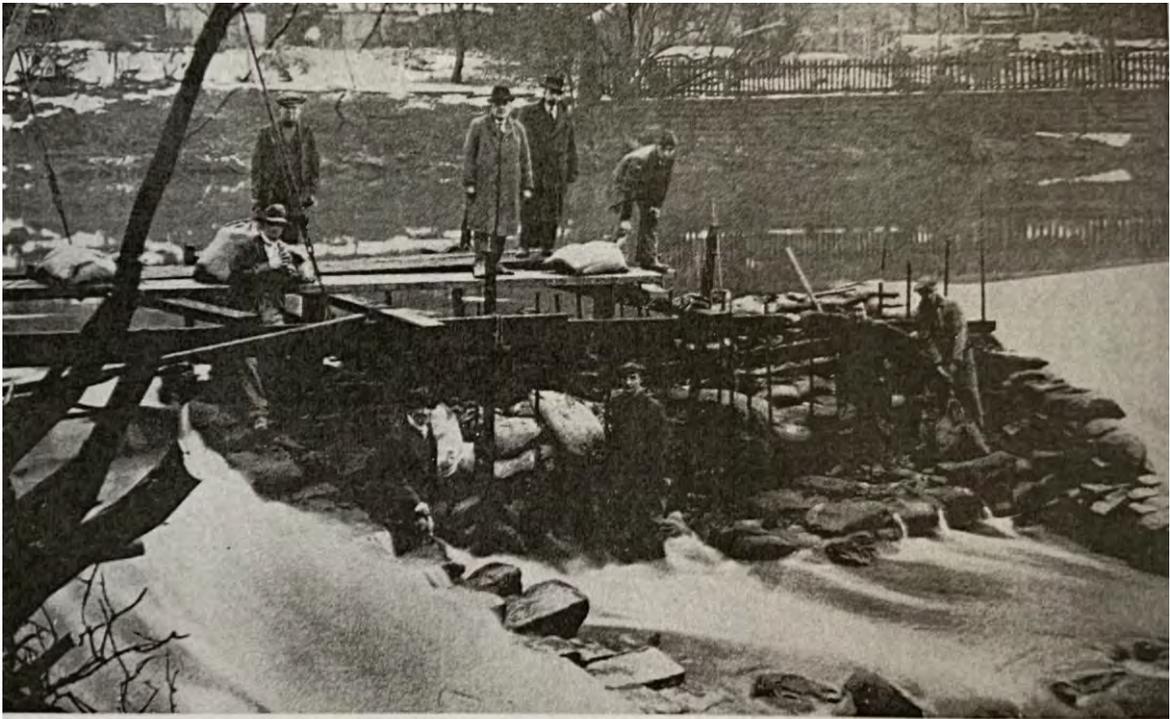
Figure 2 Photograph of repairs undertaken on Newlay Weir in 1938

In 1938, repairs were made to the weir (Figure 2) but little else is known about the weir during the intervening years. The reasons for the repairs undertaken in 1938 are not known, but it is thought that the repair included the replacement of stone setts with concrete on the right side of the weir, looking downstream.

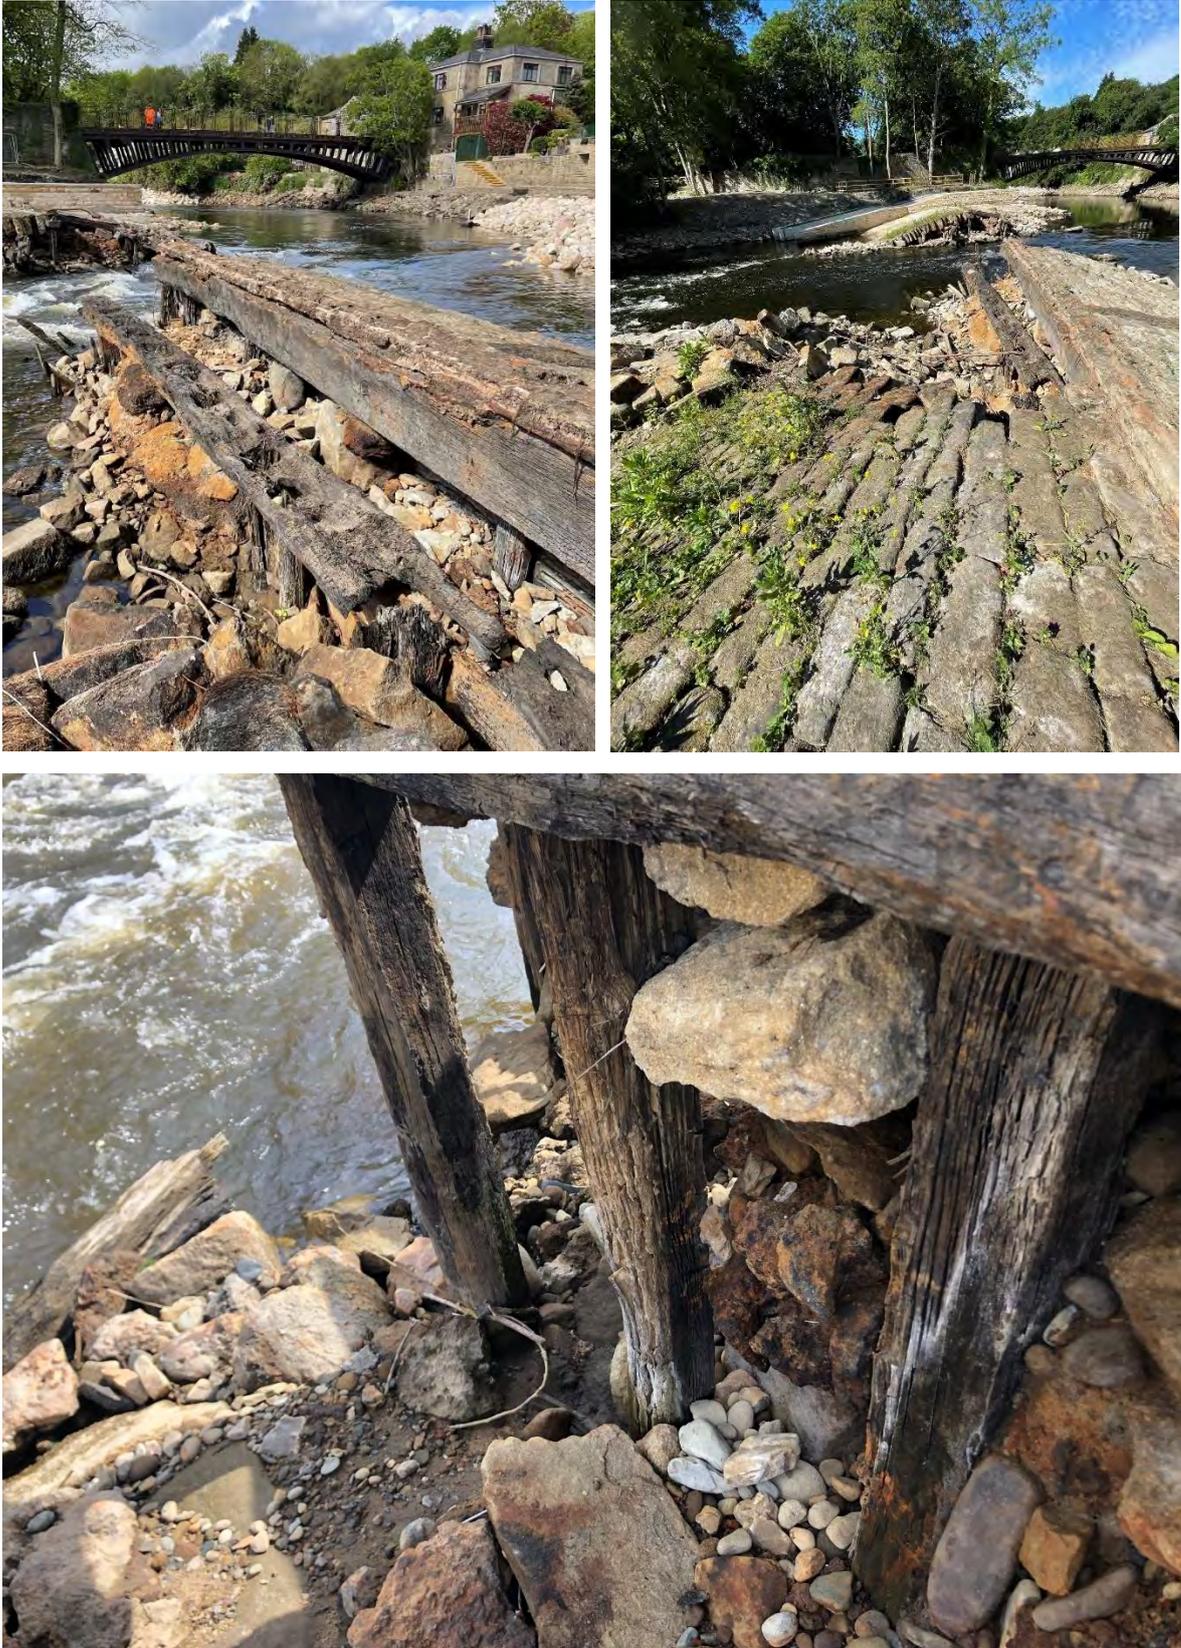
Figure 11 Images of the collapsed Newlay Weir - 11/05/2021

Observations made by Arup’s structural engineer on the site visit concluded that for the age of the weir, the timber frame was in fair condition, but there were signs of failed timber connections between the vertical and horizontal timbers where the breach had occurred, and

the structure was exposed to the flow of the river. The main timber crest was still intact away from the breach (Figure 11). This shows that the main vertical timber piles still have enough capacity to withstand the forces acting on the weir. It is unknown if the timber crest at the breach location was still in fair condition prior to the breach. However, according to the AECOM report (2018), the crest of the weir appeared to be level.

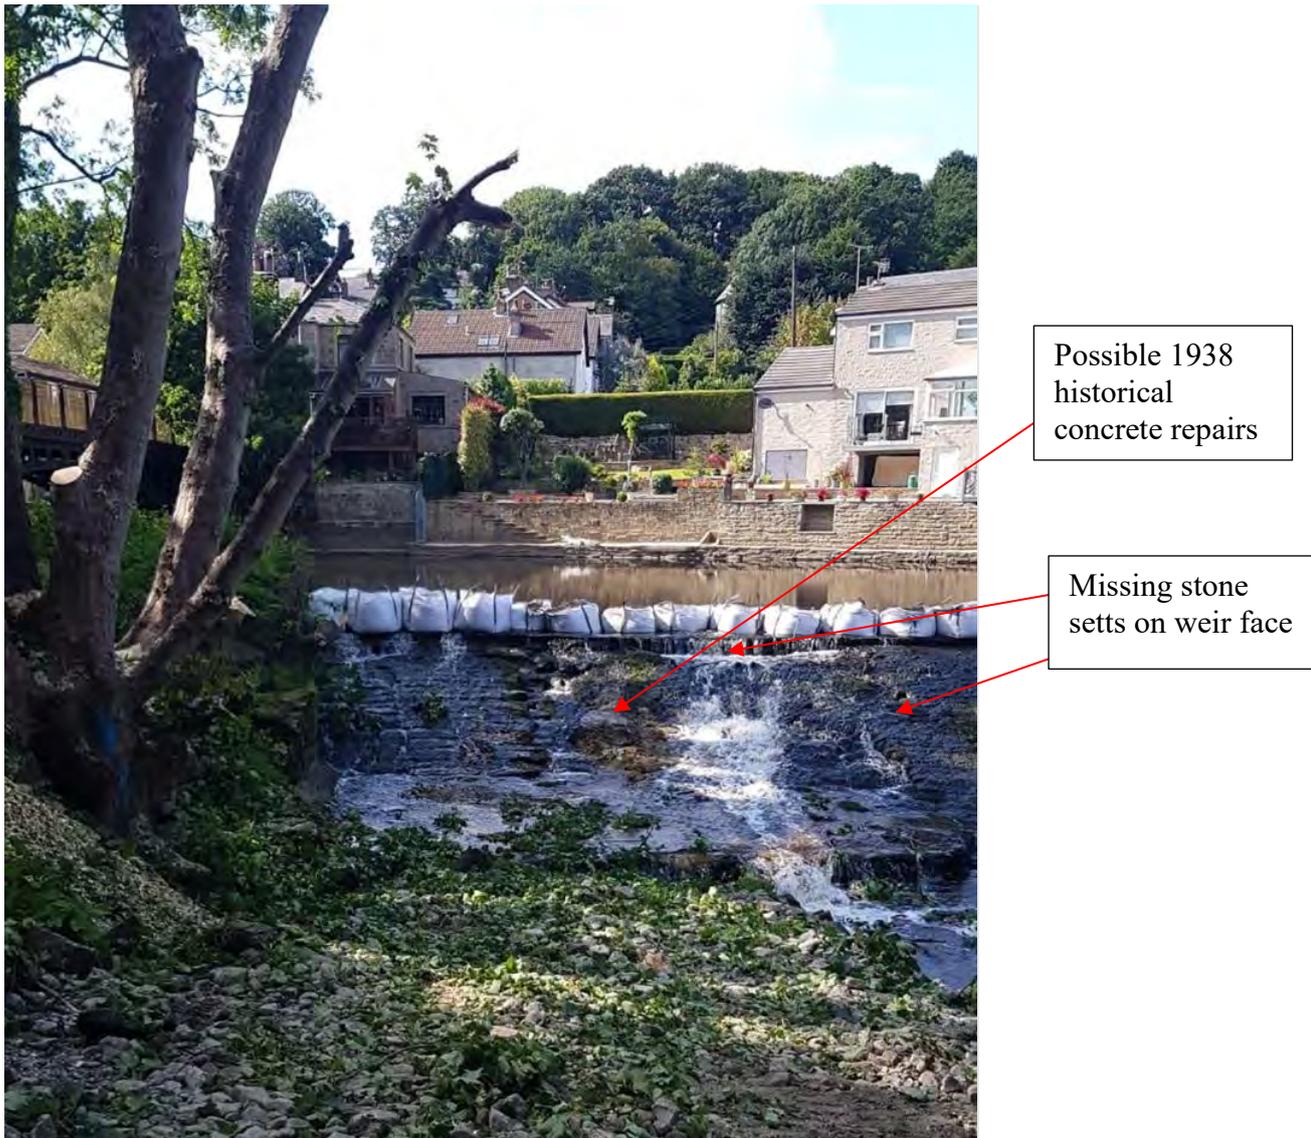
Figure 14 Sand bags placed on weir to allow access (taken by the Environment Agency)

Figure 13 and Figure 14 show sand-filled bulk bags, placed at the crest of weir to reduce the river flow in the location of the proposed fish pass. The low flow at the time of these photographs reveals detail of the condition of the weir that is not evident from the 2018 AECOM structural inspection or the Fishtek 2020 pre-condition photographic survey.

Masonry stone setts extend to the right bank, but there are missing stone setts on the downstream face between approximately 3m to 8m from the right bank. Concrete infill repair is evident at approximately 4m from the right bank and is thought to relate to historical repairs in 1938. Deterioration of the weir is evident through missing stone setts on the downstream face, approximately 5m from the right bank between the stone setts and the concrete repair. This is in the area mentioned in the Fishtek pre-condition survey. Loss of stone setts at the top of the downstream face is also evident.

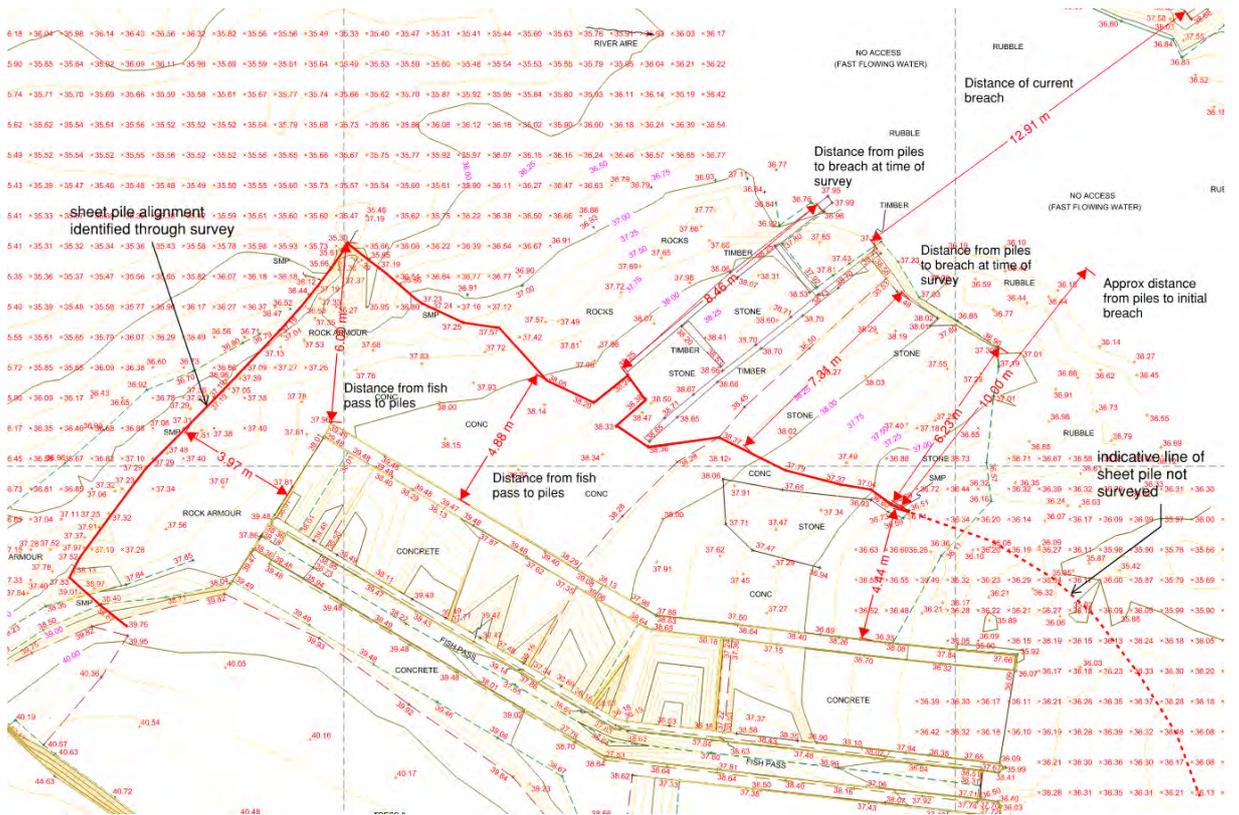
Figure 22 Sheet pile location in relation to breach

The closest pile at the toe of the downstream face to the breach at the time of the survey was 6.23m but photographic evidence from section 6 indicates that the initial breach was further into the channel; estimated to be 10m from the closest pile as shown in Figure 22.

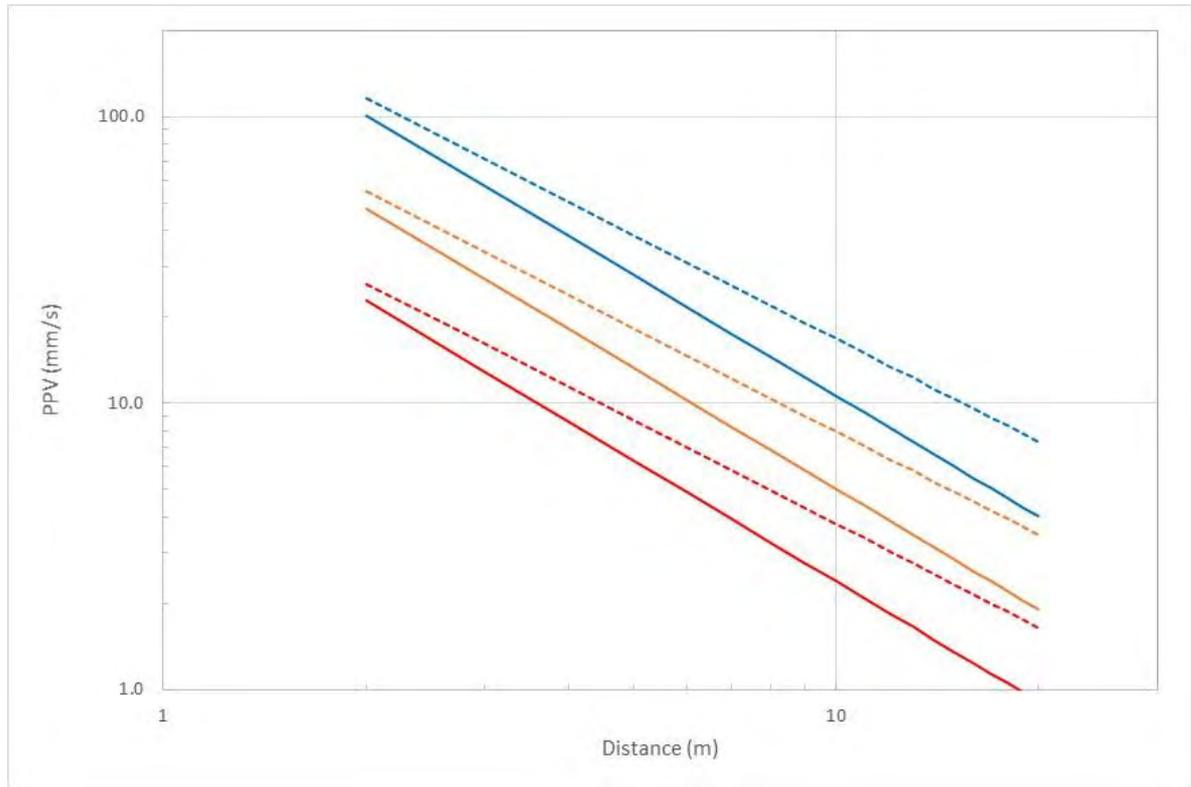
Figure 23 Predicted PPV during pile driving

Figure 23 assumes balanced eccentric moment (solid lines) and out of balance during start up / run down (broken lines) for three levels of probability that the level could be exceeded (50% red; 33% amber; 5% blue). Assuming the failure was initiated approximately 10m from the closest pile, Table 1 shows the PPVs that may have occurred.

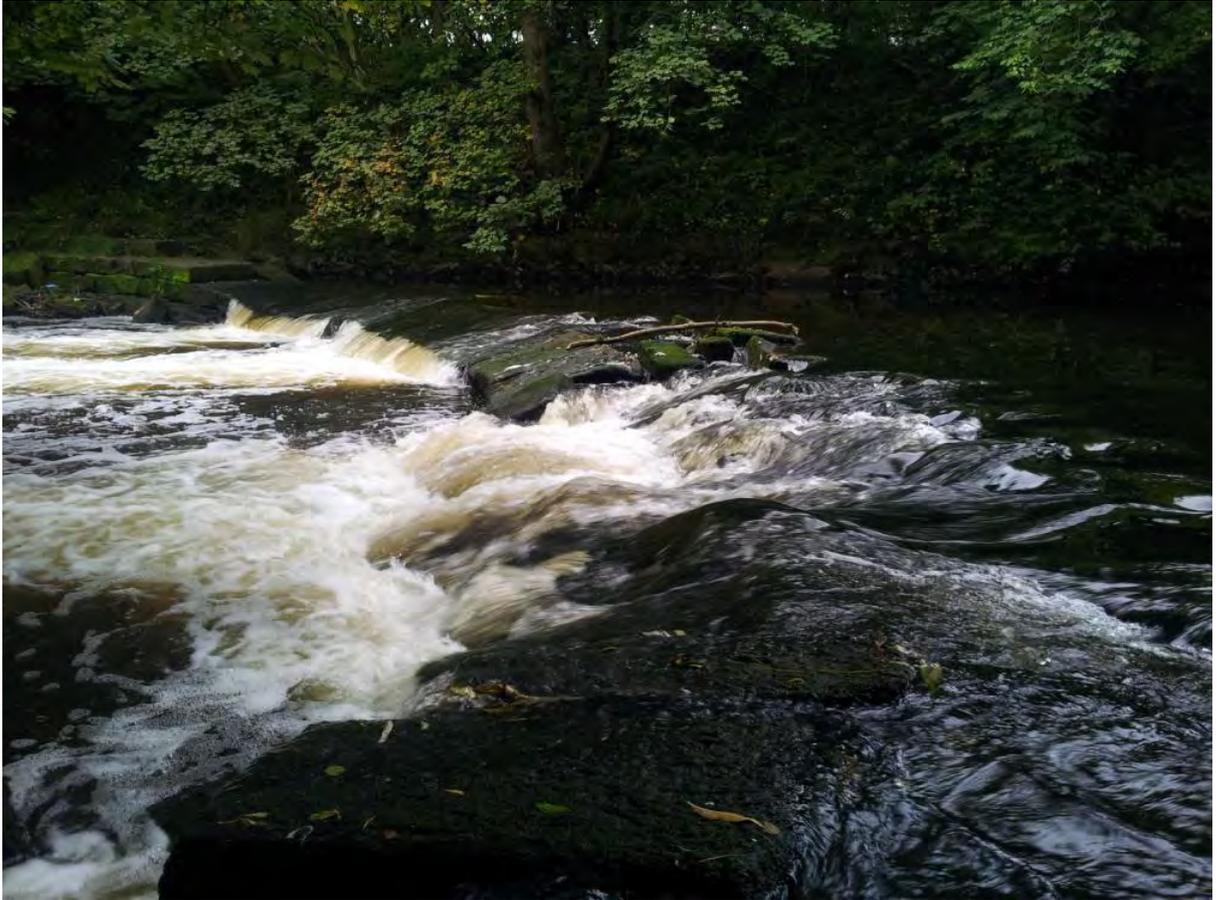
Figure 33 Newlay Weir Lower in 2014 showing the partial collapse of the structure

The partially collapsed Newlay Weir Lower was removed in 2015. A contemporary report^[19], written before the removal, acknowledged an unlikely but medium impact risk to infrastructure, a probable but minor impact risk relating to tree loss, bank collapse and knickpoint migration, and a likely but minor impact risk to a reduction in upstream water levels, velocity and erosion increase, and downstream sediment deposition. However, the report did note that there was no evidence of the banks adjusting as a result of the reduction in water levels caused by the partial collapse.

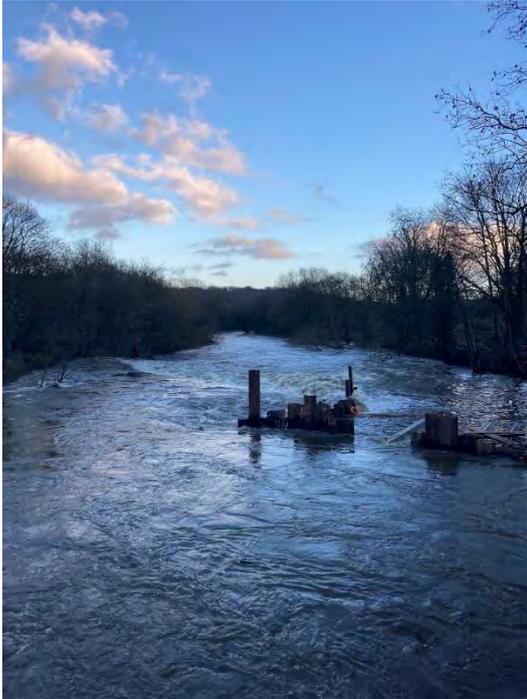
Figure 45 Photo taken on 7th February (public survey photo)

restricting flows and increasing turbulence, redirecting flows towards the centre of the channel.

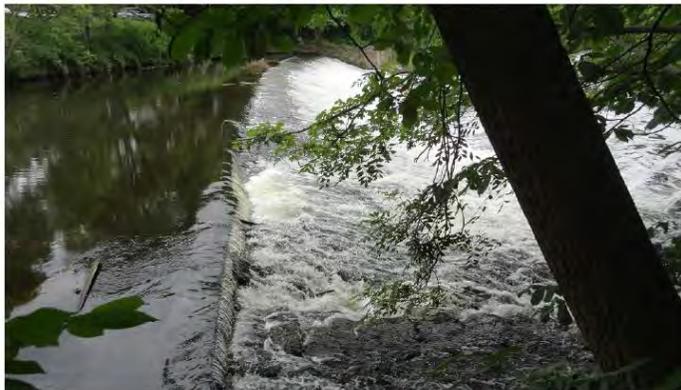
Photograph 4.5 : View of top weir block at proposed fish pass, buckled line of blocks

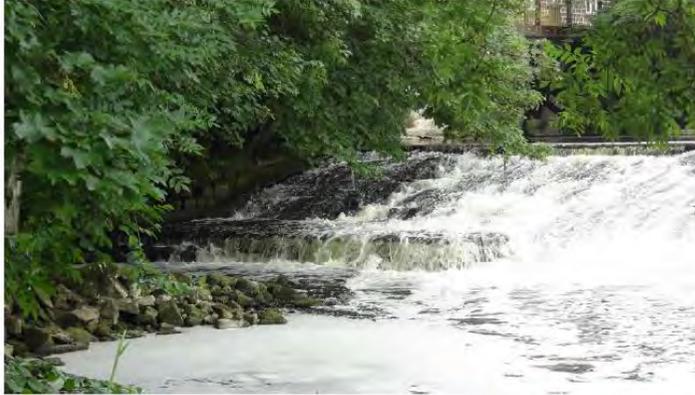
Photograph 4.6 : View of right hand bank chute slope, eroded surface d/s of buckled weir

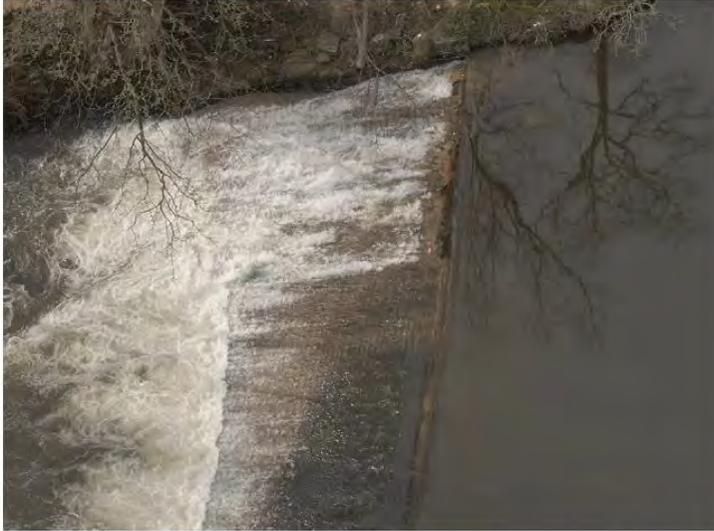
Figure 14: Condition of weir, aeration on weir face could indicate damage - Annotation 2020-04-21 100917.

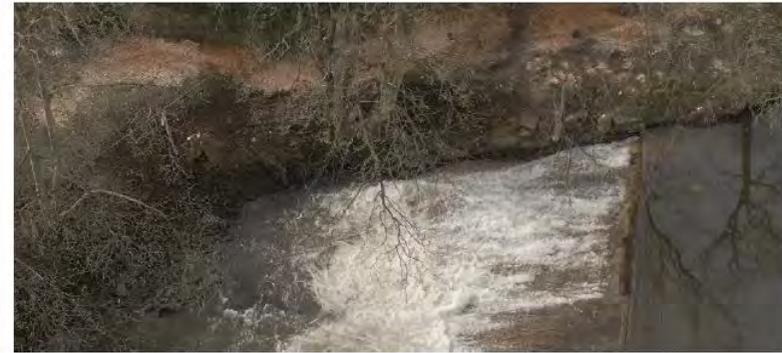
Figure 15: View of river wall, irregular patterns locations of wall collapses - Annotation 2020-04-21 101010.
