Wessex Water Services Limited

Trowbridge Bioresources Centre

CIRIA 736 IED Report - Secondary Containment Assessment

Addendum to Environmental Permit Application (Ref: EPR/BB3934AG)

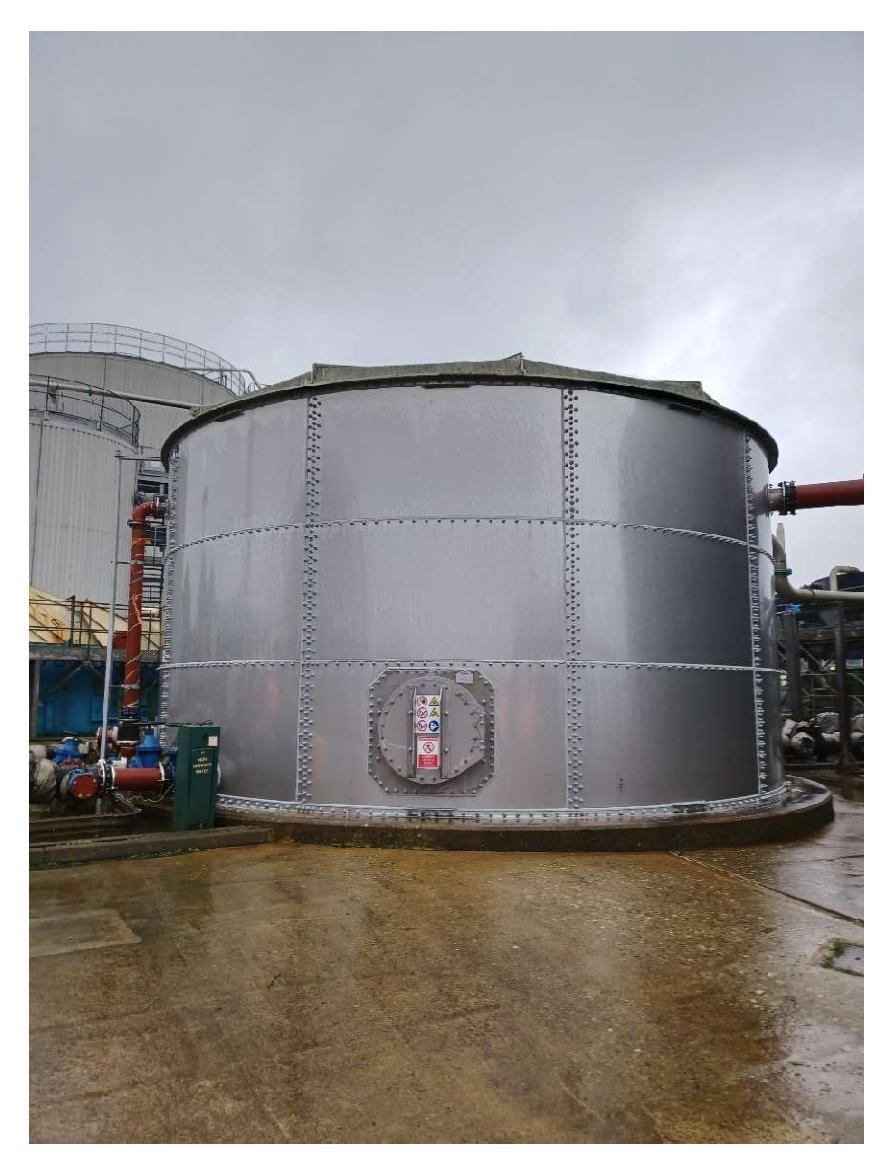
Figure 8.1 Sludge Reception Tank

| Table 8.1 Trowbridge BC Sludge Storage Tanks and Sludge Reactor Tanks Overview | | | | | | | | | | |
|--|---|--|---|--|--|--|---|--|--|--|
| General condition | Excellent overall condition with no visible defects | xcellent overall ondition with no visible defectsWeathered with patch repairs and presence of emerging corrosion holes at typical sludge air interface levels – further repair works recommended to maintain long term serviceability. Recently completed tank inspectionWeathered repairs of ellipsic hole air further repairs of ellipsic hole air further repairs wisible | | Weathered with presence of emerging corrosion holes at typical sludge air interface levels. further repair works recommended to maintain long term serviceability. | Cladding over the tanks is in good condition and no visible leaks. Tank inspections are planned to verify external and internal condition. | Cladding over the tanks is in good condition and no visible leaks. Tank inspections are planned to verify external and internal condition. | Good overall condition. Tanks are drained every year for inspection. | Weathered but extent unknown. Internal tank inspection to be completed. | | |

| | Table 8.1 Trowbridge BC Sludge Storage Tanks and Sludge Reactor Tanks Overview | | | | | | | | | |
|--|---|---|---|---|--|--|--|--|--|--|
| Surrounding surface conditions | The immediate ground is impermeable (reinforced concrete). Occasional visible superficial cracks in the concrete, and vegetation at joints. There is a patch of grass in proximity. | The immediate ground is impermeable (reinforced concrete). Occasional superficial cracks in the concrete. | The immediate ground is impermeable (reinforced concrete). Occasional visible superficial cracks in the concrete and vegetation | The immediate ground is impermeable (reinforced concrete) with some permeable gravelled areas | All APD vessels are located on a reinforced concrete slab with reinforced concrete surround. | Varying ground conditions – reinforced concrete slab and surround with patches of gravelled areas. | Permeable gravelled area surrounding the tank. Patches of reinforced concrete in proximity. | Permeable gravelled surface surrounding the tanks. | | |
| Secondary Containment provision to Ciria 736. | None. The impermeable ground surrounding the tank. The tank has been replaced in 2021 with a Stainless Steel tank, which is more resilient. Process safeguards implemented. | None. The impermeable ground surrounding the tank. Process safeguards implemented. | None. The impermeable ground surrounding the tank. Process safeguards implemented. | None. The impermeable ground surrounding the tank. Process safeguards implemented. | None. The impermeable ground surrounding the tank. Process safeguards implemented. | None. Immediate ground conditions are impermeable, bollards are installed around both tanks, and process safeguards are implemented. | None. Process safeguards implemented. Routine inspection of the tanks. | None. Process safeguards implemented. | | |

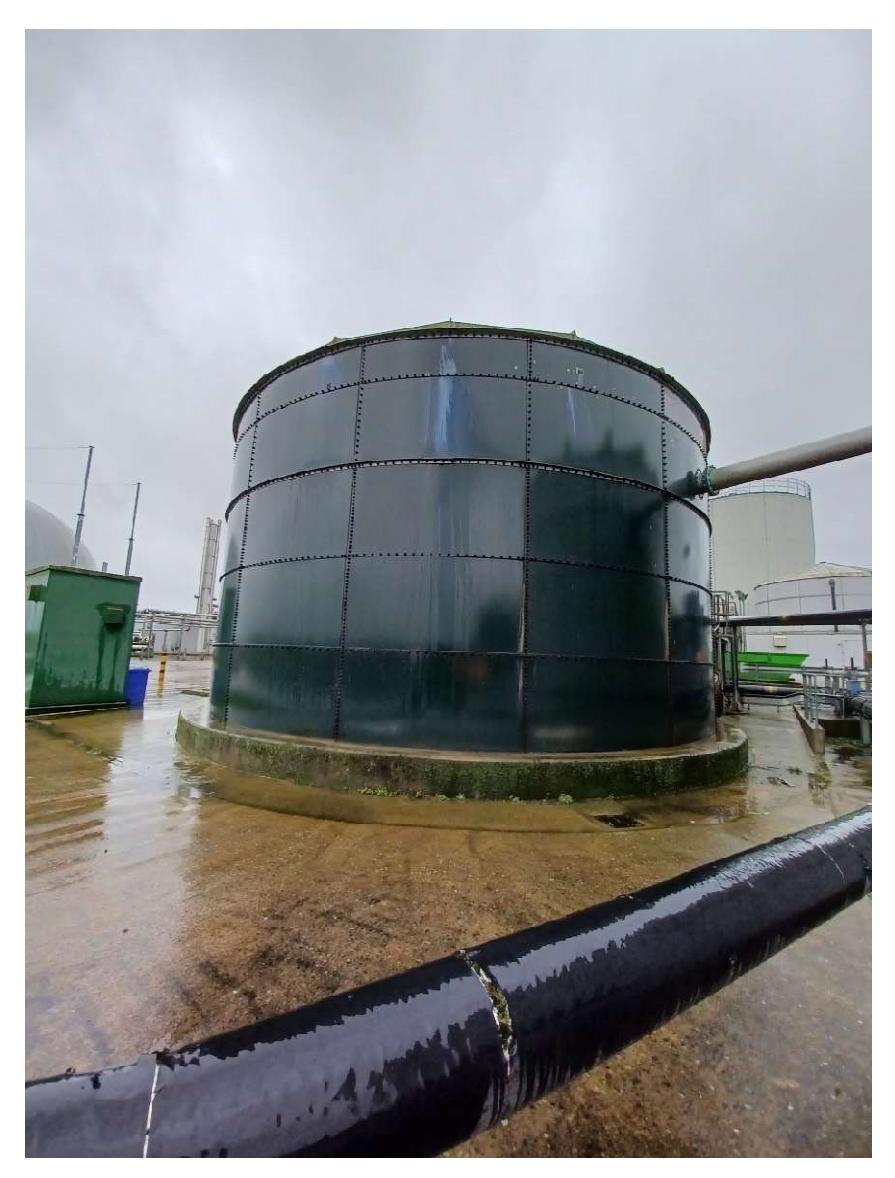
Figure 8.3 Pre-Thickened Storage Tank 1

| Asset ID | Asset Name | Material | Condition | Catastrophic Loss of Containment Frequency Risk in Line with CIRIA 736 Method | Probability of Catastrophic Failure in Line with CIRIA 736 Method | Comments |
|---|---|---|---|---|--|---|
| с | Pre-Thickened Storage Tank 1 | Glass Coated Steel | Moderate | М | Marginal or partial loss of containment scenarios will have a probability of occurrence closer to | Tanks subject to technical supervision during installation and wa Assets are 10 years old, therefore full internal inspection and su with manufacturer's recommendations. Simple operation to store and maintain homogenous sludge mix Moderate condition and moderately resilient material to corrosio High level overflow physical safeguard is in place. Control inhibit Ability to isolate and internally inspect the asset. |

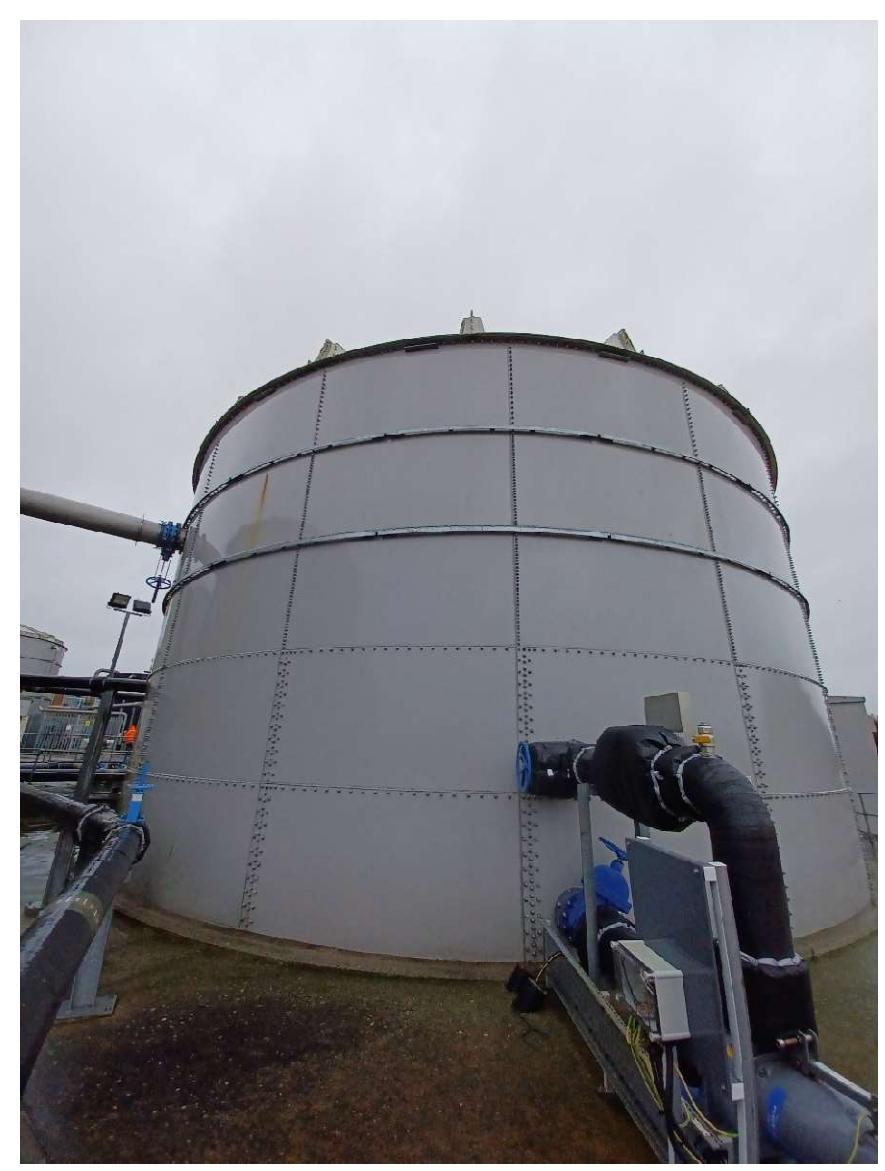
Figure 8.5 Pre-Thickened Storage Tank 2

| Asset ID | Asset Name | Material | Condition | Catastrophic Loss of Containment Frequency Risk in Line with CIRIA 736 Method | Probability of Catastrophic Failure in Line with CIRIA 736 Method | Comments |
|---|---|---|---|---|--|---|
| D | Pre-Thickened Storage Tank 2 | Glass Coated Steel | Moderate | М | 1:100 years. Catastrophic loss of containment scenarios, linked to global stability, natural or man-made | Demonstration of previous maintenance in response to corrosio corrosion observed. Tank is offset from vehicle routes. Low level pipework present over impermeable surfacing. Marginal loss of containment possible due to corrosion pin holes maintained. Partial loss of containment possible due to operator error with lo rectified. |

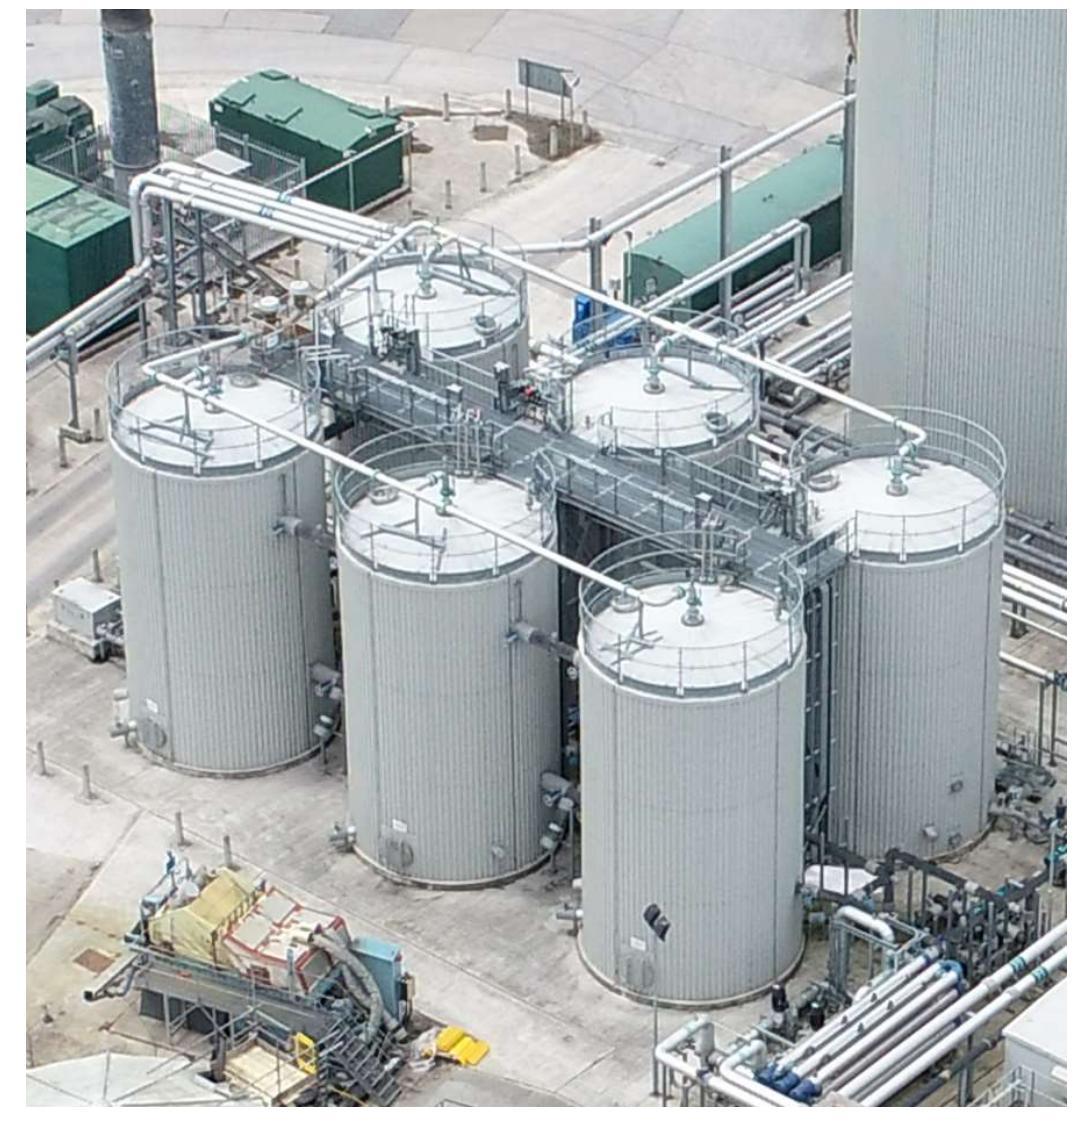
Figure 8.9 APD Plant

| Asset ID | Asset Name | Material | Condition | Catastrophic Loss of Containment Frequency Risk in Line with CIRIA 736 Method | Probability of Catastrophic Failure in Line with CIRIA 736 Method | Comments |
|---|---|---|---|---|--|--|
| H1-H6 | Acid Phase Digesters | Glass Coated Steel, bitumen internal liner | Moderate | М | In line with CIRIA 736, all of the assets lie between the 1% (1 in 100) and 0.001% (1 in 1 million) Less than 0.001% (1 in 1 million) (moderate risk) category. | Tanks subject to technical supervision during installation and wa Relatively complex operation to hydrolyse and digest sludge so subsequent overtopping, or under-pressurisation become credib maintained, and other protection safeguards fail. Presence of biogas means explosion and short-lived flame in the instances when multiple safeguards fail. Assets are 10 years old, therefore full internal inspection and sul Anti-foaming dosing in place manually and no history of foaming Material with inclusion of internal bitumen liner is very resilient to External cladding may increase risk of external corrosion. High level overflow physical safeguards are in place. Control inh Isolation and internal inspection of asset requires temporary shu |

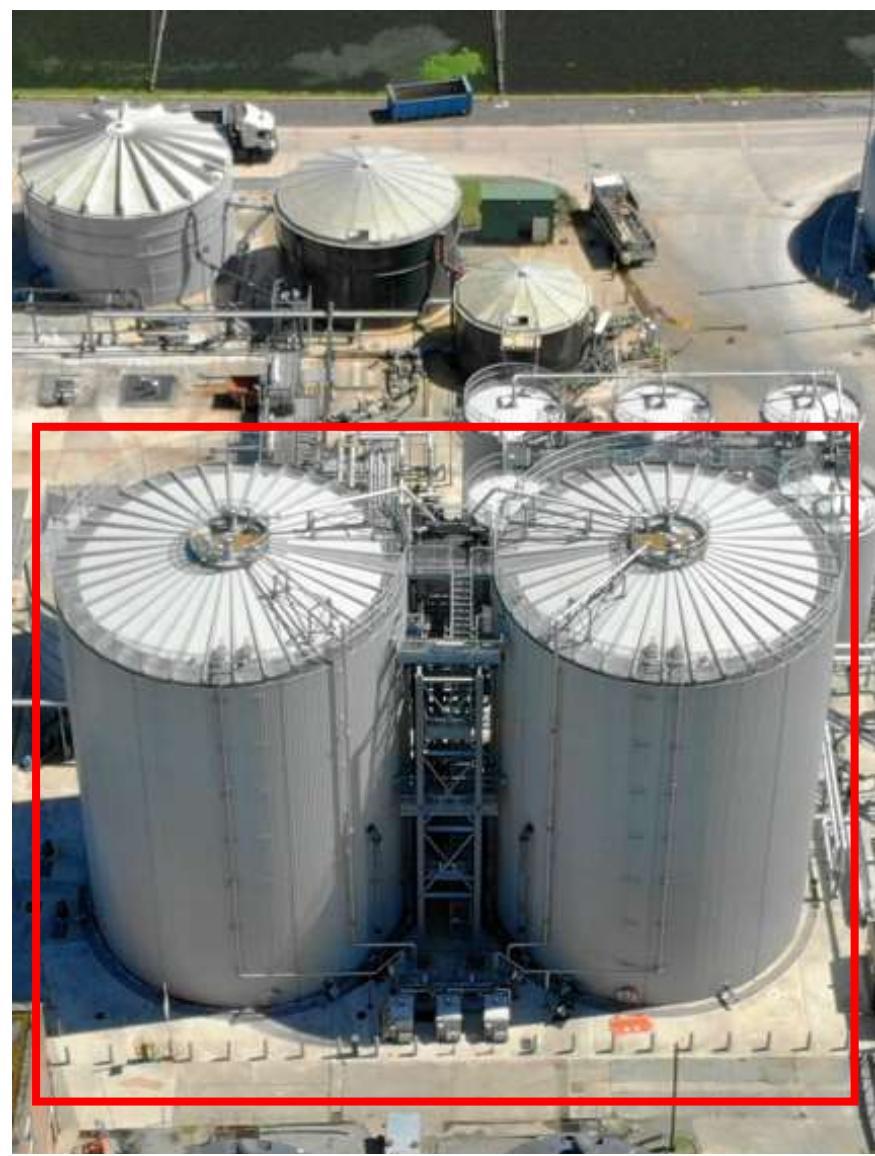
Figure 8.11 Mesophilic Digesters

A rapid and complete loss of containment would be reasonably expected for a glass coated steel digester (pressurised) tank which has exceeded its design life and is showing clear signs of severe corrosion and fatigue.
