ECOLOGICAL REPORT

Preliminary Bat Survey - Oxford Flood Alleviation Scheme (FAS)

Environment Agency

November 2016

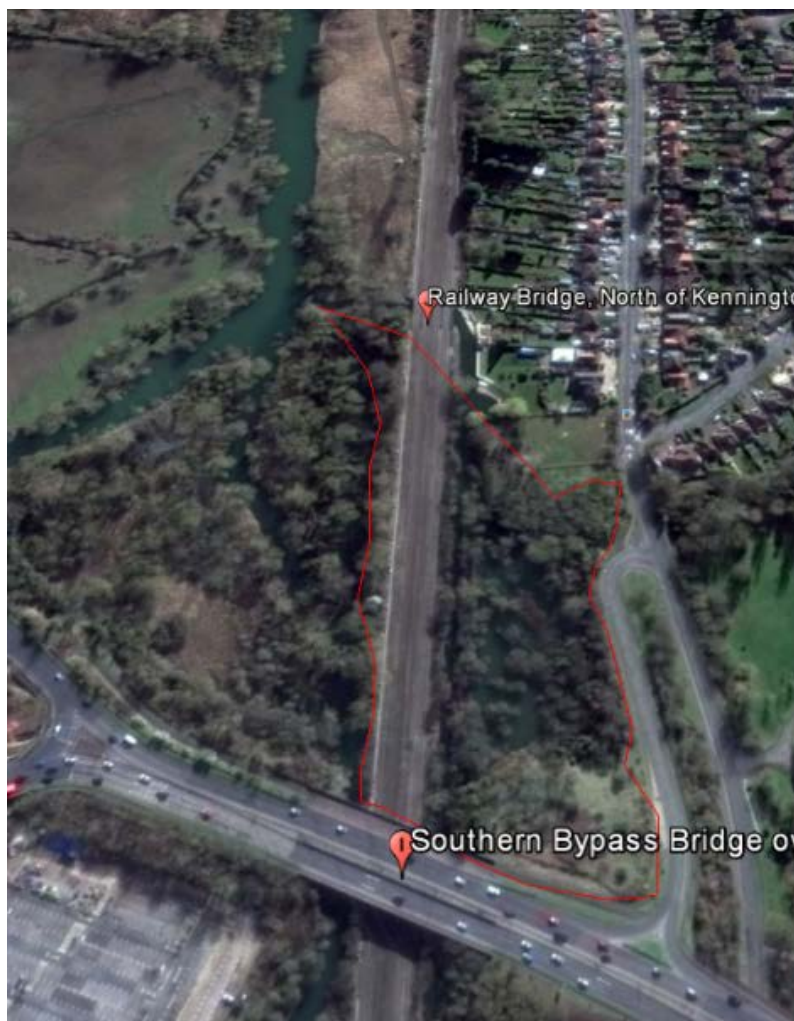
Figure 1. Area not surveyed

One area, shown on Map 5 in Appendix 1 and illustrated in Figure 1 below, was not accessible at the time of the survey, due to its location between the river, road and rail corridors. It is recommended that this area be subject to further inspection by an experienced bat worker, should vegetation removal or increased levels of noise and vibration be anticipated as a result of the proposed works. Such an assessment will require special access consent from network rail as it lies adjacent to the operational corridor. Boat access may also be required for some of the trees. Felling works were underway in this location at the time of surveys and so access was not permissible during the survey window.

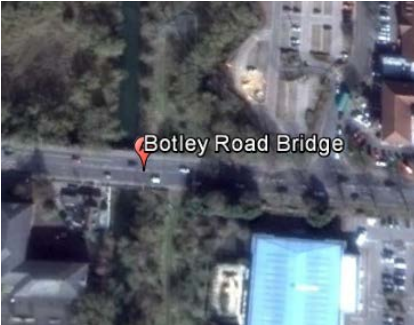
Name of structure or building	Description & Access Details	Suitability for bats	Recommendations for further surveys
<p>A. Botley Road</p>

<p>Concrete Road bridge over the River Isis to the south of Sea Court Car park located at Grid reference: SP 49066 06299.</p> <p>Operated by Oxford Council Highways Department. County Hall, New Road, Oxford, OX1 1ND. Tel.</p> <p>Access to the south of this feature is restricted and will be required by boat or access from 3rd party land ("Richer Sounds" building see below).</p> <p>Access to the north of the structure can be achieved from the road corridor.</p> <p>Work adjacent to water course will require applicable safety precautions life jacket throw rope etc.</p>	<p>Moderate</p> <p>Several gaps and crevices in structure which could be utilised by bats due to their size, protection and surrounding riverine corridor.</p> <p>No evidence of bat use noted during inspection but inspection restricted by features river corridor position.</p>	<p>Should works to this bridge be required as part of the project, particularly those that would alter the underside of the structure over the river corridor or which would result in increased levels of light, noise or vibration or exposure to higher water levels, then it is recommended that two separate emergence/re-entry survey visits. One dusk emergence and a separate dawn re-entry survey, be undertaken between May and September with at least one of surveys between May and August. The surveys should be undertaken by two surveyors positioned either side of the bridge and ideally on a boat or pontoon so that their view of the structure is not obscured.</p>

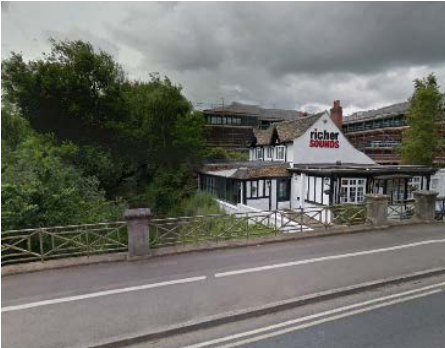
<p>B. 1 West Way Richer Sounds Building</p>

<p>Brick and timber framed building with a tiled pitched roof immediately adjacent to the river corridor. Several gaps and crevices providing suitable roosting habitat noted on river side of building.</p> <p>Operated by Richer Sounds, 1 West Way, Botley Road, Oxford. OX2 0JB. Tel: 0333 900 0052.</p> <p>Grid Reference: SP 49066 06299.</p>	<p>Moderate</p> <p>Several gaps and crevices in structure which could be utilised by bats due to their size, protection and surrounding riverine corridor.</p> <p>No evidence of bat use noted during inspection but inspection restricted as property owner was on holiday.</p>	<p>Should works to this building be required as part of the project, particularly those that would alter the underside of the structure over the river corridor or which would result in increased levels of light, noise or vibration or exposure to higher water levels, then it is recommended that two separate emergence/re-entry survey visits. One dusk emergence and a separate dawn re-entry survey, be undertaken between May and September with at least one of surveys between May and August. A minimum of 3 surveyors will be required to adequately survey this structure.</p>

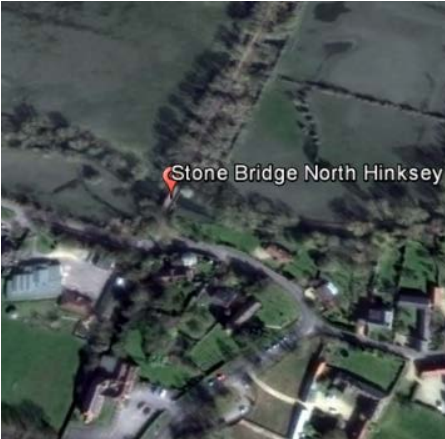
<p>C. Stone Bridge, North Hinksey Village</p>

<p>A stone and brick bridge which carries a public right of way (Willow Walk) over Hinksey stream.</p> <p>Operated by Oxford Council Highways Department. County Hall, New Road, Oxford, OX1 1ND. Tel.</p> <p>Access to the south of this feature is restricted and will be required by boat or access from 3rd party land</p> <p>Work adjacent to water course will require applicable safety precautions life jacket throw rope etc.</p> <p>Grid Reference: SP 49477 05578</p>	<p>Moderate</p> <p>Several gaps and crevices in structure which could be utilised by bats due to their size, protection and surrounding riverine corridor.</p> <p>No evidence of bat use noted during inspection but inspection restricted to those arches on dry land.</p>	<p>Should works to this bridge be required as part of the project, particularly those that would alter the underside of the structure over the river corridor or which would result in increased levels of light, noise or vibration or exposure to higher water levels, then it is recommended that two separate emergence/re-entry survey visits. One dusk emergence and a separate dawn re-entry survey, be undertaken between May and September with at least one of surveys between May and August. The surveys should be undertaken by two surveyors positioned either side of the bridge and ideally on a boat or pontoon so that their view of the structure is not obscured. Positioned either side of the bridge and ideally on a boat or pontoon so that their view of the structure is not obscured.</p>

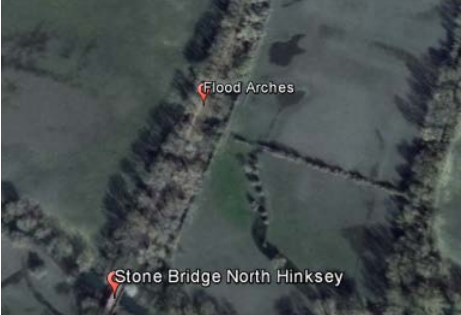
<p>D. Flood arches north of stone bridge</p>

<p>Concrete flood arches under public right of way. Located to the north of the stone bridge.</p> <p>Grid Reference: SP 49576 05685 and SP 49592 05708</p>	<p>Low</p> <p>Low number of potential roost sites but good surrounding habitat meaning use as a roost feature is potential.</p> <p>No evidence of bat use noted during inspection but inspection restricted for arches of the bridge over the river corridor.</p>

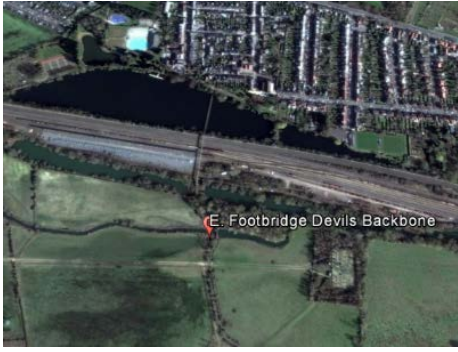
Name of structure or building	Description & Access Details	Suitability for bats	Recommendations for further surveys
<p>E. Footbridge Devils Backbone</p>

<p>Footbridge carrying Public Right of Way over Hinksey Stream Grid reference: SP 51182 04454</p>	<p>Moderate</p> <p>Several gaps and crevices in structure which could be utilised by bats due to their size, protection and surrounding riverine corridor.</p> <p>No evidence of bat use noted during inspection but inspection restricted to those arches on dry land.</p>	<p>Should works to this bridge be required as part of the project, particularly those that would alter the underside of the structure over the river corridor or which would result in increased levels of light, noise or vibration or exposure to higher water levels, then it is recommended that two separate emergence/re-entry survey visits. One dusk emergence and a separate dawn re-entry survey, be undertaken between May and September with at least one of surveys between May and August. The surveys should be undertaken by two surveyors positioned either side of the bridge and ideally on a boat or pontoon so that their view of the structure is not obscured.</p>

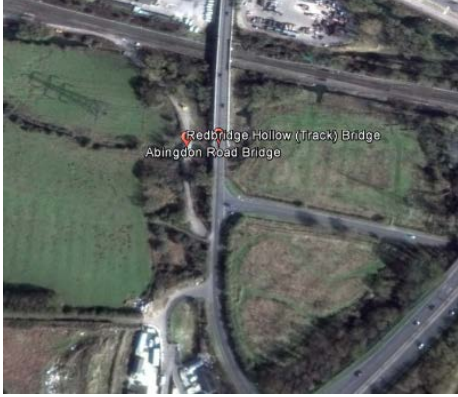
<p>F. Abingdon Road Bridge (Red Bridge)</p>

<p>Local Authority Road Bridge carrying Abingdon Road over stream. Operated by Oxford Council Highways Department. County Hall, New Road, Oxford, OX1 1ND. Tel. Grid Reference: SP 51652 03701</p>	<p>Moderate</p> <p>Several gaps and crevices in structure which could be utilised by bats due to their size, protection and surrounding riverine corridor.</p> <p>No evidence of bat use noted during inspection but inspection restricted due to elevated height and water corridor.</p>	<p>Should works to this bridge be required as part of the project, particularly those that would alter the underside of the structure over the river corridor or which would result in increased levels of light, noise or vibration or exposure to higher water levels, then it is recommended that two separate emergence/re-entry survey visits. One dusk emergence and a separate dawn re-entry survey, be undertaken between May and September with at least one of surveys between May and August. The surveys should be undertaken by two surveyors positioned either side of the bridge and ideally on a boat or pontoon so that their view of the structure is not obscured.</p>

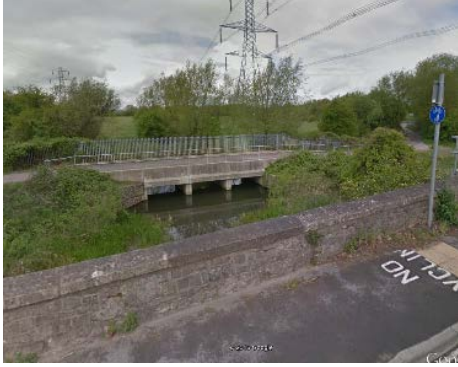
<p>G. Redbridge Hollow (Track) Bridge</p>

<p>Stone and concrete bridge carrying access track over stream. Grid Reference: SP 51636 03717</p>	<p>Moderate</p> <p>Several gaps and crevices in structure which could be utilised by bats due to their size, protection and surrounding riverine corridor.</p> <p>No evidence of bat use noted during inspection but inspection restricted due to water corridor.</p>	<p>Should works to this bridge be required as part of the project, particularly those that would alter the underside of the structure over the river corridor or which would result in increased levels of light, noise or vibration or exposure to higher water levels, then it is recommended that two separate emergence/re-entry survey visits. One dusk emergence and a separate dawn re-entry survey, be undertaken between May and September with at least one of surveys between May and August. The surveys should be undertaken by two surveyors positioned either side of the bridge and ideally on a boat or pontoon so that their view of the structure is not obscured.</p>

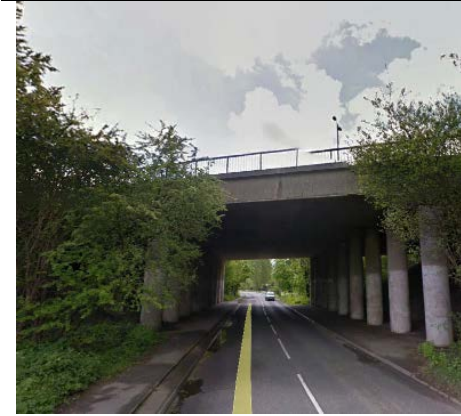
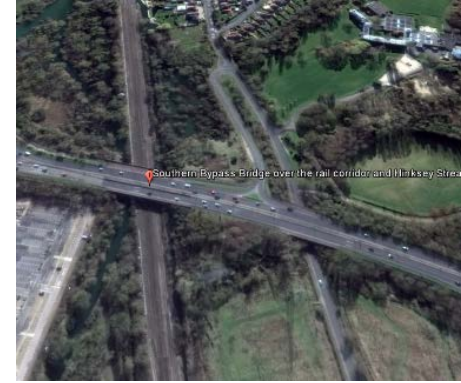
<p>I Southern Bypass Bridge over the rail corridor and Hinksey Stream</p>

<p>Concrete Road Bridge Carrying Southern bypass A423 over rail corridor and Hinksey Stream</p> <p>Grid reference: SP 51874 03506</p>	<p>Moderate</p> <p>Several gaps and crevices in structure which could be utilised by bats due to their size, protection and surrounding riverine corridor.</p> <p>No evidence of bat use noted during inspection but inspection restricted due to water corridor.</p>	<p>Should works to this bridge be required as part of the project, particularly those that would alter the underside of the structure over the river corridor or which would result in increased levels of light, noise or vibration or exposure to higher water levels, then it is recommended that two separate emergence/re-entry survey visits. One dusk emergence and a separate dawn re-entry survey, be undertaken between May and September with at least one of surveys between May and August. The surveys should be undertaken by four surveyors positioned either side of the bridge and ideally on a boat or pontoon so that their view of the structure is not obscured. Access to the site is restricted by the rail corridor.</p>

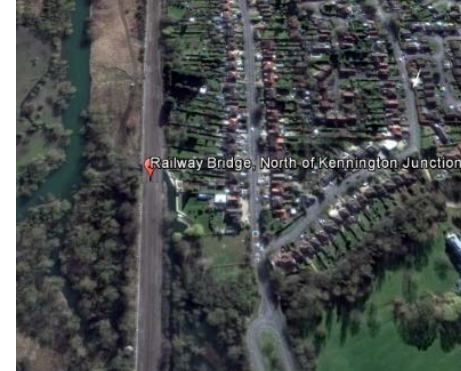
<p>J. Railway Bridge over water course North of Kennington Junction</p> <p>Rail bridge carrying railway over tributary to Hinksey Stream. Access restricted by live railway corridor.</p> <p>Grid Reference: SP 52007 03236</p>	<p>Moderate</p> <p>Several gaps and crevices in structure which could be utilised by bats due to their size, protection and surrounding riverine corridor.</p> <p>No evidence of bat use noted during inspection but inspection restricted due to water corridor.</p>	<p>Should works to this bridge be required as part of the project, particularly those that would alter the underside of the structure over the river corridor or which would result in increased levels of light, noise or vibration or exposure to higher water levels, then it is recommended that two separate emergence/re-entry survey visits. One dusk emergence and a separate dawn re-entry survey, be undertaken between May and September with at least one of surveys between May and August. The surveys should be undertaken by four surveyors positioned either side of the bridge and ideally on a boat or pontoon so that their view of the structure is not obscured. Access to the site is restricted by the rail corridor.</p>
