Hoveton Wetlands Restoration WFD Compliance Assessment

June 2014

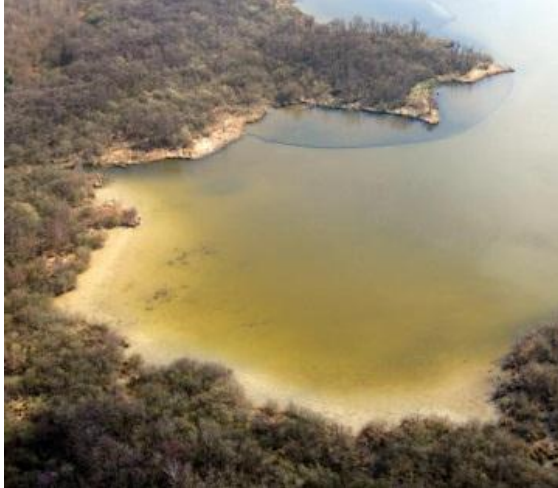
Figure 1. Aerial photo of HGB taken in 2013. Note turbid water and limited macrophytes. (from NE leaflet 'Hoveton Wetlands Restoration Project')

The creation of species-rich fen using the dredged sediment and geobags will occur in areas where there is currently little marginal vegetation and degrading banks (Figure 1.). Geobags will be used to re-profile the banks approximately back to an historical profile using aerial photography from the 1940's (Figure 2.) The geobags are filled with the dredged sediment and capped with fen vegetation to create a retaining wall. The void behind the wall and the existing bank is filled with sediment. Planting and natural colonisation will occur overtime to create a natural looking bank with marginal aquatic vegetation. A similar scheme in neighbouring Salhouse Broad has shown almost immediate results with macrophyte species colonising the newly created fen. The movement of sediment in and around the broad may increase turbidity and nutrient levels due to suspension of organic sediment but this impact will only be temporary.

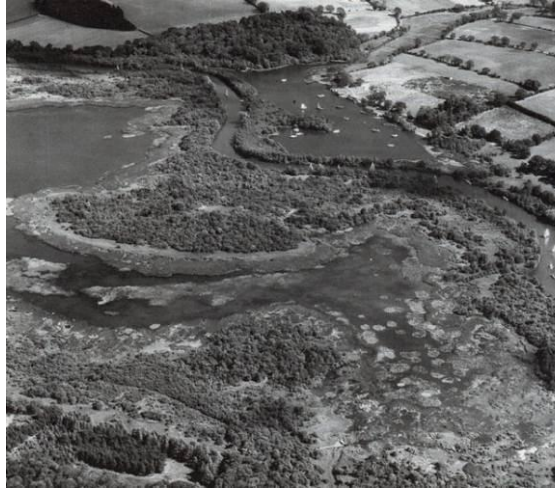
Figure 2. Aerial photo of HGB taken in 1949. Note extensive submerged macrophyte growth. (from NE leaflet 'Hoveton Wetlands Restoration Project')
