# Trent Valley IDB Main River Maintenance

**Service Plan**  
**Map Ref: 4110-1**  
**Watercourse: Cocker Beck**

**Map Ref: 4110 - 2  
Cocker Beck  
Bridge & Debris Run**

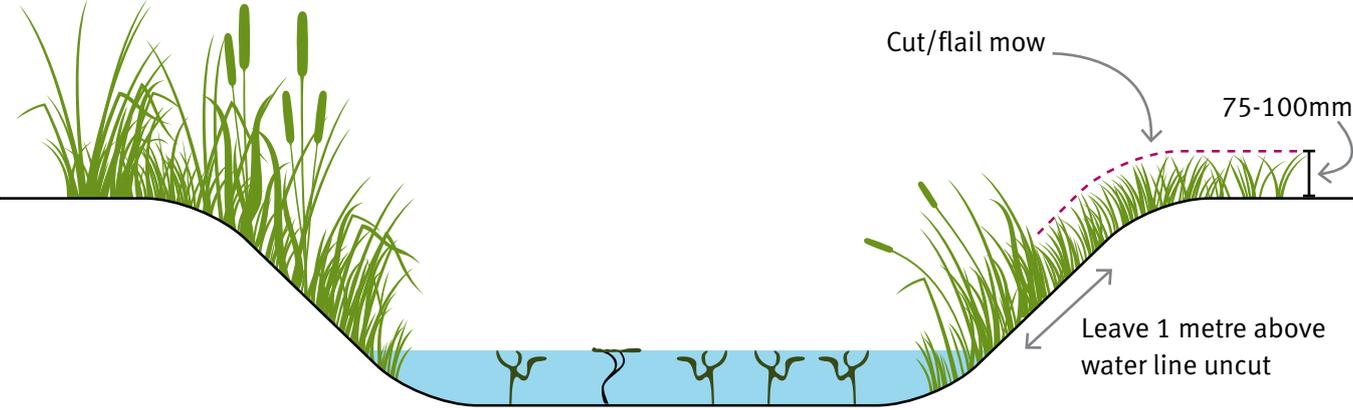
Annual maintenance this side only

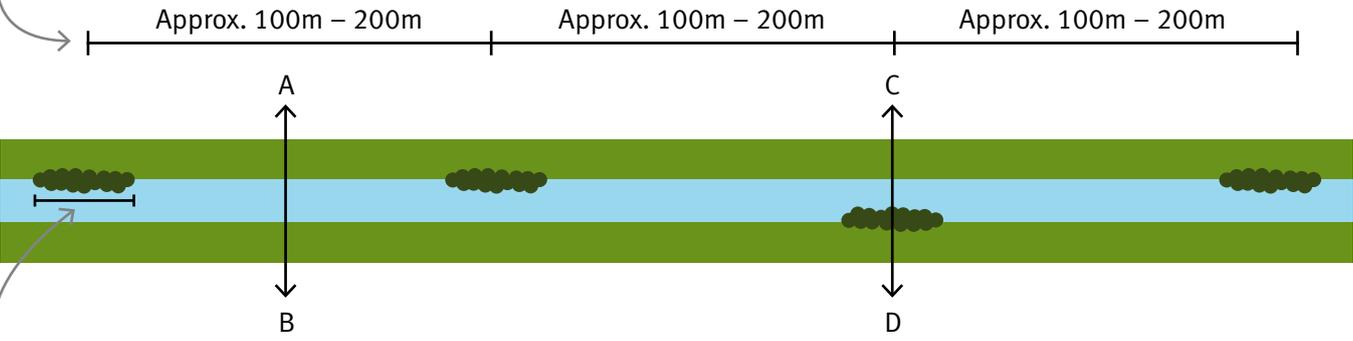
### W4 Weed control

Distance between aquatic margin centres

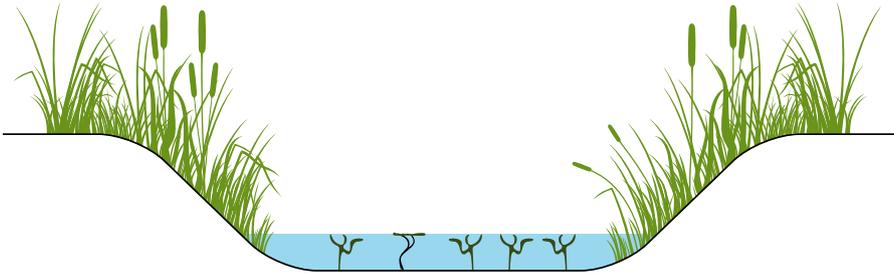
Approx. 20m of aquatic margin

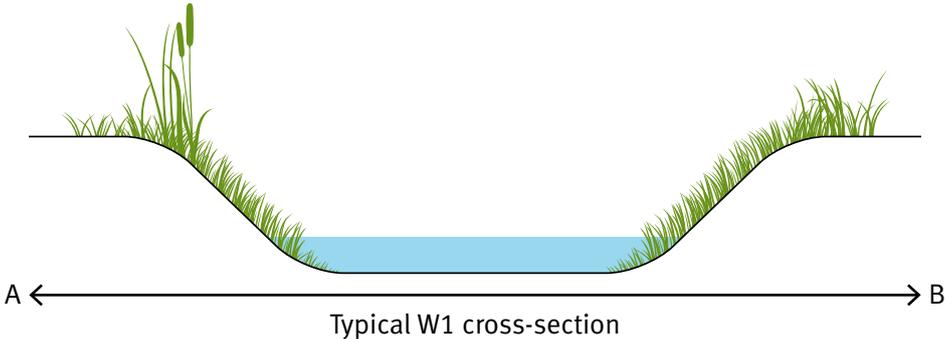
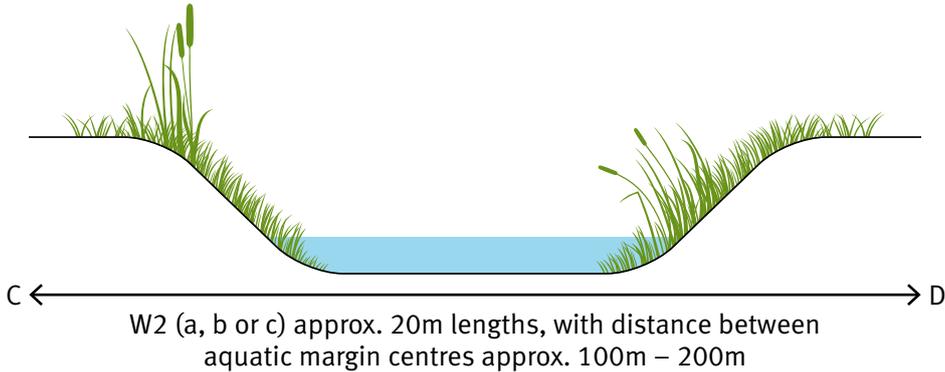
Typical growth before maintenance

Maintain short lengths of approx. 20m of aquatic margin on alternating sides

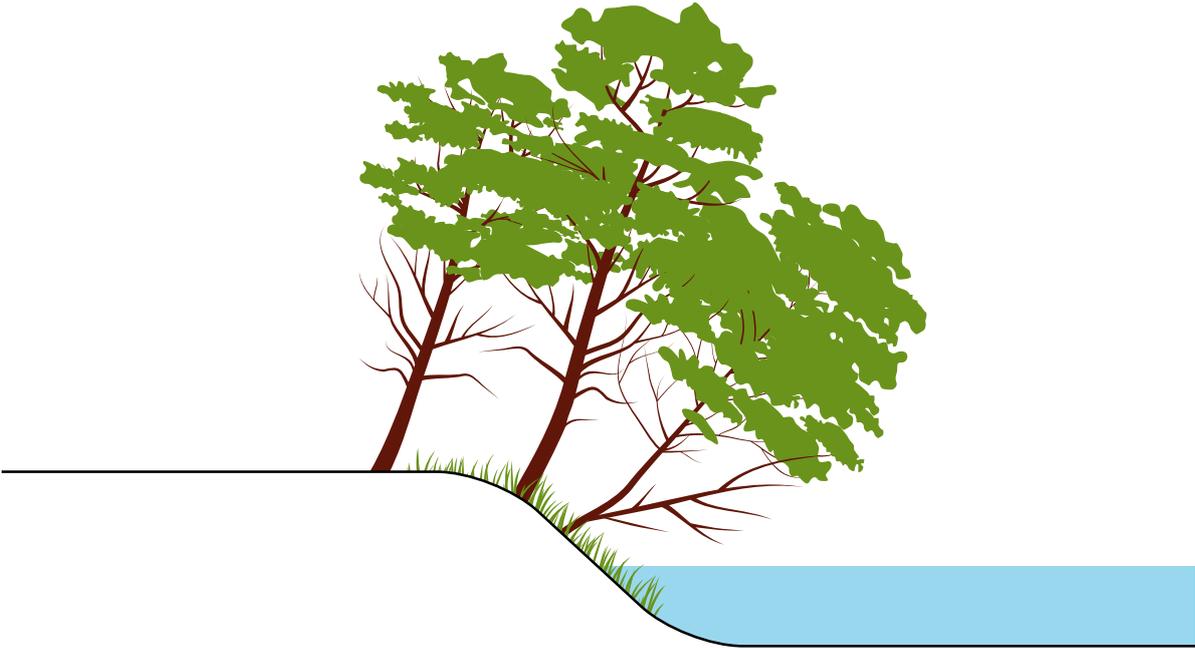
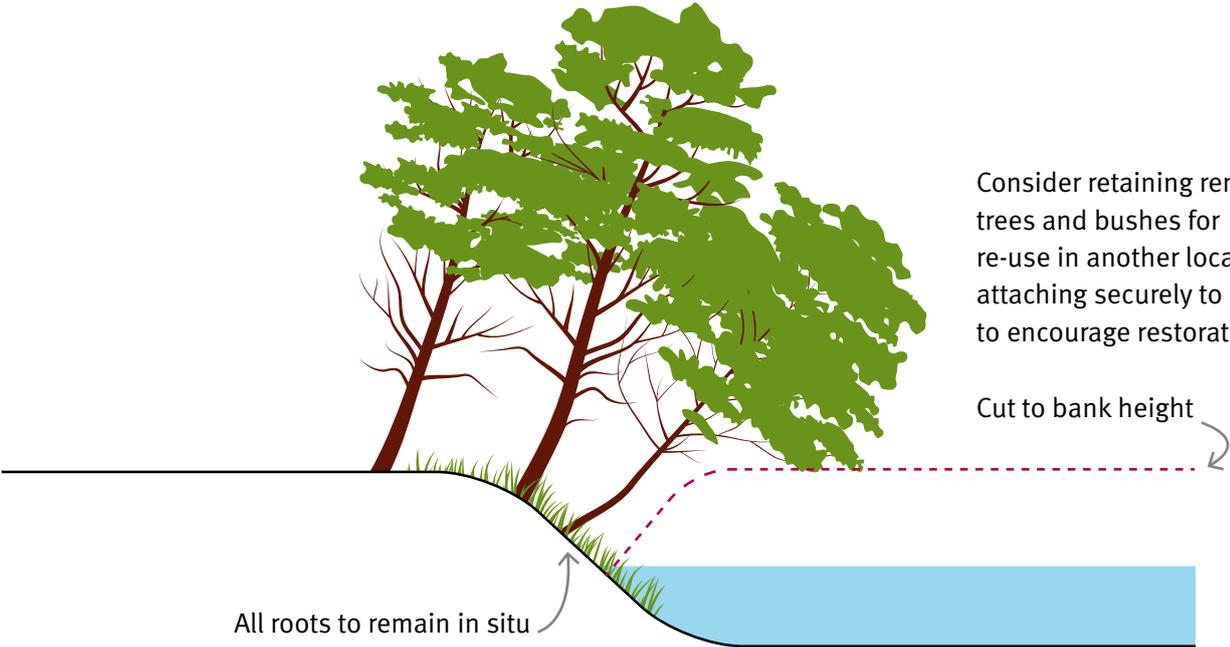
### TB3 Tree and bush management

Tree and bush work can usually be undertaken between September and Mid-February, unless nesting birds are present.

Consider retaining removed trees and bushes for re-use in another location, attaching securely to a river bed to encourage restoration river

Cut to bank height

All roots to remain in situ
