Reducing flooding in Chesham Newsletter Summer 2018

Vale Brook culvert condition

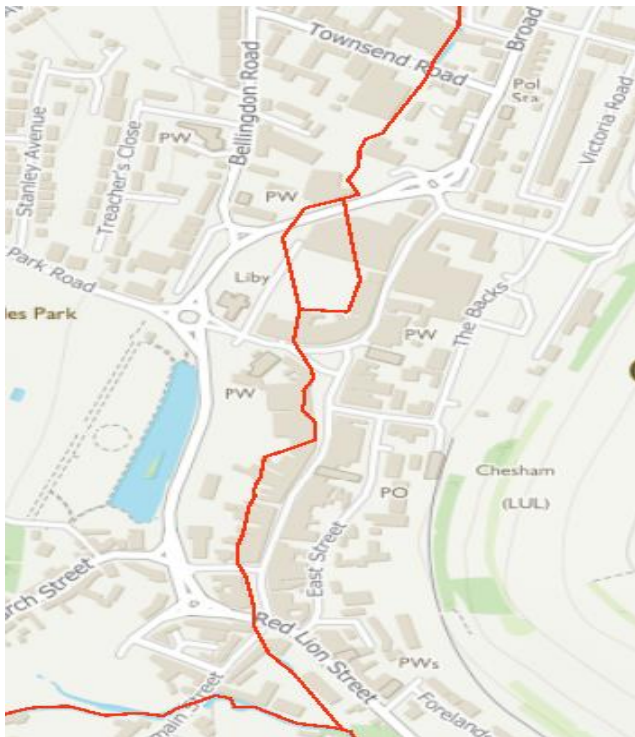
Current route of the Vale Brook

The Vale Brook runs through the centre of Chesham. This brook is largely underground in a series of buried tunnels (called culverts). Some of the culvert sections are now over 150 years old and they are in varying states of disrepair. The debris within the culvert limits the amount of water that can flow through it, causing a flood risk during heavy rain.

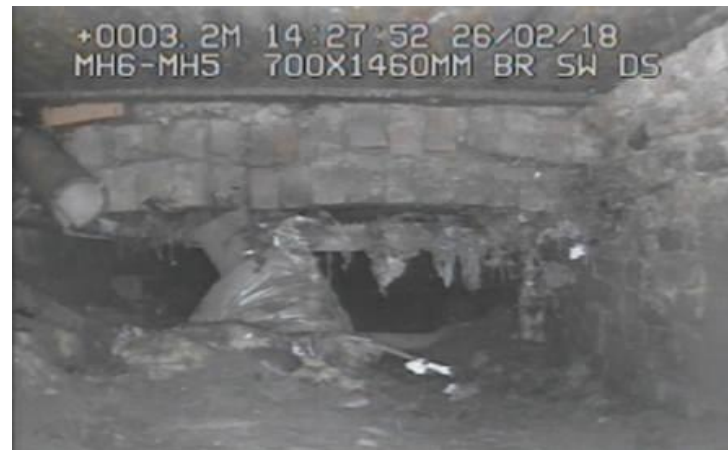
The survey confirmed which sections of the culvert are in poor condition and where debris has built up. The CCTV remote vehicle used to enter the culvert was unable to enter sections through the town centre due to excessive debris. We are working with our contractor to develop a plan to remove some of the debris from the culvert to allow the camera vehicle to pass through. This is a difficult process because of the small size of the culvert and potentially poor condition of the culvert structure.

CCTV image of the Vale Brook Culvert

Earlier this year, we commissioned another CCTV survey of the whole length of culvert, from Townsend Road down to where it joins the River Chesh. This survey lets us see the latest condition of the culvert to assist our decision making to develop options to reduce short and long term flood risk.

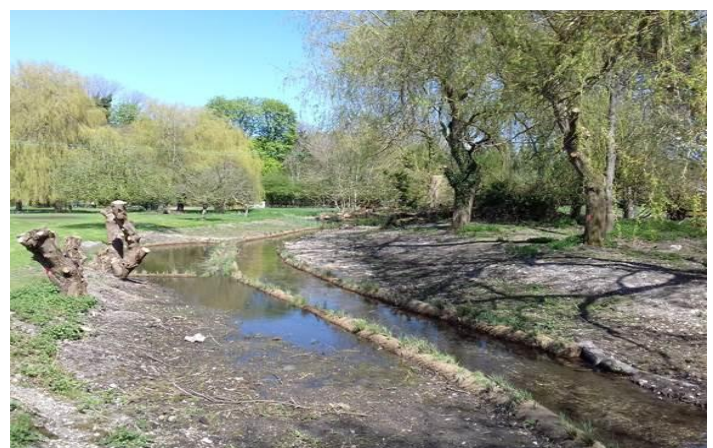
The restored reach is located along a 200m section of the Missenden Stream which flows through part of the Great Hundridge Manor Estate, bordering Chesham Tennis Club and the grounds of the Tennis Club itself. Historically, the river channel in this location has been widened, deepened and impounded by two concrete weirs. As a consequence, flow, when present, is sluggish and the reach acts as a sink for sediment, which overlies much of the gravel bed especially on the upstream side of the weirs and adjacent to the tennis courts, where the channel is at its widest.

By carrying out this restoration work, this section of the river Chess catchment will be returned to a more "natural" state. It will allow the natural chalk stream processes to re-create habitat, carry natural amounts of sediment and reconnect the channel and floodplain. Once the habitat is created the wildlife will come back to this reach of the river Chess.

Missenden Stream ready to be recolonized by wildlife
