Yarm Environmental Enhancement Work Proposals

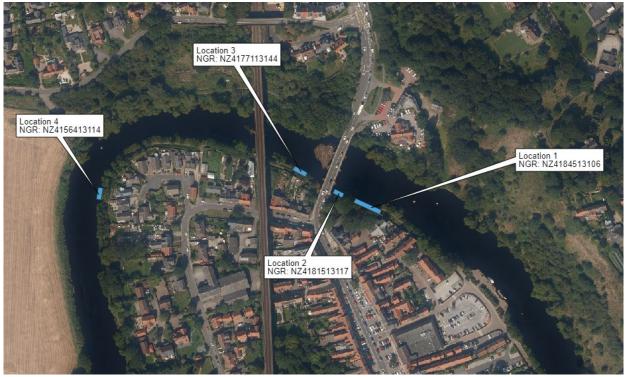
Figure 1. Map of potential intervention locations in Yarm

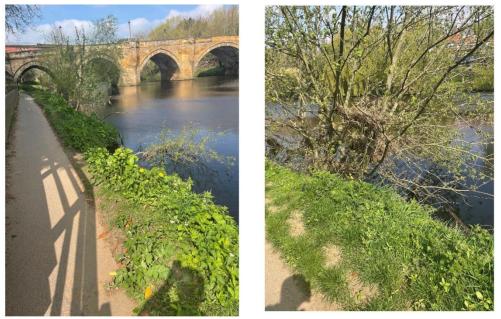
Figure 2. Images of the eroding bank and willow tree at Yarm.

Figure 2 above shows images of the sections of bank to be worked upon and the existing willow tree growing. The bank here is steep; therefore, this solution will be challenging to implement. Figure 3 below shows some willow spilling work previously carried out by the Tees Rivers Trust on another water course

Erosion is occurring along the toe of the bank, with concerns raised about potential erosion into the adjacent footpath. In order to rehabilitate the bank, it is proposed to tether some large woody debris (tree trunks) along the toe of the bank anchored in place with a combination of rebar pins through the trunk itself and some living willow stakes. Behind the tethered trunk a section of willow spiling could then be installed and back filled with soil and seeded. The tethered trunk will aid in protecting the newly installed spiling allowing it to grow and form roots into the bank helping to

Historically coir roll has been employed on this site as remnants of the stakes used to tether it in place are still present, in some areas reeds have successfully taken root. The section of bank in question does have a willow tree growing at the top end (see figure 2 below) and it would be possible to lay some of the longer limbs back into the bank (akin to hedge laying) again to aid with the protection and rehabilitation of the bank. This proposal will improve the resilience of 20m of riverbank.

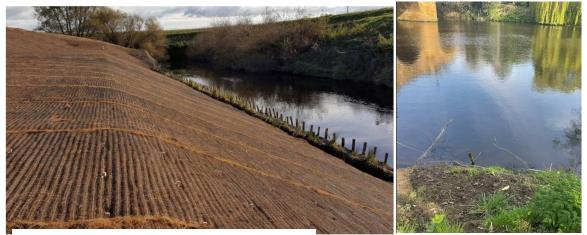
Figure 4. Coir matting before being seeded

Figure 5. Eroded area of bank from dogs entering the channel

At location 2, there is an area of bank being used repeatedly as an access point by dogs, showing signs of erosion. The proposal here is to reinforce the bank surface using either a natural geotextile (coir type material) or bank reinforcement mesh to create a more purpose-built area for this activity. The lower edge of the bank could be armoured further either with a coir roll or using a timber edge (tree trunk or similar). The reinforced area of bank can then be seeded with a mixture of native and locally sourced plant species, creating valuable habitat. Figure 4 below shows coir matting before the seed has taken. Species rich planting over the coir matting, will increase floral diversity providing habitat for native invertebrates.

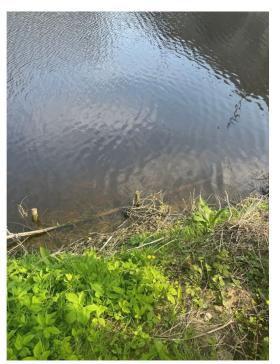
Figure 6. Images of failed willow spiling at Yarm

Location 3 is upstream of the road bridge. This area has had previous works installed which have now failed (see pictures below of the stakes). Replacement of the coir roll would be recommended coupled with some willow spiling to further reinforce the toe of the bank. The willow spiling will grow into the bank, strengthening the bank. The total length of this section is 15m.

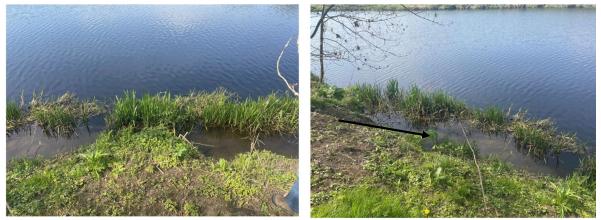
Figure 7. Images of pre planted coir roll which has partially grown

Location 4 has previously had pre planted coir roll installed and these have grown to a certain degree. It is recommended that some additional coir roll be installed in this area (arrowed areas), possibly with a more diverse range of reeds. Increasing the reed area will provide a range of benefits, including additional shelter for birds and mammals, structure, food sources, and provision of localised shade and generally an increase in habitat complexity and biodiversity. The proposal should improve the resilience of around 10m of riverbank.
