Birley Hay Farm Hydroelectric Power Scheme

Environmental Report

Birley Hay Farm

Fisheries assessment

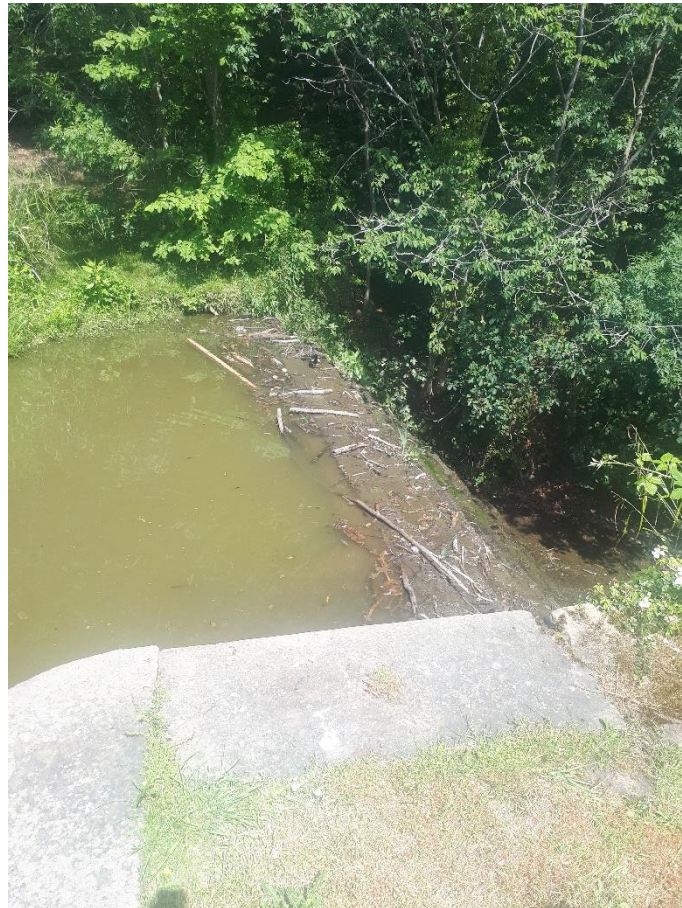
Figure 1: view looking across the existing weir.

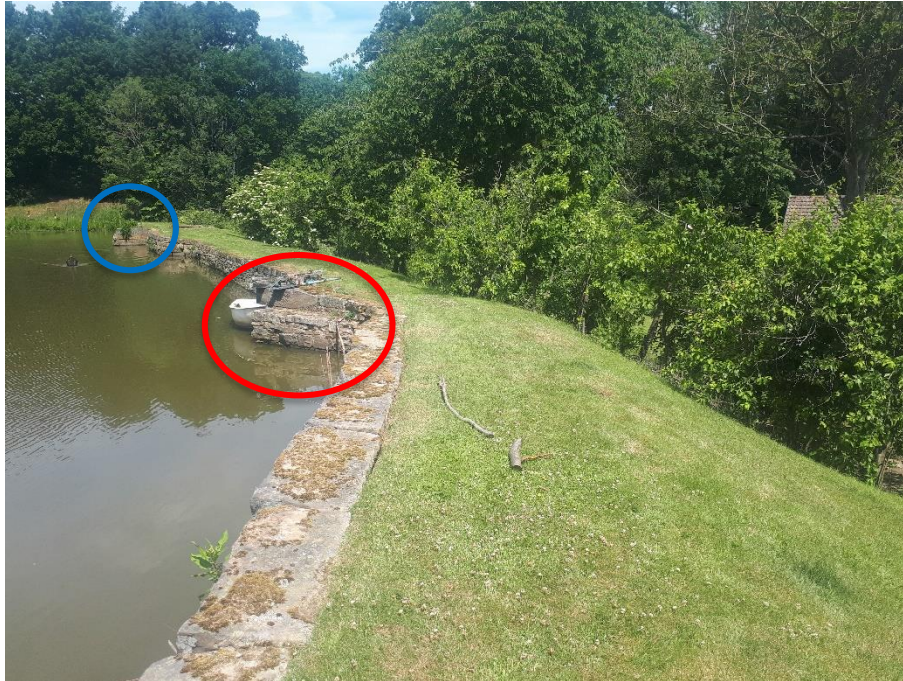
Figure 2: view of the intake location (red) with the weir location also shown (blue).

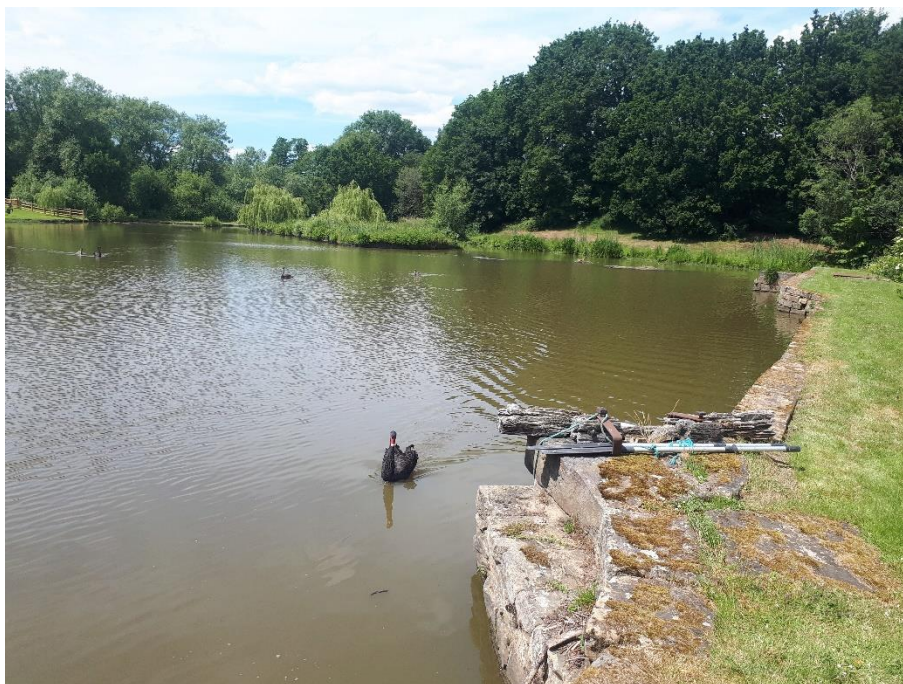
Figure 3: view of the mill pond from the intake location.

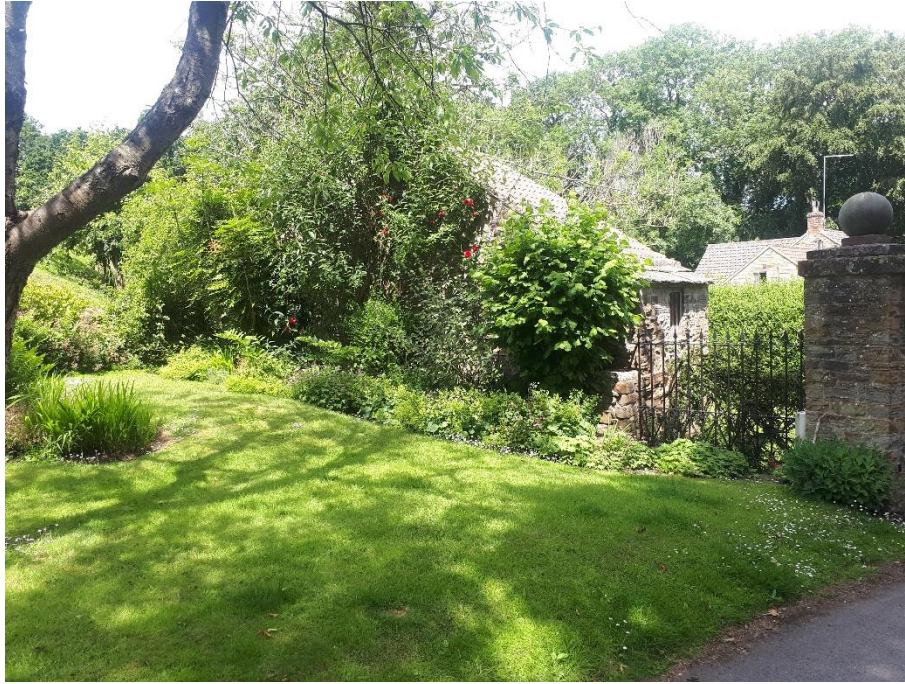
Figure 4: view of the wheelhouse (intake to the left).

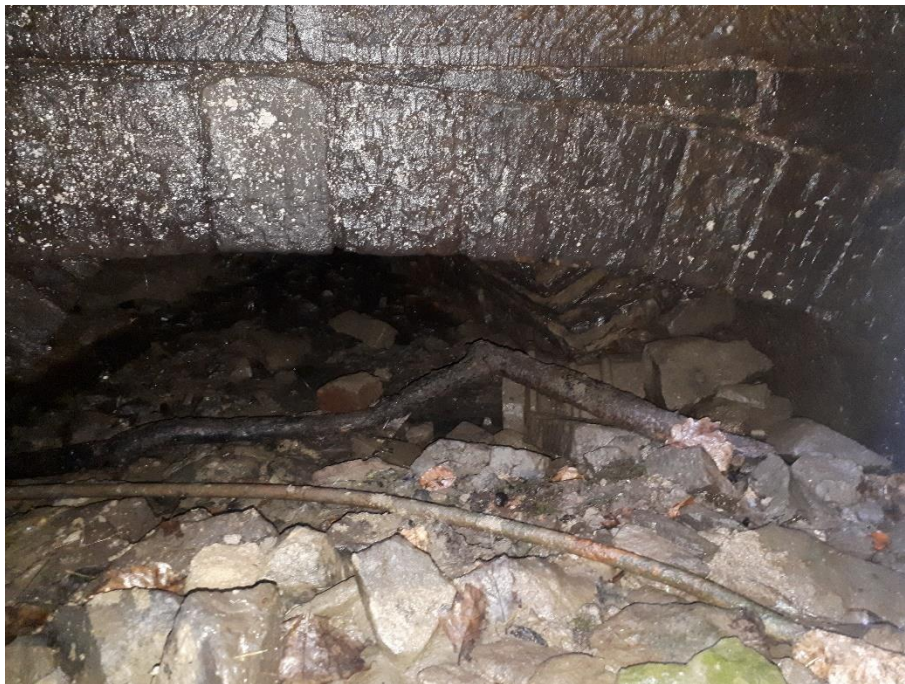
Figure 5: entrance to the culvert in the wheelhouse.

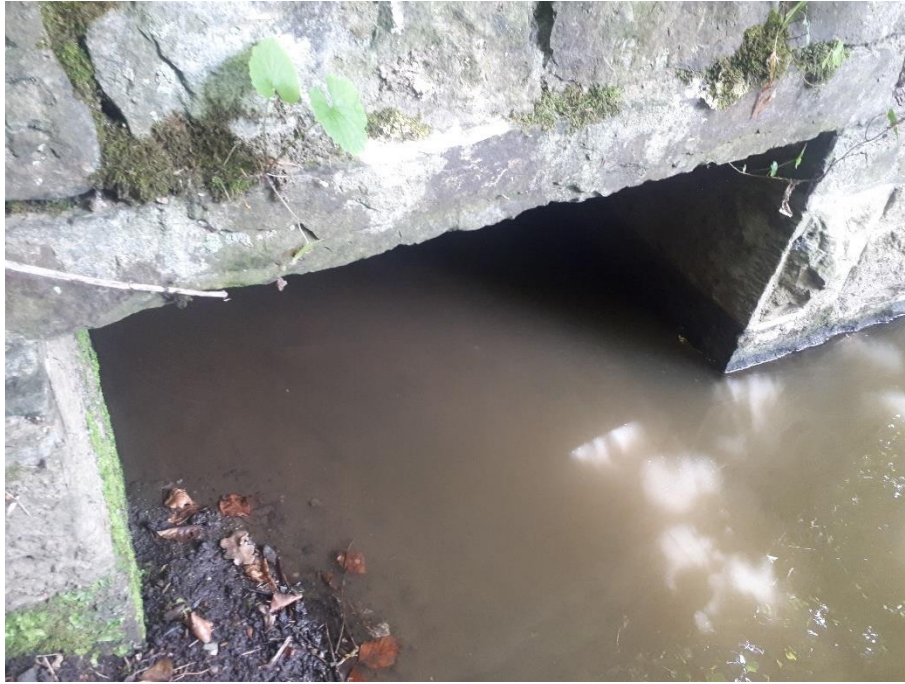
Figure 6: discharge from the culvert to The Moss.

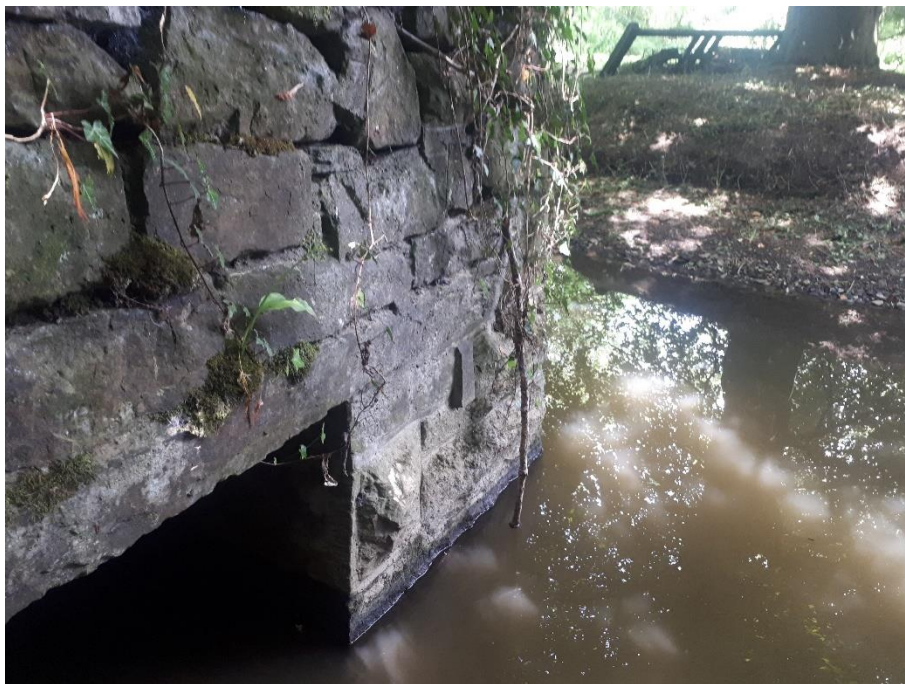
Figure 7: view looking across The Moss from the culvert discharge.

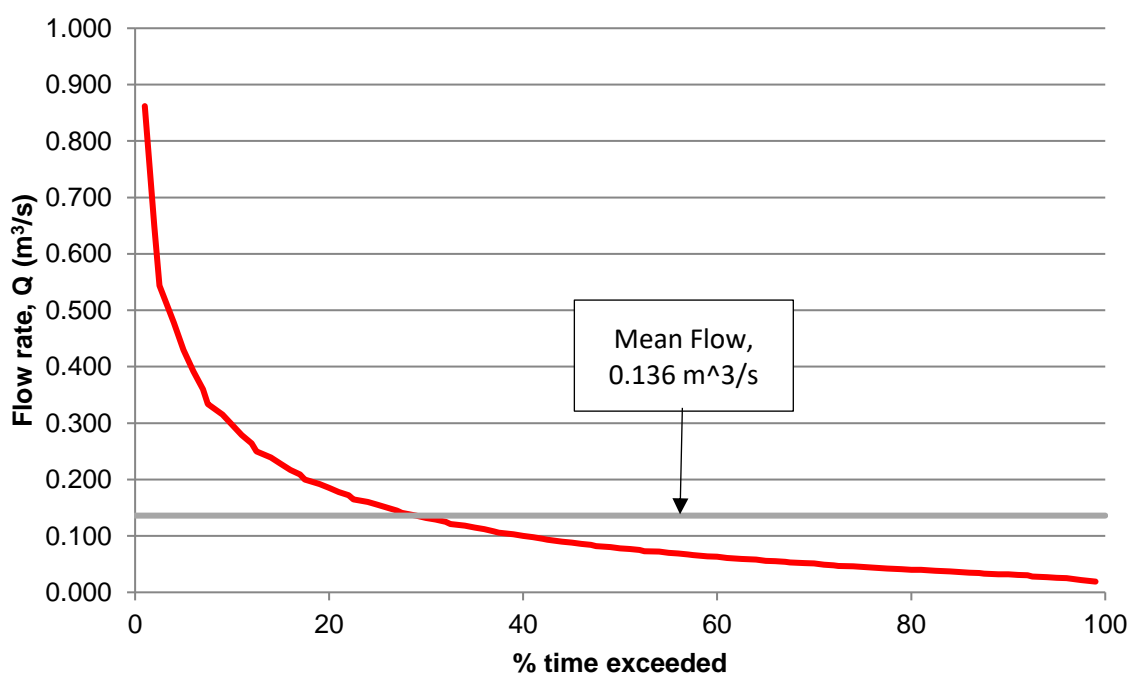
The nearest EA gauging station is number 27025 on the Rother at Woodhouse Mill. When scaled for the catchment area, Q_{mean} was found to be 142 litres/sec. The catchment area for this station is much larger than at Birley Hay Farm. Therefore, the LowFlows 2 programme has been used to estimate the flow data for the site. The flow data from LowFlows is given in Table 1 and a flow duration curve is also provided (Figure 8).

Figure 8: flow duration curve for the site.

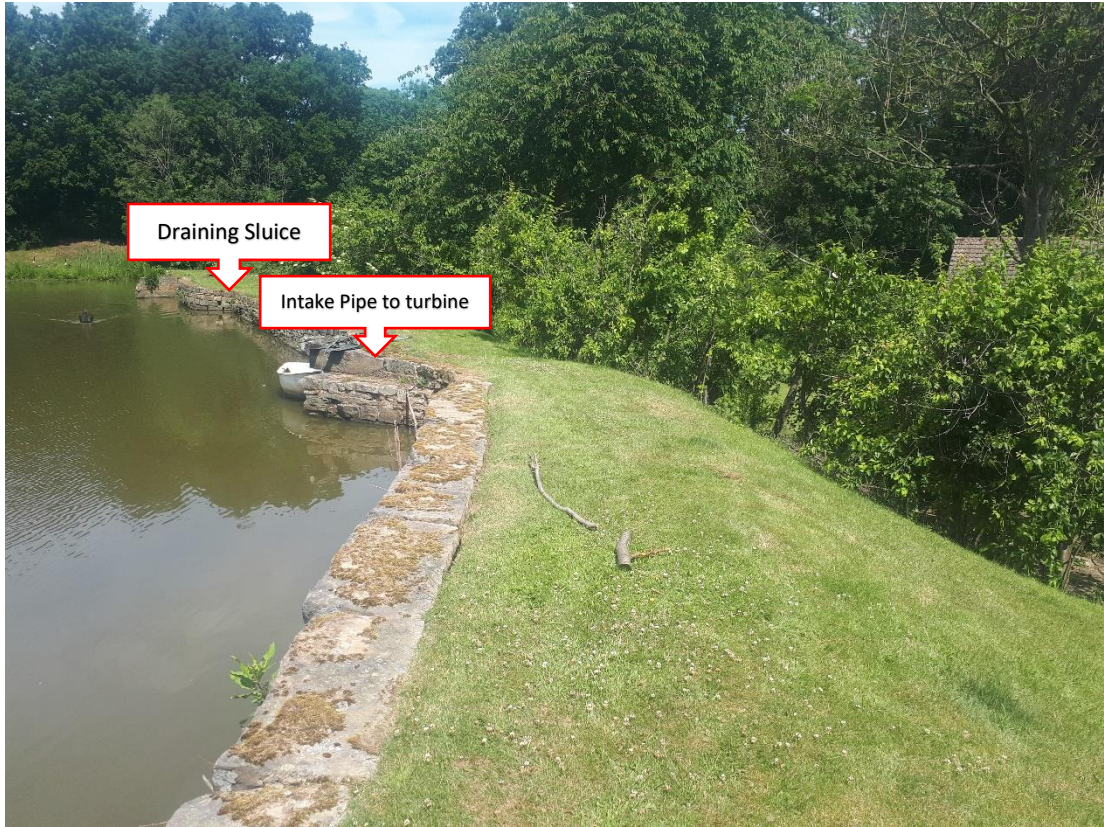
There is an intake pipe approximately 1.5 m below the current spill level of the pond that would supply water to the original wheels or turbines. This pipe is still 'live' and has an operable valve on the end of it.

Figure 3: Mill Pond draining sluice and intake pipe to turbine house location

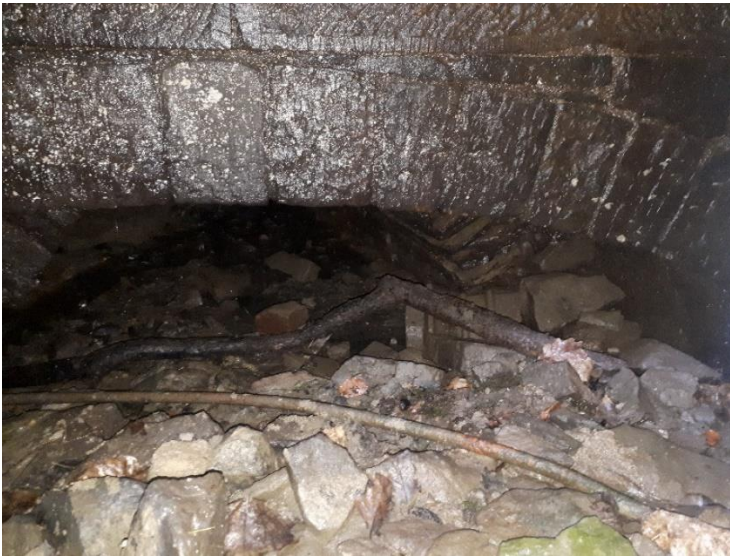
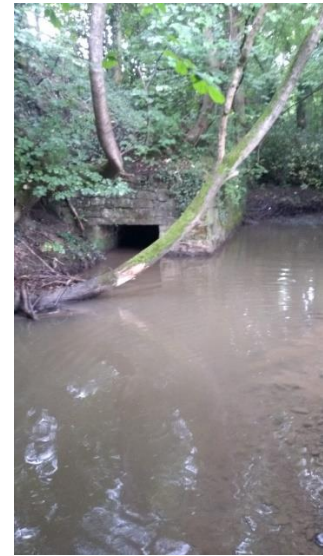
Figure 4: Wheel pit culvert entrance and culvert outfall.

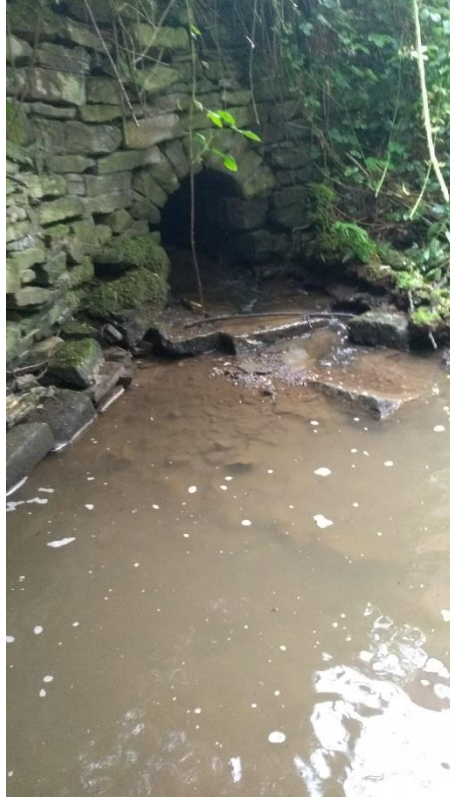
Figure 5: Tributary culvert outfall, 85m downstream of weir.

There is a small tributary, Figure 5, joining the River Moss, approximately 85 m downstream of the spill weir.

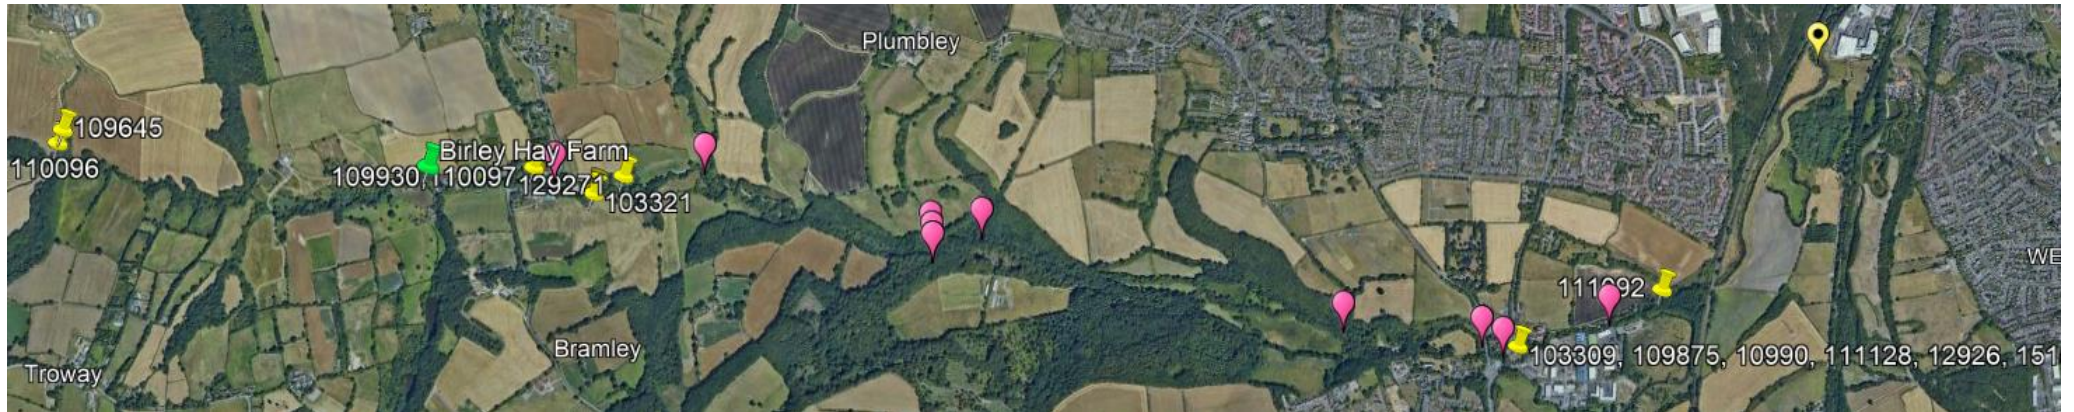
The EA fish survey data locations have been plotted in Google Earth below to show the Survey ID of each site in relation to Birley Hay Farm and the ten weirs (red points) downstream of Birley Hay presenting eight barrier locations to migration. There are multiple weirs also on the River Rother beyond that. The first of these is also shown (yellow point).

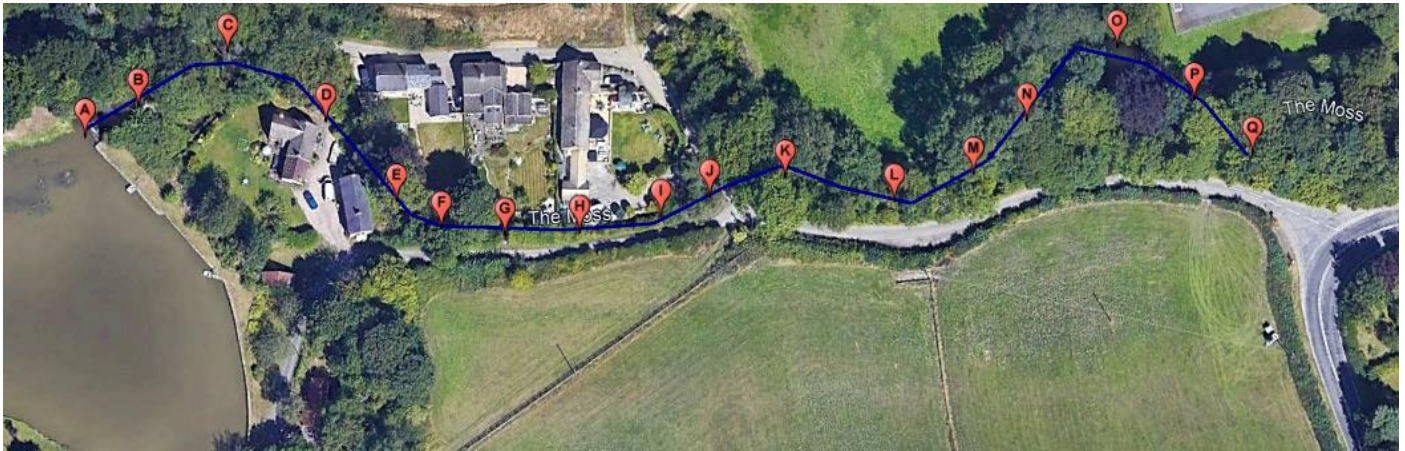
Figure 6: baseline survey assessment locations.

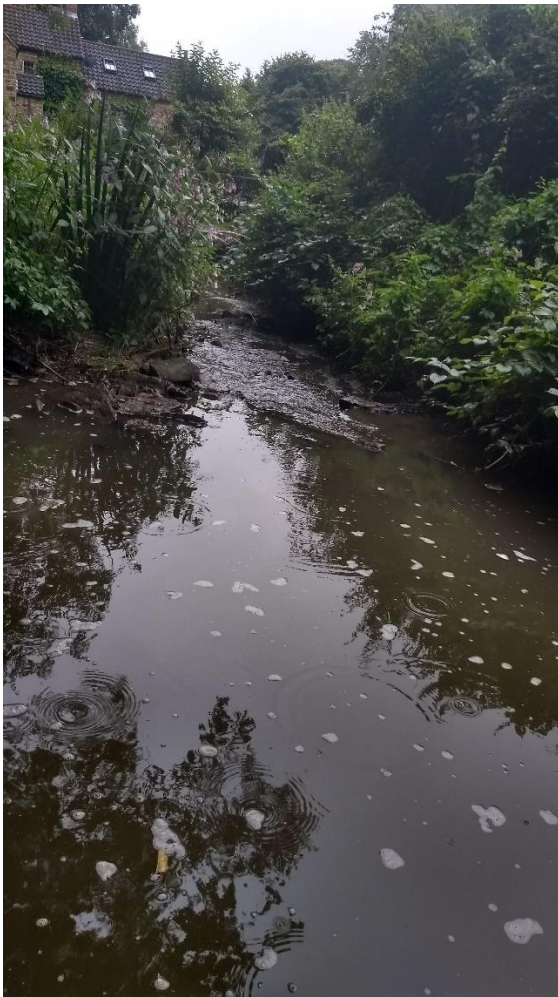
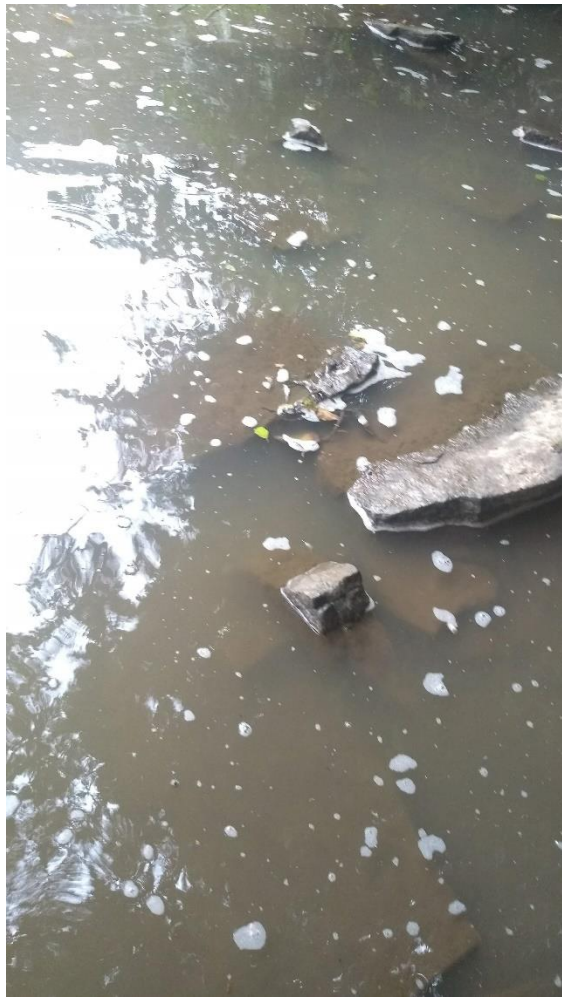
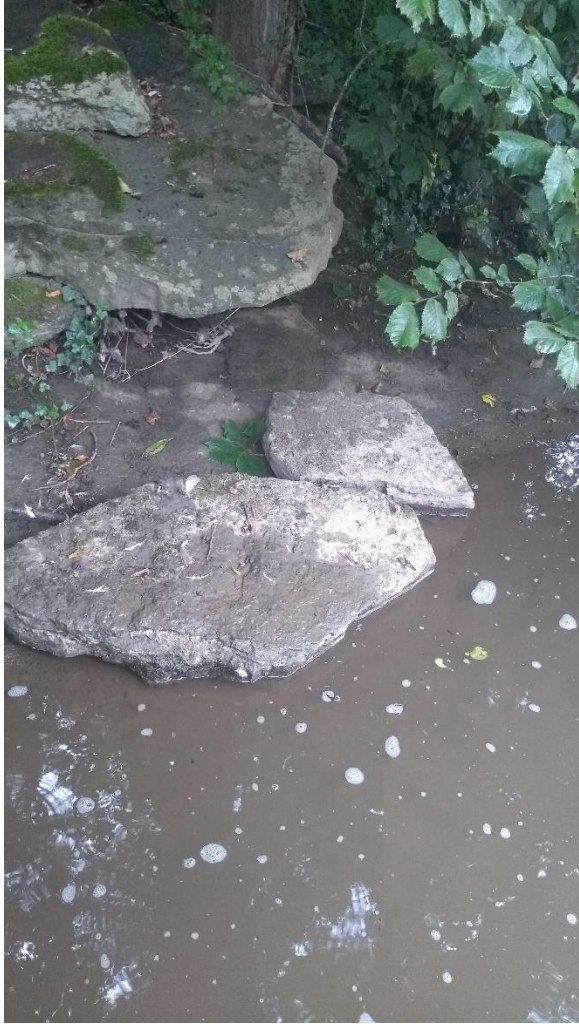
Location C is looking down the river toward the cottage on the first bend below the weir. Further photos show the nature of bed, bank and maximum pool depth below the weir in that area. Bed material is mostly larger stones.

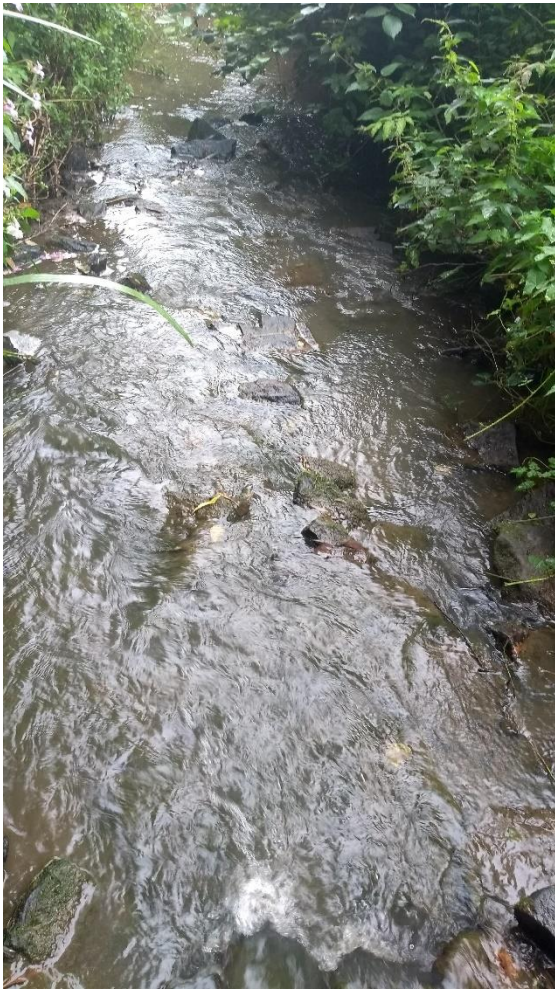
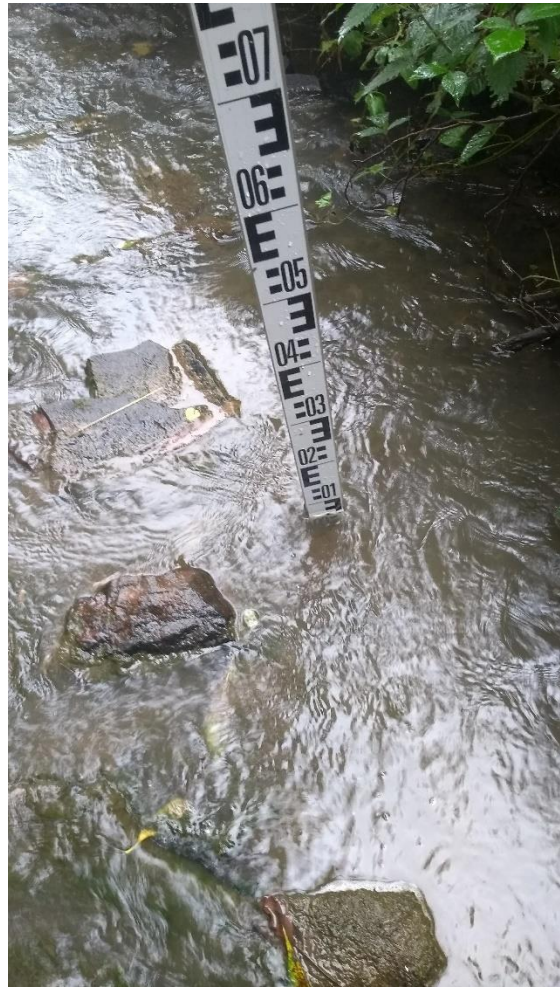
Location D is looking down the river toward the cottage. Shallower narrow rocky channel approx. 2.5 m wide.

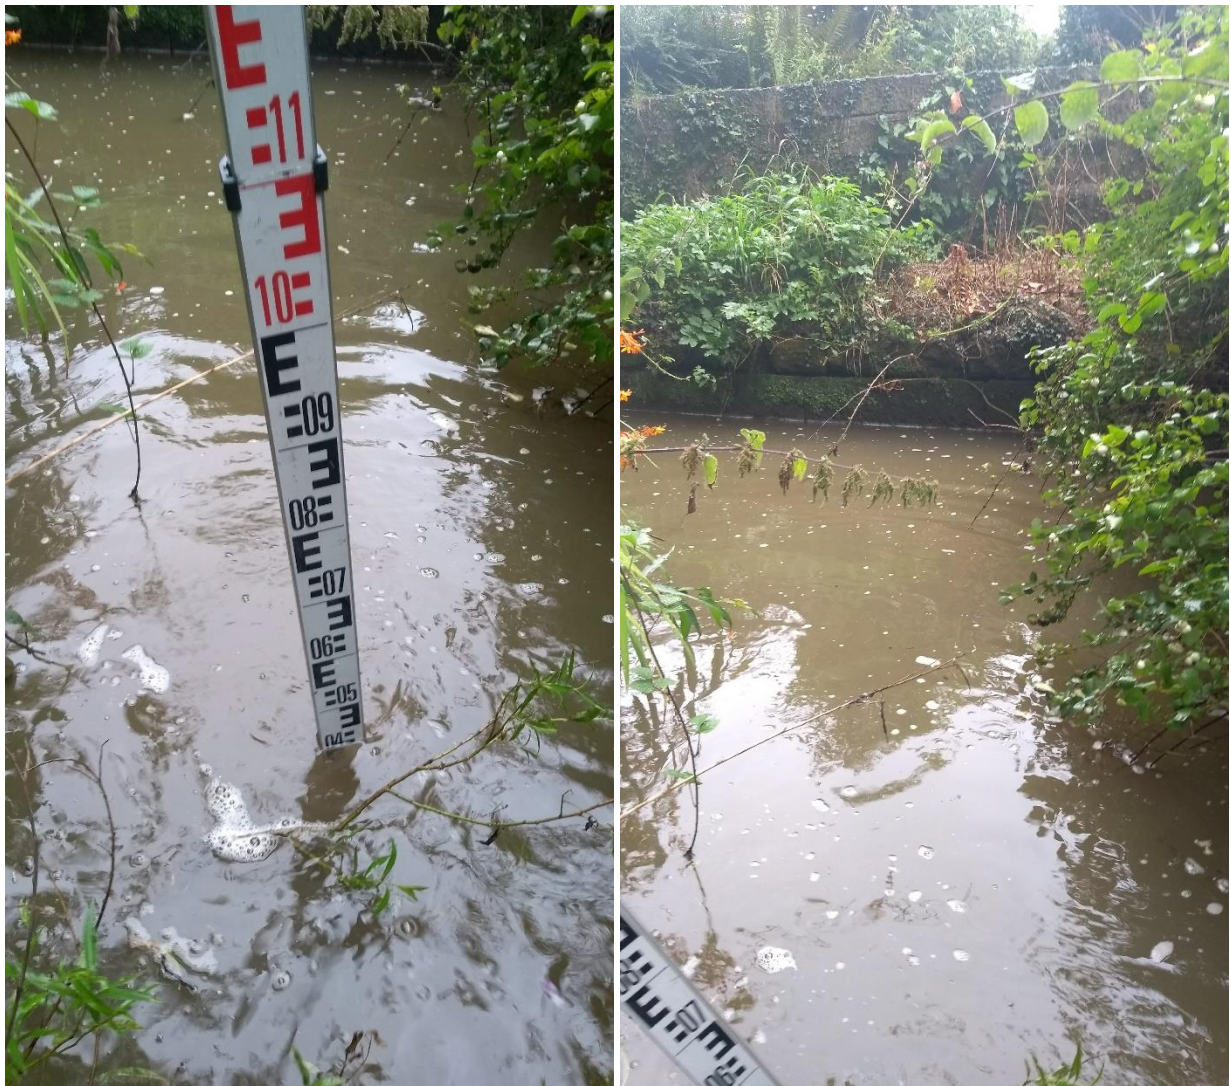
Location E is showing depth of corner adjacent to the bend by the Mill Cottage. Bed material is generally silty with large stones.

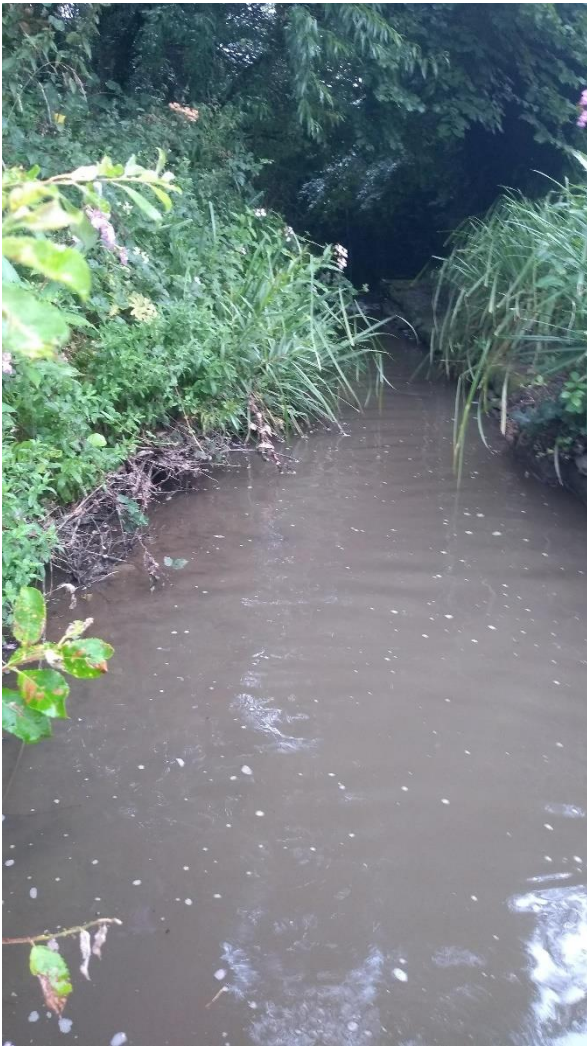
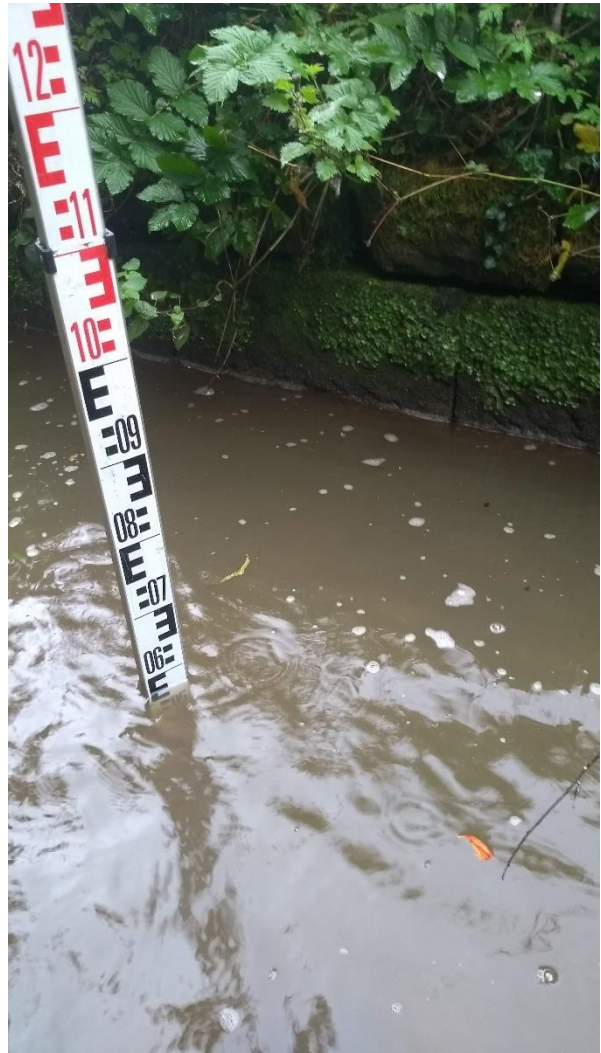
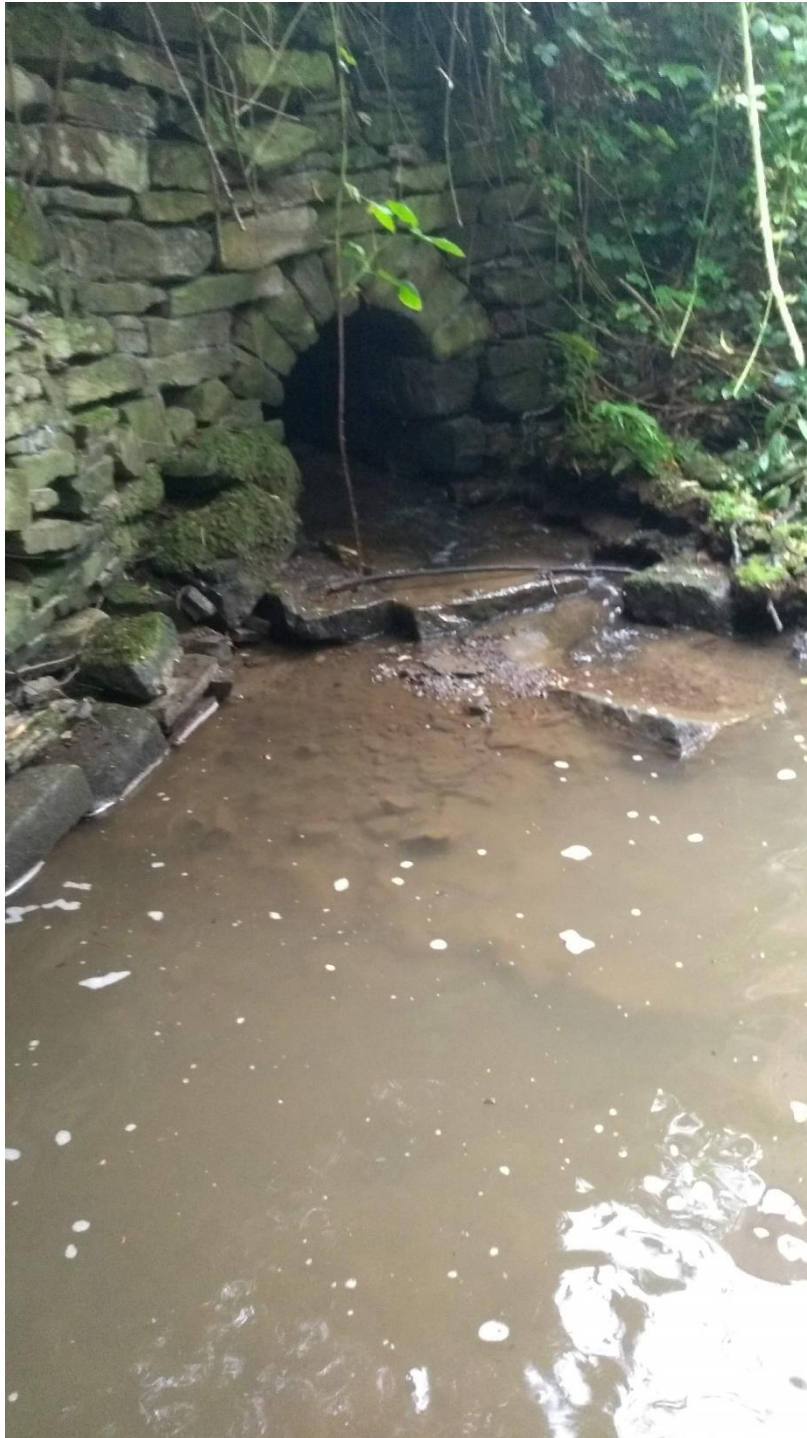
Location F is looking downstream just below the bend at location E. Depth and bed material remains consistent with location E. Outfall of culvert from small tributary between E and F also shown below.

Culvert outfall of tributary to the Moss shown in figure 1.

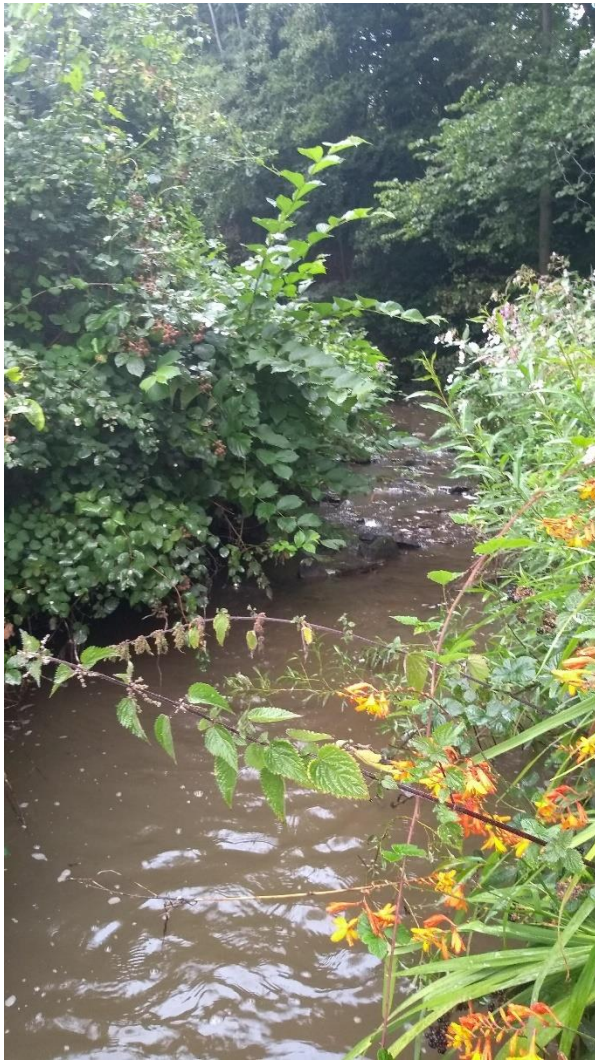
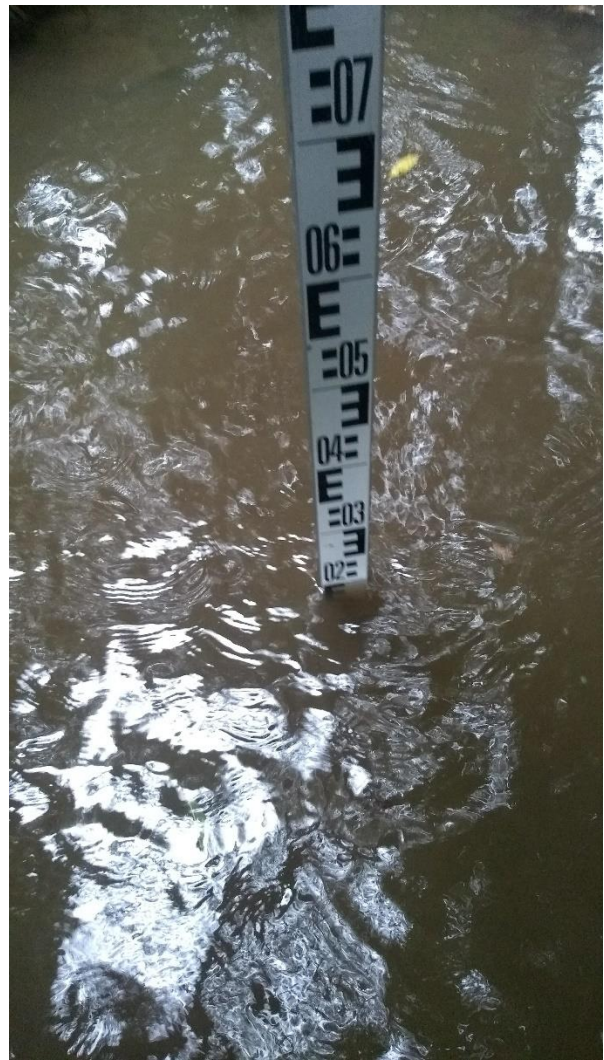
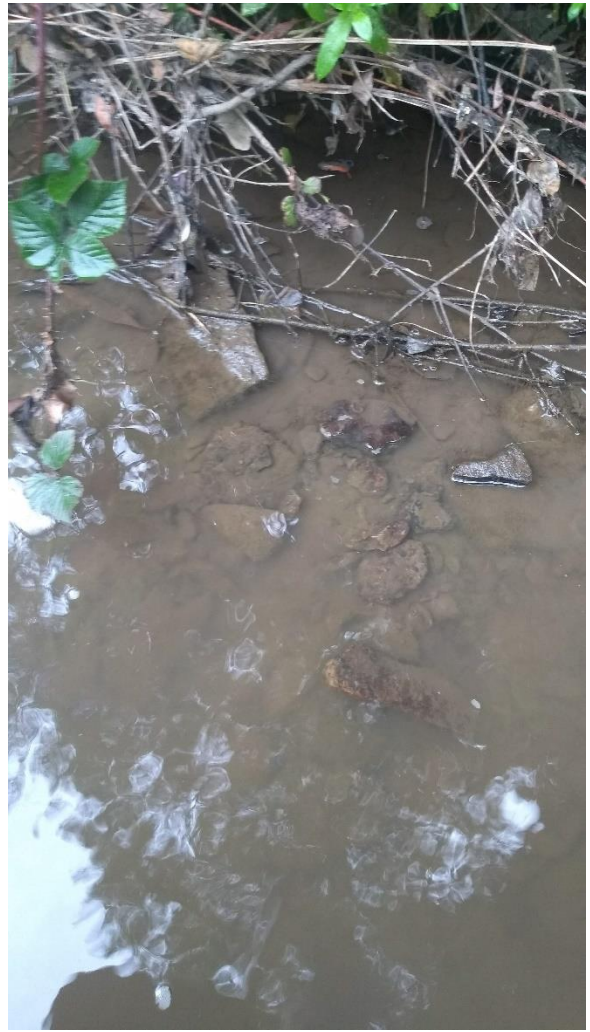
Location G shallows again. Bed material remains mostly larger stones but build-up of silt and some smaller stones on banks. River approximately 3 m wide.

Left bank / right bank facing downstream

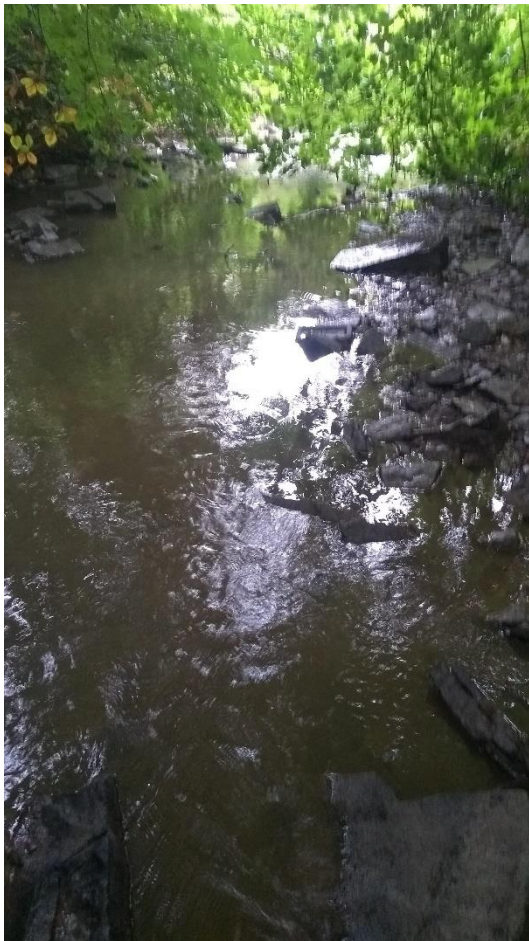
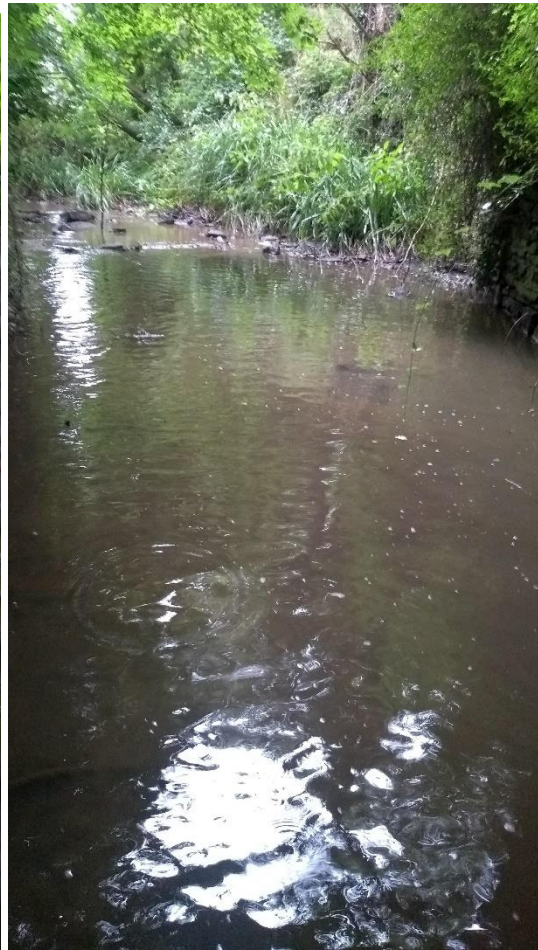
Location H

Location H, the river shallows and widens further. Bed material on banks has higher content of gravels and smaller stones, otherwise still fairly large rocks throughout the larger channel.

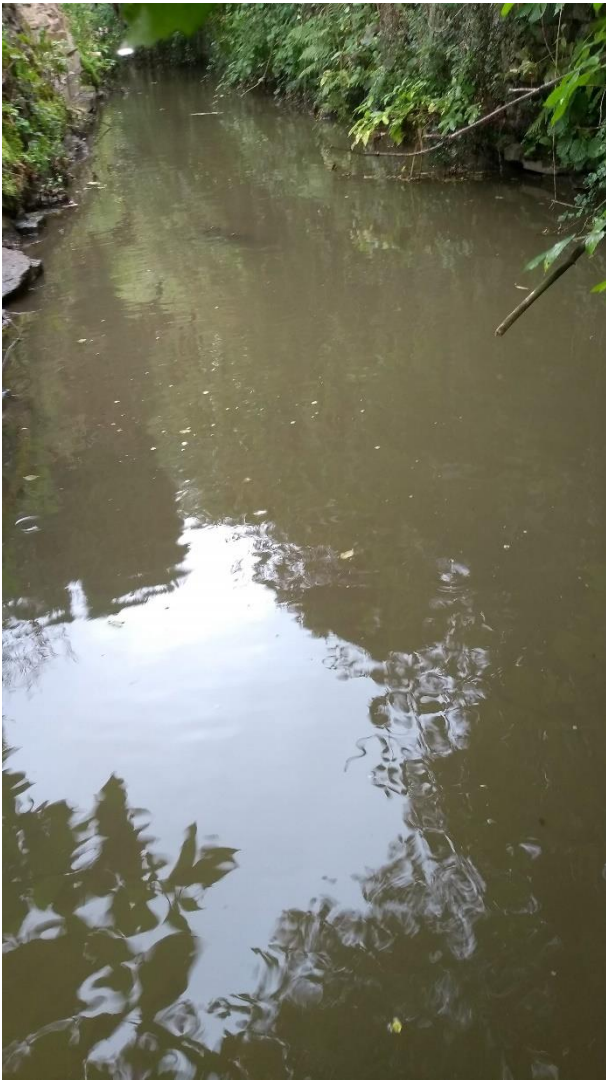
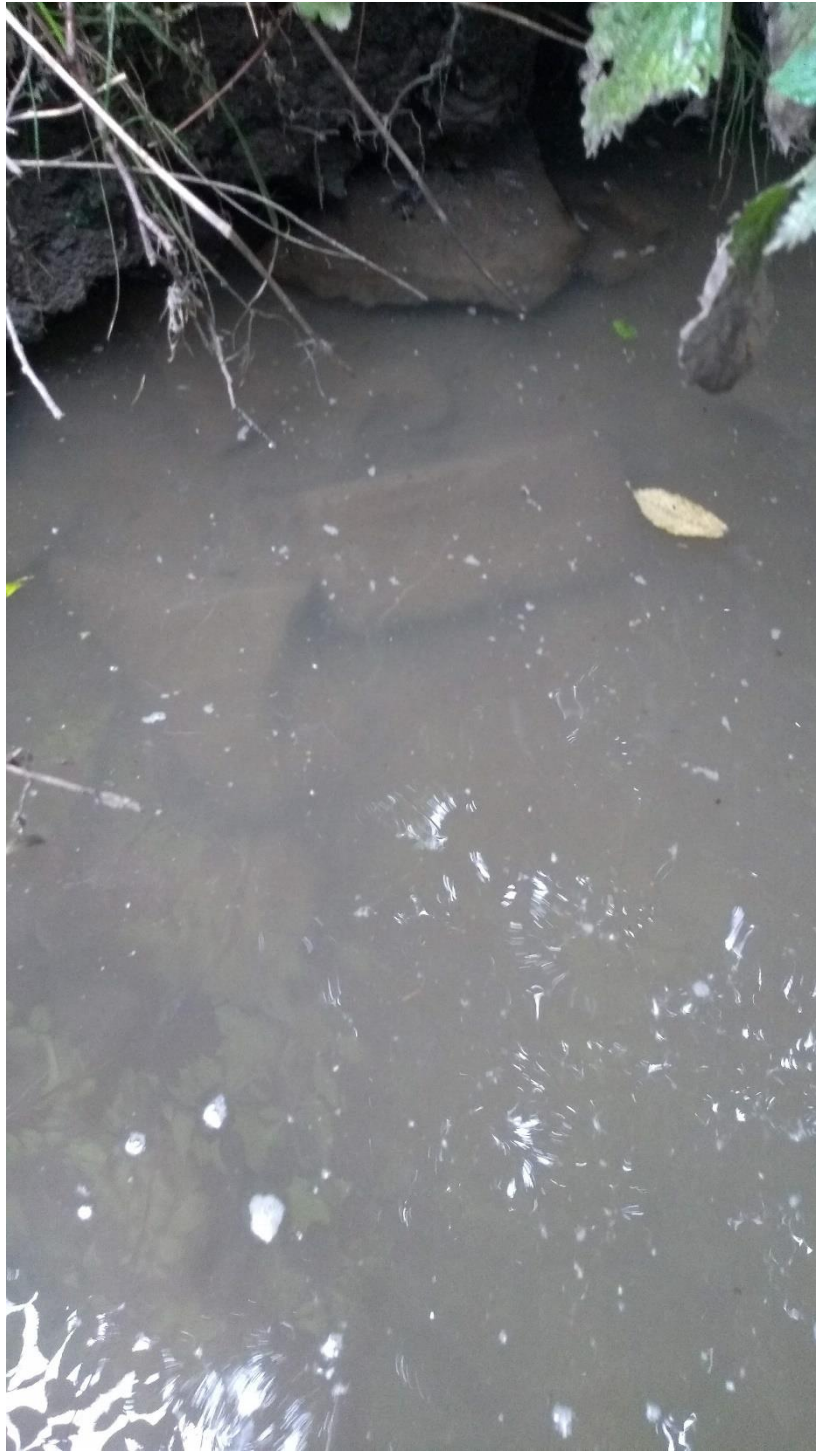
Location I becomes a 'man-made' channel from location H toward the bridge at location J. Depth and width are uniform. Bed material is a mix of rubble and stones. Still silty.

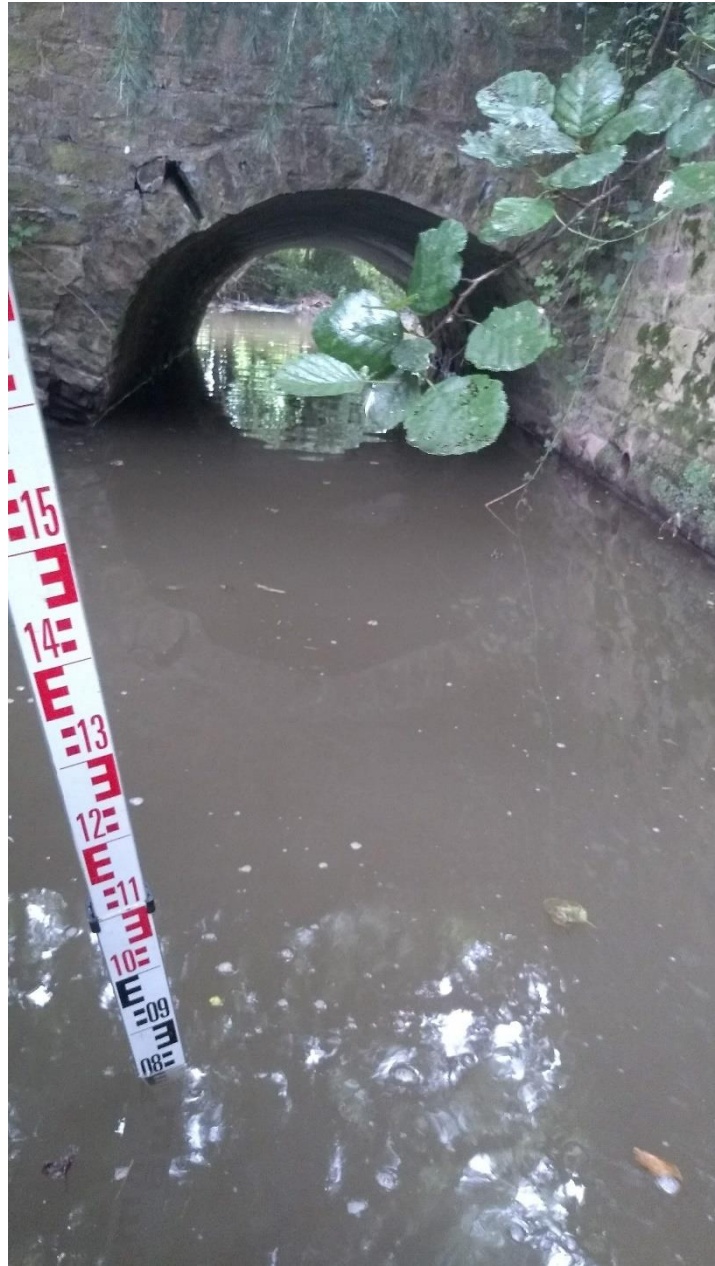
Location J is upstream of the bridge. Depth becomes too deep to wade (over 1.3 under bridge). Bed is all rock/stone with no small material evident.

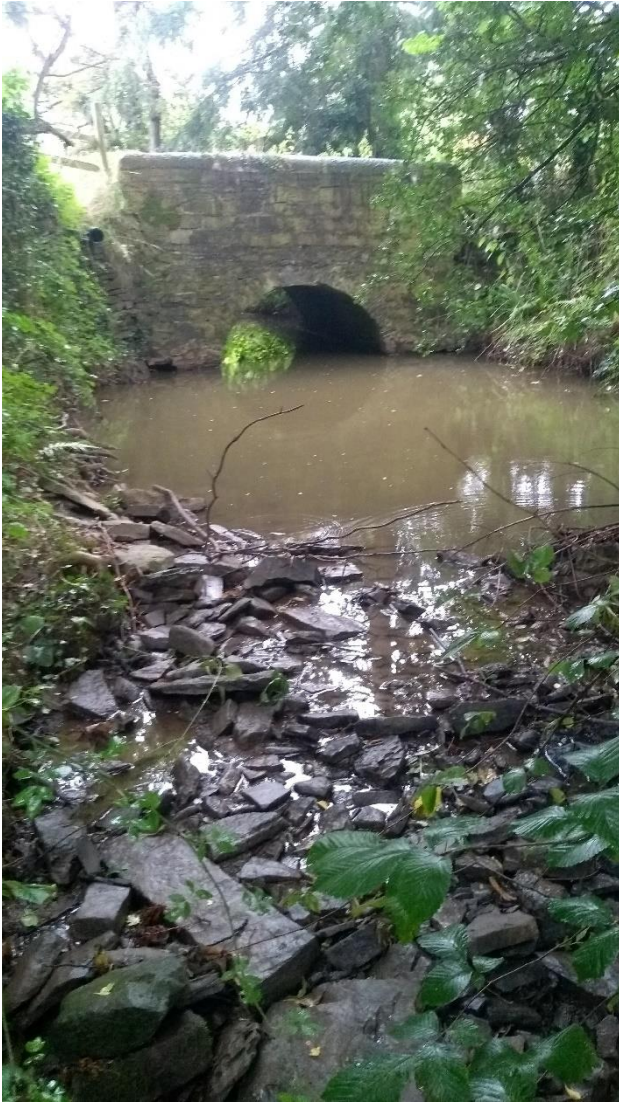
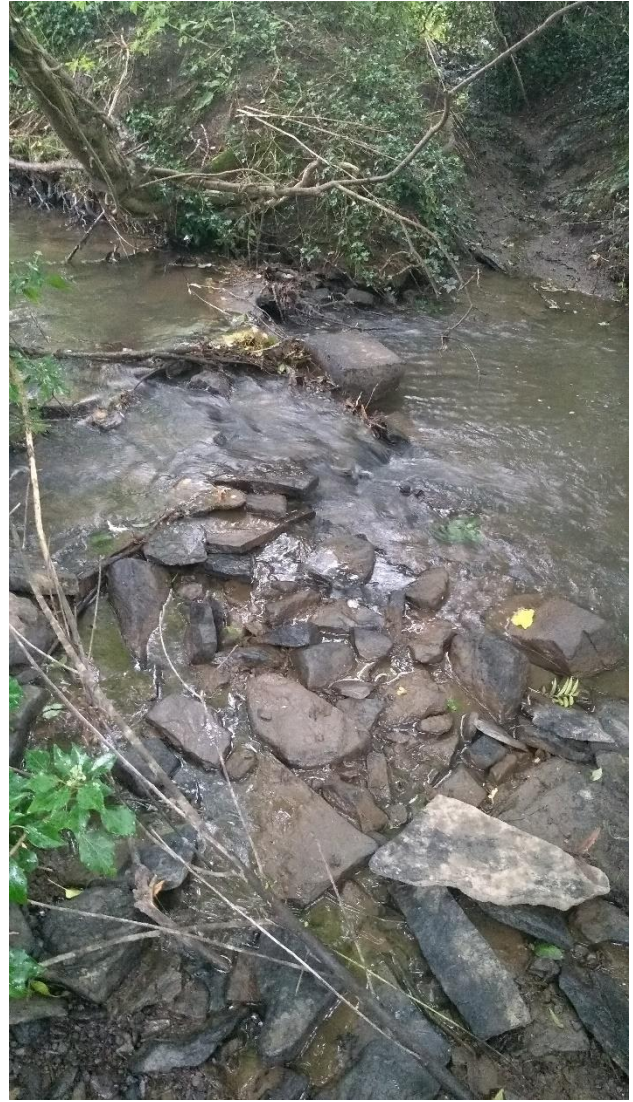
Location K is looking upstream toward the bridge and across the 'natural' weir and small tributary ditch.

Material deposited from upstream, through bridge scour during high flow events, explaining lack of bed material immediately upstream.
