Birley Hay Farm Hydroelectric Power Scheme

Environmental Report

Birley Hay Farm

Fisheries assessment

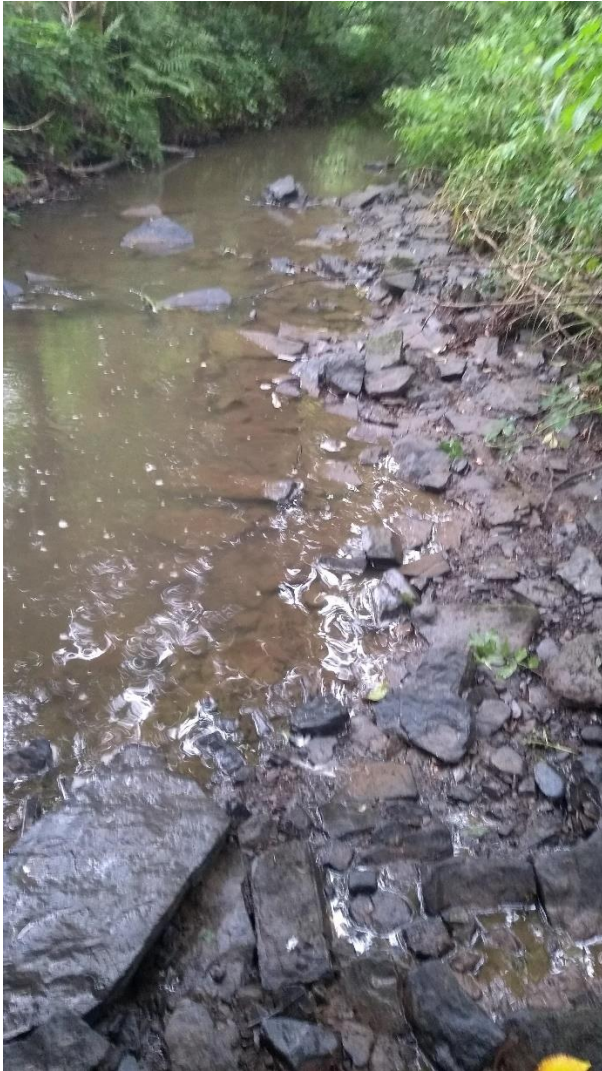
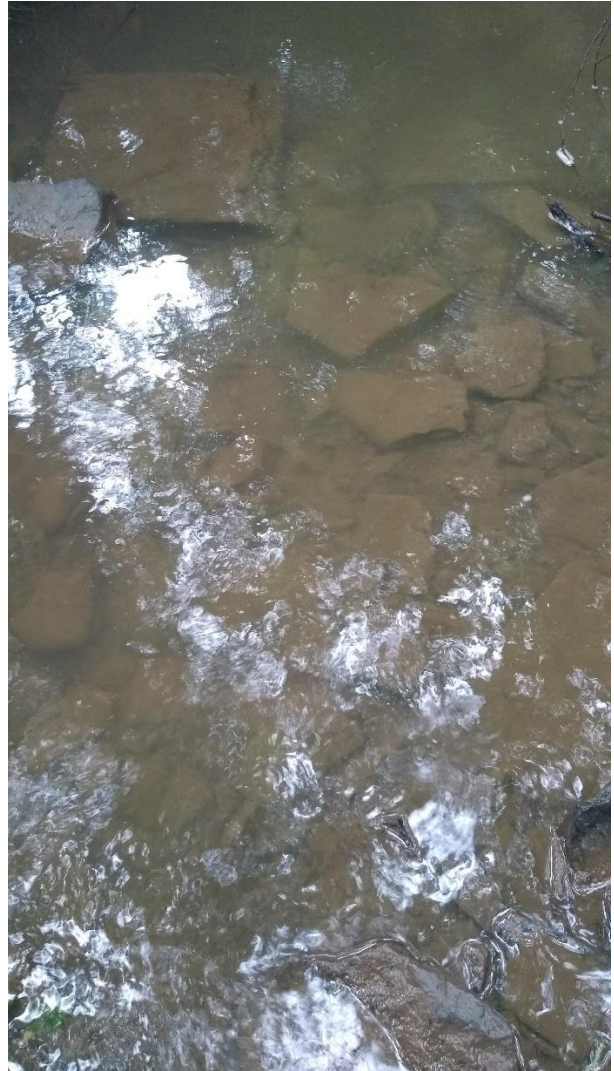
Location L the river widens, shallows and slows again. Bed material is uniform mix of rocks and shale.

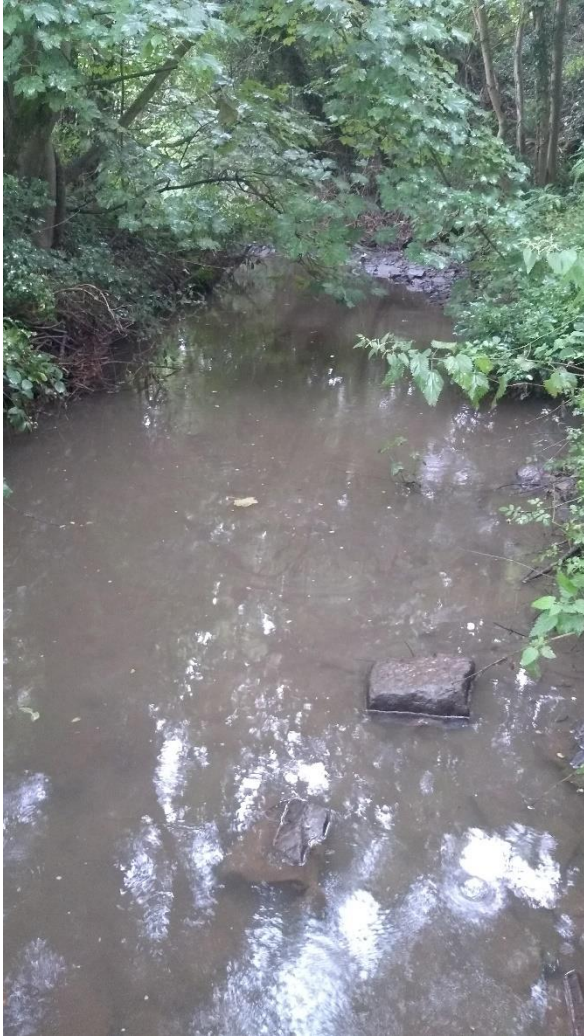
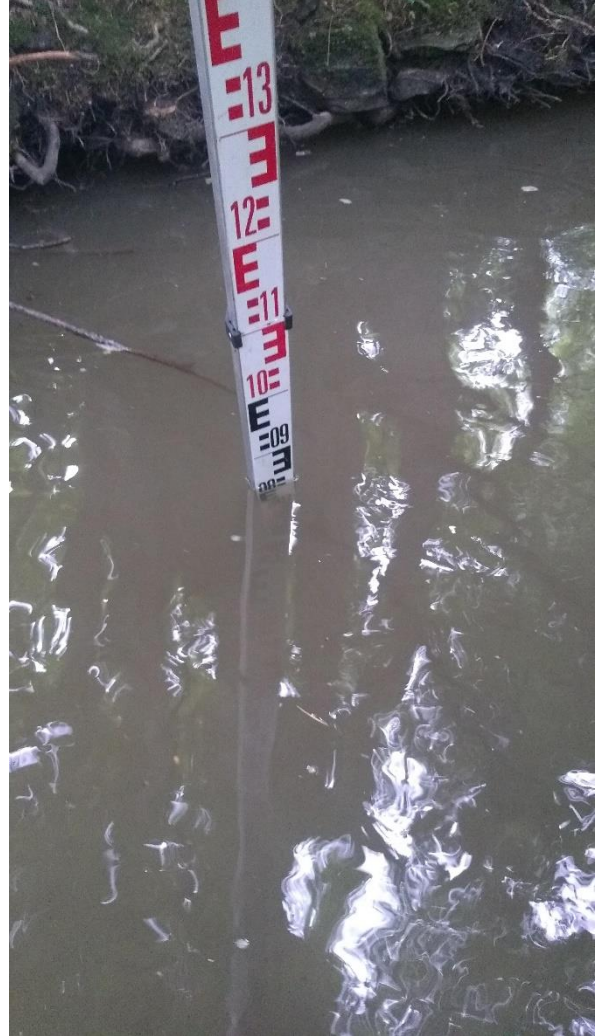
Location M

Location M, the river continues with a mix of deeper pools and shallow reaches over a distance of around 25m.

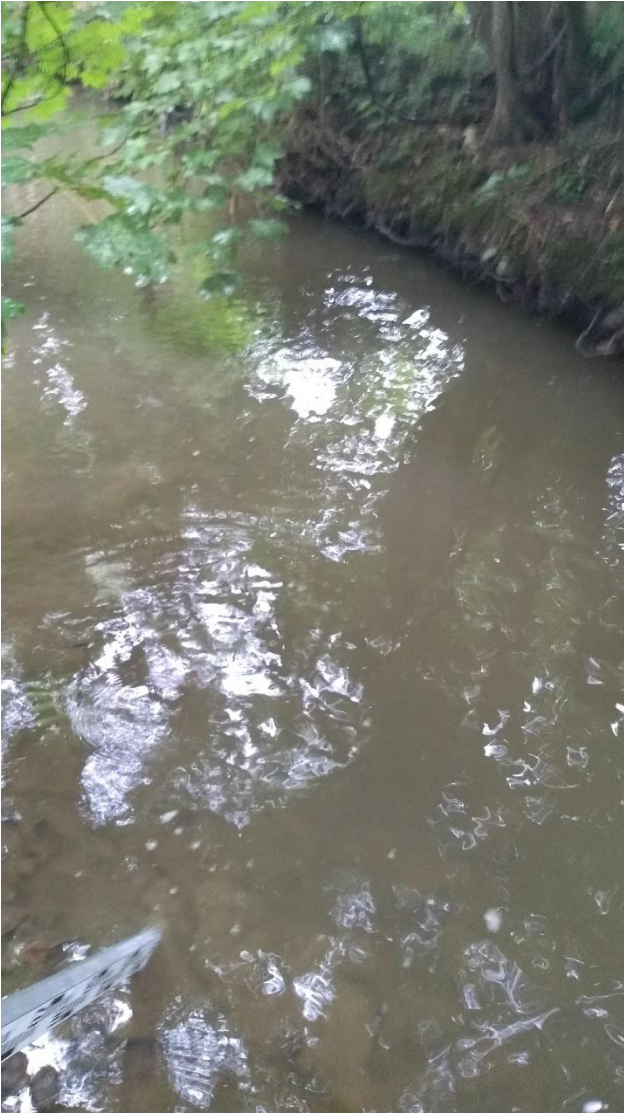
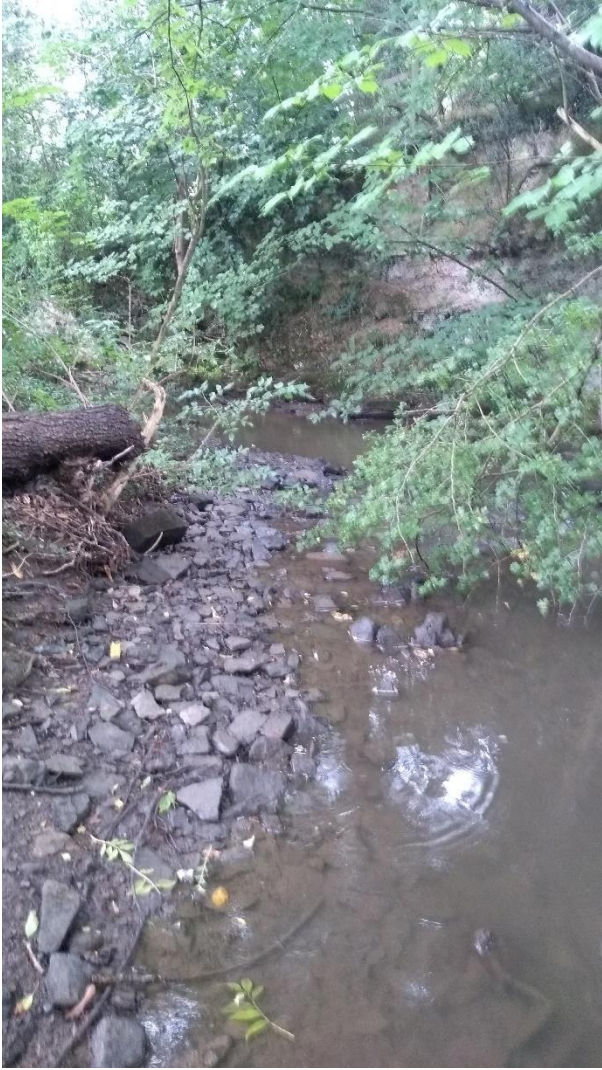
Location N

Location N, the river continues with a mix of deeper pools and shallow reaches over a distance of around 50m.

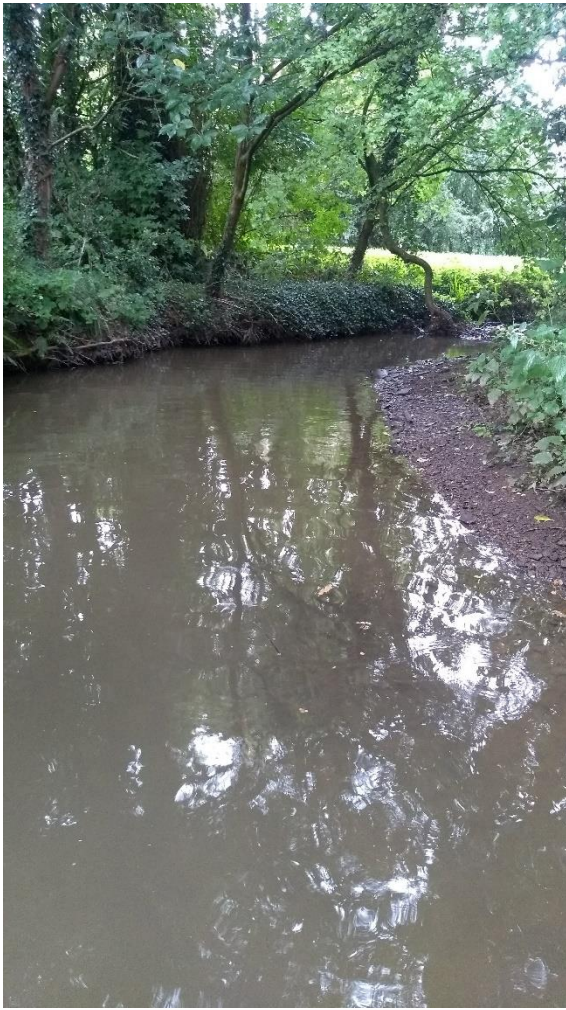
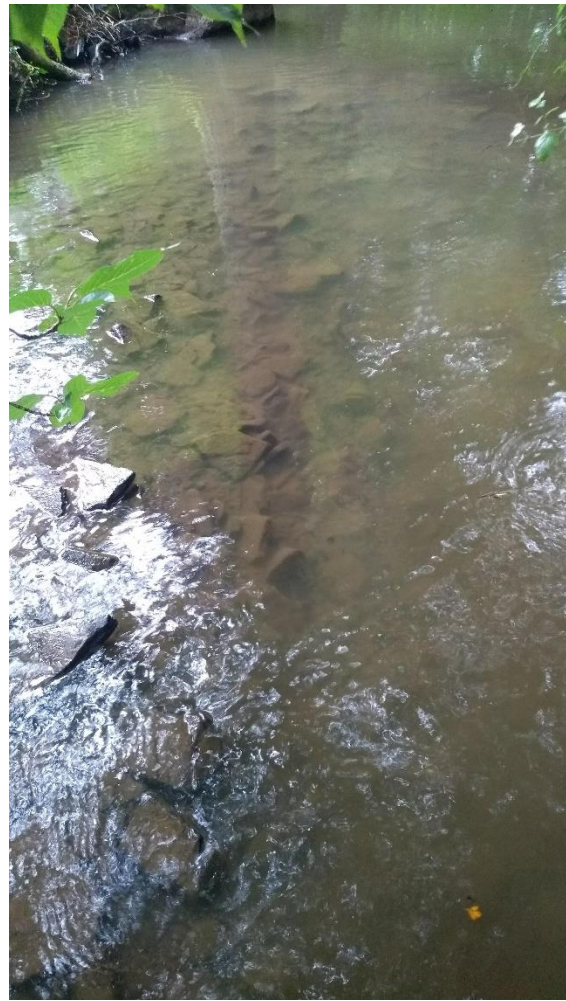
Location O wider shallow reach on bend toward the outfall location. Larger stones under water, smaller shale and gravels on one bank.

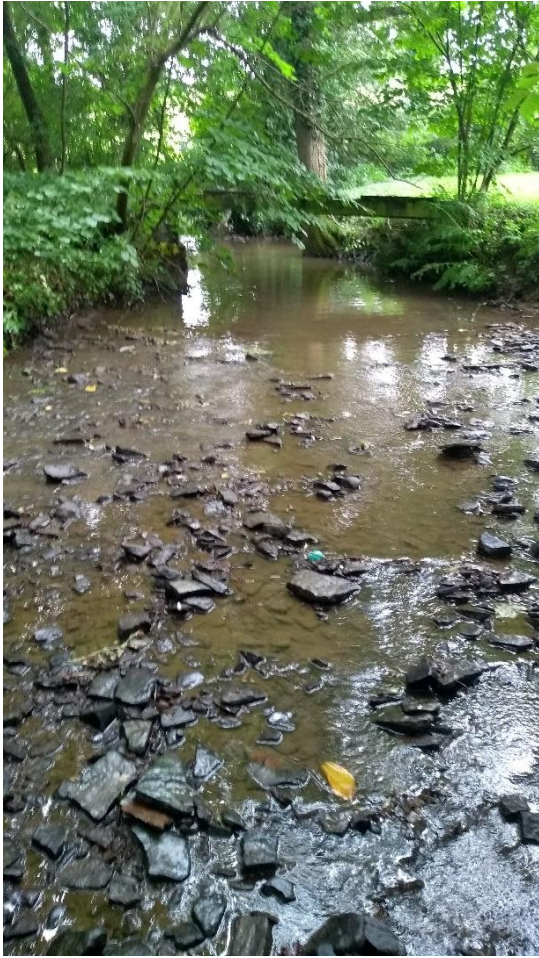
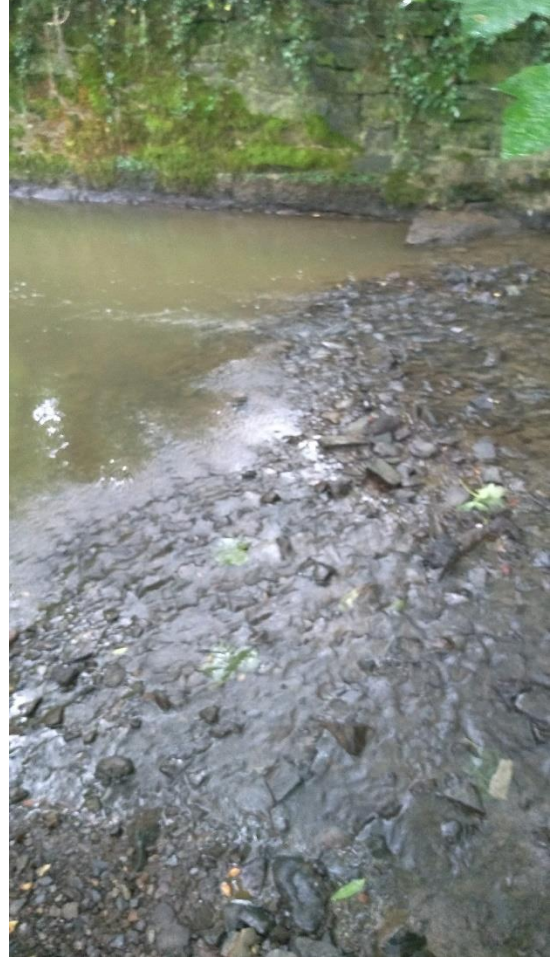
Location P is looking upstream and downstream from approx. 15m upstream of the culvert outfall location.

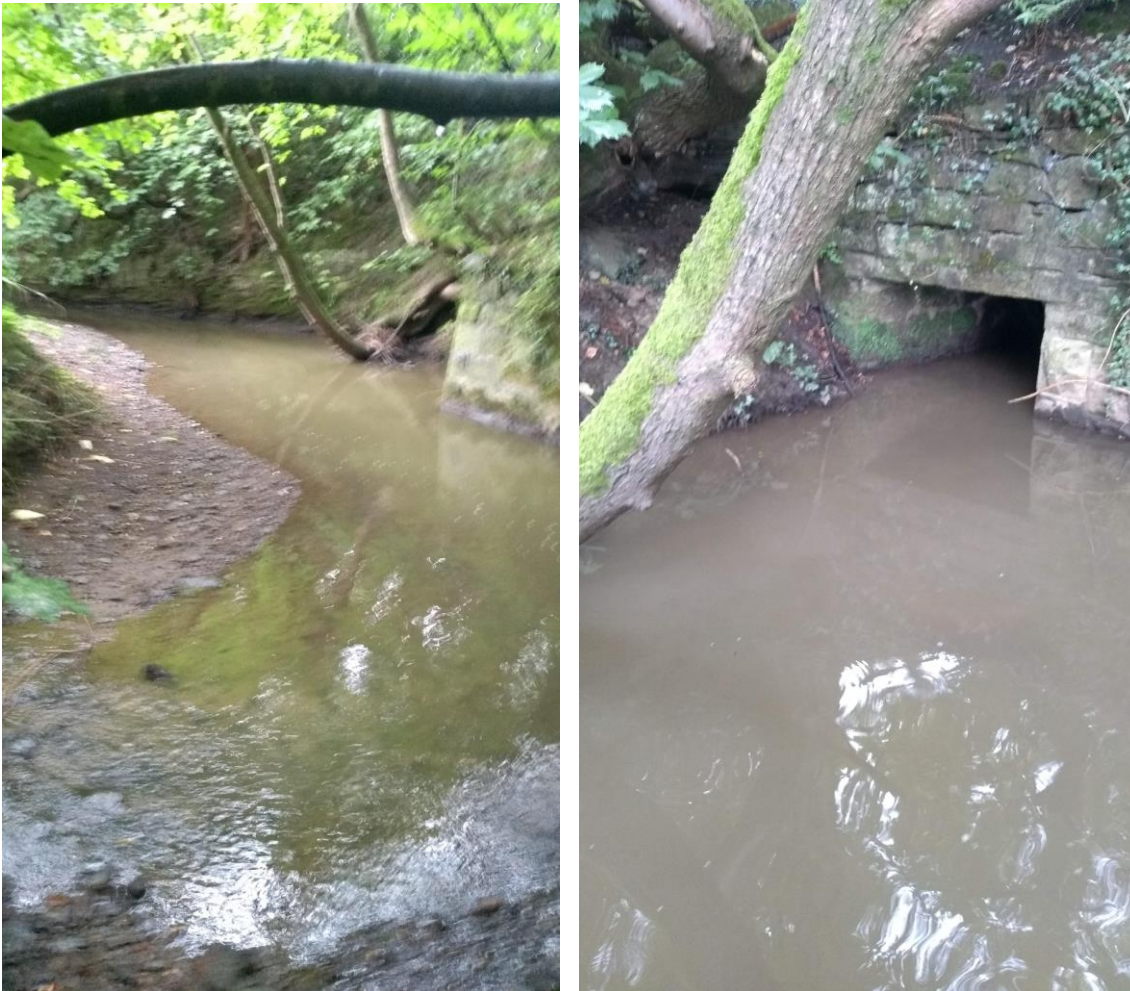
Location Q is looking near the outfall downstream and showing the outfall.

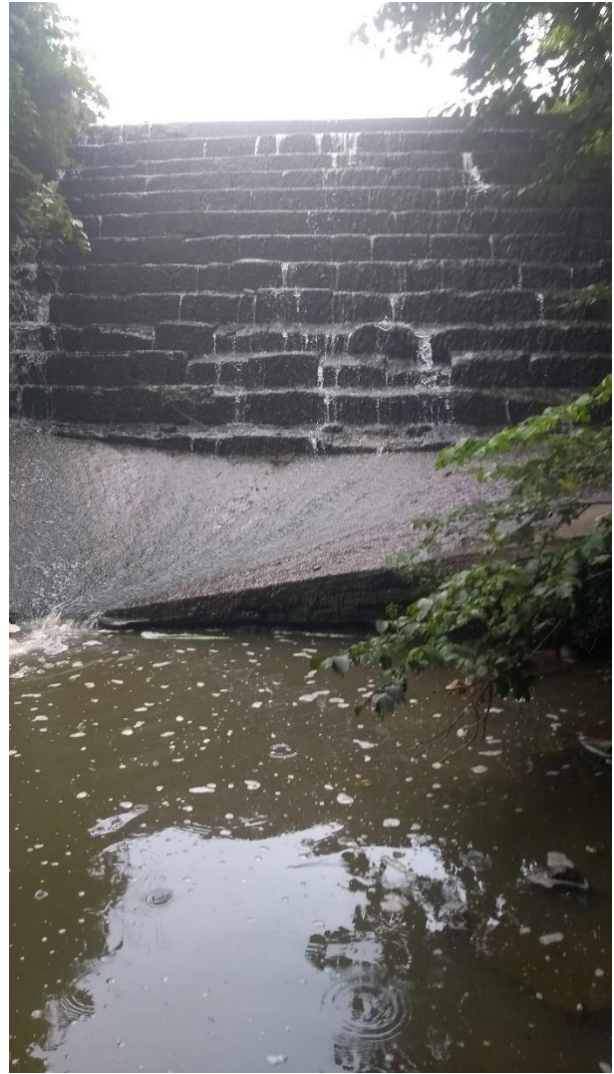
Figure 2: Overspill dam weir from above and below.

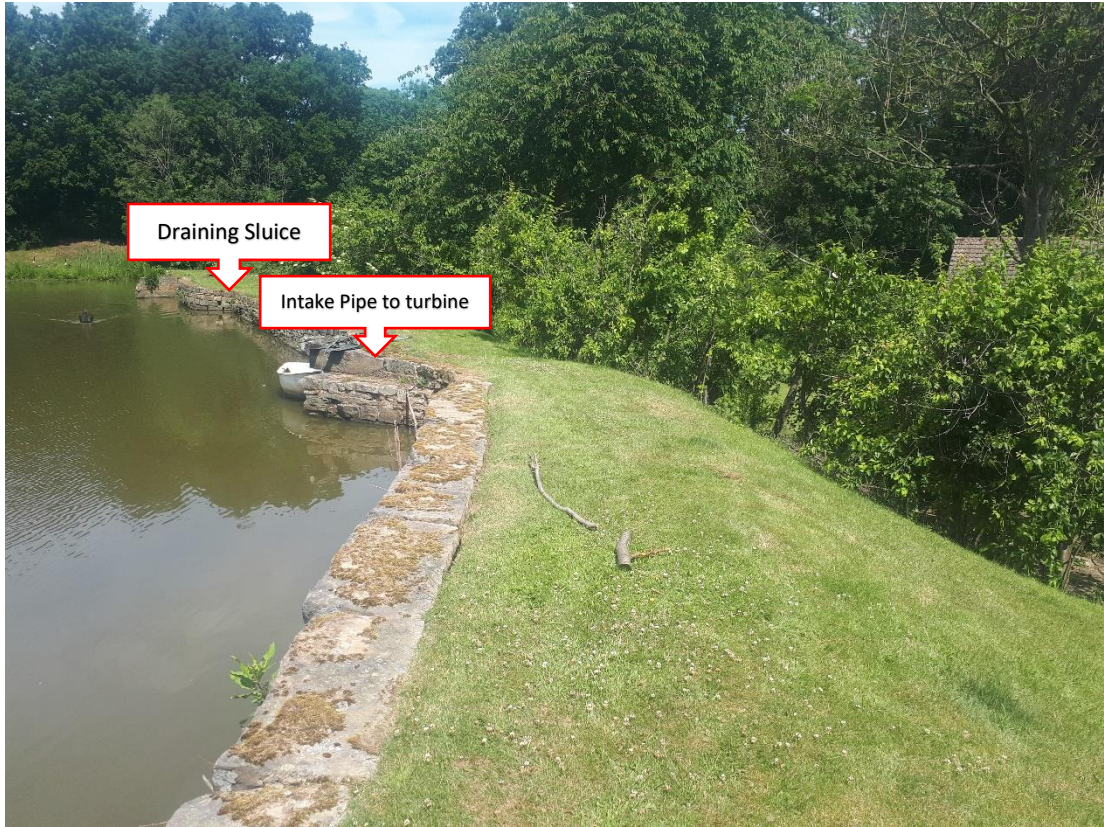
Figure 3: Mill Pond draining sluice and intake pipe to turbine house location

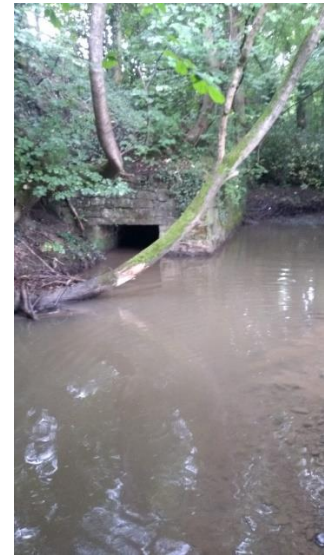
Figure 4: Wheel pit culvert entrance and culvert outfall.

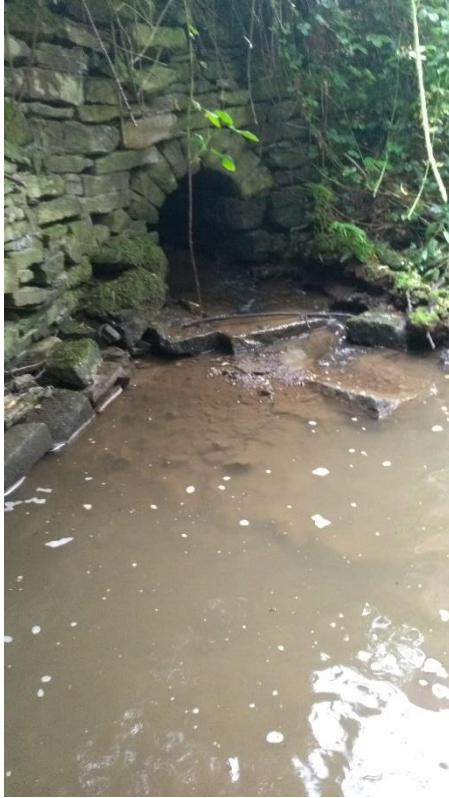
Figure 5: Tributary culvert outfall, 85m downstream of weir.

There is a small tributary, Figure 5, joining the River Moss, approximately 85 m downstream of the spill weir.

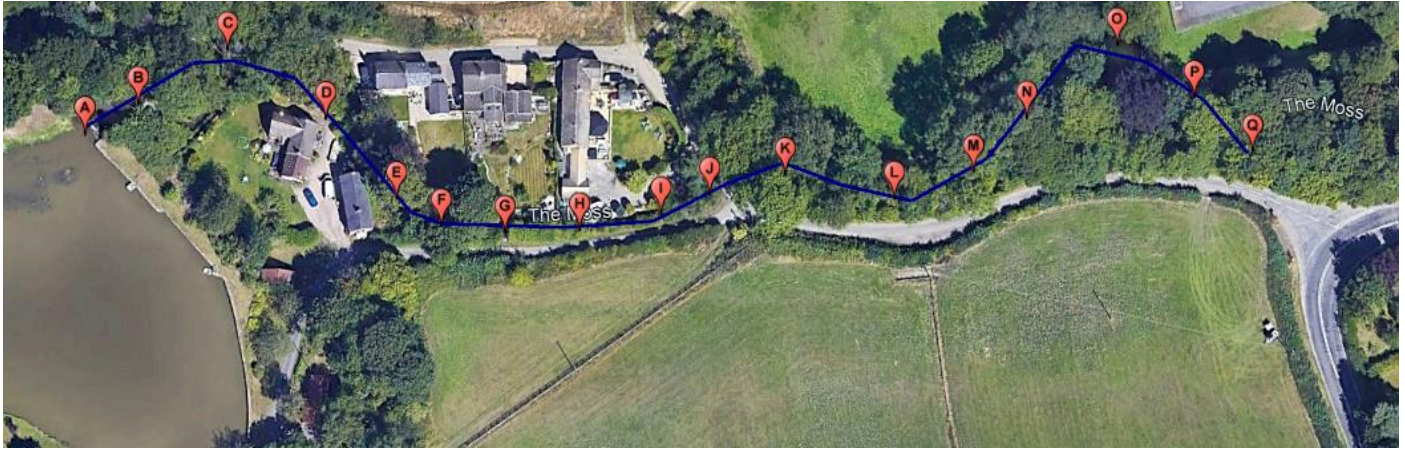
Figure 7: baseline survey assessment locations.

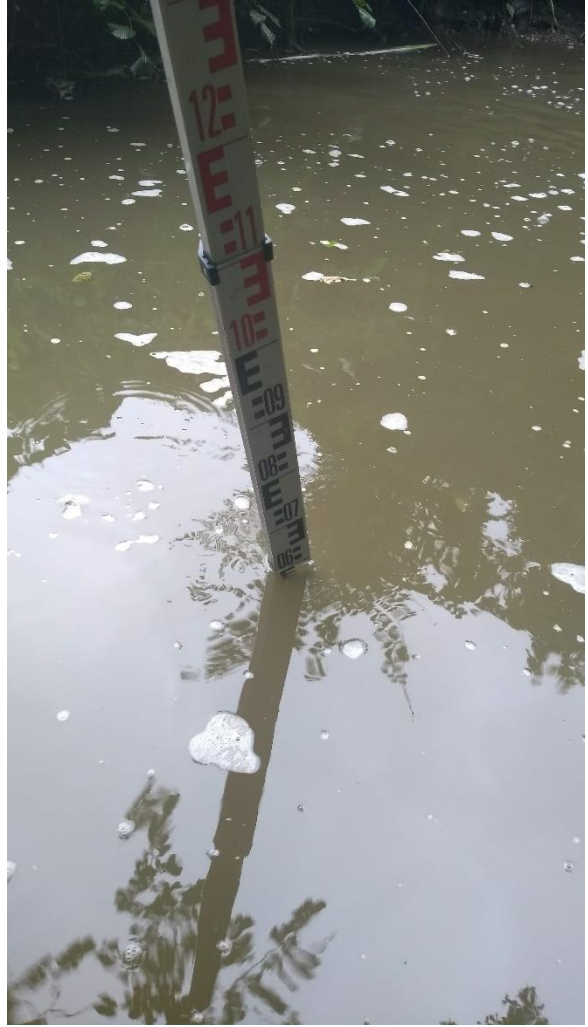
Location C is looking down the river toward the cottage on the first bend below the weir. Further photos show the nature of bed, bank and maximum pool depth below the weir in that area. Bed material is mostly larger stones.

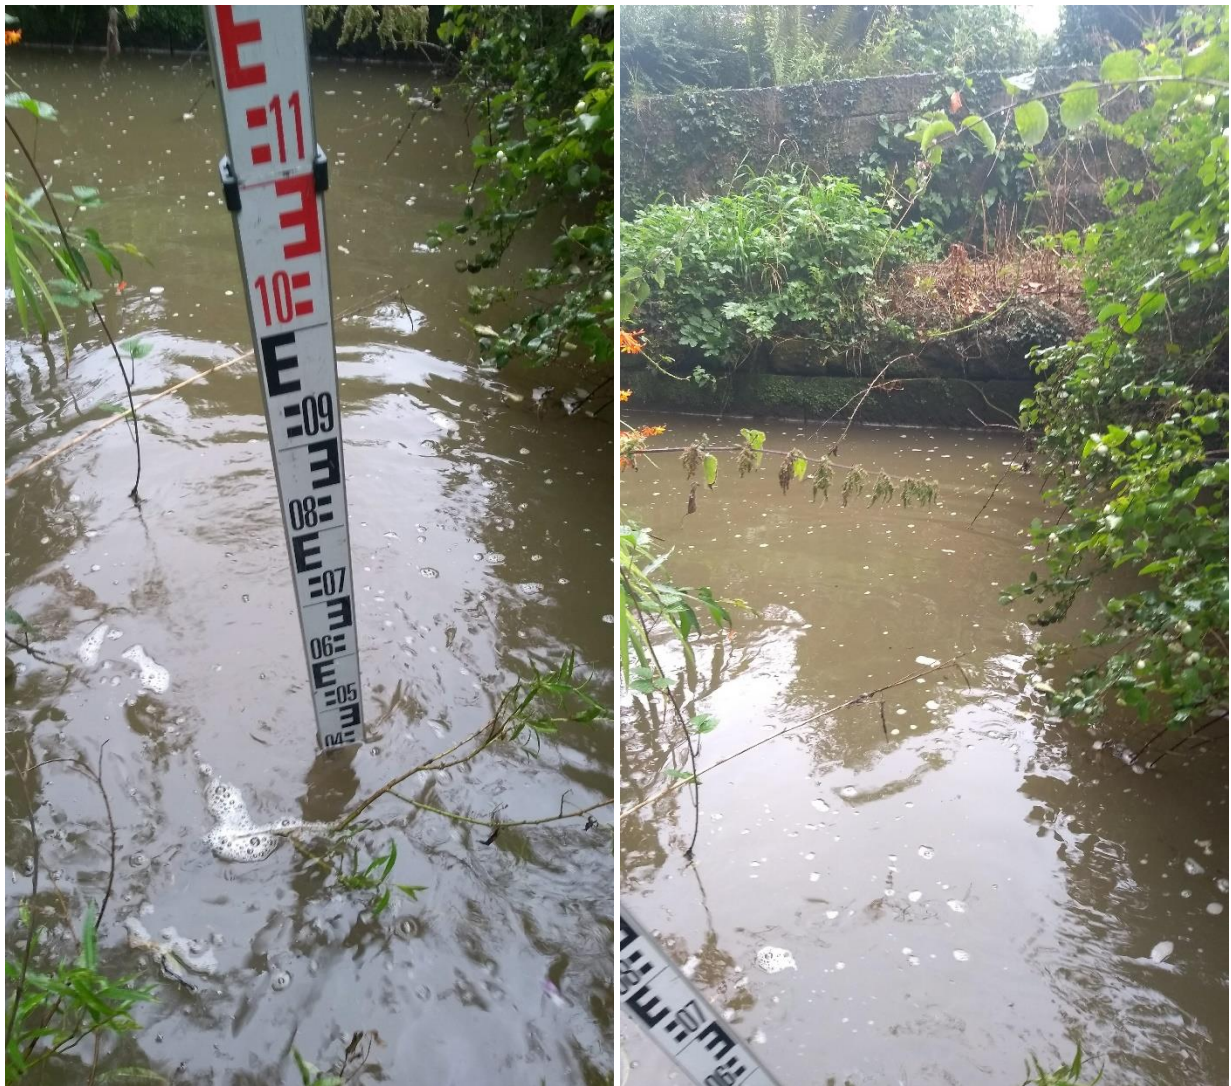
Location E is showing depth of corner adjacent to the bend by the Mill Cottage. Bed material is generally silty with large stones.

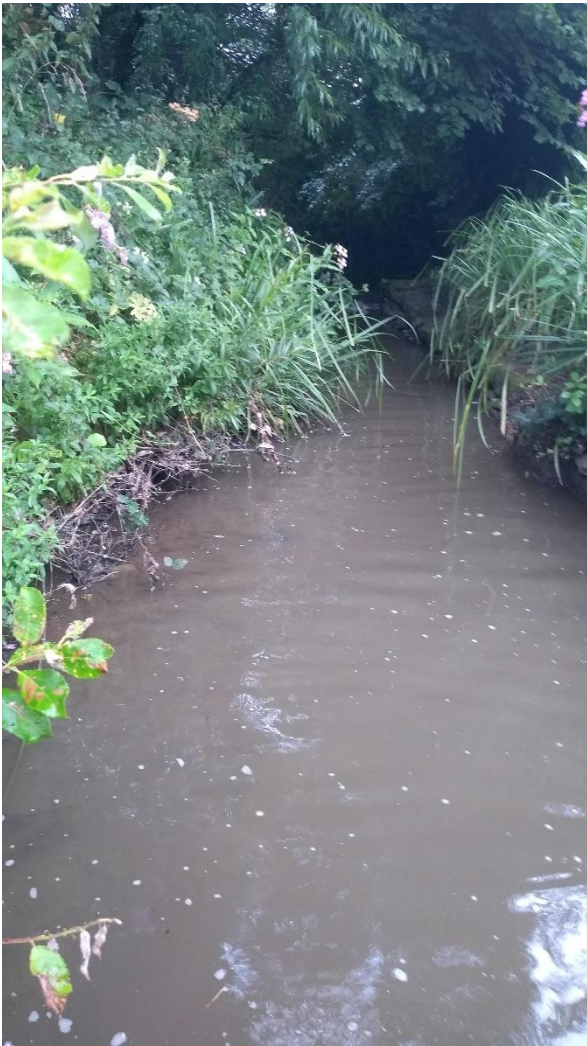
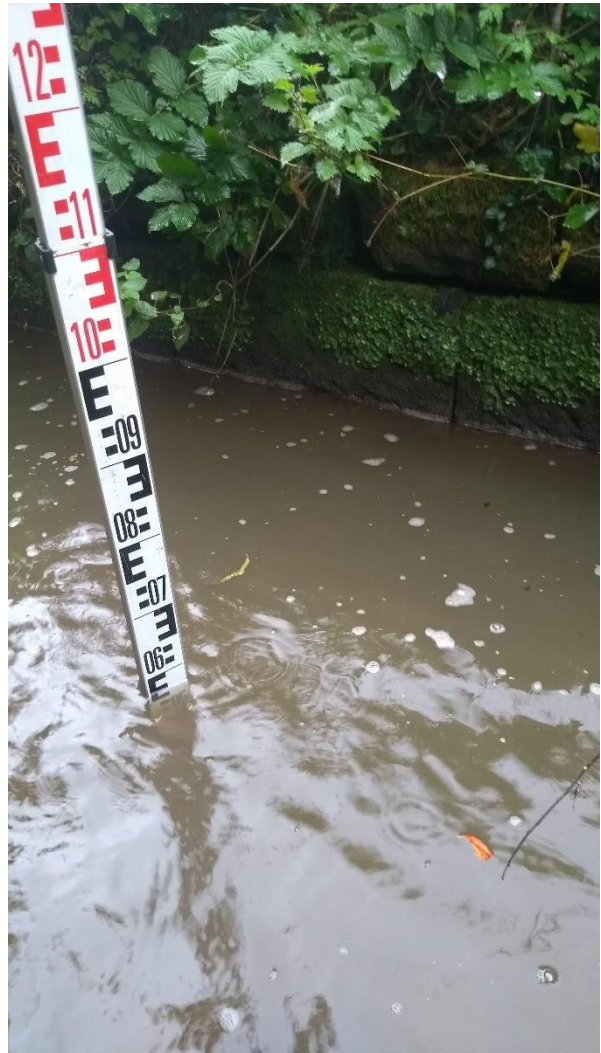
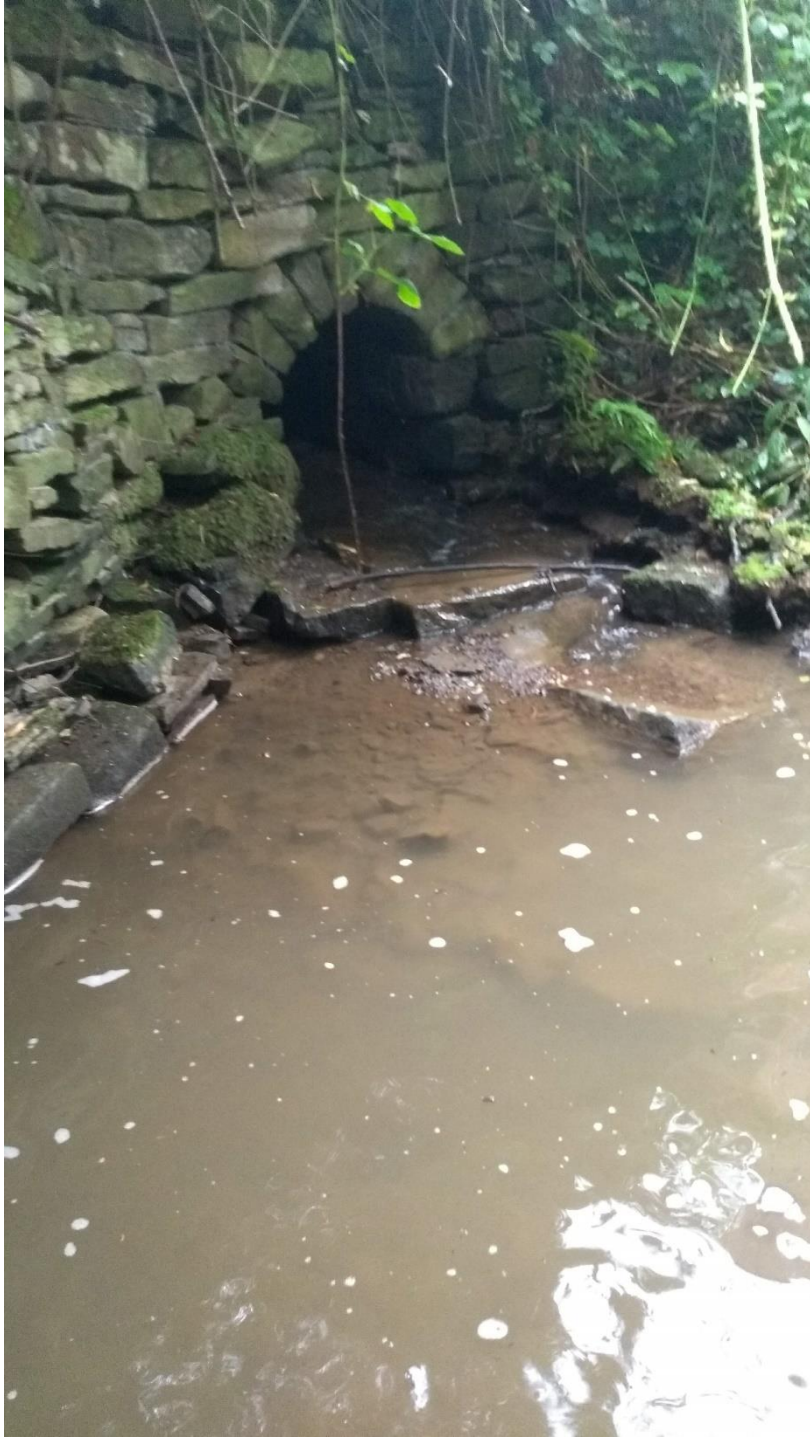
Location F is looking downstream just below the bend at location E. Depth and bed material remains consistent with location E. Outfall of culvert from small tributary between E and F also shown below.

Culvert outfall of tributary to the Moss shown in figure 1.

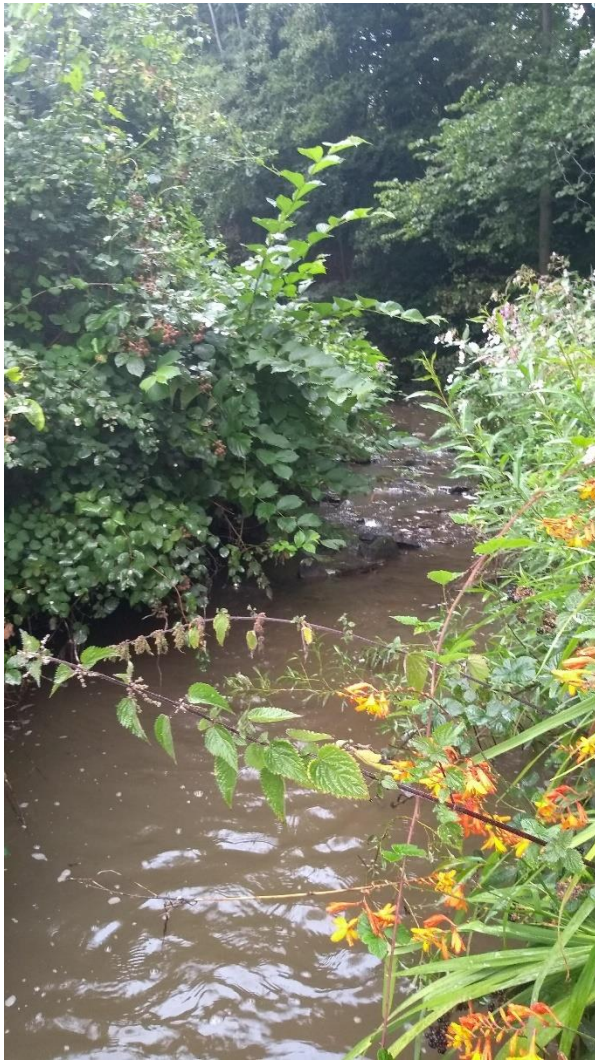
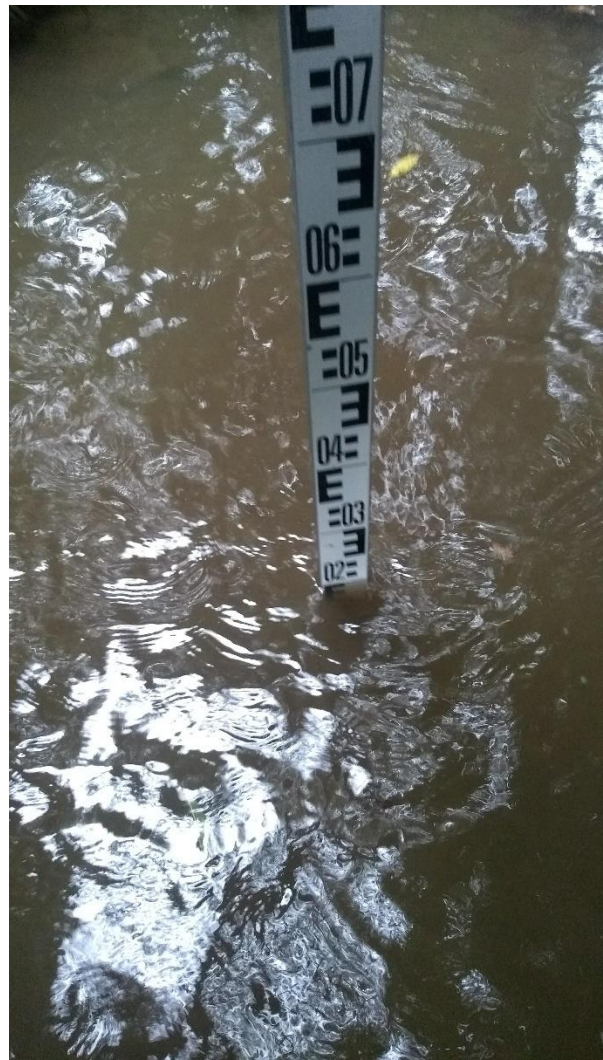
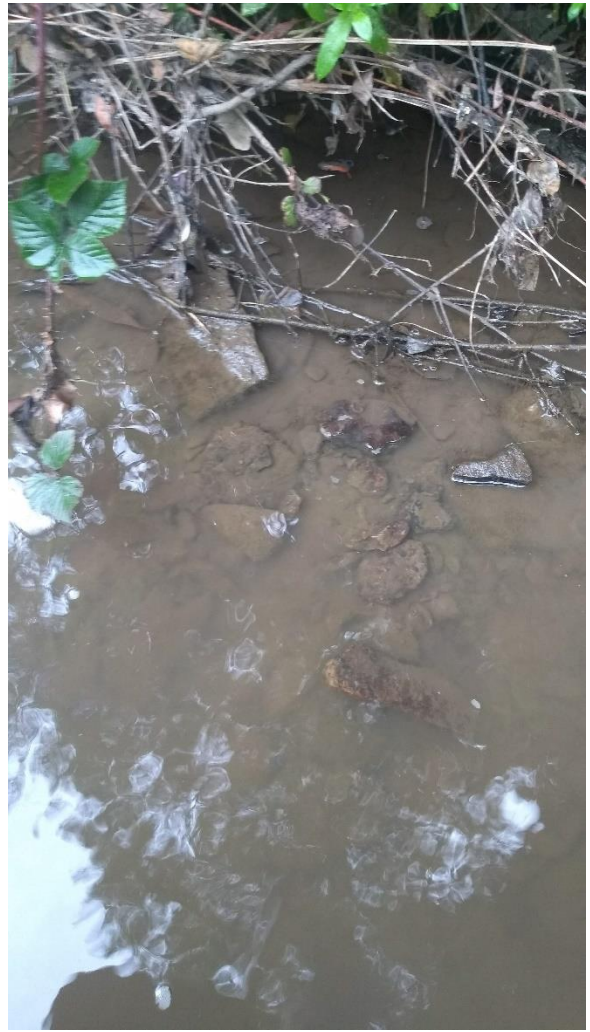
Location G shallows again. Bed material remains mostly larger stones but build-up of silt and some smaller stones on banks. River approximately 3 m wide.

Left bank / right bank facing downstream

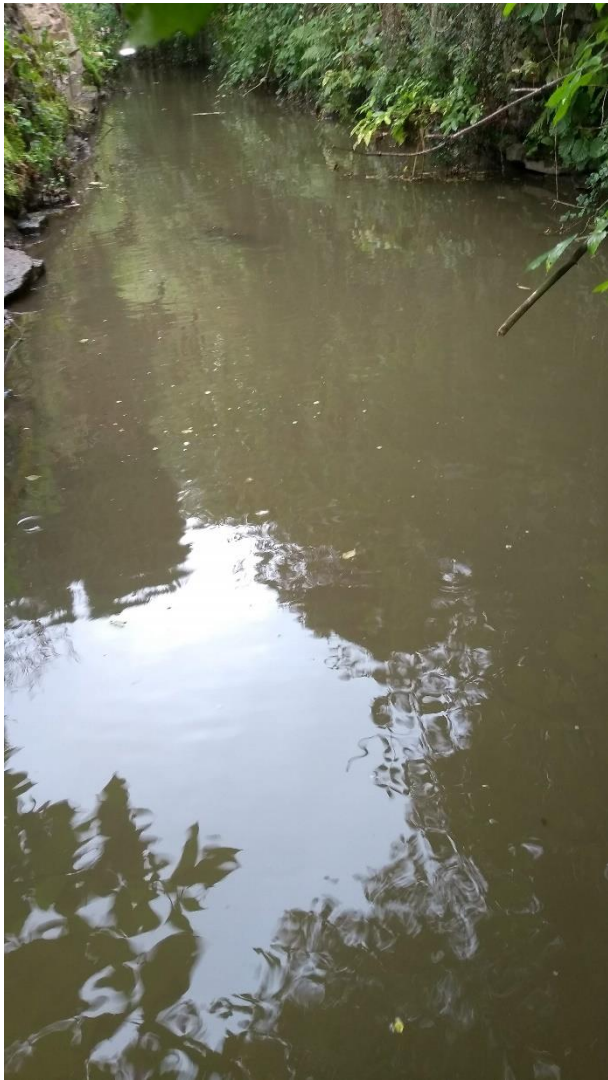
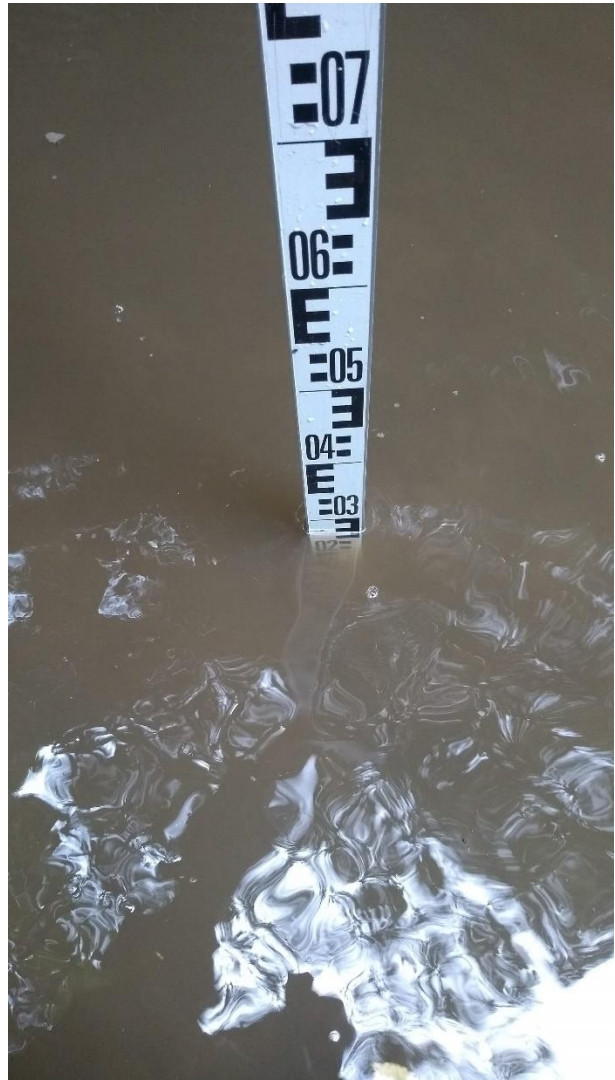
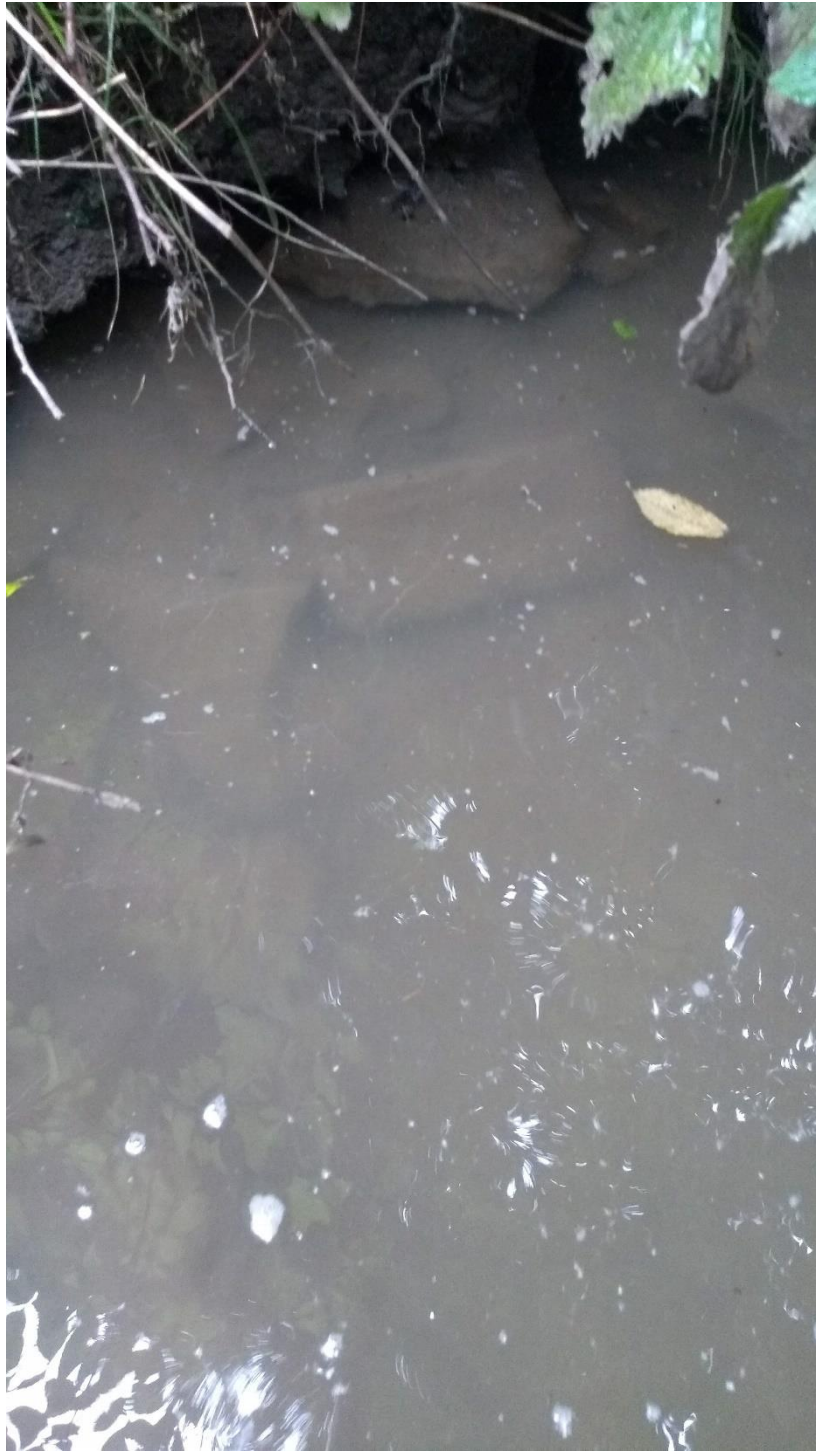
Location I becomes a 'man-made' channel from location H toward the bridge at location J. Depth and width are uniform. Bed material is a mix of rubble and stones. Still silty.

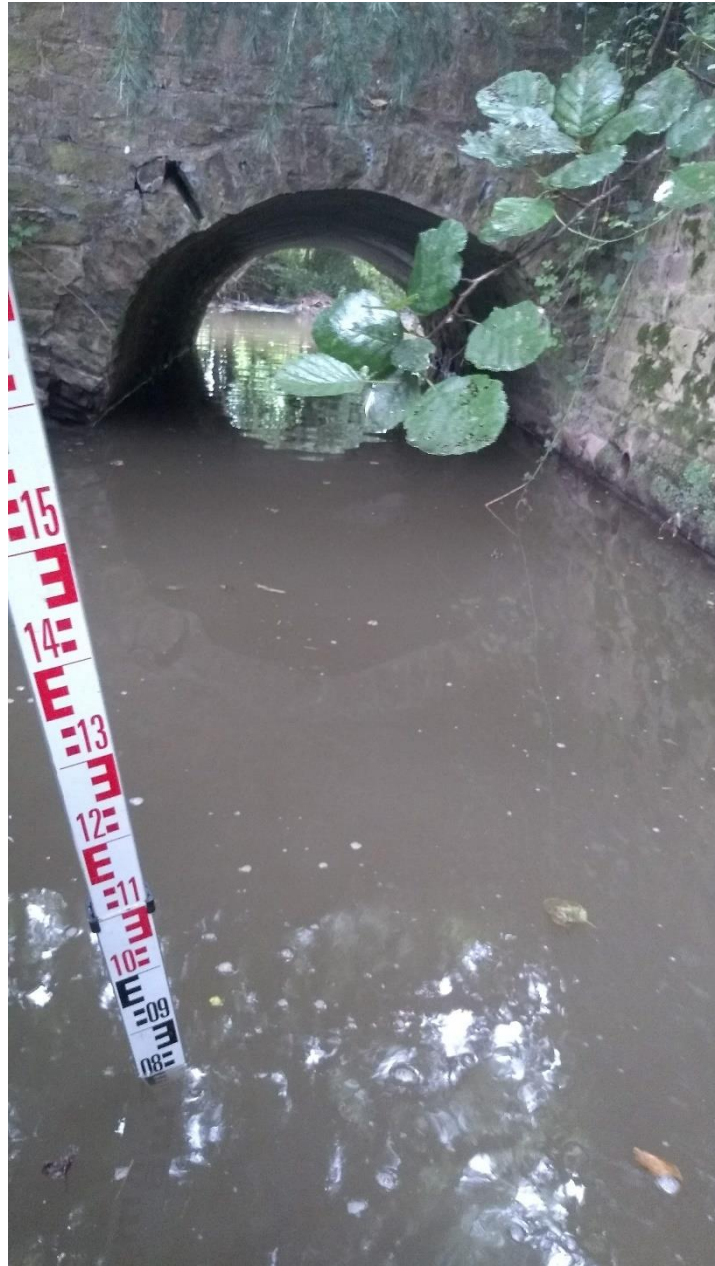
Location J is upstream of the bridge. Depth becomes too deep to wade (over 1.3 under bridge). Bed is all rock/stone with no small material evident.

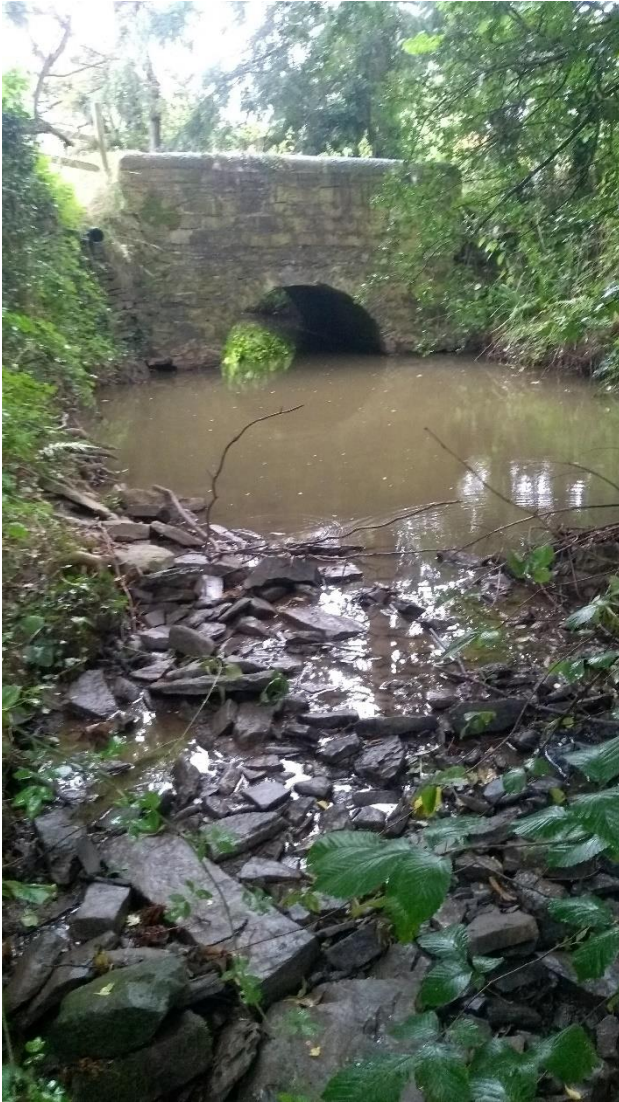
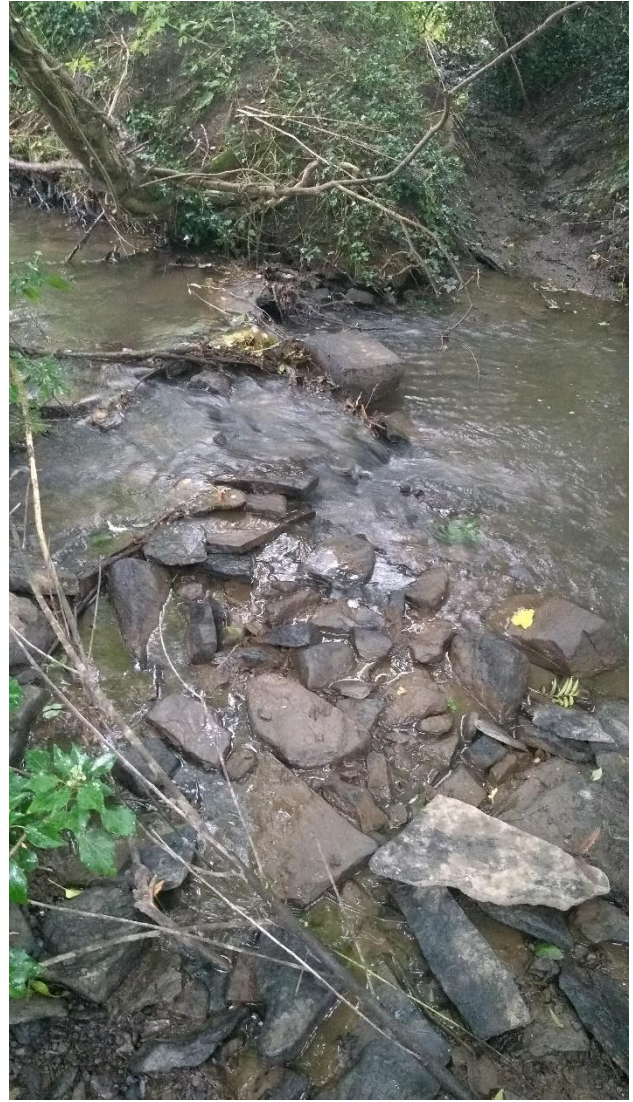
Location K is looking upstream toward the bridge and across the 'natural' weir and small tributary ditch.

Material deposited from upstream, through bridge scour during high flow events, explaining lack of bed material immediately upstream.

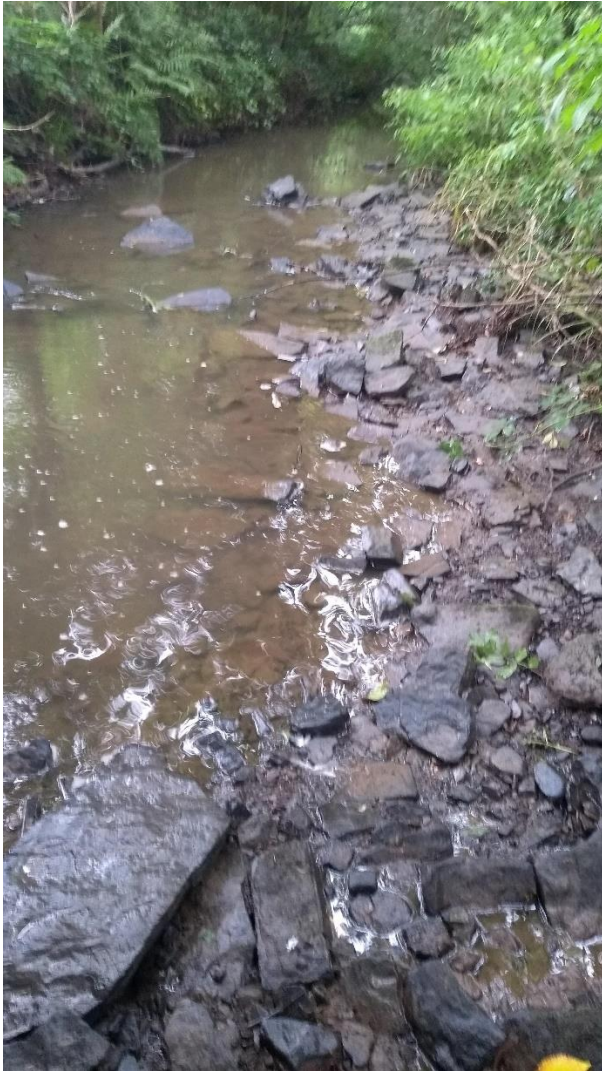
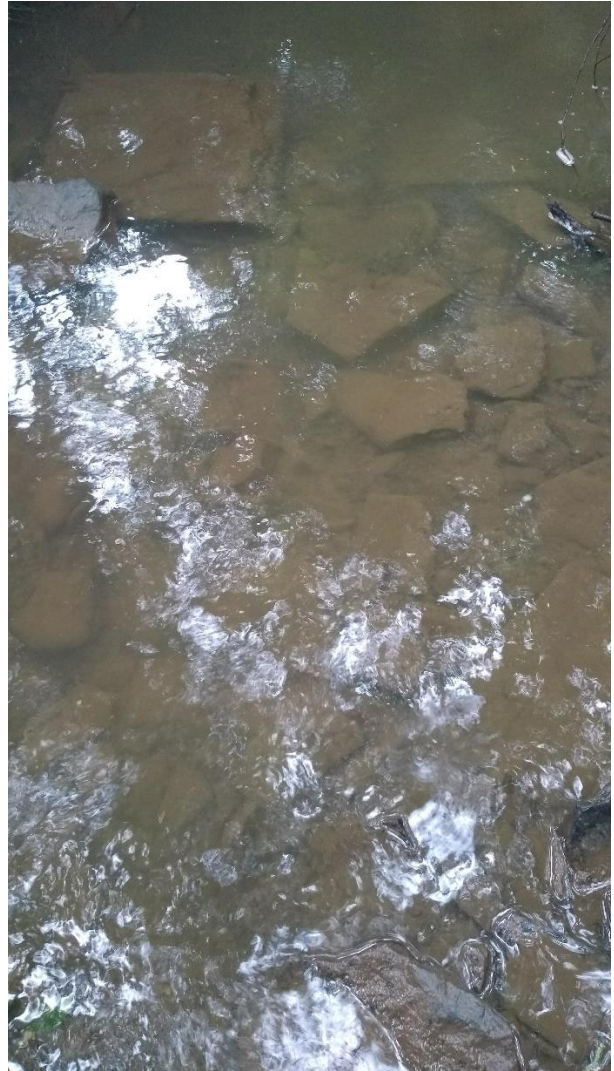
Location L the river widens, shallows and slows again. Bed material is uniform mix of rocks and shale.
