Birley Hay Farm Hydroelectric Power Scheme

Environmental Report

Birley Hay Farm

Fisheries assessment

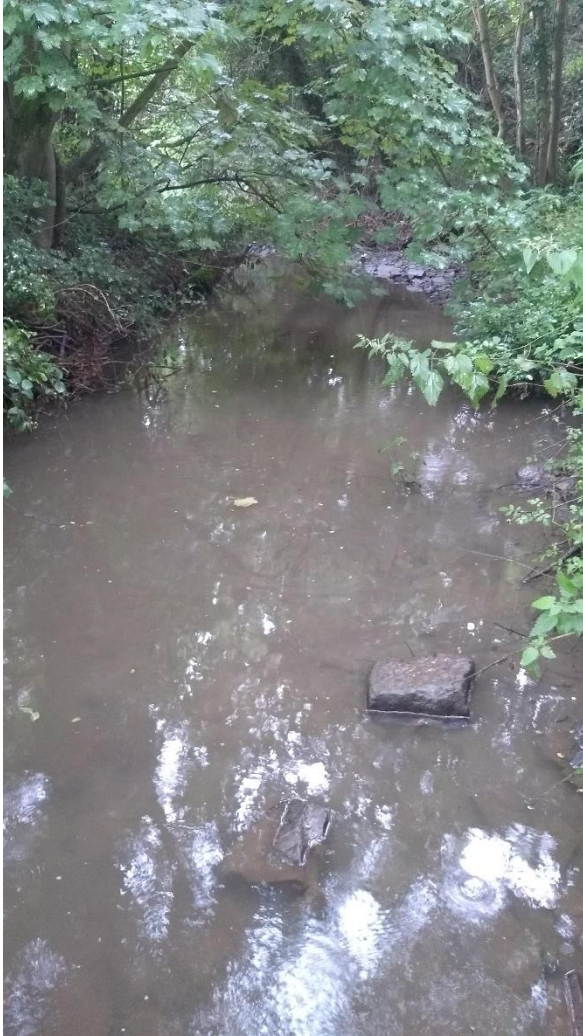
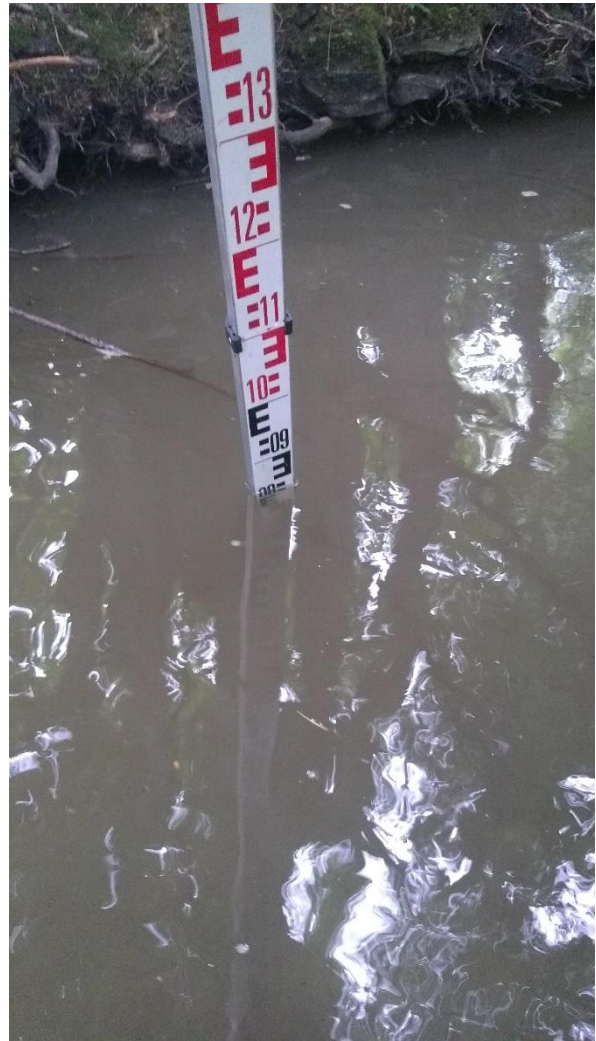
Location M

Location M, the river continues with a mix of deeper pools and shallow reaches over a distance of around 25m.

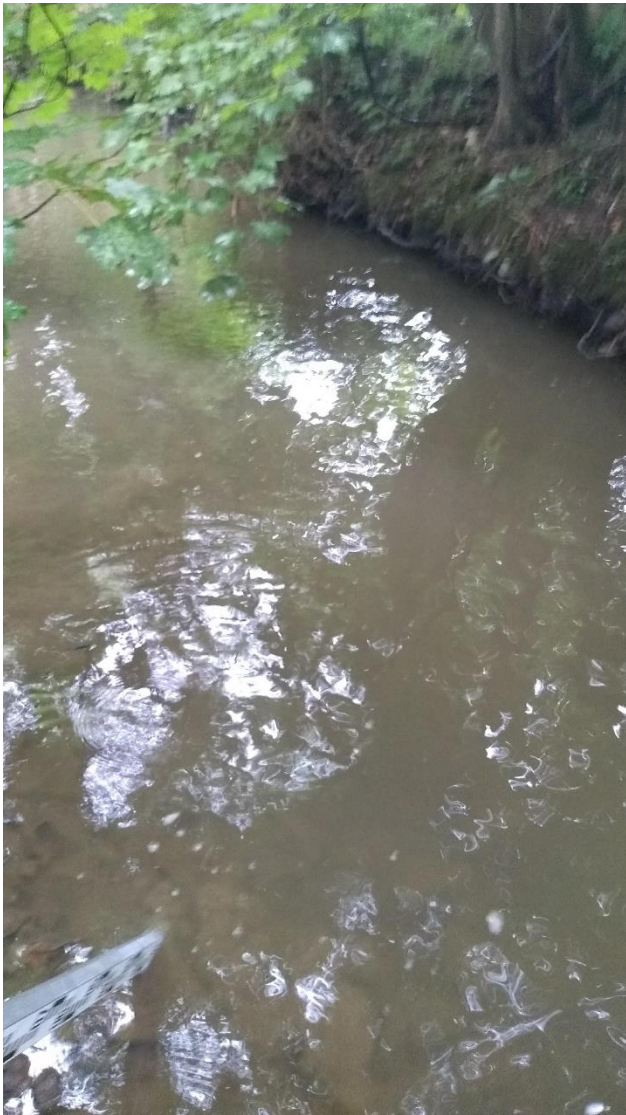
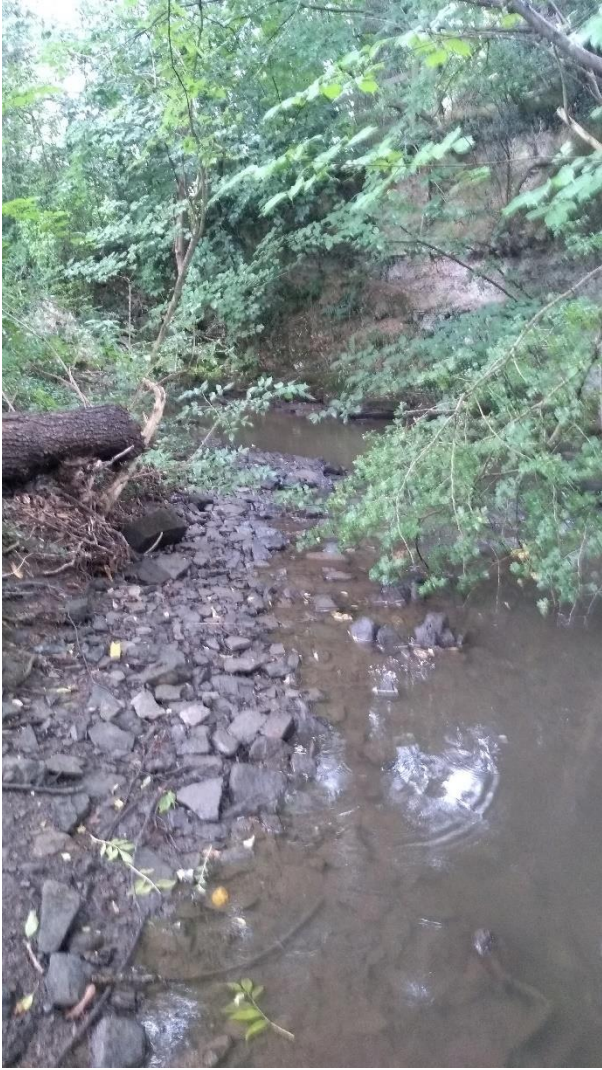
Location N

Location N, the river continues with a mix of deeper pools and shallow reaches over a distance of around 50m.

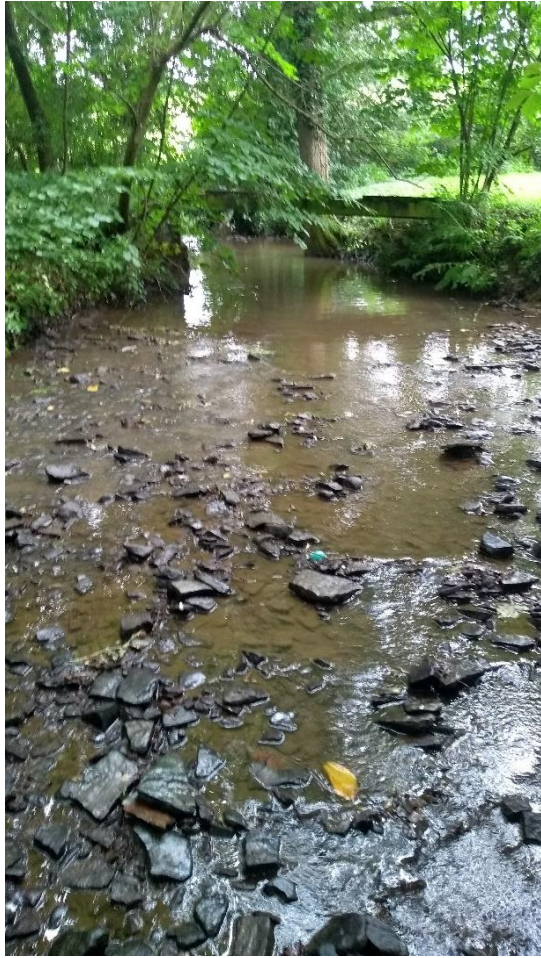
Location P is looking upstream and downstream from approx. 15m upstream of the culvert outfall location.

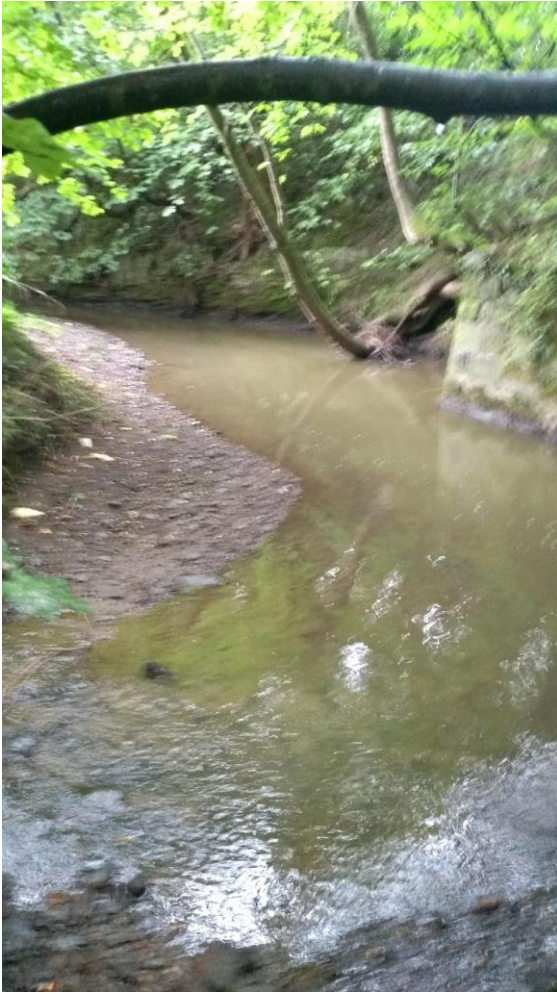
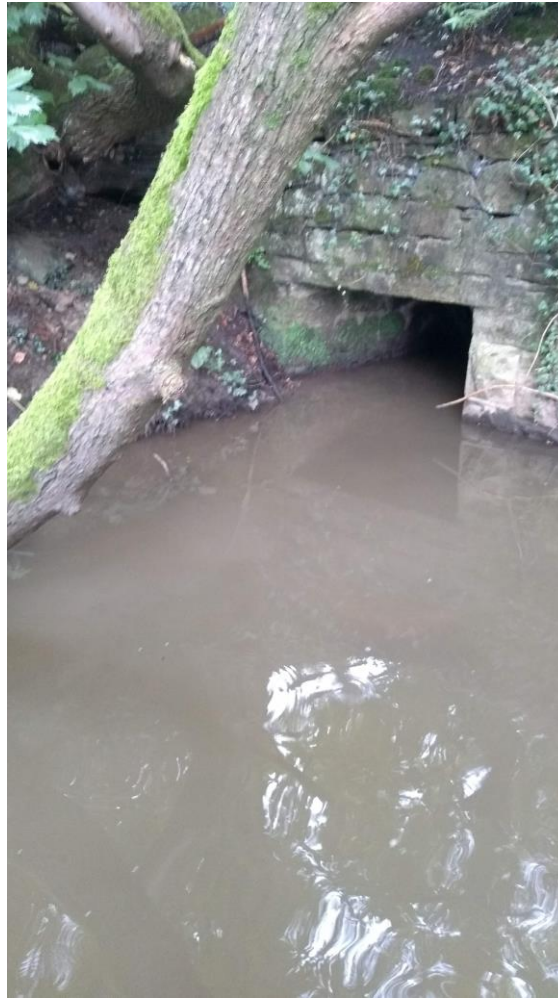
Location Q is looking near the outfall downstream and showing the outfall.
