| AD ANDIDRAIN | | CLIENT : UNITED UTILITIES | |
| DRAIN CLEARANCE - SEWER SERVICES | | Drawing Title : BURMLEY WWTW | |
| This document is the property of Andidrain and should not be used for any other purpose without the permission of Andidrain. It is provided on the understanding that Andidrain is not liable for any loss or damage arising from its use. | | Dwg No : 1 | |

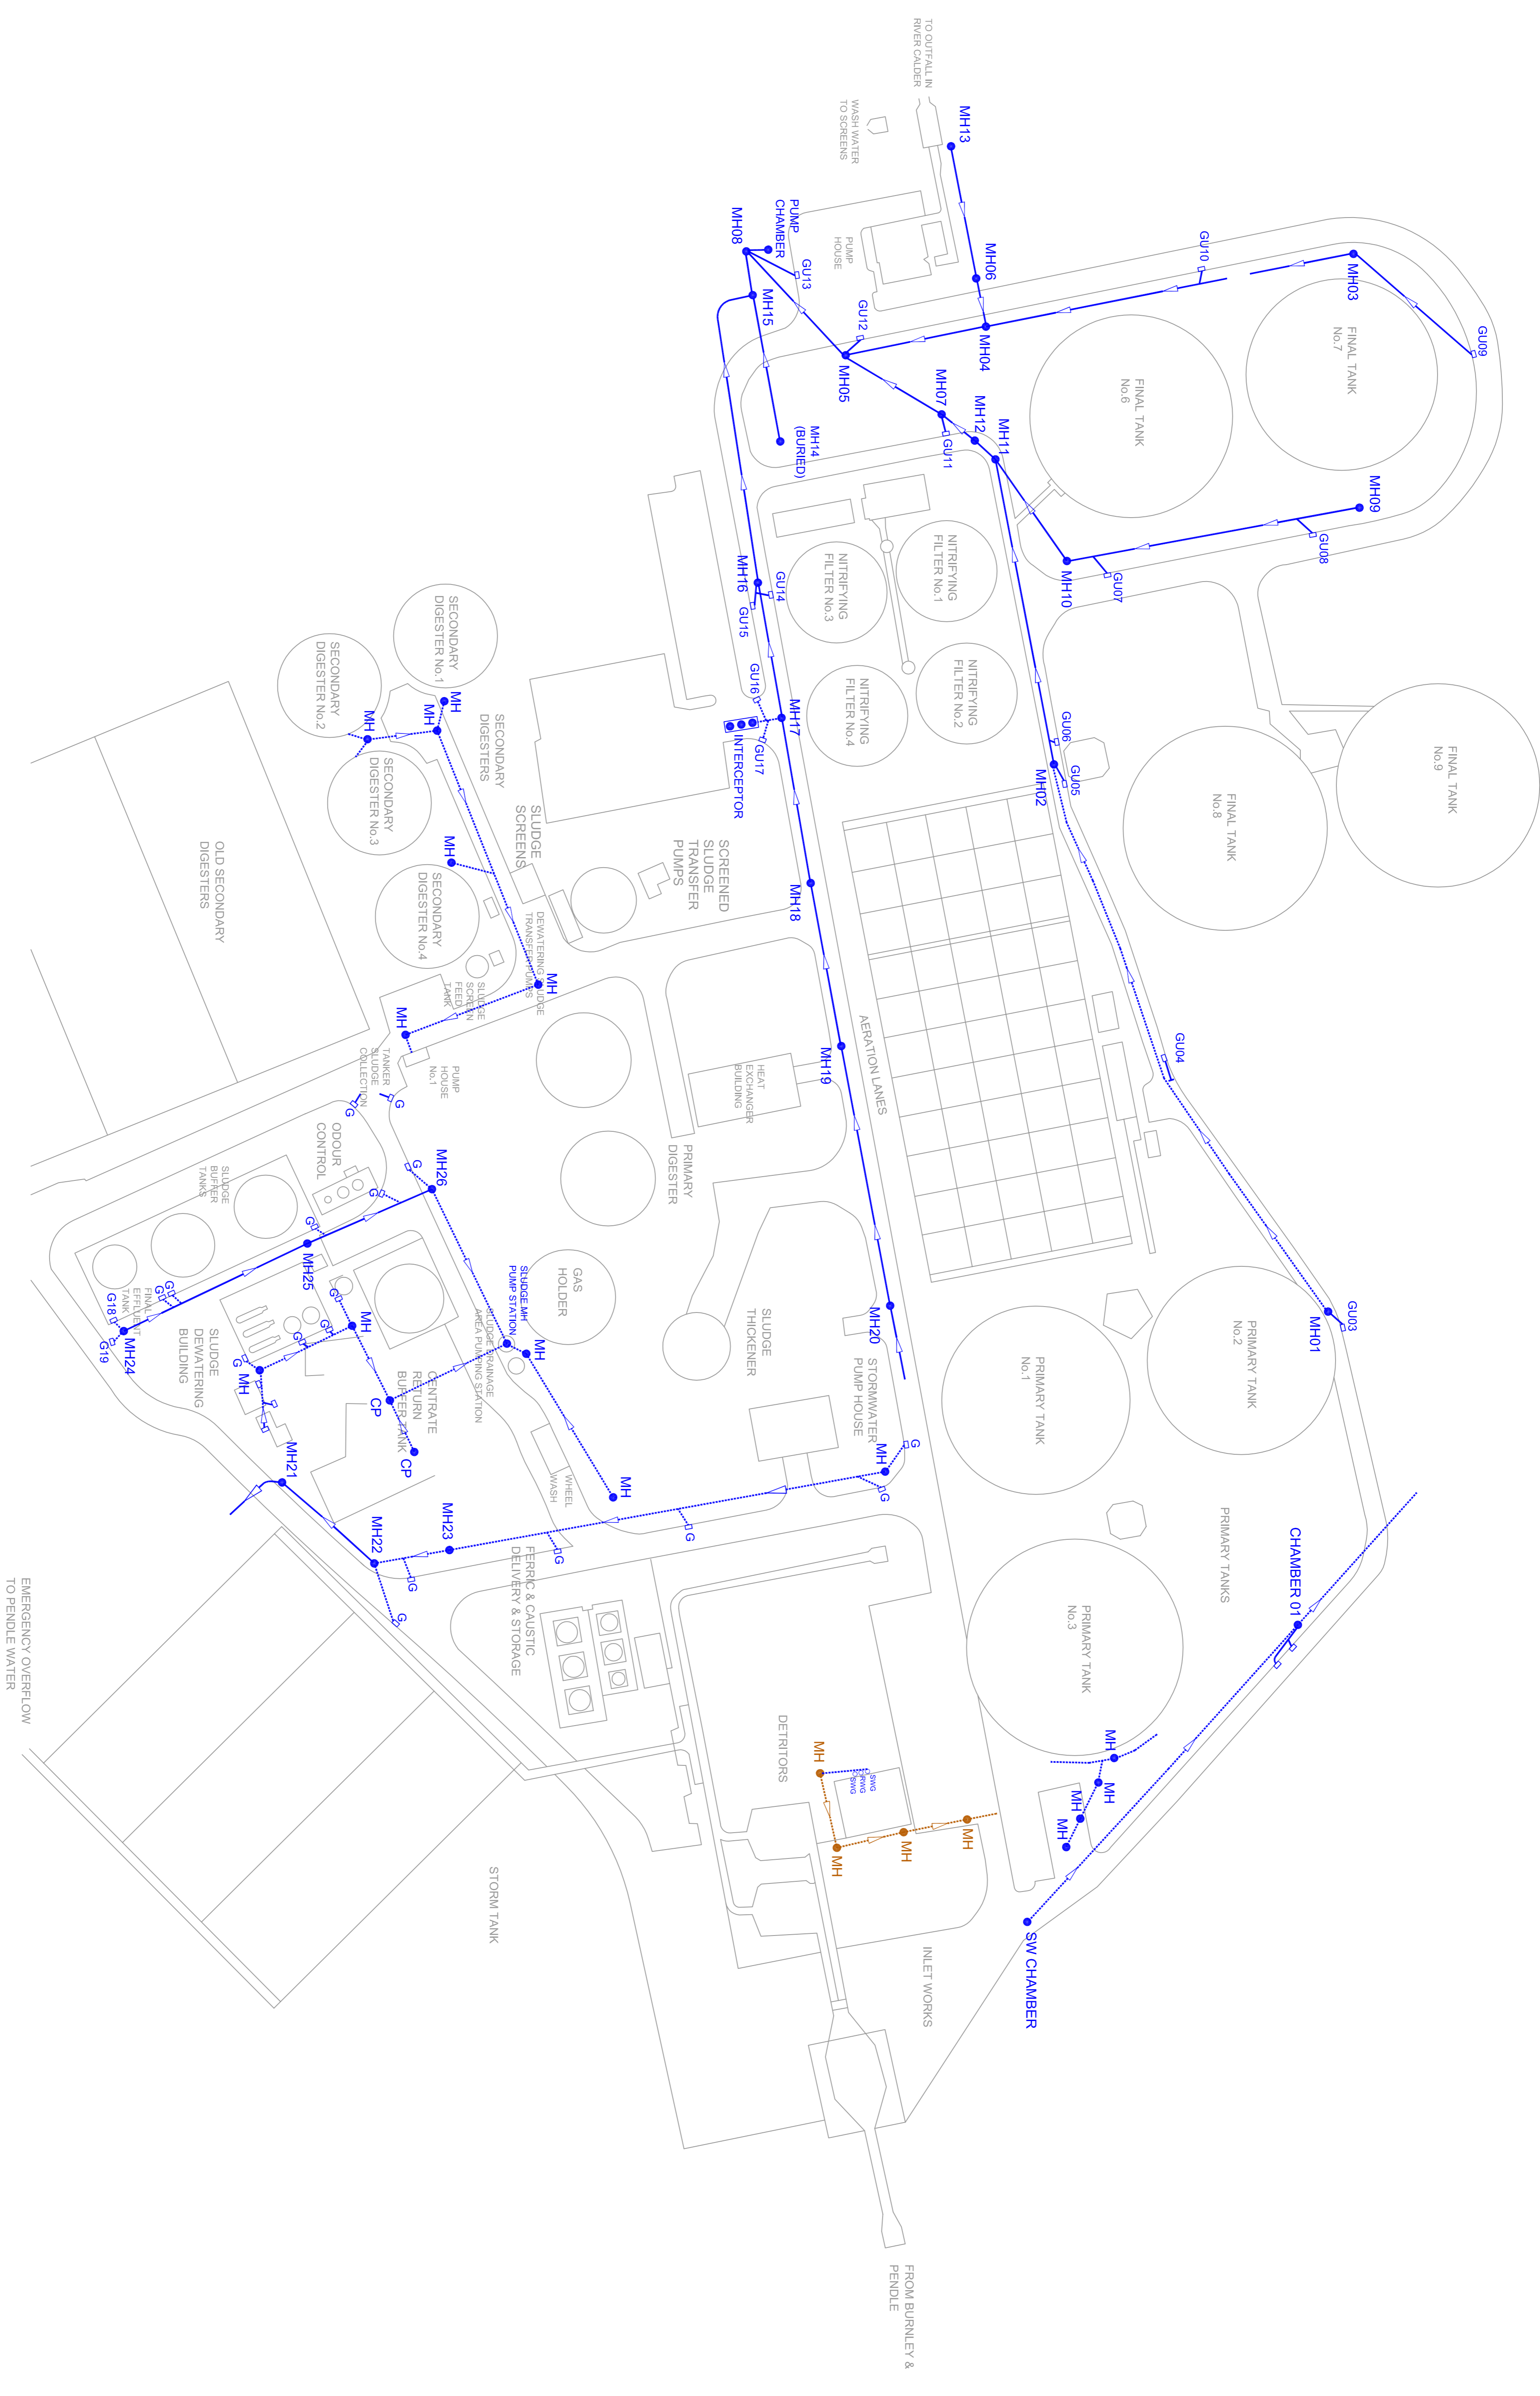
MANHoles INSTALLED IN GROUP ARE IN HIGHER THAN THAT OF THE GROUP PIPE RESULTING IN THE CREATING A SIFT TRAP

REASON WHY MANHoles SITS FULL OF WATER
