# THE ARLEY CONSULTING COMPANY LIMITED

**Report No 05292/11**

**ENVIRONMENTAL SETTING AND SITE DESIGN  
for the  
FORMER SAPPI PAPER MILL  
BLACKBURN**

**BLACKBURN WATERSIDE REGENERATION LIMITED  
4th Floor  
Queen Victoria House  
41-43 Victoria Street  
Douglas  
Isle of Man  
IM1 2LF**

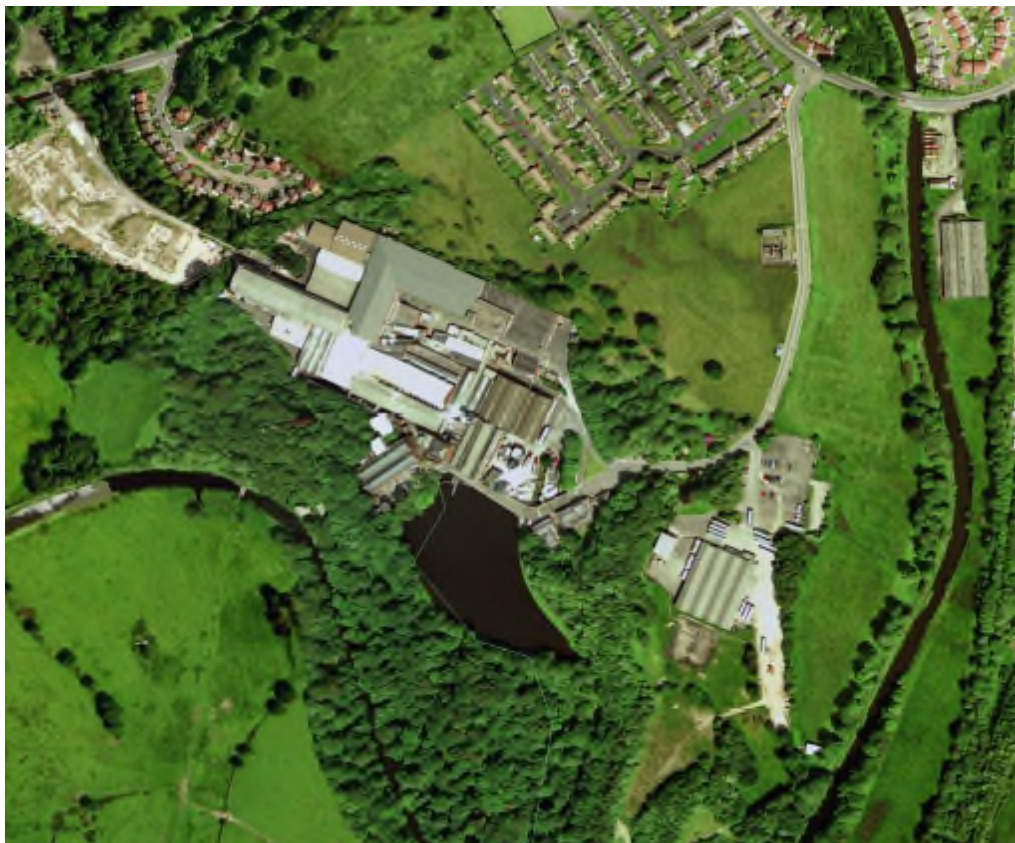
**Figure 1: Google Earth Image 2000**

3.1.2 Google Earth imagery for the site is available from 2000 onwards and supports the site history presented in Table 2. Figure 1 below is from 2000 which shows the Sun Mill largely demolished but the Star Mill in the centre of the site.

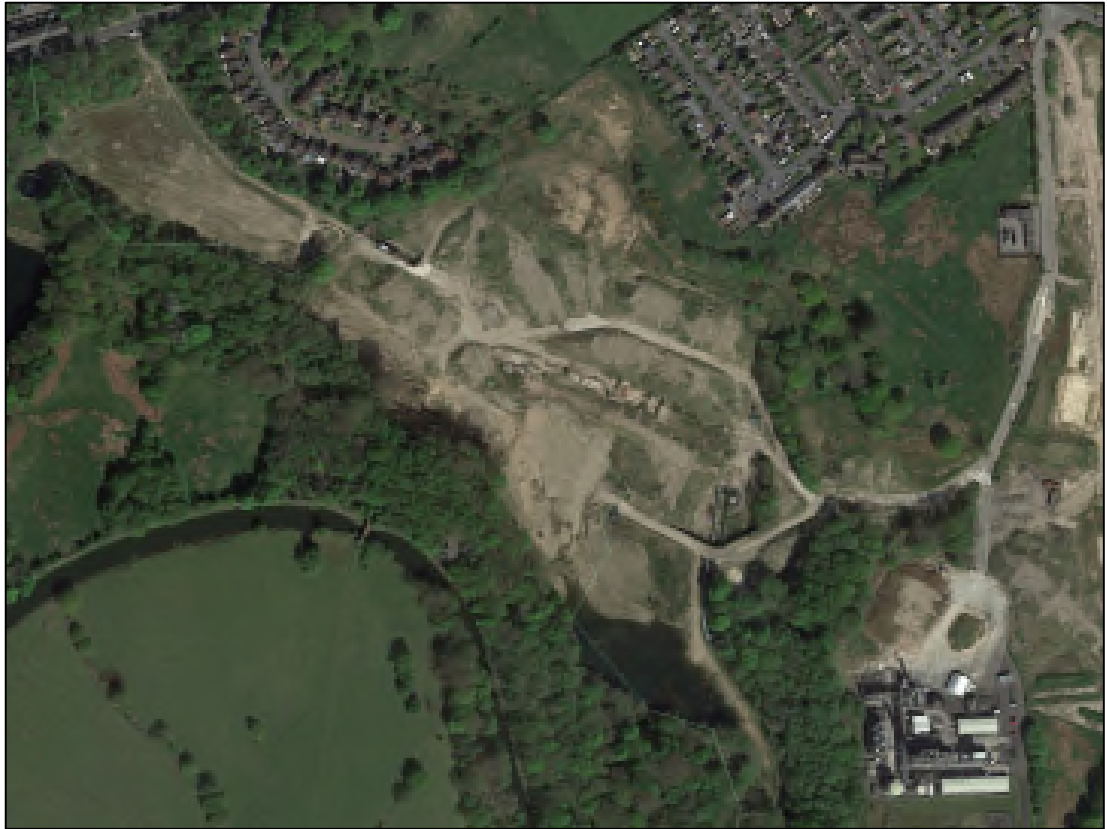
Figure 2: Google Earth Image 2020

- 3.1.3 Following demolition of the mills and the grant of outline planning permission for development, waste soil was imported under a Materials Management Plan. Around 88,000 m<sup>3</sup> of waste soil was imported under the MMP. This has been placed in stockpiles around the site, ready to be spread into engineered in according to the engineering specification.
- 3.1.4 Importation under the MMP ceased in 2019. No further development has been undertaken since this time.
- 3.1.5 Figure 2 below is a Google Earth image of the site taken in April 2020 showing Phase 4A in the centre with all buildings demolished and the Mill Lodge Reservoir partially infilled. This shows the situation at the time of permit application.

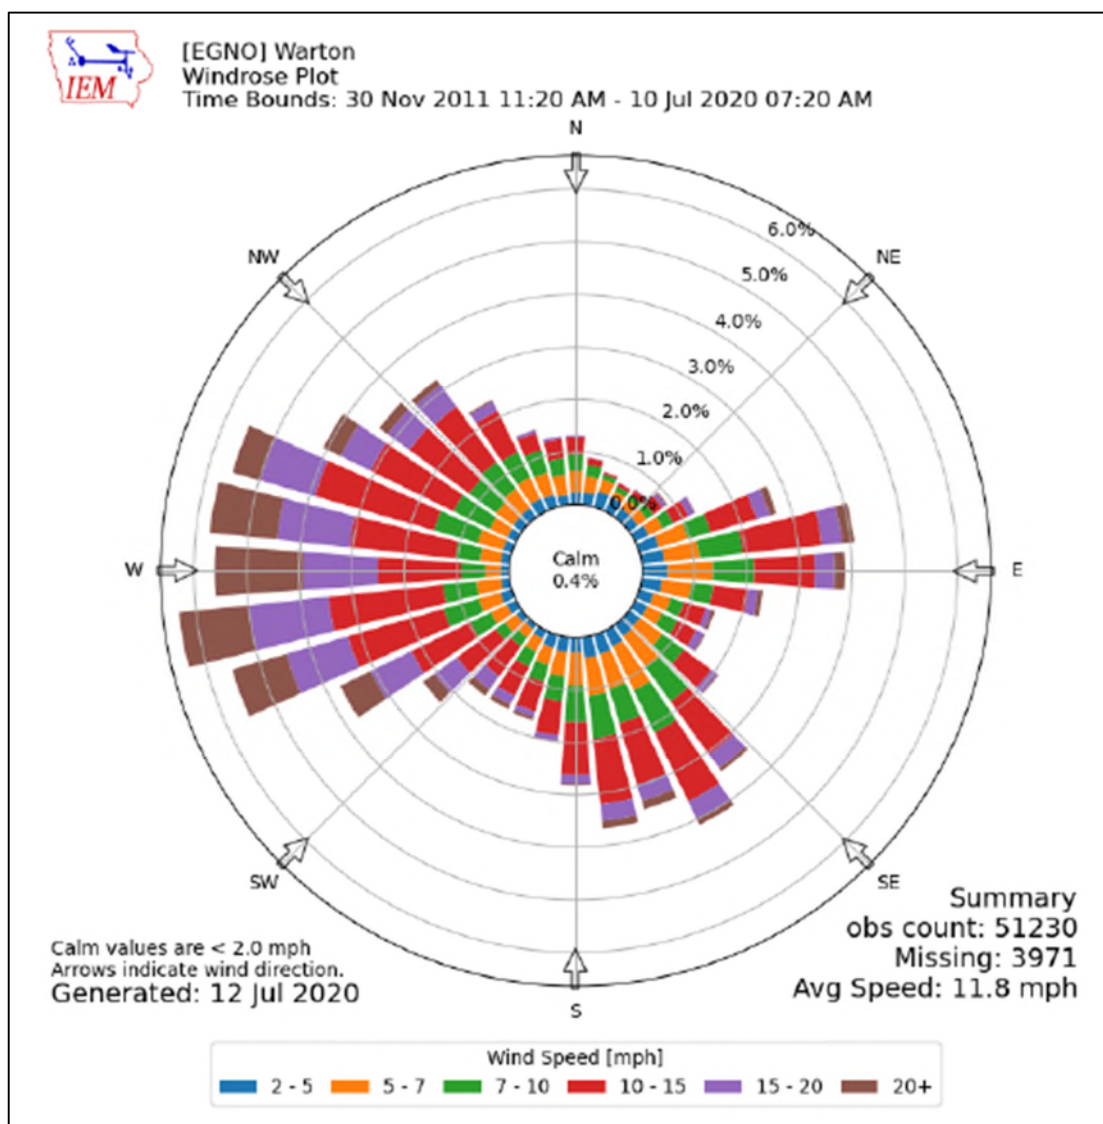
Figure 3: Annual Wind Rose for Warton Aerodrome

5.1.1 Information relating to wind speeds and direction has been obtained from the closest meteorological station at Warton Aerodrome, approximately 30 km west of the site. Data was obtained from IEM<sup>6</sup> and presented in Figure 3 below. The predominant wind direction is from the west.
