**PROPOSED WASTE TRANSFER STATION  
OFF LOWER ECCLESHILL ROAD,  
DARWEN, LANCASHIRE  
PHASE 2 SITE INVESTIGATION REPORT**

**PROPOSED WASTE TRANSFER STATION OFF  
LOWER ECCLESHILL ROAD, DARWEN,  
LANCASHIRE**

**PHASE 2 SITE INVESTIGATION REPORT**

**Date: 16/06/2014**

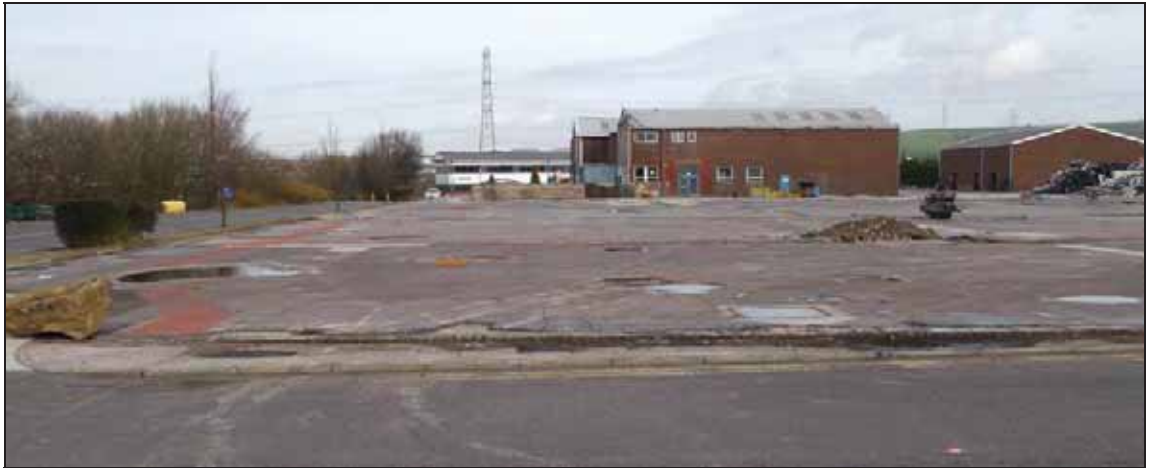
- 9.4.1 The proposed WTS development is to consist of a relatively large steel framed building in the central part of the site with associated access road and external operation area (vehicle unloading, turning areas etc). A separate welfare and office building and associated car park will be located in the southwest of the site.
- 9.4.2 The new main facility building will be directly located over the existing concrete slab from the previous building that occupied the site. The fieldwork has shown that the slab consistently recorded thickness of 0.2m and is reinforced and appears to be in good condition.

**Figure 6 – Photo looking north from SW corner of proposed warehouse building. Photo shows existing concrete slab.**

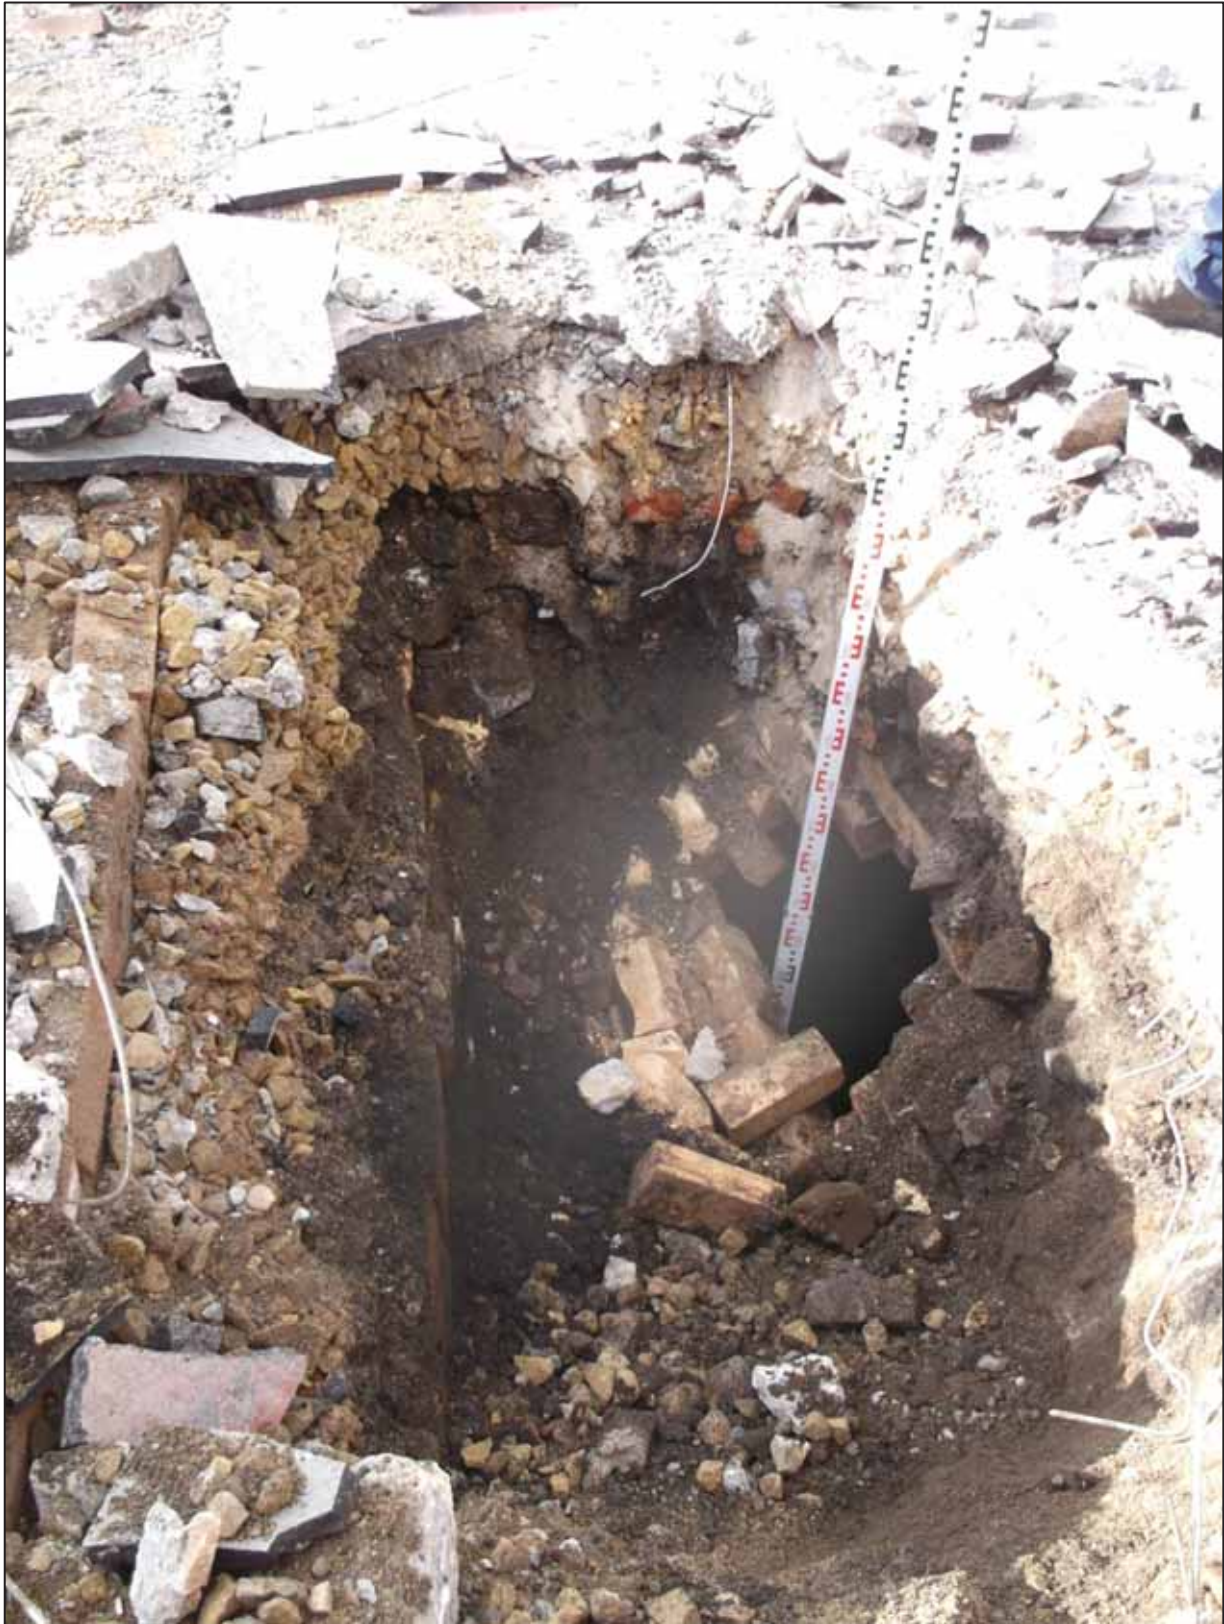
**Photograph 2: Trial Pit TP3**

- 6.3.5 Voids were encountered within exploratory locations BH5B, BH6, TP3 and TP16. The void within TP3 was identified as a flue/drain likely to historically be feeding the chimneys previously on site with a thickness of 0.95 m. The void with a thickness of 0.40 m within TP16 is believed to be an historic water tank however this could not be confirmed. Exploratory locations BH5B and BH6 have voids of thicknesses of 2.00 m and 0.80 m respectively that are thought to be other flues/drains however this could not be confirmed due to the limitations of observing ground conditions in cable percussive boreholes.

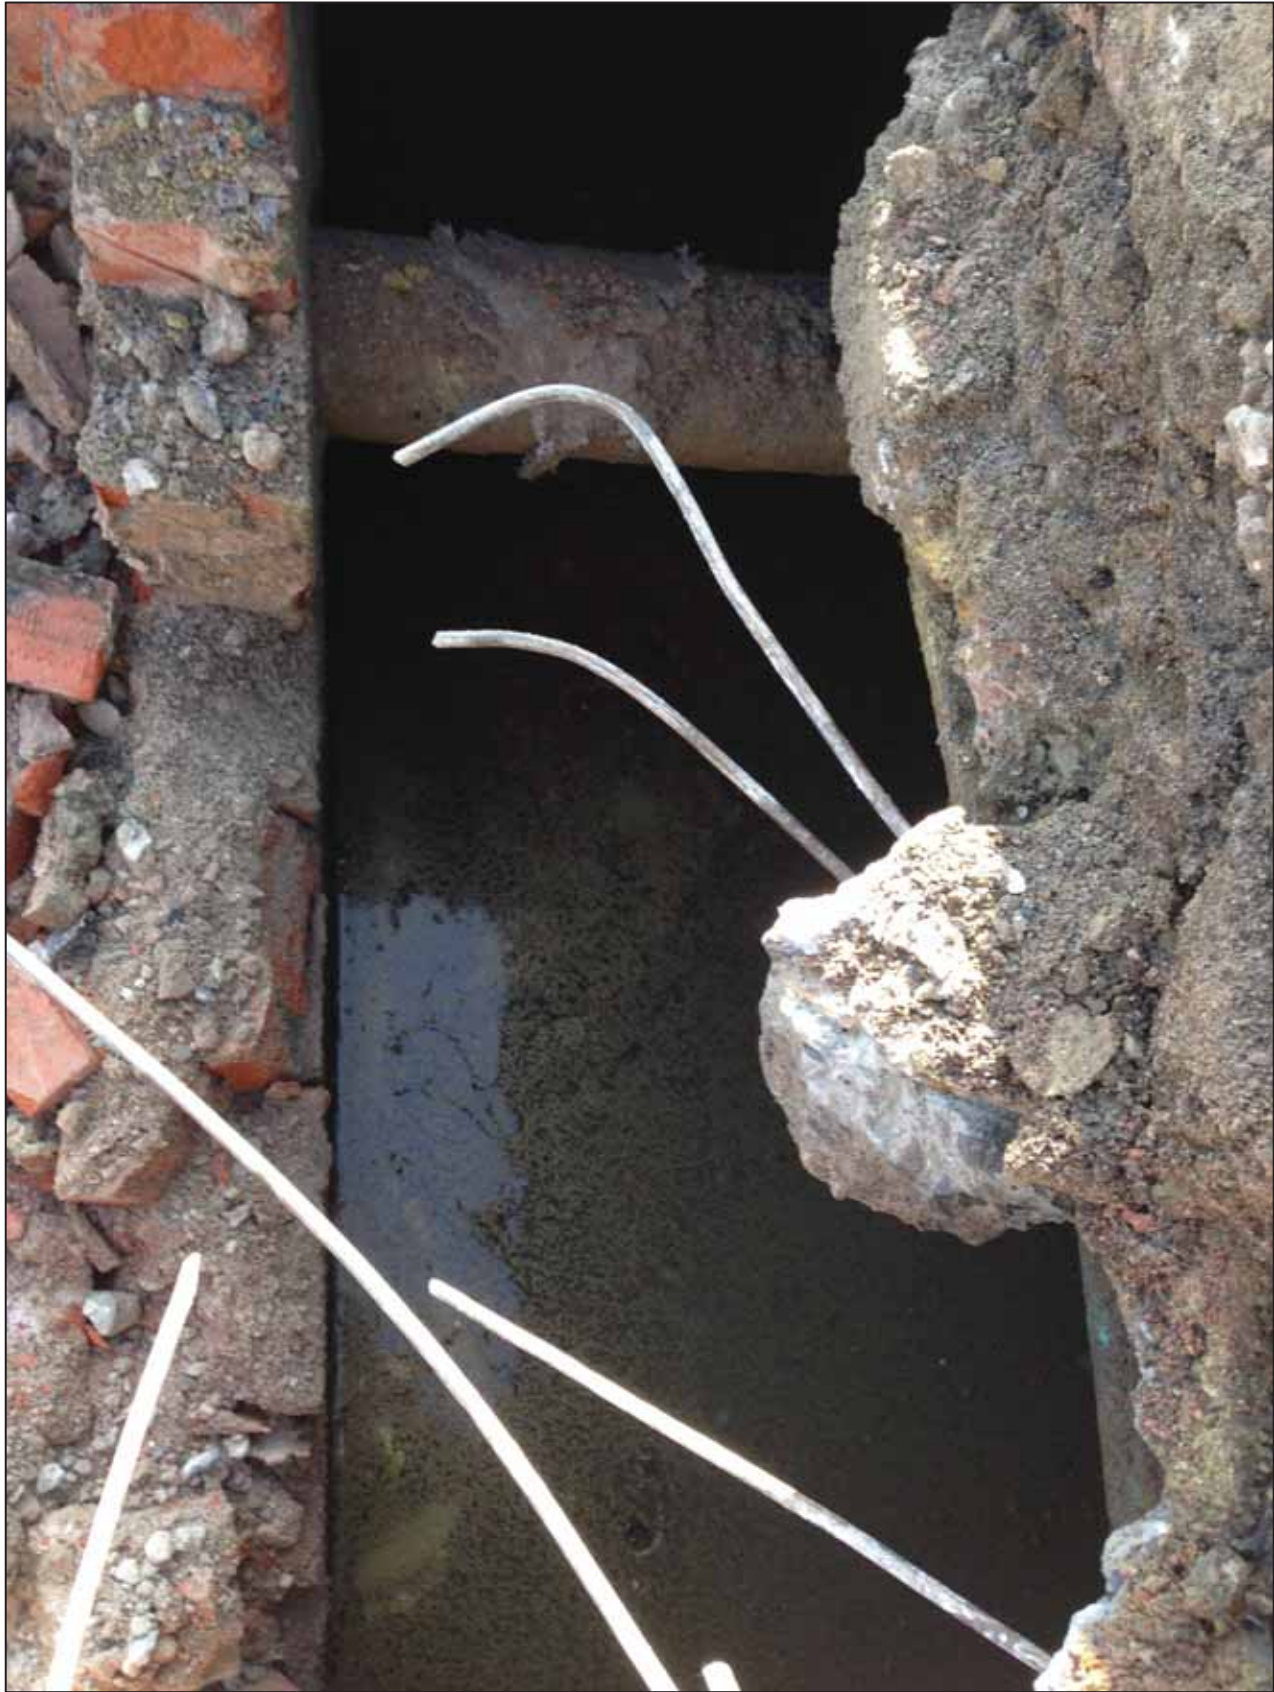
**Photograph 7: Trial Pit TP16 (suspected old water tank)**

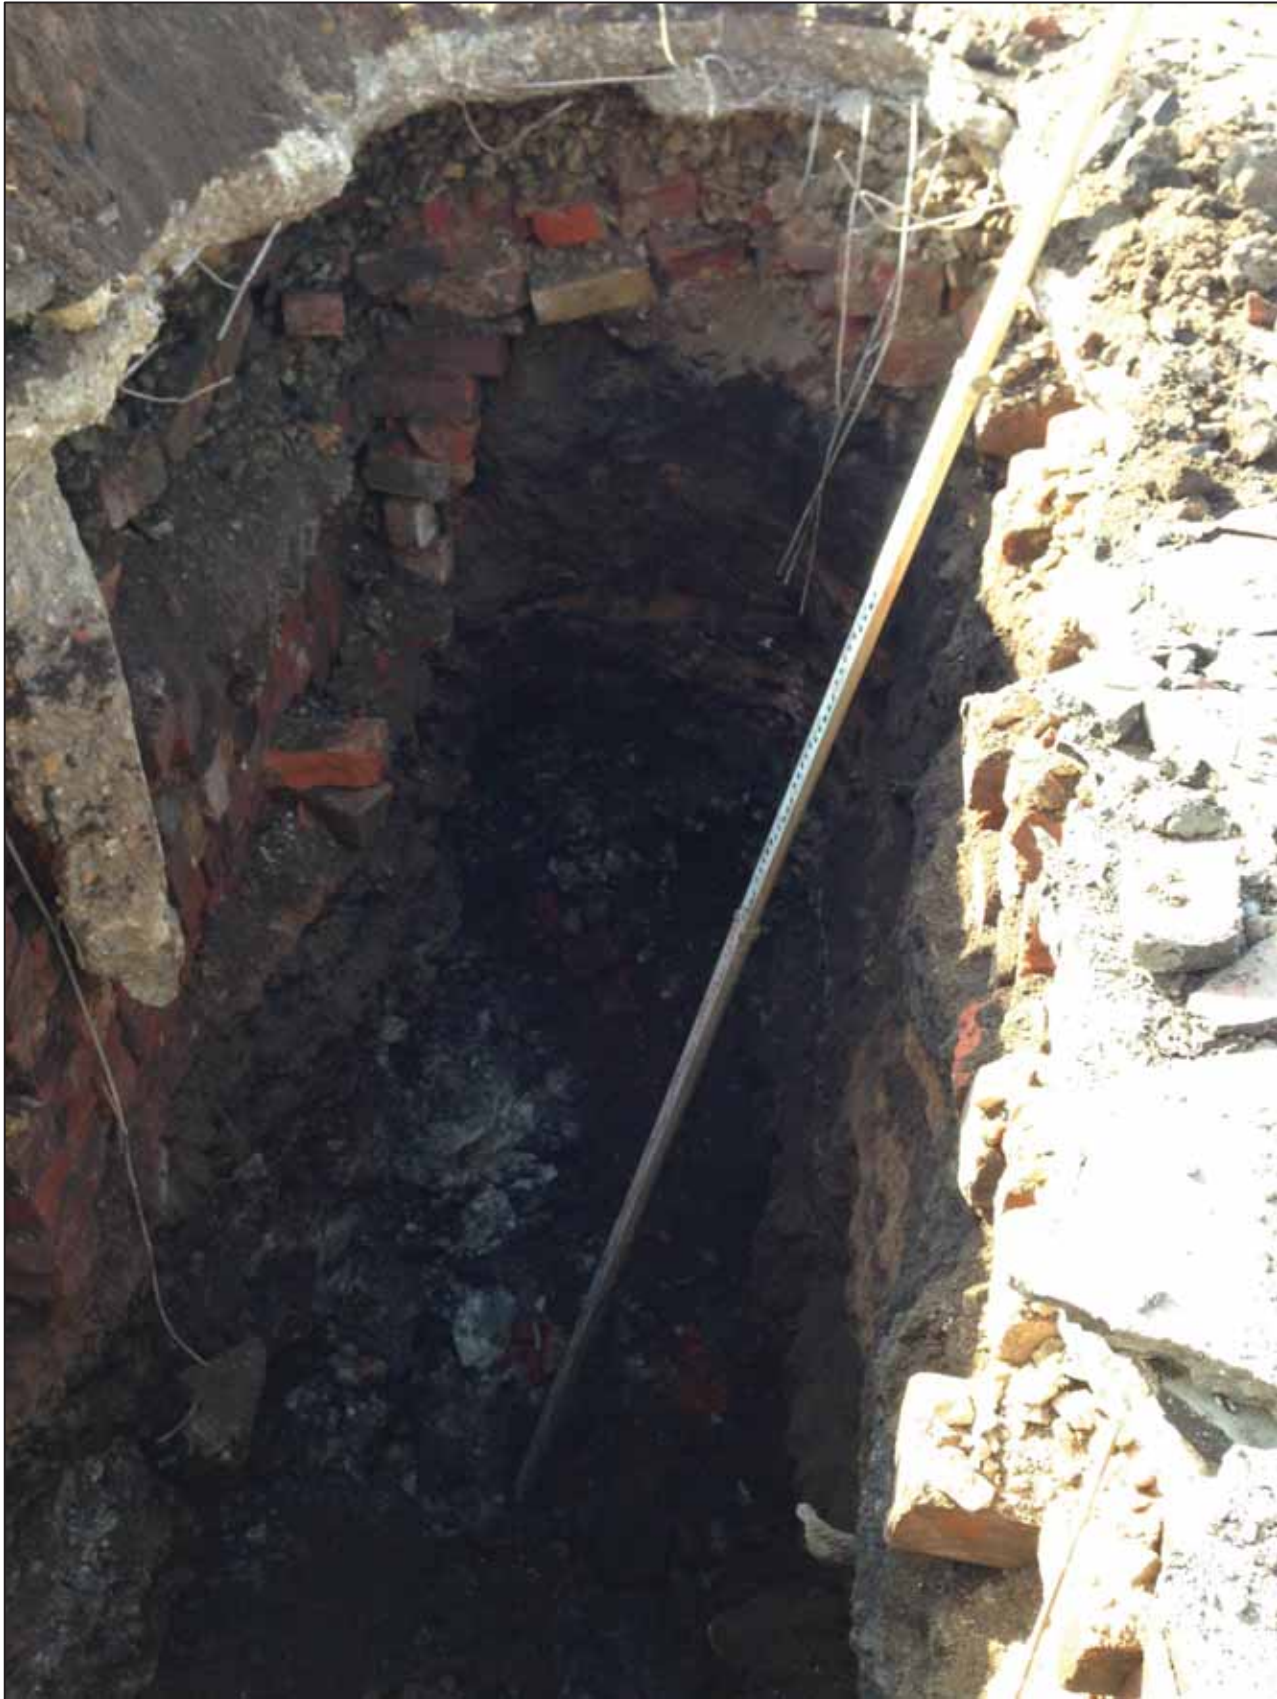
**Photograph 8: Trial Pit BH4-TP (Layer of slag at base at approx. 1.80 m bgl )**
