## Application for Permit Variation

### Permit N° 53997 (New Tip)

## Closure Plan and supporting documents

**REMEDATION AND RESTORATION OF  
NEW TIP  
PLANNING CONSENT 10/12/1110;  
CONDITION 2**

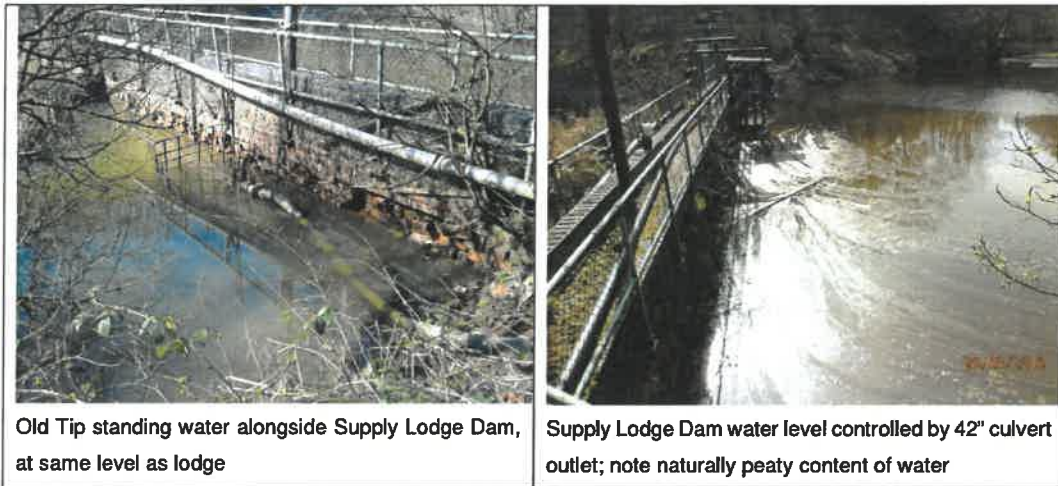
3.4.4. A leachate drainage system is in place adjacent to the Supply Lodge dam to pump leachate to the effluent plant, however standing water levels are typically similar on either side of the dam, showing that pumping here simply draws water through or around the dam from the Supply Lodge (see photos below).

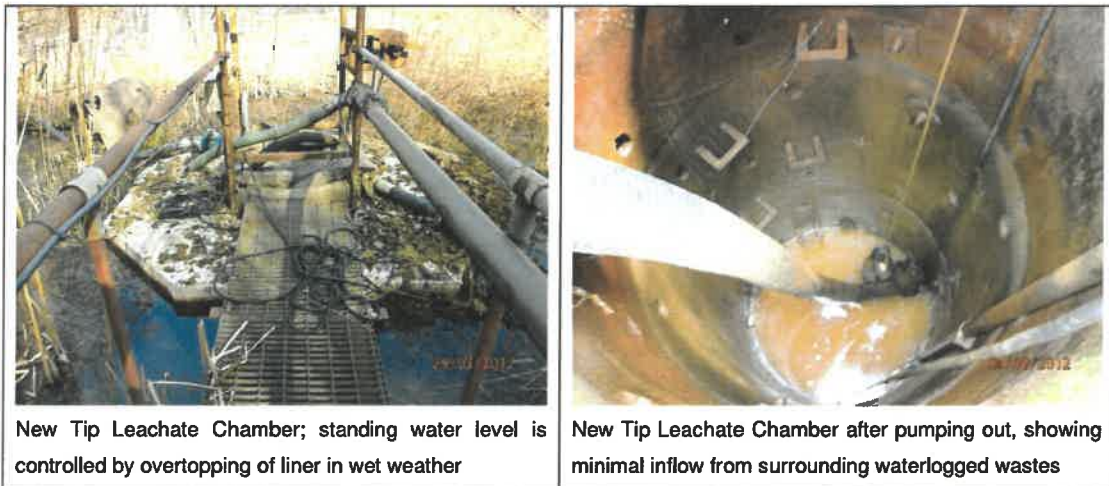
3.5.2. The tip is lined with a butyl membrane to prevent migration of solid material, gas and leachate. A basal drainage system was also installed to manage groundwater and residual flow along the valley floor. Leachate generated within the New Tip is collected in a sump and returned to the TNSB outlet, however pumping from the leachate chamber is unable to effect dewatering of the adjacent wastes due to their cohesive nature and high-water retention (see photos).

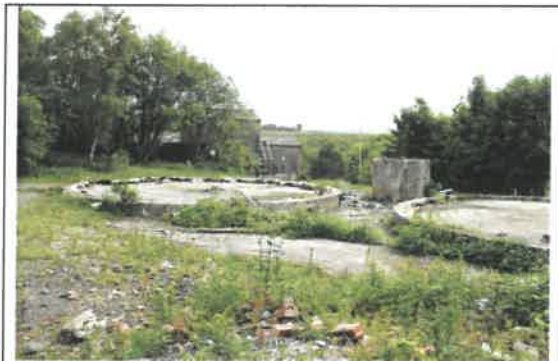
area of former fuel tanks in foreground; water tank bases to rear

5.10.3. The contamination hot-spot is associated with former paraffin and diesel storage tanks and pump plant in the area between the ash embankment and Old Landfill. Scott Wilson (2008) entries TP10/08 - TP16/08 recorded hydrocarbon observations, although WS02/08 in the same area did not. Chemical analysis however showed generally moderate or low levels of fuel residues and indicating weathering of diesel residues.

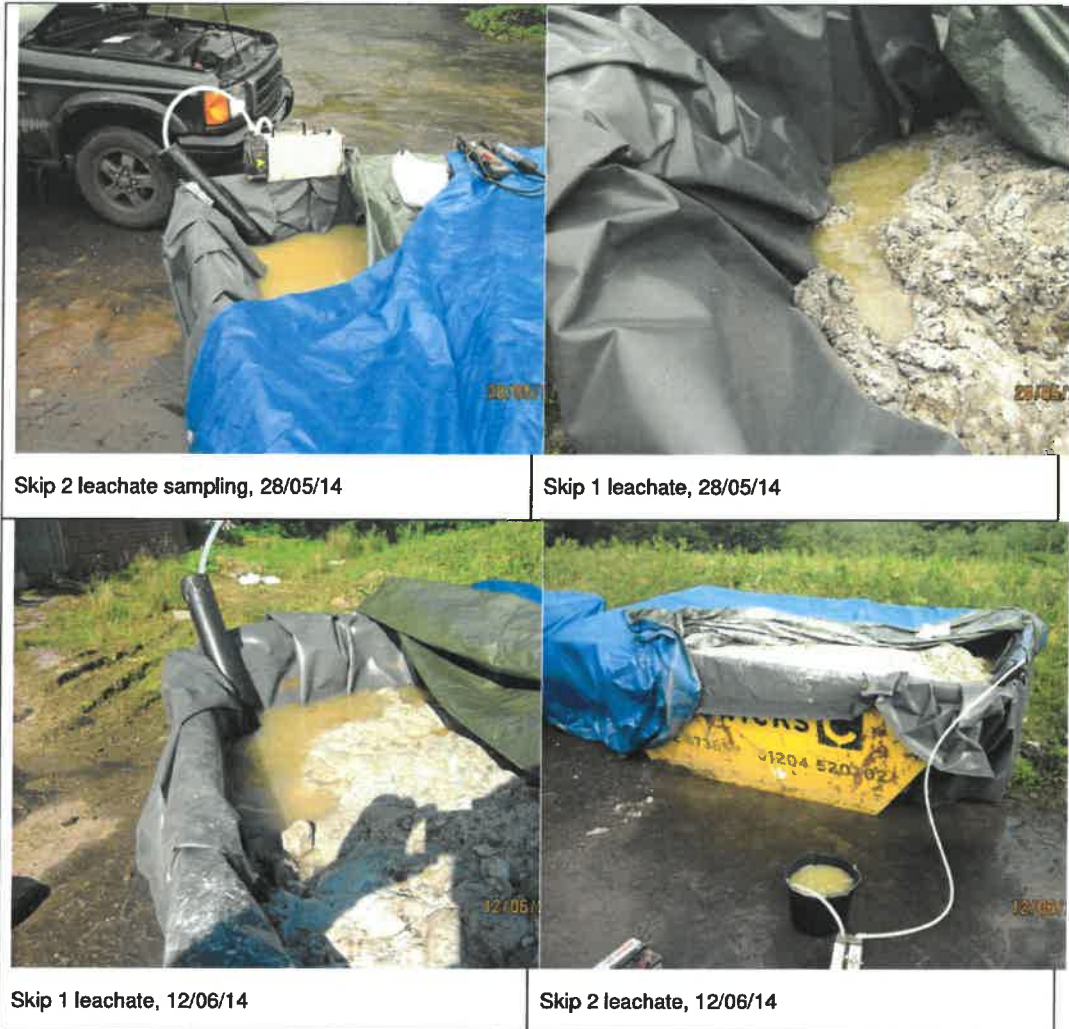
### Observations

The waste was notably softer and wetter in the skip 2 sampling position than at skip 1 position; this may be due to the down-hill waste being older and more consolidated, despite the water table being effectively at surface. Skip 1 material when squeezed by hand would leave a damp surface, whereas some drops of leachate could be squeezed from the skip 2 material. Neither test pit showed water/leachate entry, although skip 2 pit quickly slumped. A moderate organic odour was noted, although the wastes remained a uniform light grey colour, and the odour was undetectable more than 10m from the excavations. The sides of the skip1 pit were relatively stable, with minor slumping at about 2m depth over a period of half an hour.
