**SPRINGSIDE MILLS, BELMONT,
LANCASHIRE;**

LICENSED LANDFILLS

Closure Plan

R1635-R08-v6

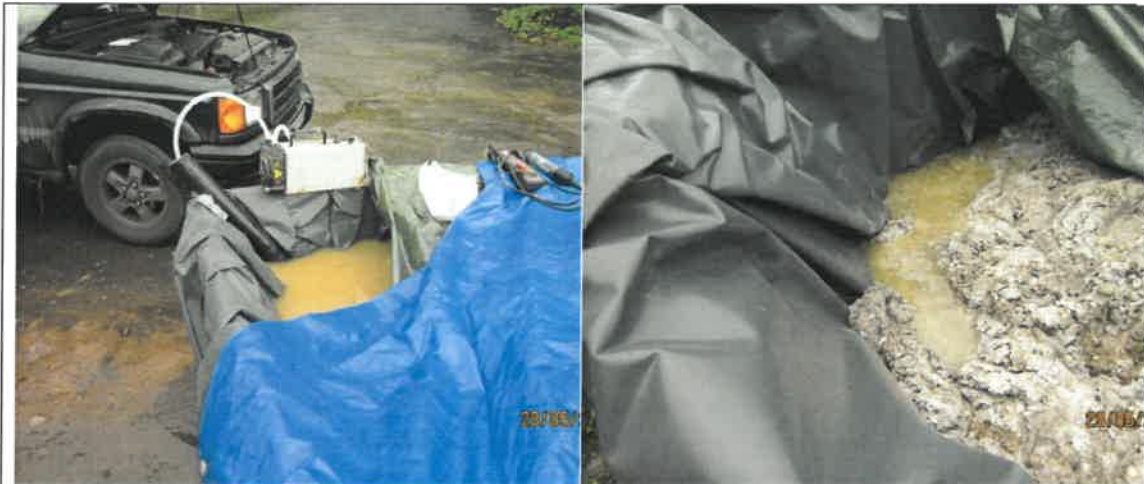
Skip 2 leachate sampling, 28/05/14

Skip 1 leachate, 28/05/14

The waste was notably softer and wetter in the skip 2 sampling position than at skip 1 position; this may be due to the down-hill waste being older and more consolidated, despite the water table being effectively at surface. Skip 1 material when squeezed by hand would leave a damp surface, whereas some drops of leachate could be squeezed from the skip 2 material. Neither test pit showed water/leachate entry, although skip 2 pit quickly slumped. A moderate organic odour was noted, although the wastes remained a uniform light grey colour, and the odour was undetectable more than 10m from the excavations. The sides of the skip1 pit were relatively stable, with minor slumping at about 2m depth over a period of half an hour.

During leachate sampling on 28th May, a small volume of water/leachate was noted in the corner of the skip on the waste surface. This was identical to the leachate removed from the standpipe and was a light milky grey colour and with a moderate organic odour. The field measurements were as follows:

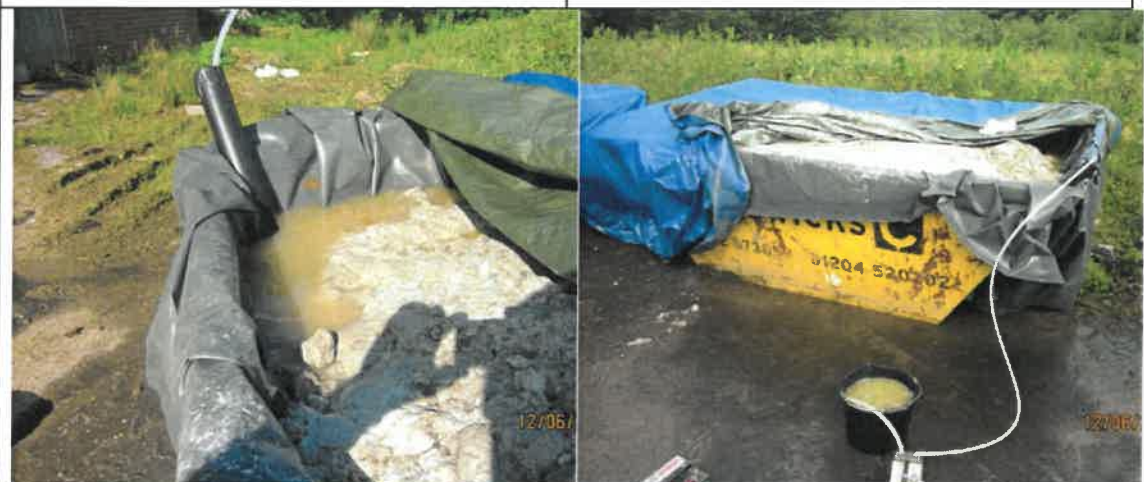
Skip 1 leachate, 12/06/14

Skip 2 leachate, 12/06/14

The skips were covered over again after sampling. A second round of pumped removal of leachate was carried out on 12th June 2014, 17 days after filling of the skips, on this occasion the volume of leachate removed from each skip to drain down the standpipe contents and any water sitting on the waste surface was recorded.

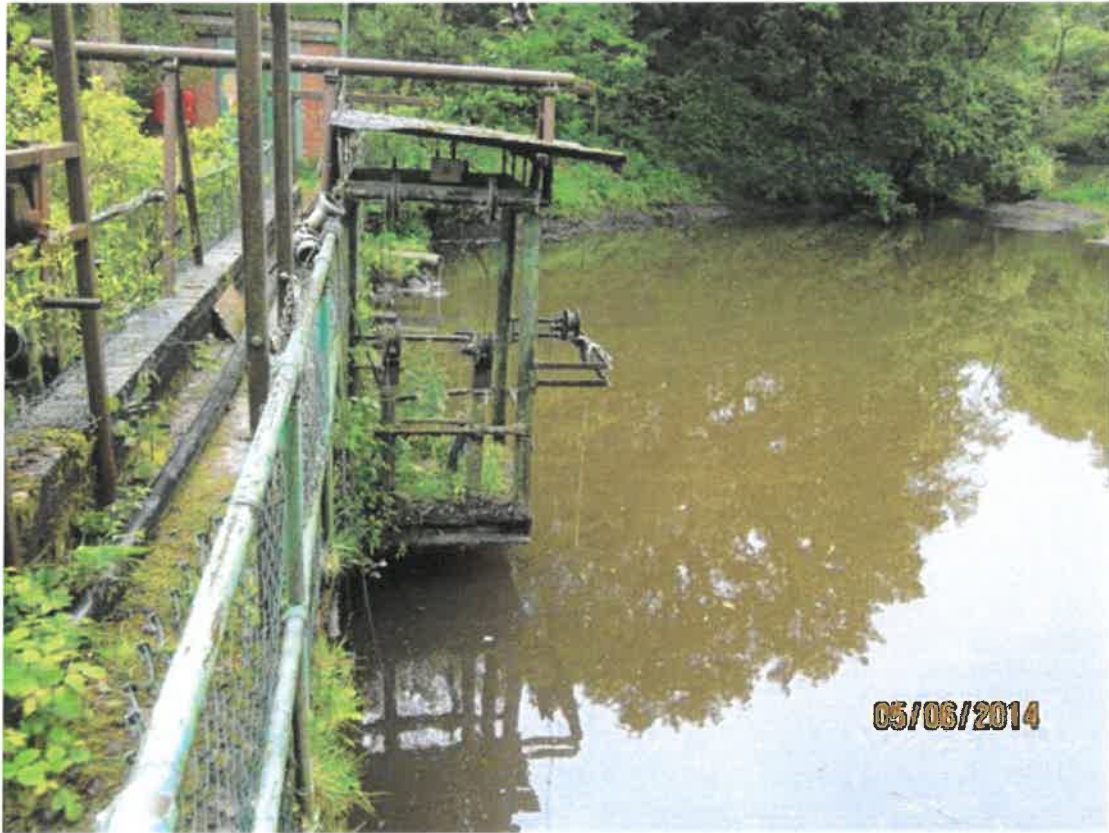
PHOTO 3 – VIEW OF SAMPLING PLATFORM AND VARIOUS FRAMES
ALONG LENGTH OF DAM

Along the top and off the side of the dam there are several steel platforms and support frames used for water sampling and monitoring. The steel is rusty and cables trail along the handrail and across the walkway.

We would recommend the platforms and other steel support frames and vegetation be removed to prevent any deterioration of the structural integrity in the long term. The areas of masonry affected should be re-pointed following any removal works.

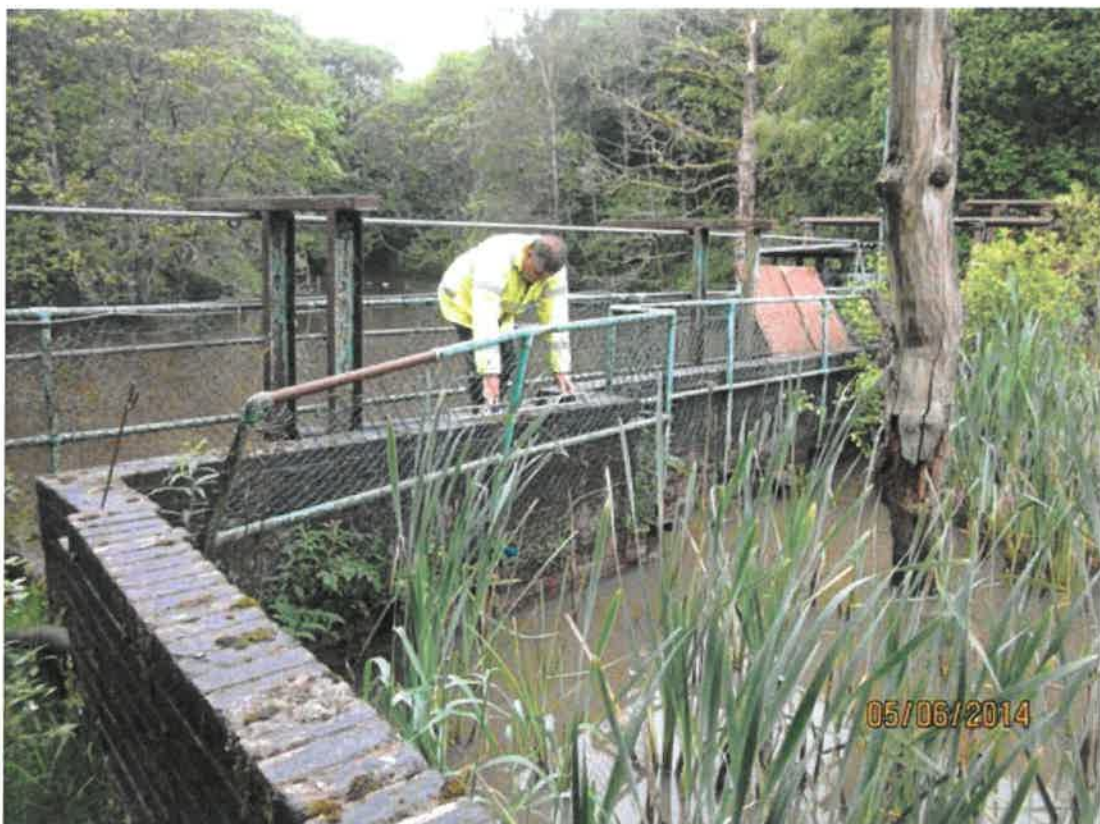
PHOTO 4 – VIEW OF FRONT FACE OF DAM

During our first visit the water level on the front of the dam was 400mm higher than the pond and on the second visit, after heavy rainfall, was 750mm above the pond. There is a degree of water seepage through the brickwork, which over time, and subject to rainfall, will allow the hydrostatic pressure to reduce or equalise.

The dam generally is in good overall condition and is plumb and level along its length and there are no indications of distress or signs of movement visible.
