RESTORATION OF NEW TIP AT THE FORMER SPRINGSIDE MILLS, BELMONT

ECOLOGICAL SURVEY AND ASSESSMENT

October 2012

[ERAP Ltd ref: 2012_037]

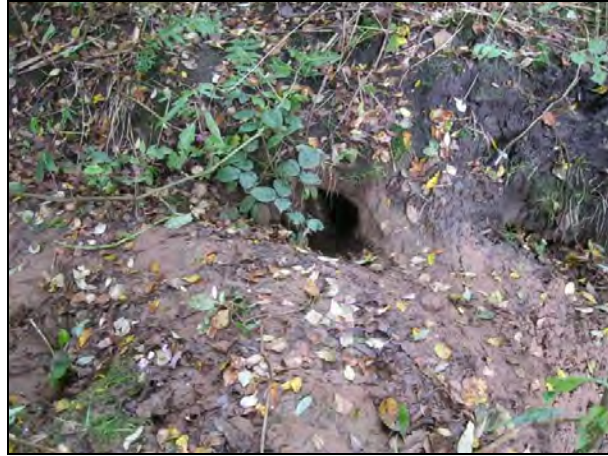
Photo 1: Outlier Badger sett outside New Tip site boundary

- 3.3.1 No Badger activity including setts and feeding signs was detected within the New Tip site boundary.
- 3.3.2 Two outlier sett entrances were detected just inside the Springside Mills boundary fence to the north of the Old Tip, refer to **Figure 2** and **Photos 1 and 2**. The holes were first detected in June 2012 but no evidence of Badger was detected. A follow up survey in August 2012 did not detect any evidence of Badger. Examination of the holes in October 2012 detected Badger hairs at the entrance to both setts. No extensive pathways, latrines or other sett entrances were located. Gaps beneath the palisade fence at the northern Springside Mills site boundary indicate Badger leave and enter the site from the north.

- 3.3.3 It is concluded that the two setts are outlier setts in seasonal use. The sett entrances are located on higher ground more than 30 metres from the northern edge of the New Tip site boundary. The tunnels extend northwards, away from the Old Tip.
- 3.3.4 A comprehensive search of the woodland habitats both within the palisade fencing around the Springside Mills site and land outside the boundary fence up to a distance of 200 metres did not detect any other signs of Badger but a main sett must be present within the wider Longworth Clough area.

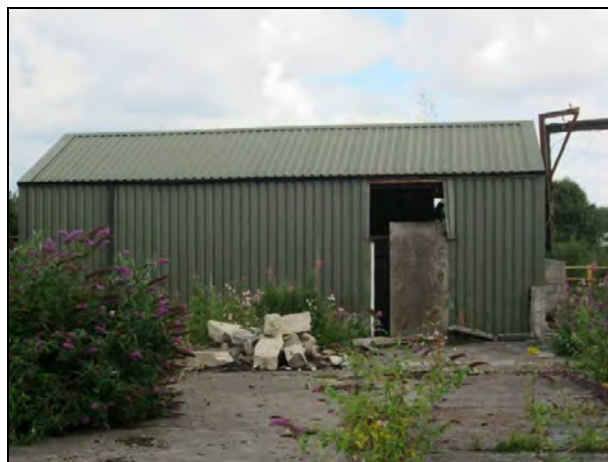
Photo 2: West elevation of Building E

- 3.3.5 Building E is a single storey building composed from corrugated metal sheeting with a corrugated metal roof (refer to **Photo 2**). The doorway is open to create draughty, exposed conditions. No evidence of use of Building E by roosting bats was detected; the building is assessed to have negligible suitability for use by roosting bats owing to the absence of suitable cracks, crevices and roosting opportunities.

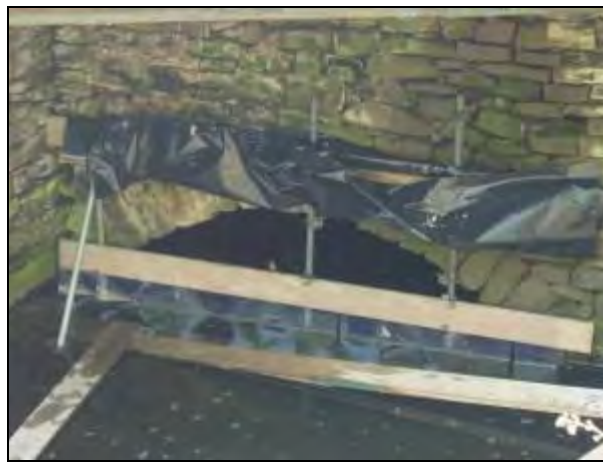
Photo 3: Photograph to illustrate proposed tunnel exclusion apparatus

- e. It is important that the exclusion is carried out during periods of suitable weather as it is important to be confident that if bats are present then they will have left the roost in the evening.
- f. The barrier will be of plastic tarpaulin sheeting (or other material) fixed to the tunnel entrance and exit so that it can be rolled up and lowered down to the level of the water. It would be fixed around the edges such that there are no gaps when the sheeting is rolled down. There will be a metal pipe attached to the bottom of the sheeting to prevent it lifting.
- g. The exclusion apparatus must remain in position during the works to prevent bats from entering the working area (until the tunnel is removed);
- h. This method was successfully applied by ERAP Ltd in Accrington. A photograph of the exclusion apparatus in position is presented below.

- 5.5.4 If the water percolation through the underarch of the tunnel persists which makes conditions unfavourable it is still recommended that the following precautionary actions are implemented: -

- d. After two consecutive nights of suitable weather for bat activity (>8°C with no rain and no more than a slight breeze) it can be stated that there is no risk of bats being present in the tunnel.

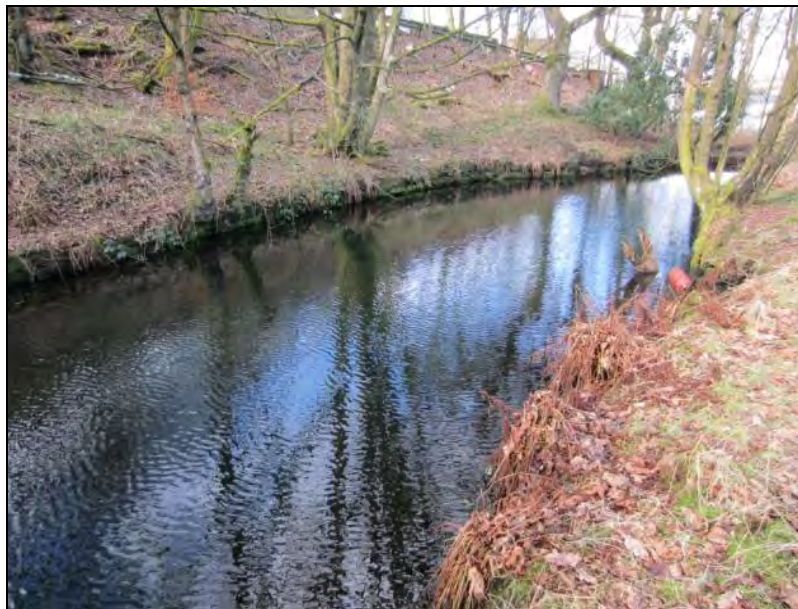
Photo 1: Pond 1 (facing south-west)

3.1.3 The pond is shaded by marginal semi-mature Pedunculate Oak and Sycamore woodland. The water is clear and approximately 0.4 metres deep.

3.1.4 No aquatic plant species were detected.

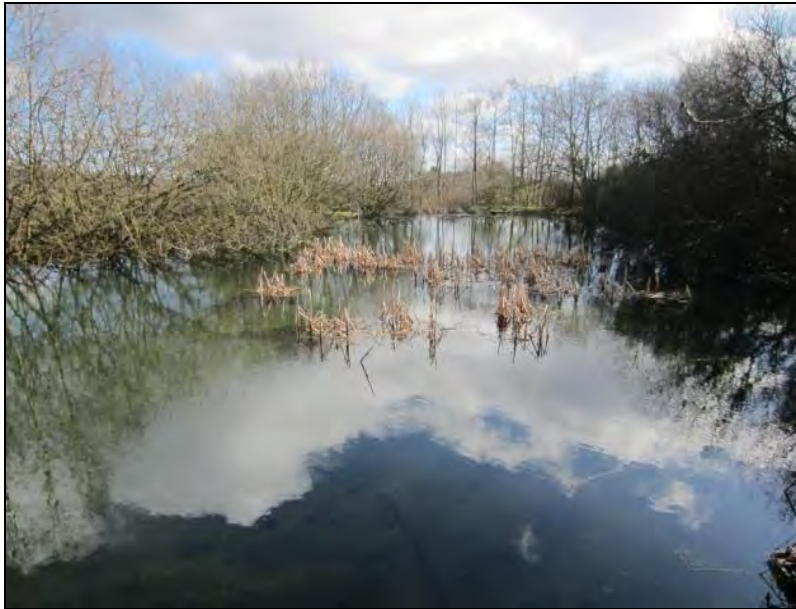
Photo 2: Pond 2 (facing east)

3.1.6 Pond 2 is large (over 900m²) and has a deep centre. The pond margins are shaded by surrounding Pedunculate Oak, Silver Birch, Rowan, Rhododendron and Willow.

3.1.7 Bulrush is present towards the eastern end and the aquatic moss *Fontinalis antipyretica* is abundant and constant over the whole pond.

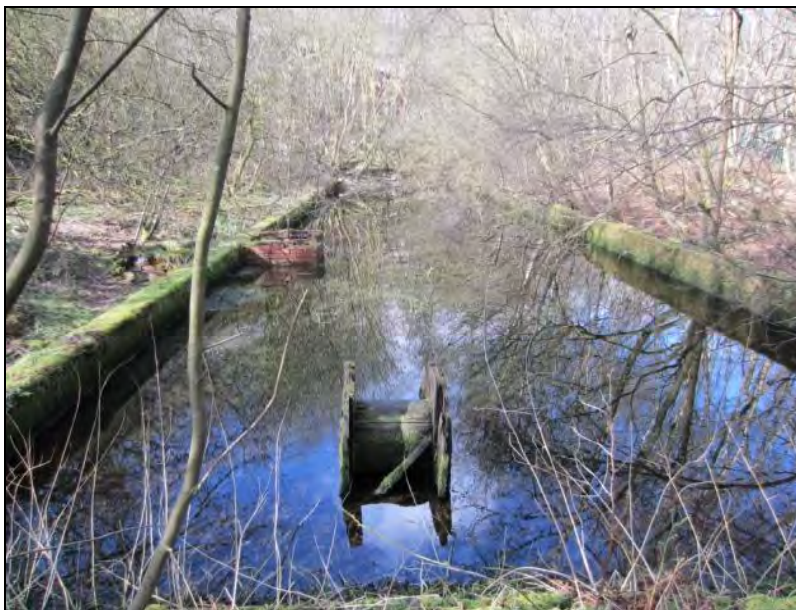
Photo 3: Pond 3 (facing north-west)

- 3.1.8 Pond 3 (**Photo 3**, below) comprises a rectangular concrete lined settling tank. The tank is shaded by marginal Common Sallow. The water is clear and up to 0.5 metres deep.
- 3.1.9 Aquatic species present comprise Common Duckweed and Common Water Starwort with very local stands of Bulrush.

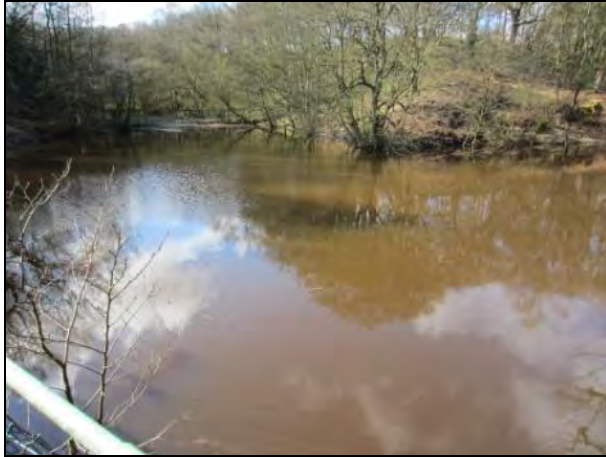
Photo 4: Deeper, dammed area of Pond 4 connected to brook.

- 3.1.10 Pond 4 (**Photo 4**, below) is a dammed lagoon at the western end of the factory/mill buildings. Three Nooked Shaw Brook flows into the lagoon from the south.
- 3.1.11 The banks of the pond are formed from steeply sloping wooded banks with a red brick dam at the eastern edge. Beyond the dam is settled paper pulp with shallow pools of water colonised by Bulrush (refer to **Photo 5**). The amphibian survey concentrated on these shallow pools where fish cannot access.

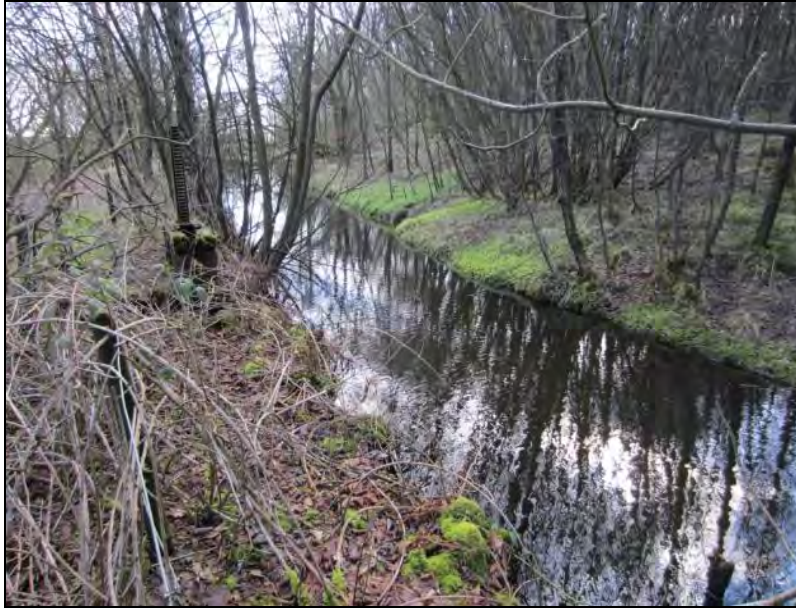
Photo 6: Pond 5 (facing south-east)

- 3.1.12 Pond 5 (**Photo 6**, below) is located within the woodland to the south of the complex of building. The Pond is part of the old mill race and has stone banks. The water is 0.5 metres deep over a deep sediment.
- 3.1.13 Local patches of *Sphagnum* moss are present on the southern margins.

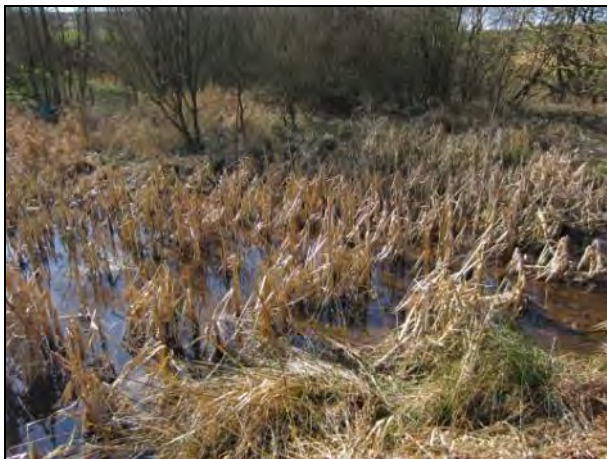
Photo 7: Pond 7 (facing south)

3.1.14 Pond 7 (Photo 7, below) is outside the main Springside Mills site. The pond comprises the headwall of a former mill race. Sedimentation has occurred which has resulted in pooling of water and colonisation by Bulrush. A steeply sloping concrete outfall directs water from Pond 7 into the stream/former mill race, refer to Photo 8.

3.1.15 Few areas of shallow open water are present but the majority of the pond is colonised by Bulrush and Soft Rush.
