**SITE CONDITION REPORT  
for  
Park House Transfer Station  
Park Road  
Bury  
BL9 5NB**

<b>1. Site Details</b>	
Name of the applicant	<a href="#">Park House Services NW Ltd</a>
Activity address	<a href="#">Park House,</a> <a href="#">Park Road,</a> <a href="#">Bury,</a> <a href="#">BL9 5BQ</a>
National grid reference	<a href="#">Site centred on SD 80289 11717</a>
Document reference and dates for Site Condition Report at permit application and surrender	<a href="#">Inert and Excavation Waste Transfer Station with Treatment permit issued 12/09/19</a> , permit WE3118AA. Bespoke Permit Variation Application 2021 Site Condition Report 22/03/21
Document references for site plans (including location and boundaries)	Park House <a href="#">Boundary Plan</a> Park House <a href="#">Site Drainage Plan</a> Park House <a href="#">Site Layout Plan</a> Park House <a href="#">Plan Showing Receptors</a>

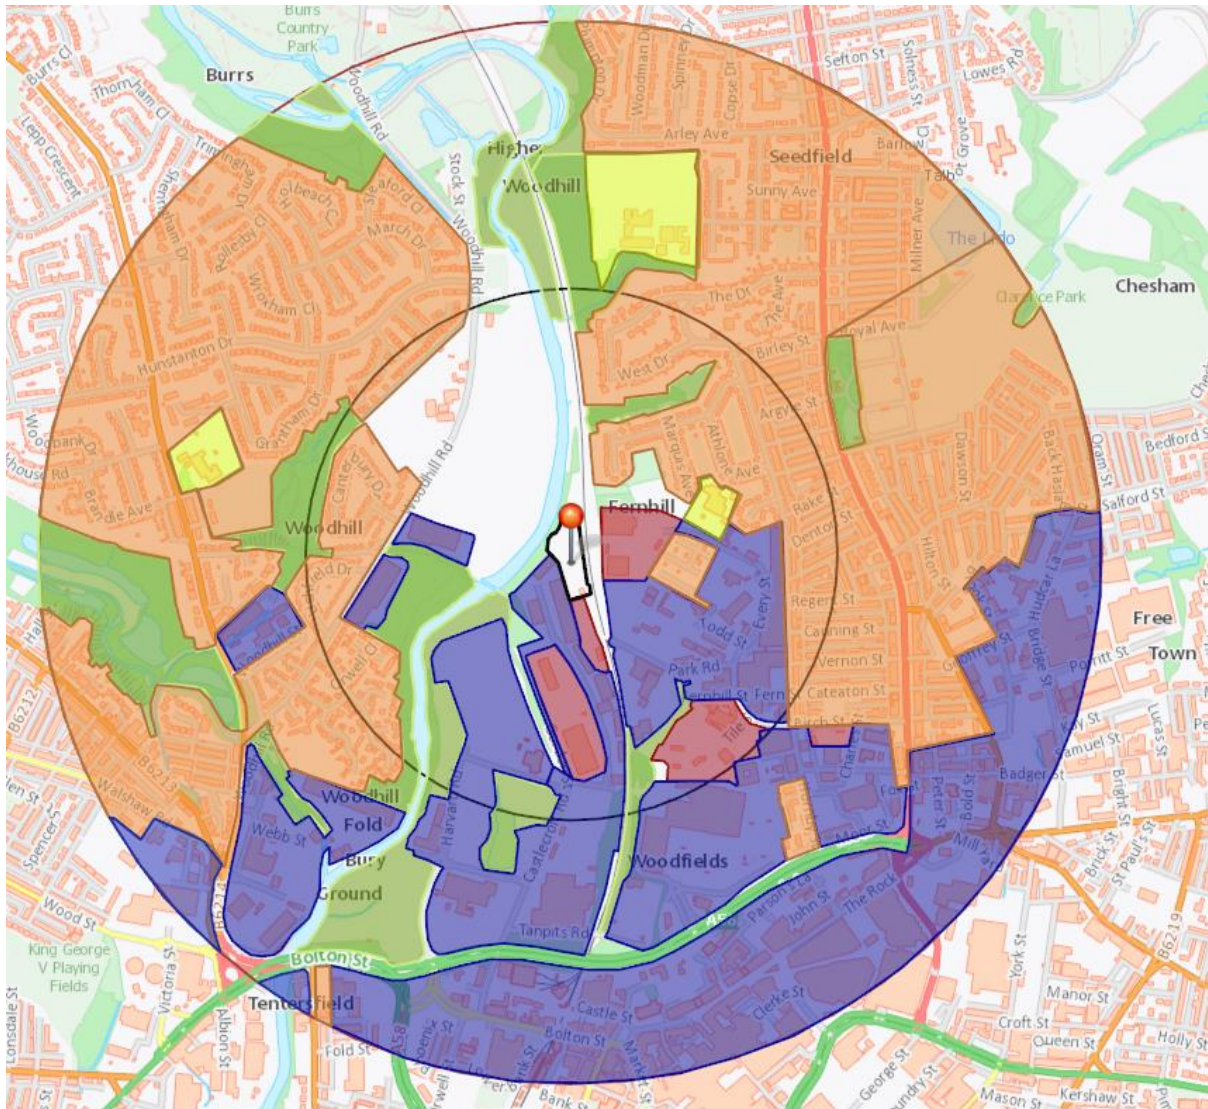
**Park House Plan Showing Receptors**

Key: Yellow: Schools,  
Purple: Industrial/Commercial,  
Orange: Residential,  
Red: Waste sites & Installations,  
Green: Habitats.  
White: Agricultural.

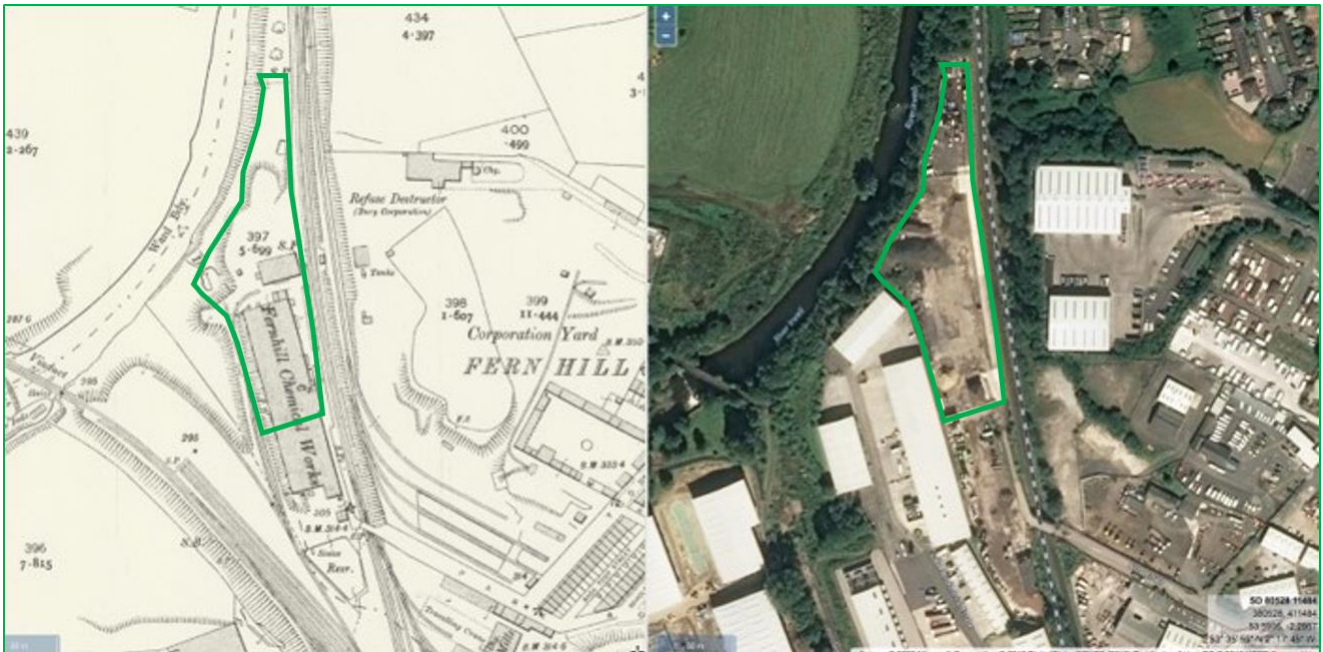
1892-1914 OS Map and Aerial View (Land owned including the site edged in green)

No ground water monitoring is carried out, the bore hole is not extant on site. The 1924 bore hole log notes the drilling was in a cellar 12 feet below ground level, this has been lost, presumably when the original factory was demolished in the 1960's and the present ground level established. The ground level is contiguous with the next-door yard which was the other half of the factory, see 1892-1914 OS map & aerial view below.
