**PRELIMINARY ENVIRONMENTAL RISK
ASSESSMENT
UNIT 9 WORLE QUARRY, WESTON-SUPER-MARE**

LINCOLN STORM LTD

**LINCOLN STORM LTD
PHASE 1 DESK STUDY REPORT**

UNIT 9 WORLE QUARRY, WESTON-SUPER-MARE

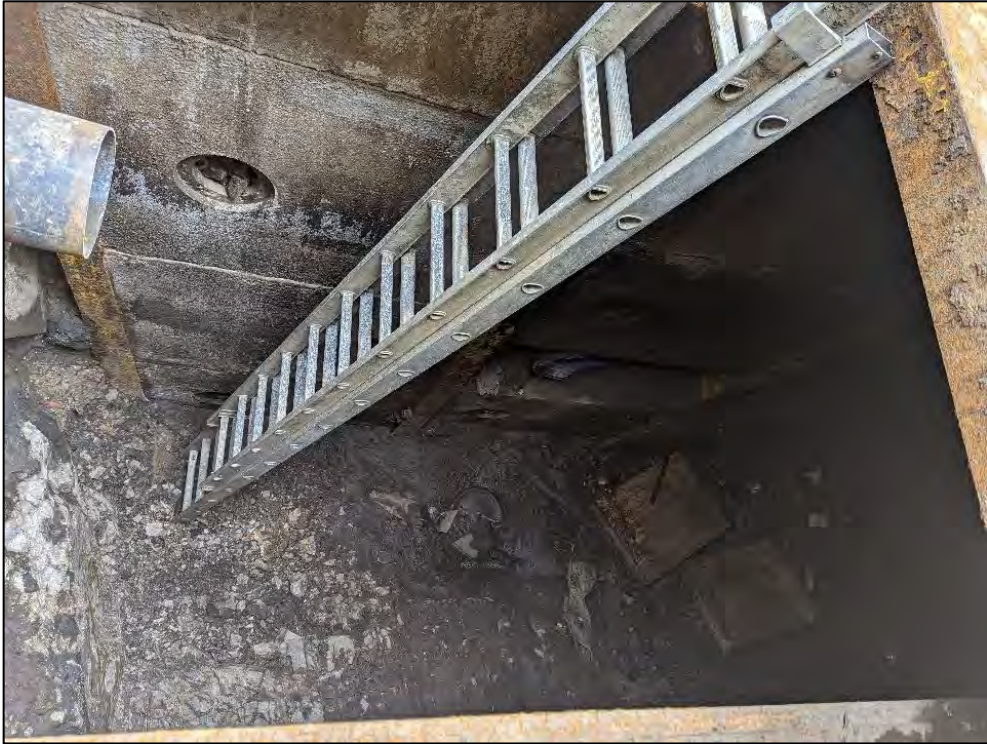
Figure Reference:	4	Description:	View looking inside sites soakaway, west of site
--------------------------	----------	---------------------	---

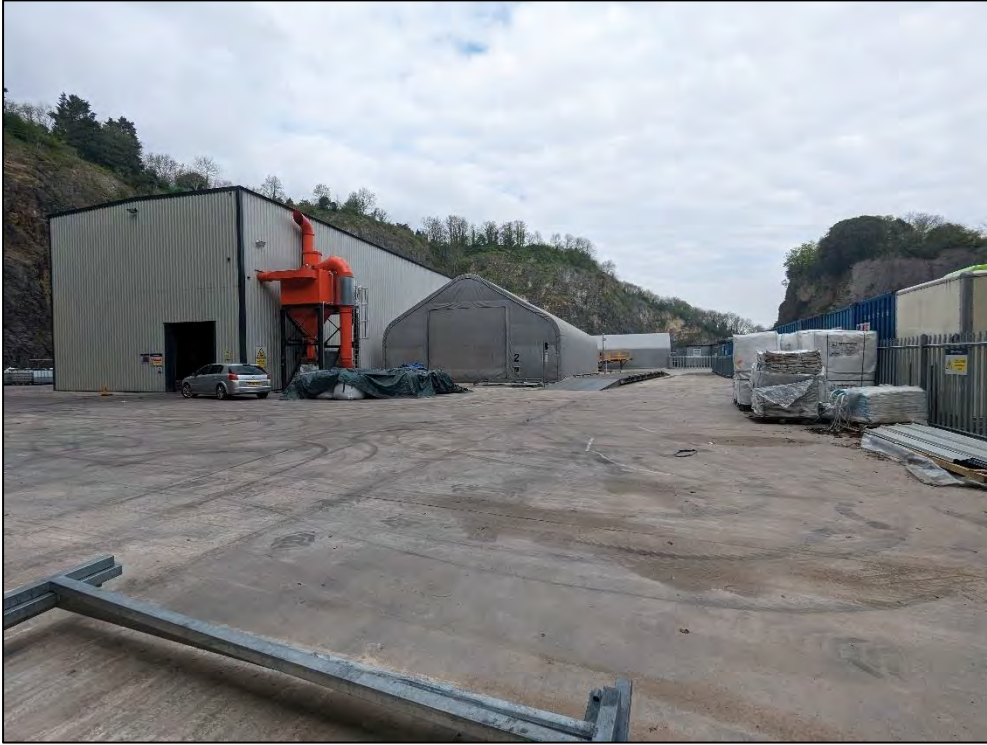
Figure Reference:	5	Description:	View of tent 2 with interceptor and warehouse 4, looking north
--------------------------	----------	---------------------	---

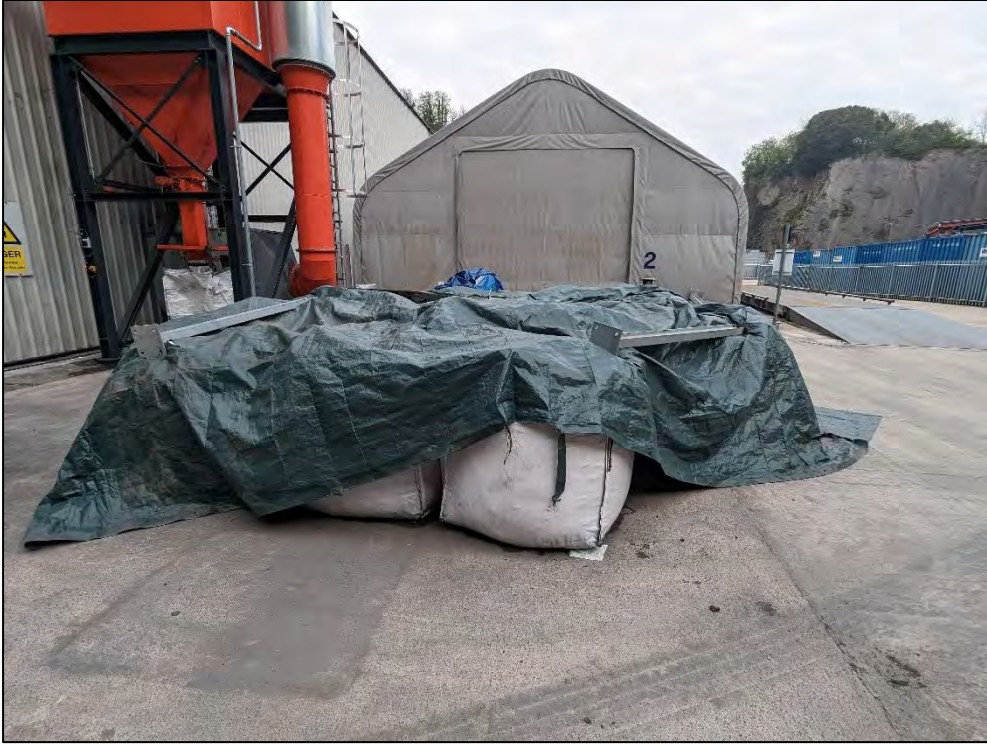
Figure Reference:	6	Description:	Stockpiled bags of recycled battery material outside tent 2
--------------------------	----------	---------------------	--

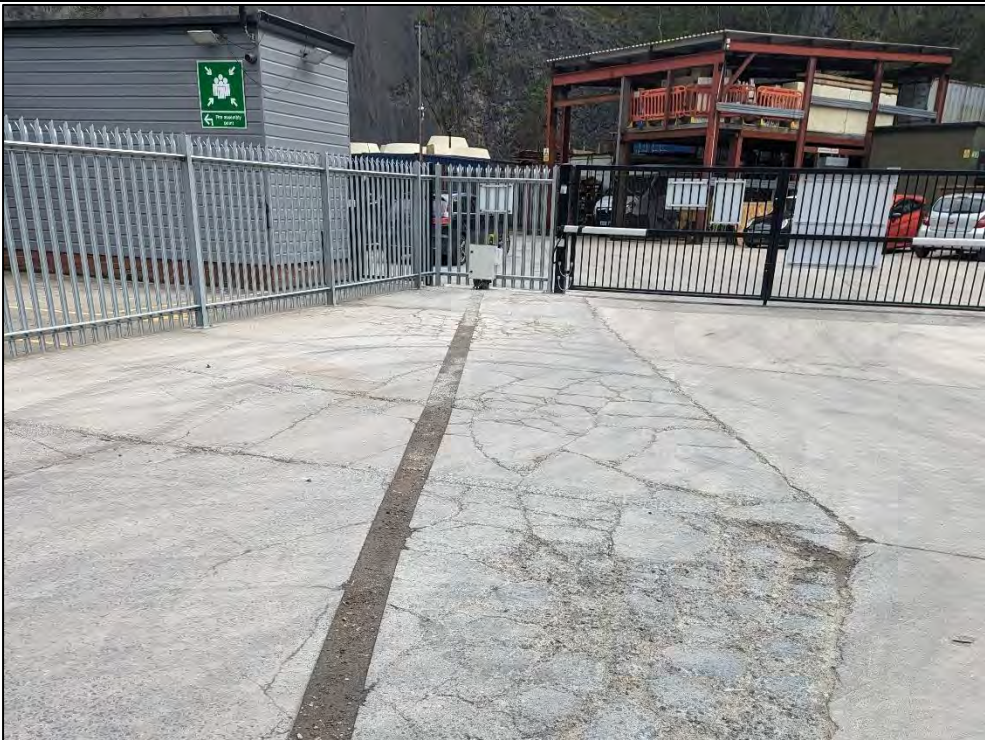
Figure Reference:	8	Description:	View of security gate and scarring in the ground. Noted poor condition of concrete.
-------------------	---	--------------	---

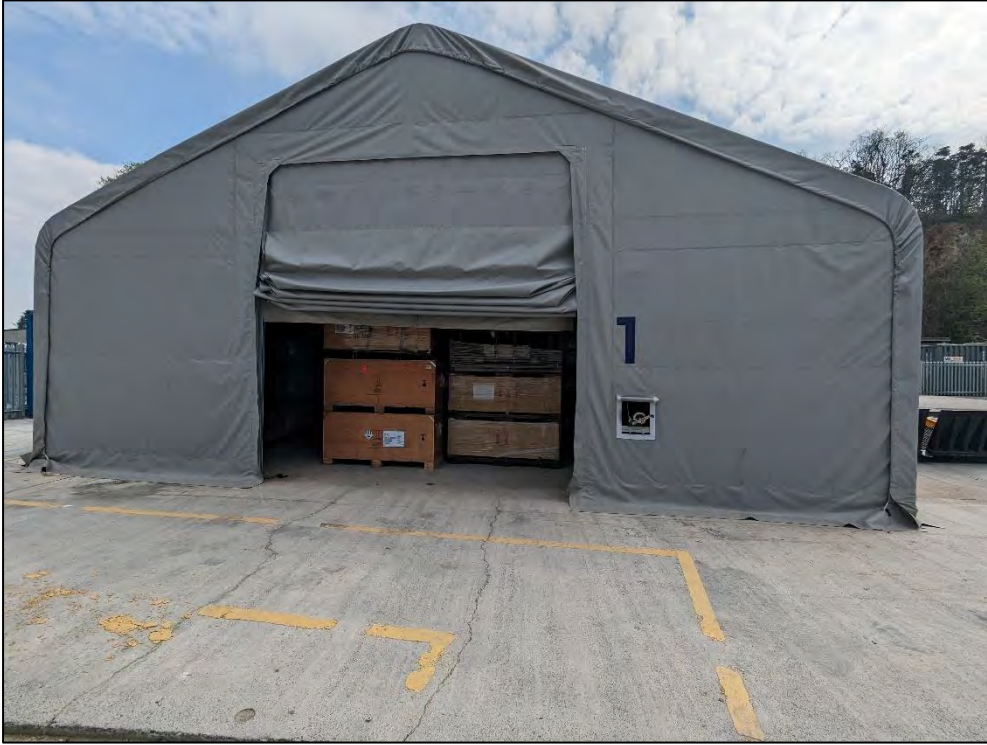
Figure Reference:	9	Description:	View of tent 1 storing lithium batteries.
--------------------------	----------	---------------------	--

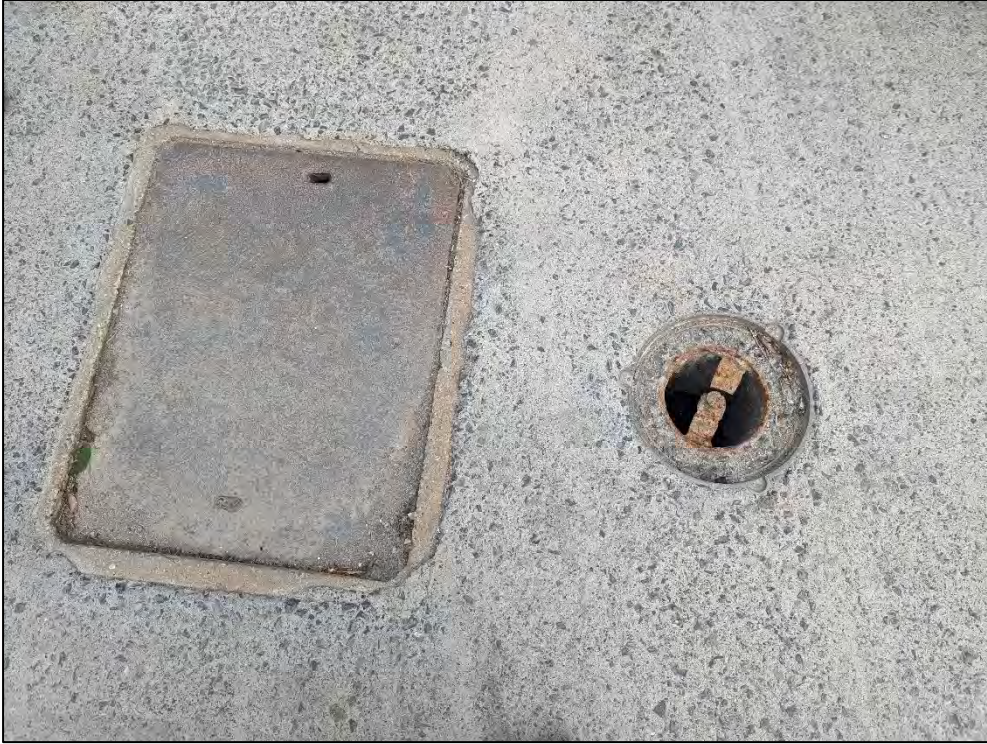
Figure Reference:	10	Description:	Septic Tank
--------------------------	-----------	---------------------	--------------------

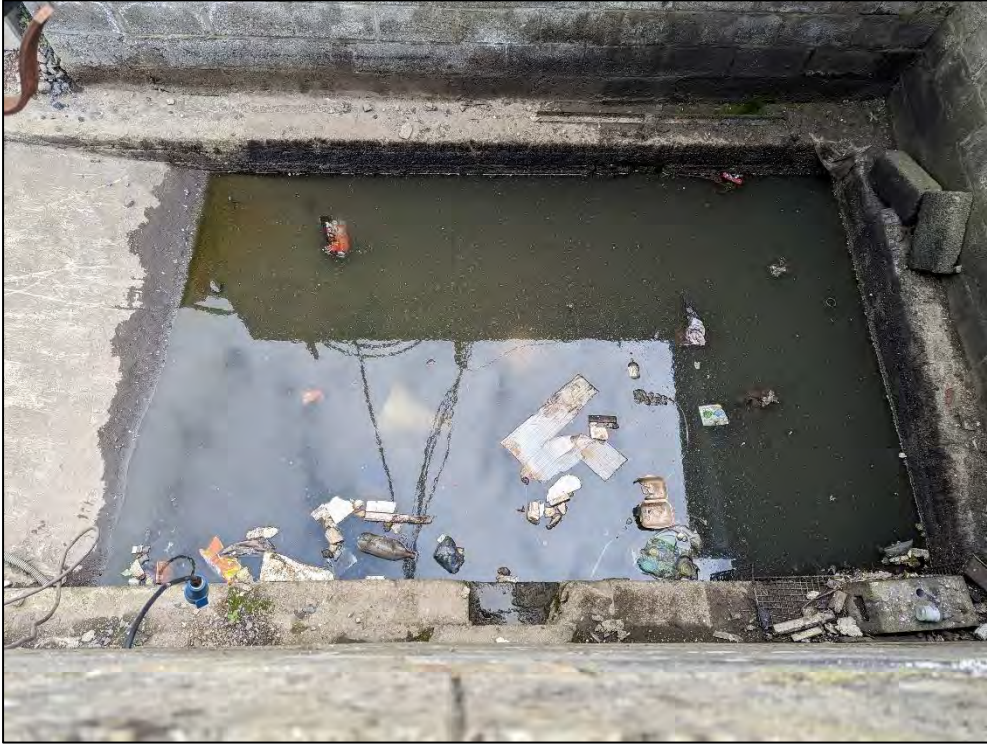
Figure Reference:	13	Description:	View of open-air surface water soakaway
--------------------------	-----------	---------------------	--

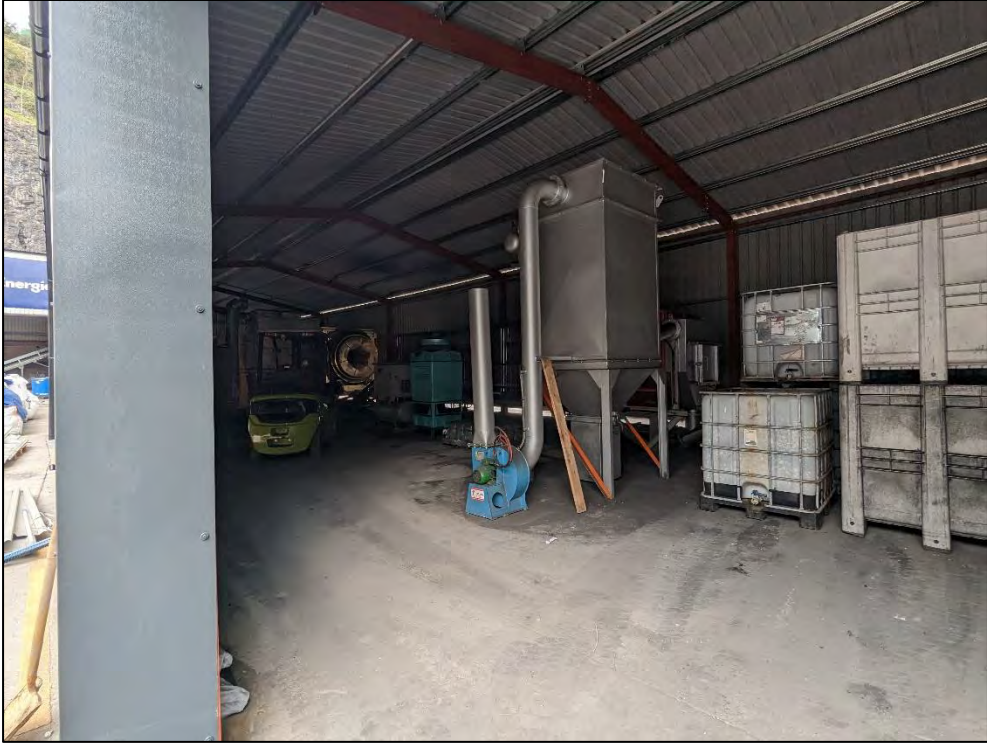
Figure Reference:	14	Description:	Inside warehouse 1 with bulk storage and operational machinery
--------------------------	-----------	---------------------	---

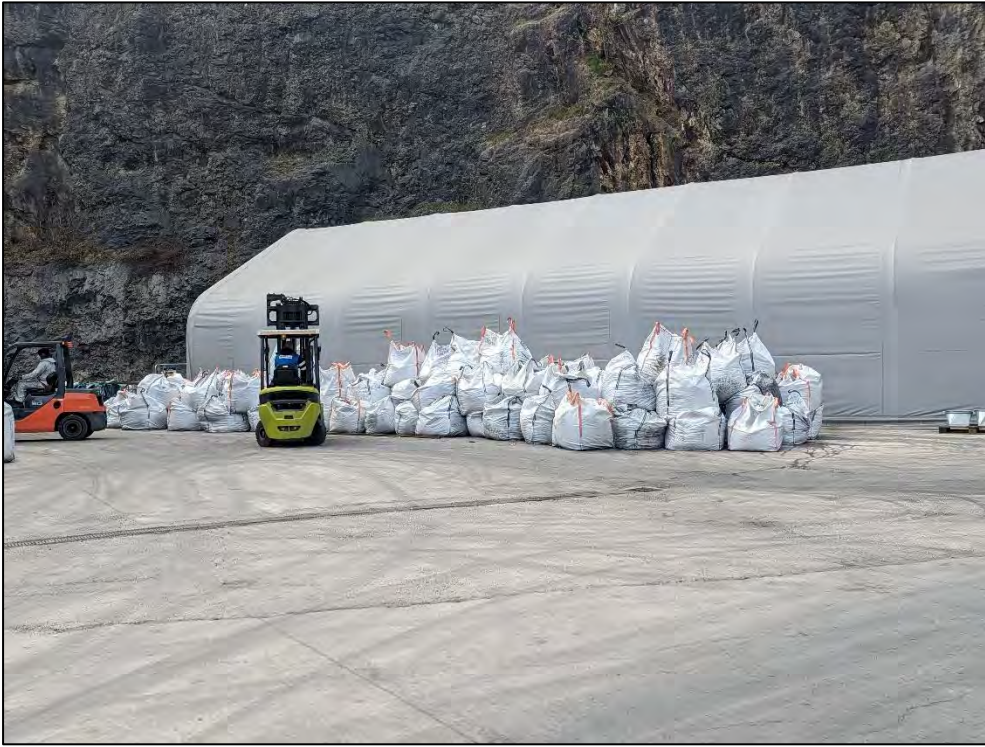
Figure Reference:	15	Description:	View of bags of recycled battery material stored on site
--------------------------	-----------	---------------------	---

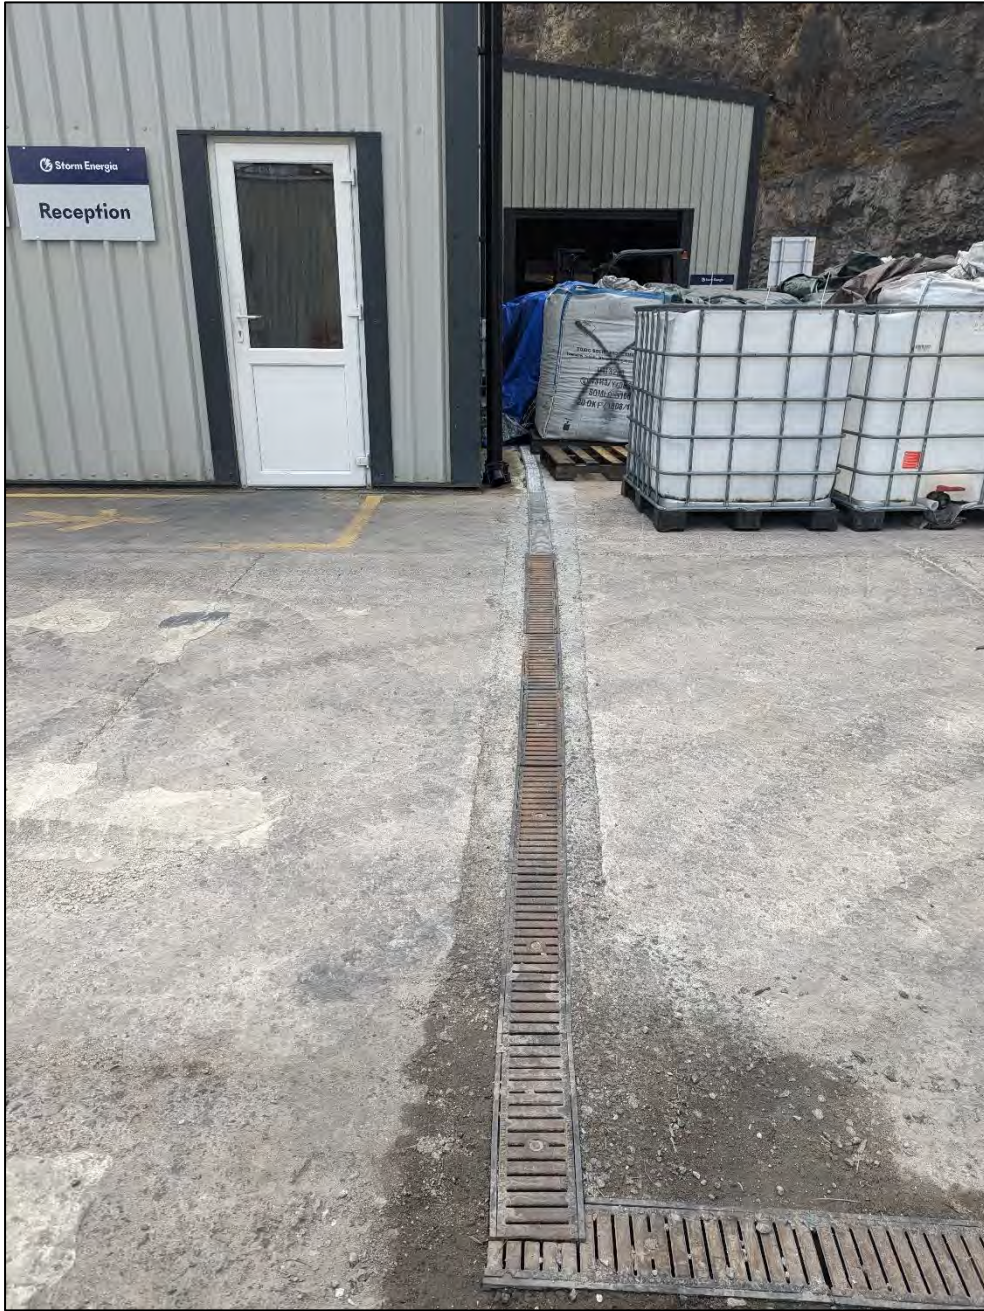
16

View of linear drainage channel central to site

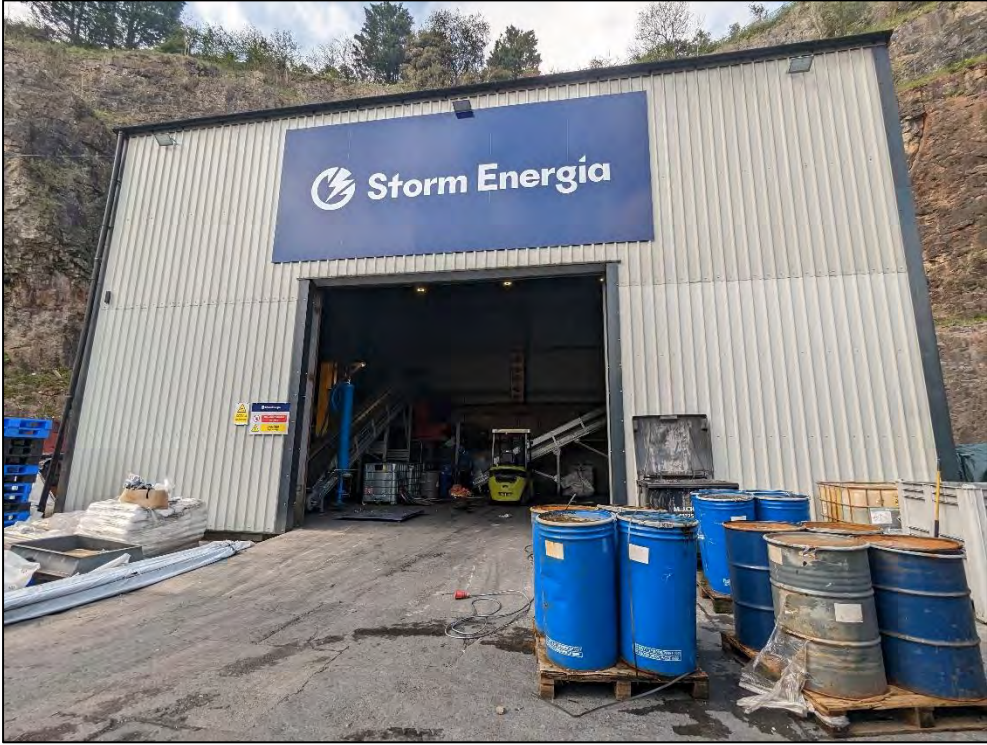
Figure Reference:	17	Description:	View of warehouse 2. Drums storing product known as "Ampte power", which has since been removed from site.
--------------------------	-----------	---------------------	---

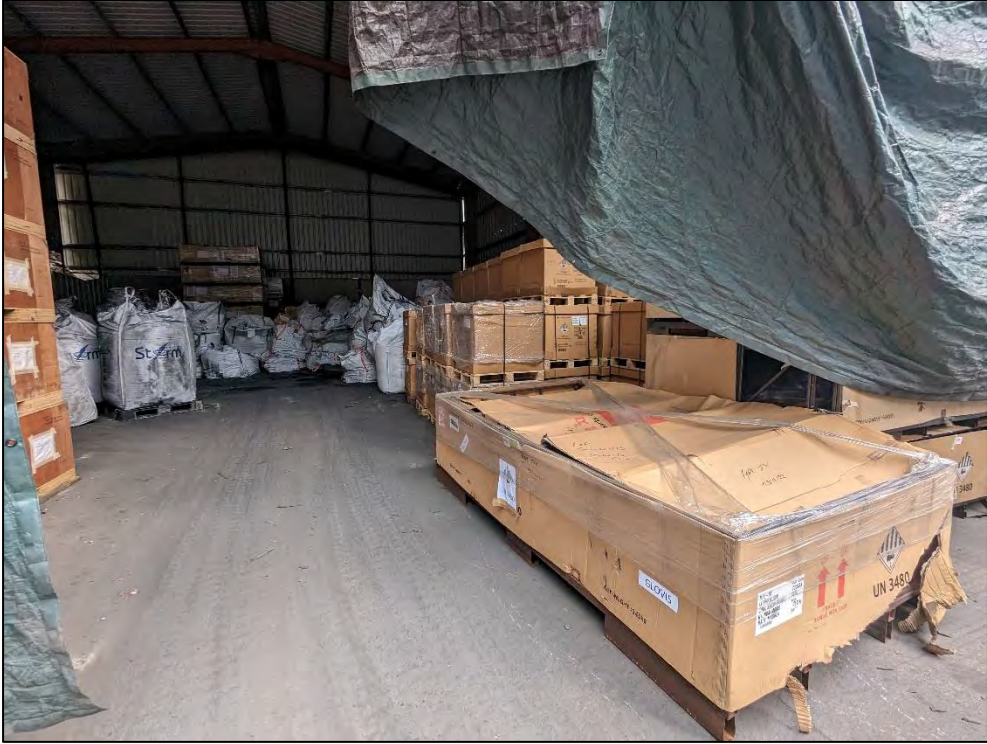
Figure Reference:	18	Description:	Warehouse 3 used for storing recycled battery material and lithium batteries.
--------------------------	-----------	---------------------	--

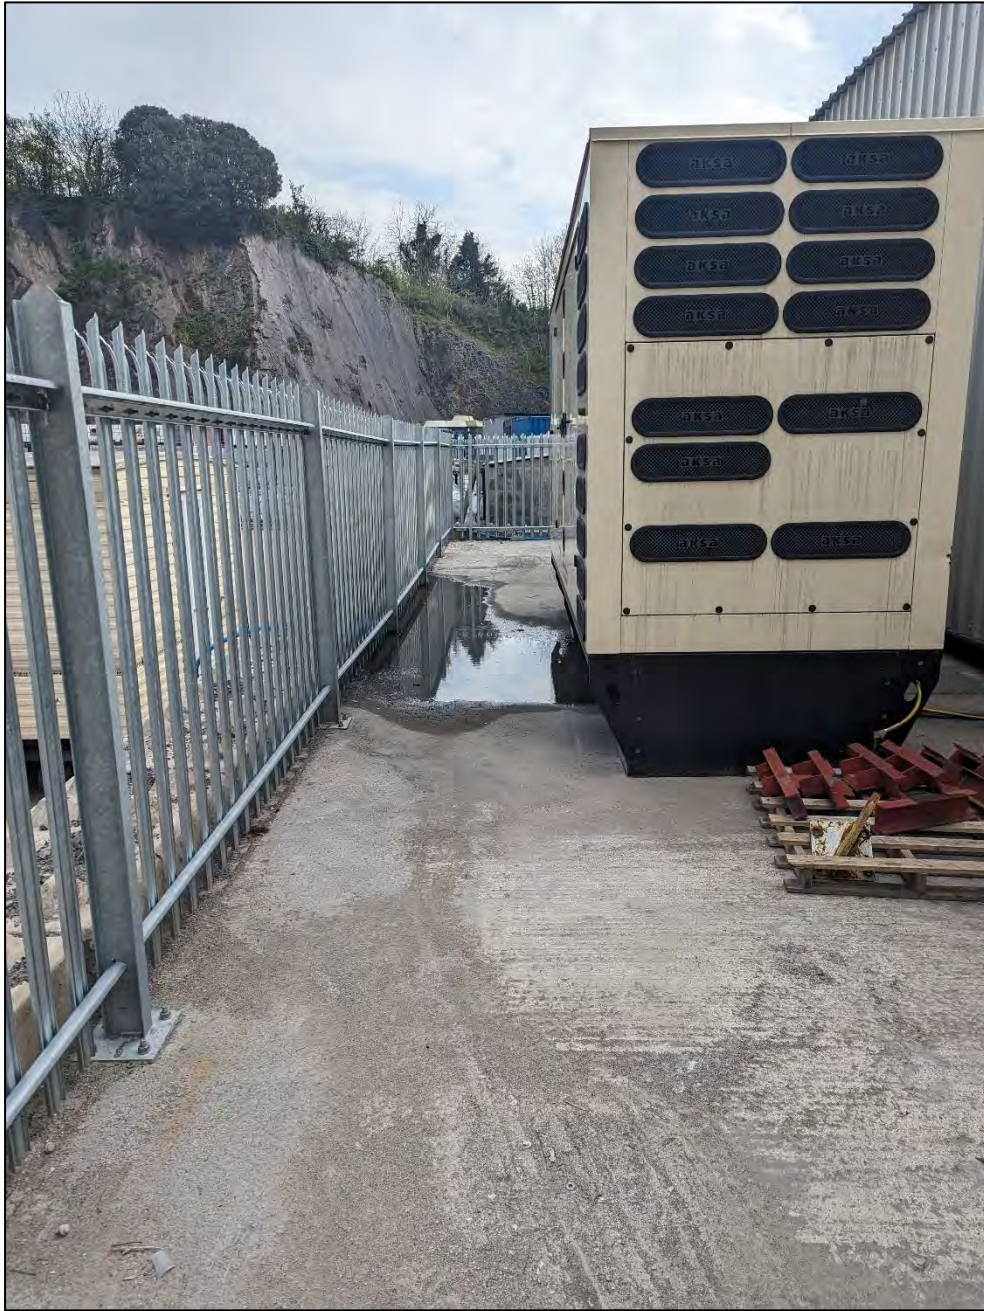
19

Large diesel generator which powers warehouse 1

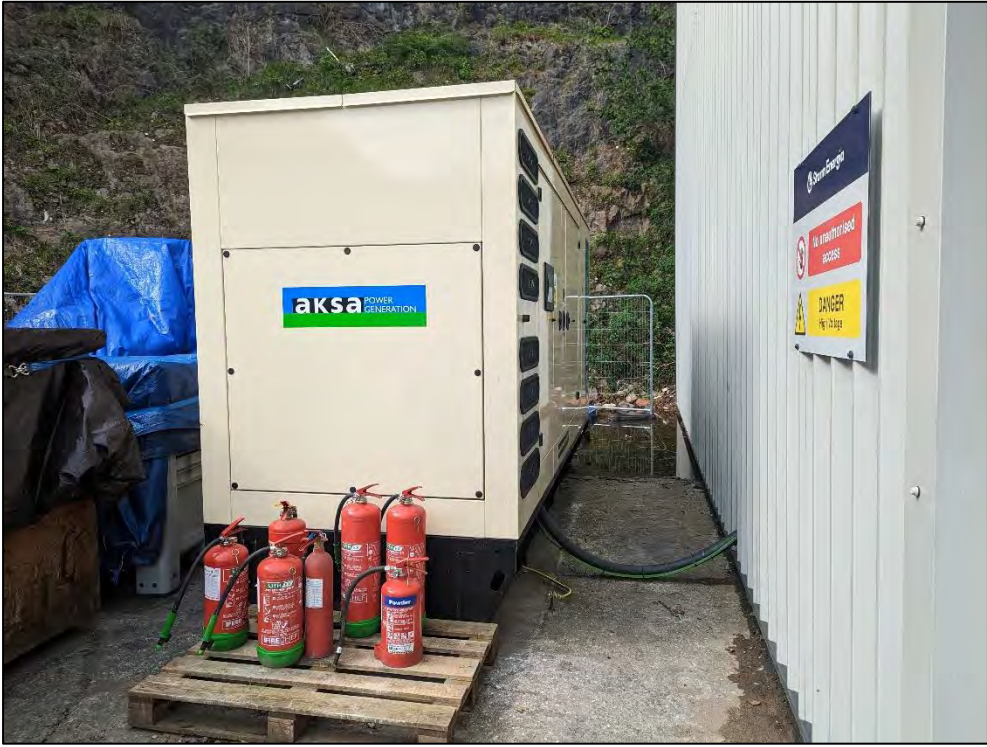
Figure Reference:	20	Description:	Generator powering warehouse 2
--------------------------	-----------	---------------------	---------------------------------------

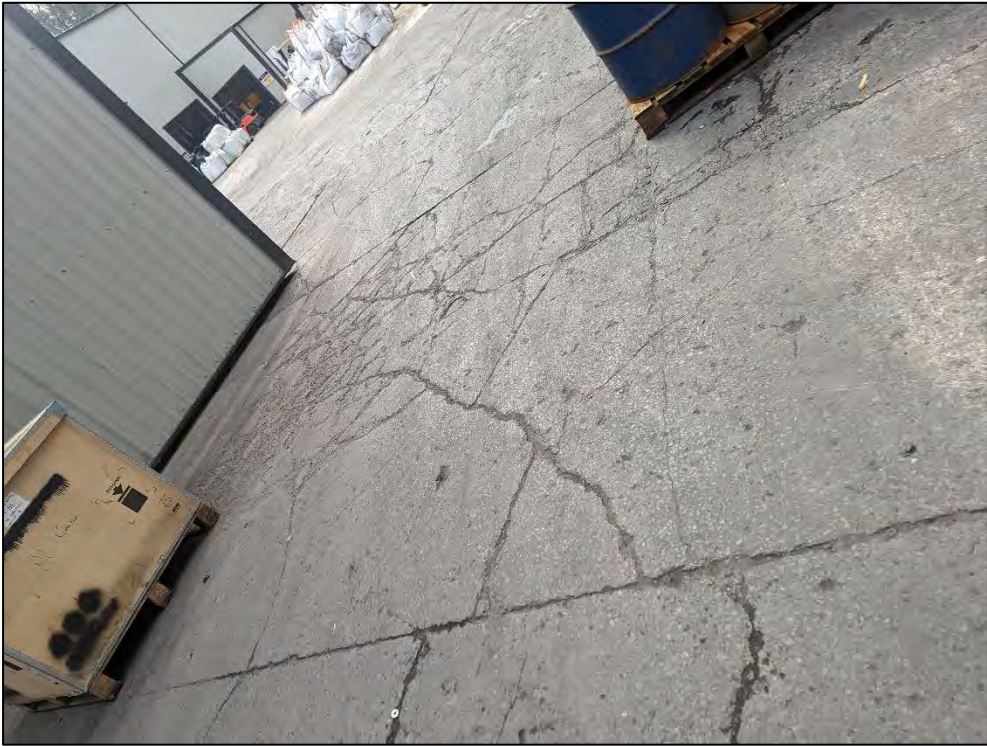
Figure Reference:	21	Description:	Poor condition of concrete, near to warehouse 2
--------------------------	-----------	---------------------	--

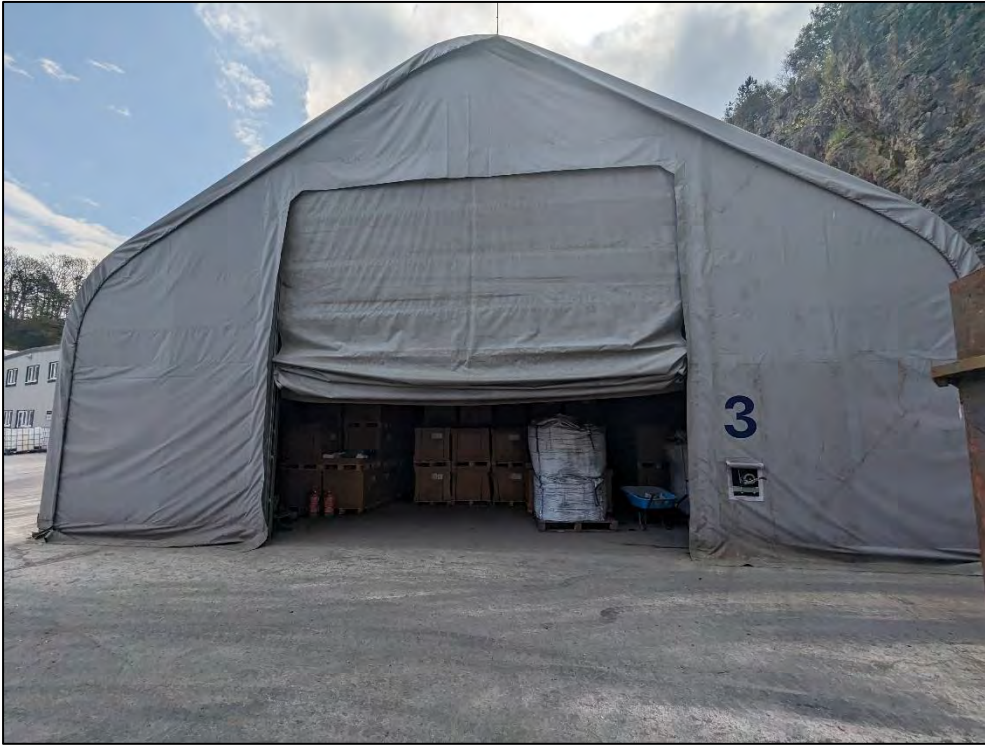
Figure Reference:	22	Description:	Tent 3 containing lithium batteries and recycled material and interceptor 1.
--------------------------	-----------	---------------------	---

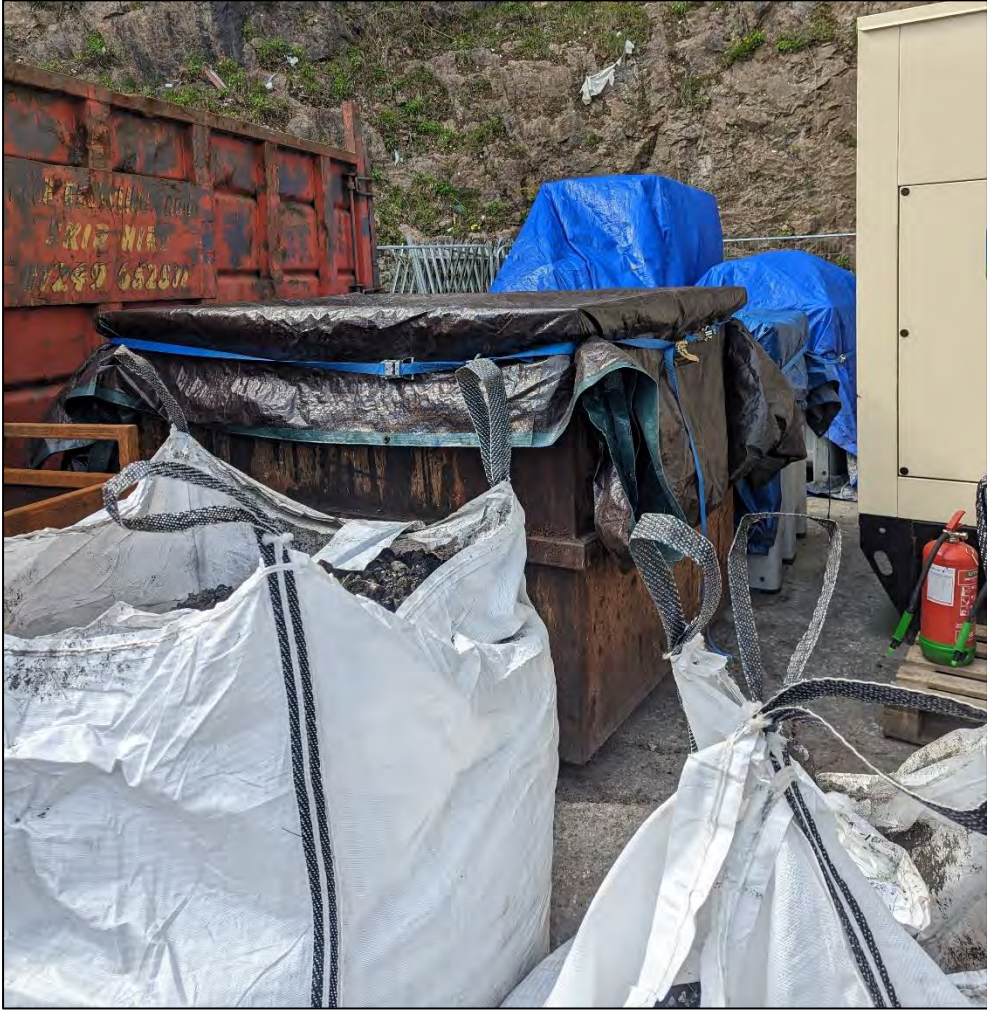
Figure Reference:	22	Description:	Area for waste storage. Skips containing shredded material.
--------------------------	-----------	---------------------	--
