Contract Completion Report

Hartcliffe Way

Reference: S2775-005				Issue: Revision A
Date:	Status:	Name:	Position:	Signature:
20/02/2021	Prepared By:	Adam Packman	Environmental Engineer

Sanctus Limited (Sanctus) was appointed by the Bristol Waste Company (Client) to carry out an enabling works package prior to the re-development of their former waste depot recycling centre at 83 Hartcliffe Way, Bristol, BS3 5RN.

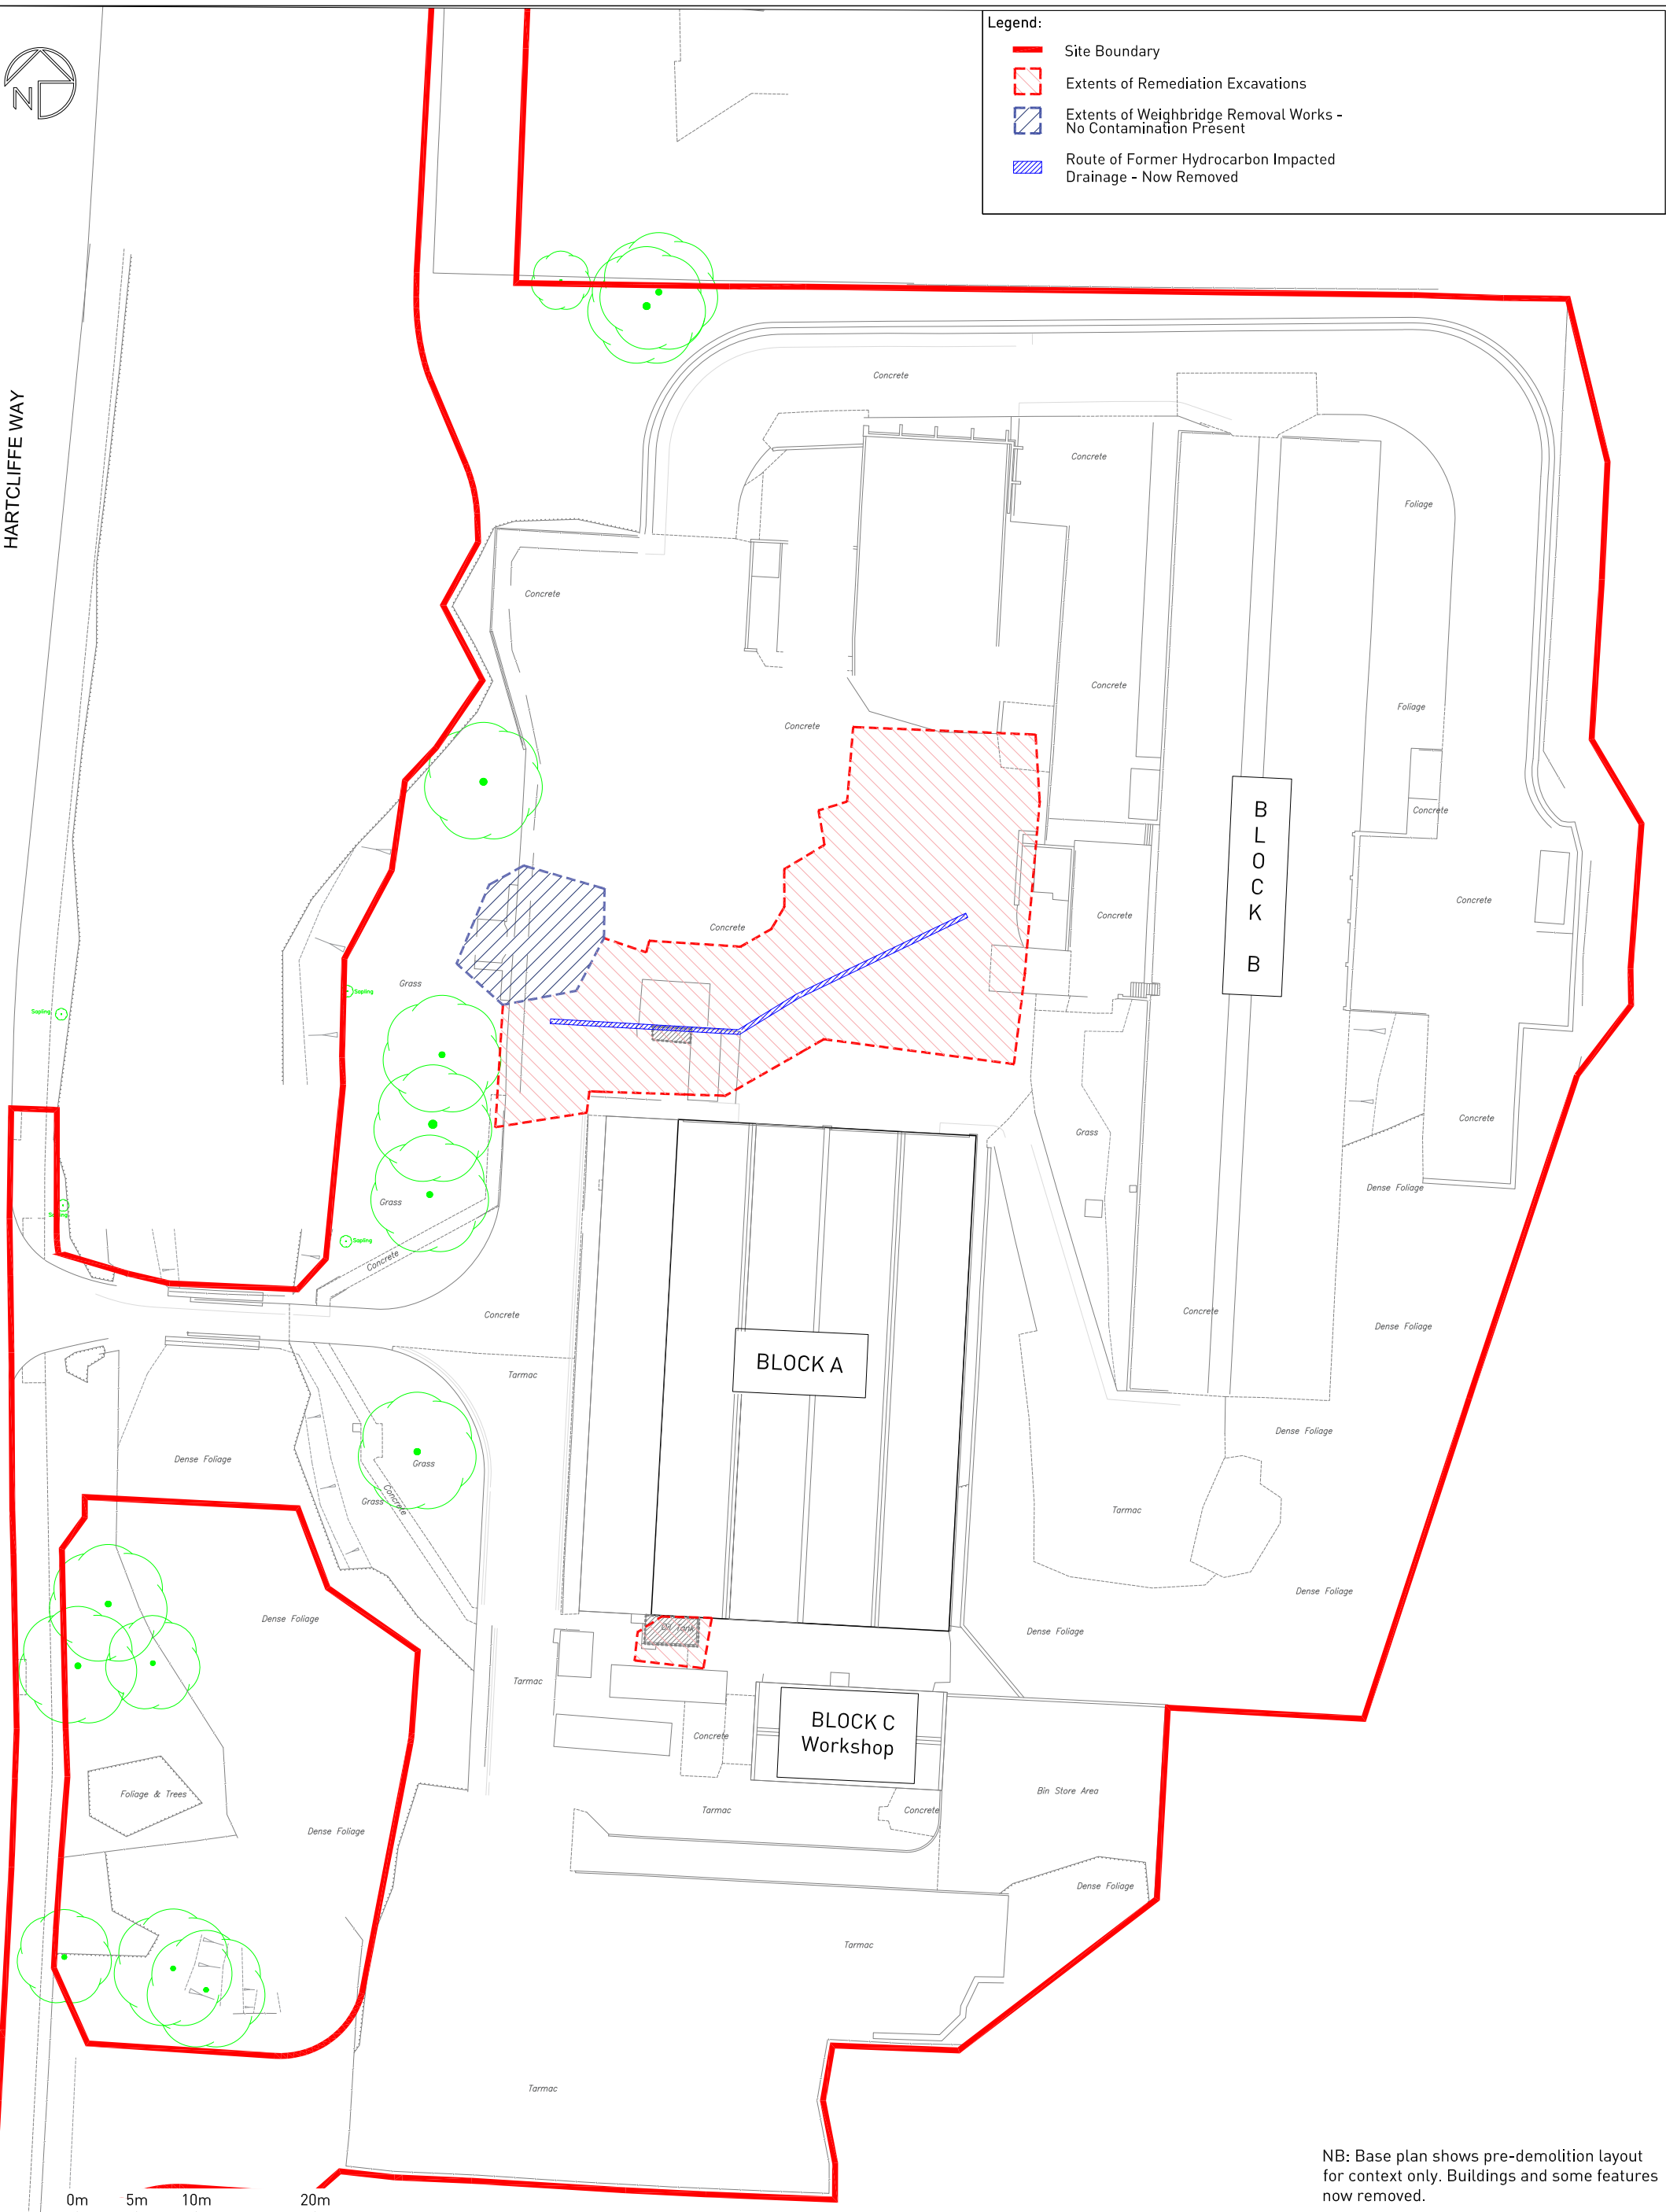
- Site Boundary
- Extents of Remediation Excavations
- Extents of Weighbridge Removal Works - No Contamination Present
- Route of Former Hydrocarbon Impacted Drainage - Now Removed

NB: Base plan shows pre-demolition layout for context only. Buildings and some features now removed.

During the removal of the hardstanding on the eastern side of the western plateau, an area of petroleum hydrocarbon impacted soils were identified which Sanctus investigated using trial pits to determine the extents of the impacted and materials and to determine whether or not remedial works were required. These works found concentrations of petroleum hydrocarbons to be present within the granular sub-base of the hardstanding that exceeded the sites reuse criteria and had migrated along a nearby drainage run which had been backfilled with granular materials.

The contaminated soils were excavated under the direct supervision of a Sanctus Environmental Engineer based on the removal of visual and olfactory evidence of contamination along with field measurements being taken using a calibrated Photoionization Detector (PID), using a threshold value of 50ppm as agreed with Yellow Sub Geo. Where the impacted soils were found to extend beneath areas of hardstanding these areas were broken out to the nearest joint in the floor slab (where possible) to leave a clean edge around the edges of the hardstanding free of any protruding rebar.

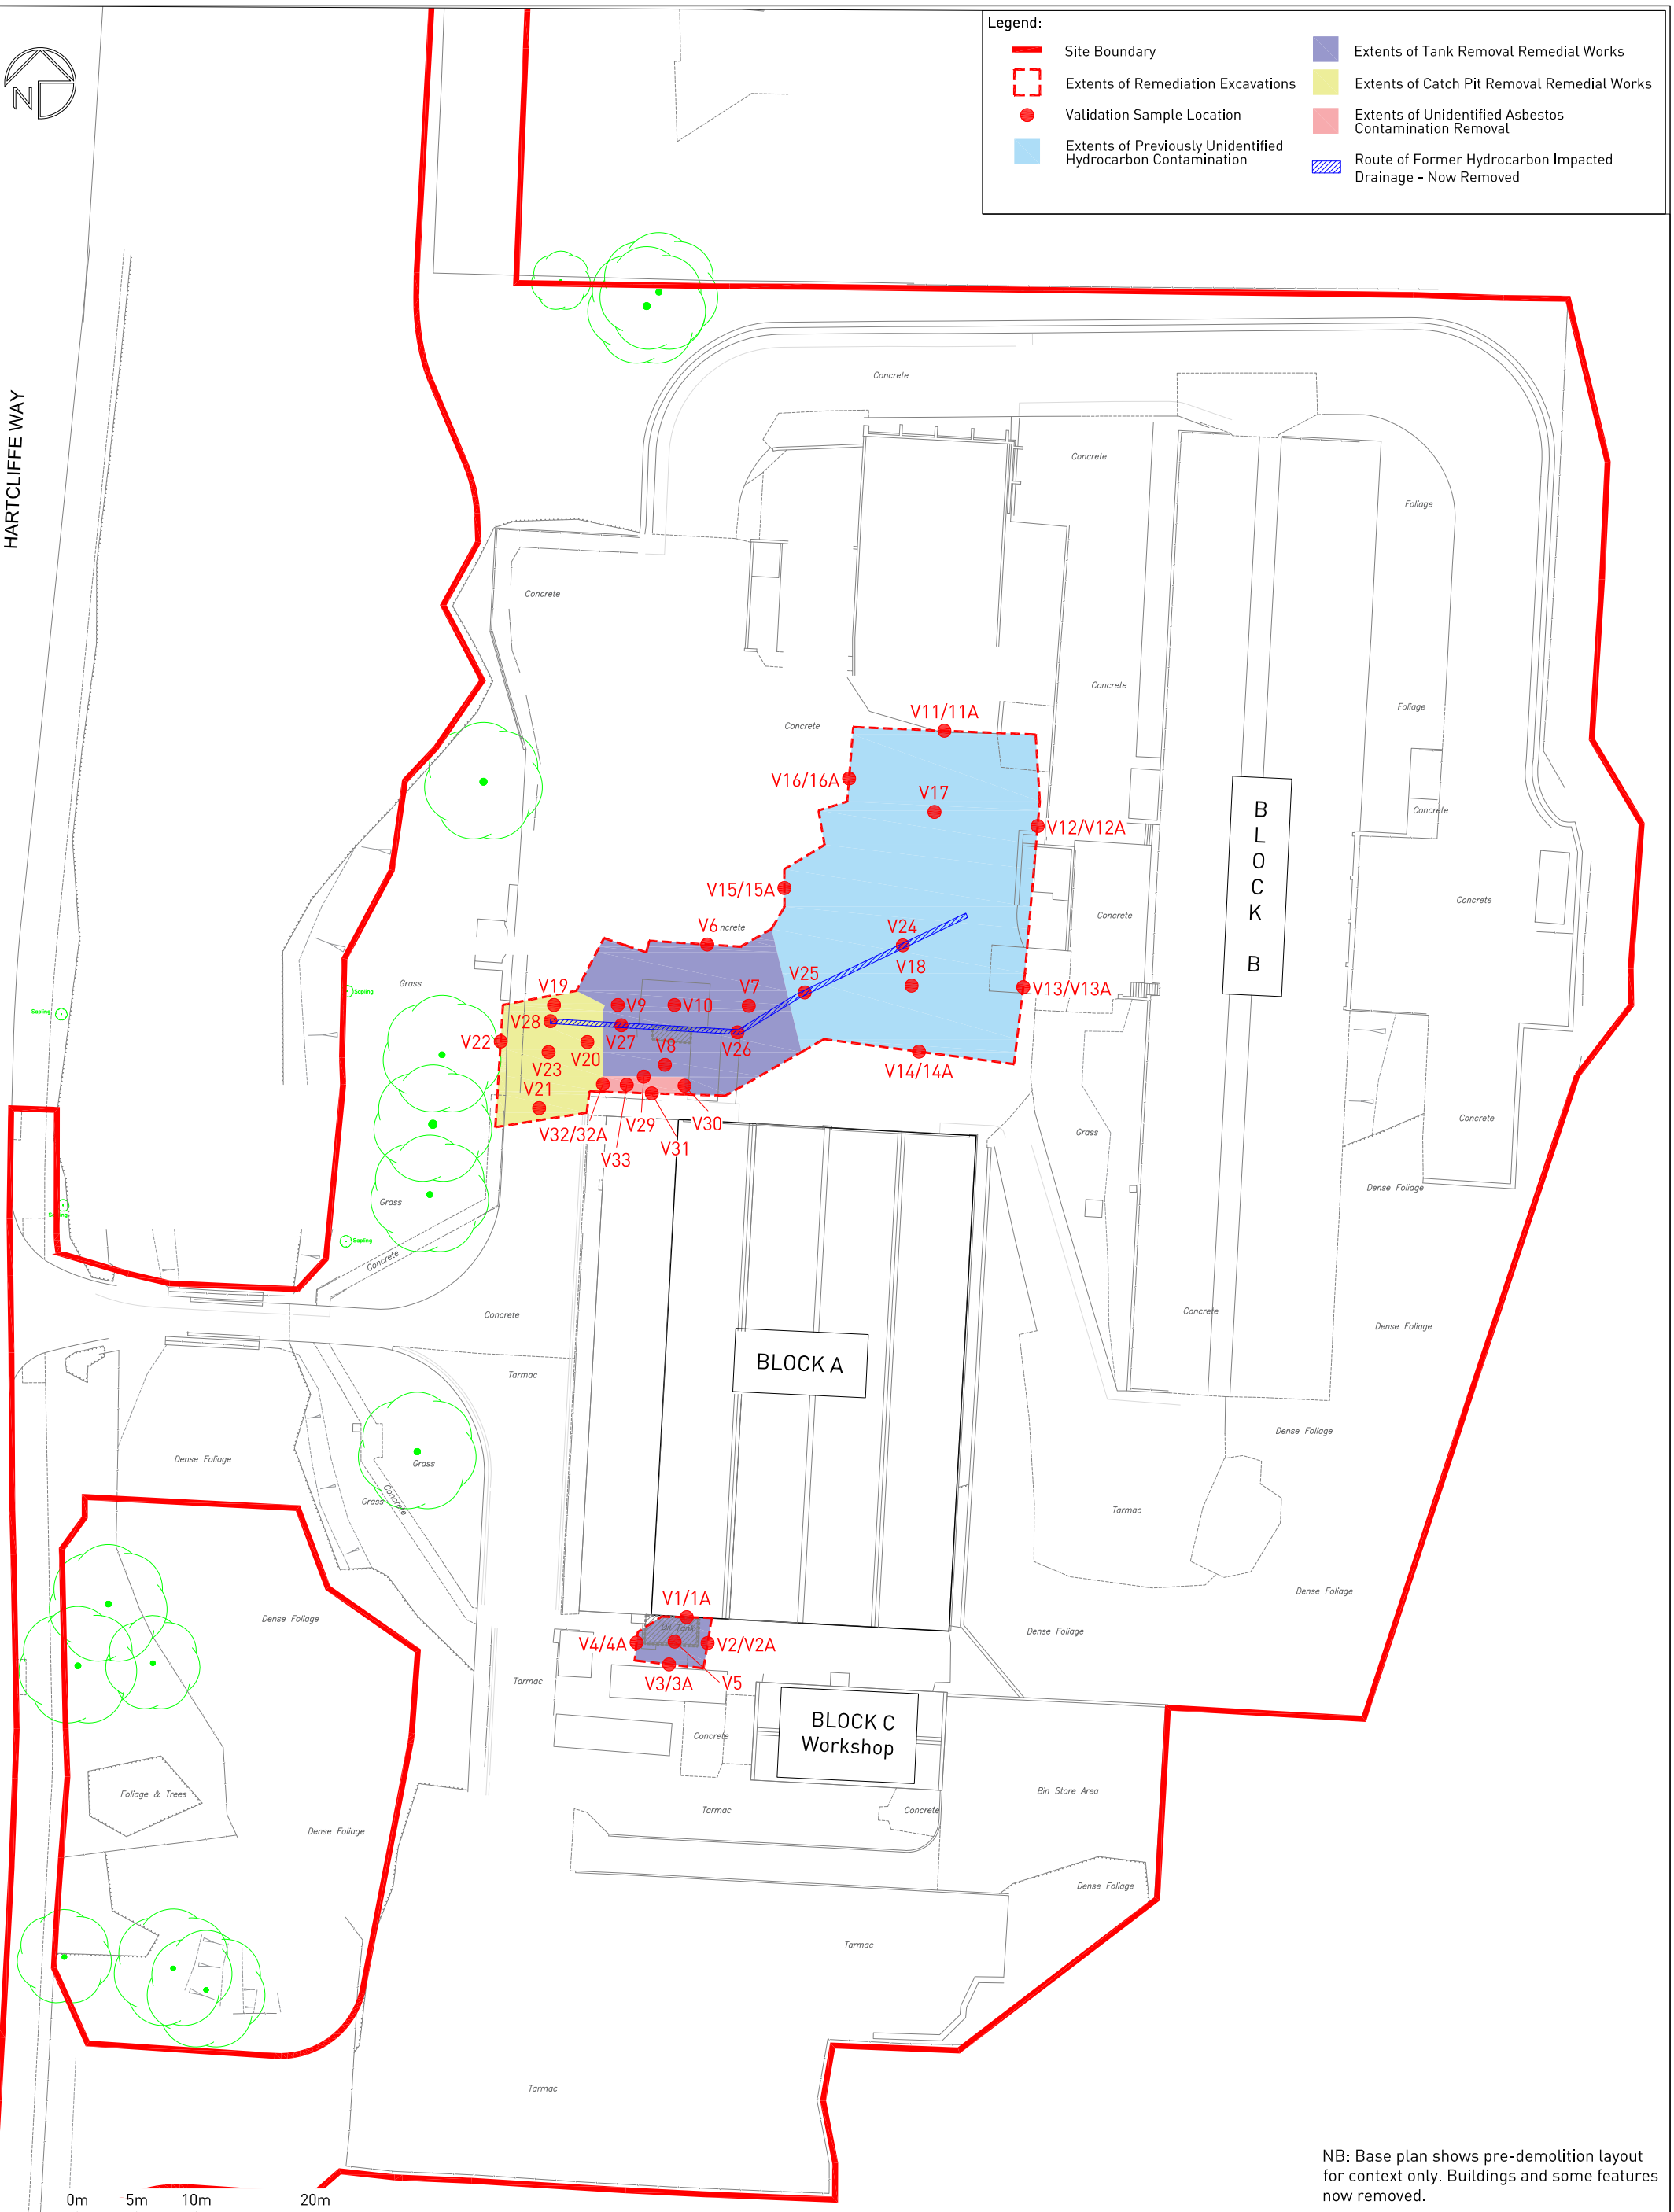
Project Name: Hartcliffe Way, Bristol		
Client: Bristol Waste Company		
Drawing Title: Validation Sample Location Plan		
Contract No: S2775	Drawing No: D2775/007	Scale @ A3: 1:500 / See Inset
Drawn By: JH	QC Check By: ST	Approved By: ST

Legend:			
	Site Boundary		Extents of Tank Removal Remedial Works
	Extents of Remediation Excavations		Extents of Catch Pit Removal Remedial Works
	Validation Sample Location		Extents of Unidentified Asbestos Contamination Removal
	Extents of Previously Unidentified Hydrocarbon Contamination		Route of Former Hydrocarbon Impacted Drainage - Now Removed

NB: Base plan shows pre-demolition layout for context only. Buildings and some features now removed.

The remedial works were considered complete following confirmation from YellowSub Geo that the remaining soils at each validation location were suitable to remain. This was confirmed via email on 18th December 2020, a copy of which can be found in Appendix G.

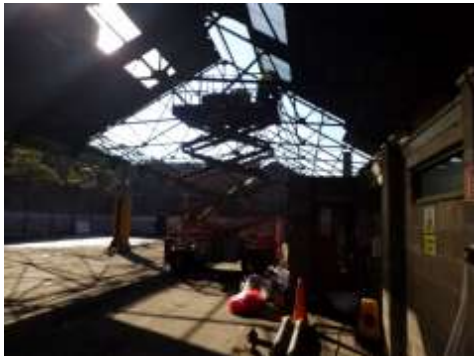
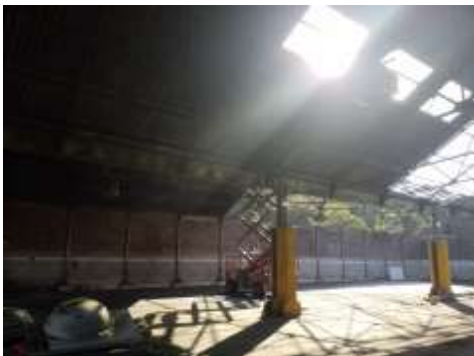
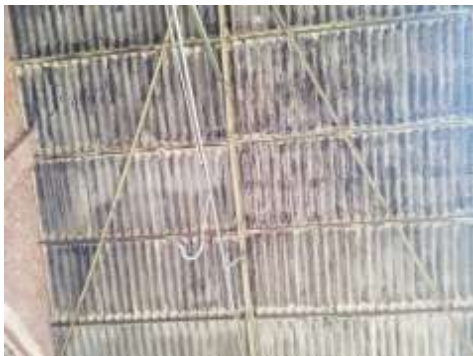
<p>Reason for Photo: General view</p> <p>Comments: General view of warehouse</p>	<p>Reason for Photo: General view</p> <p>Comments: Operatives on MEWP removing the asbestos corrugated cement roof sheets</p>	<p>Reason for Photo: General view</p> <p>Comments: Corrugated cement roof sheets being removed</p>

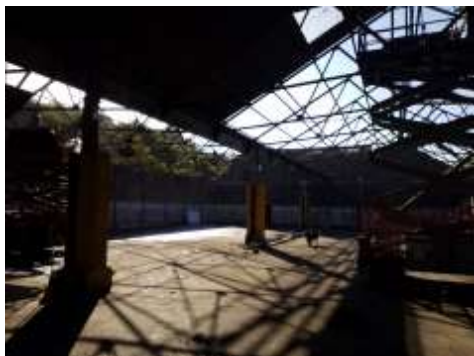
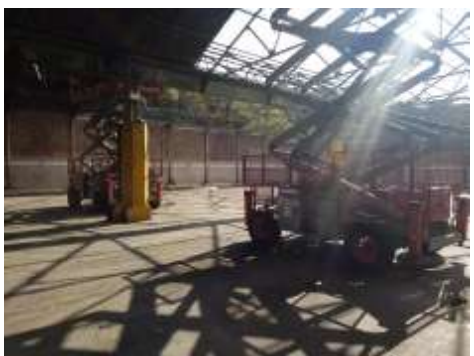
<p>Reason for Photo: General view</p> <p>Comments: General view of warehouse</p>	<p>Reason for Photo: General view</p> <p>Comments: 2x MEWPS with two lots of operatives removing asbestos corrugated cement roof sheets</p>	<p>Reason for Photo: -</p> <p>Comments:</p>

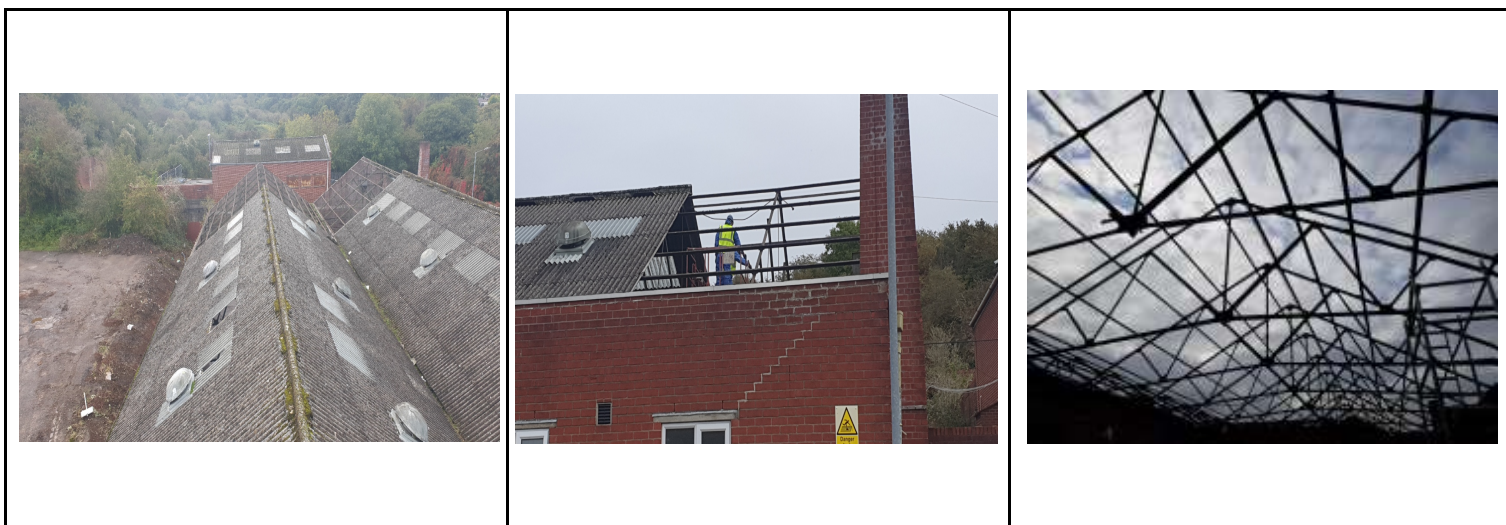
0610

Reason for Photo: General view

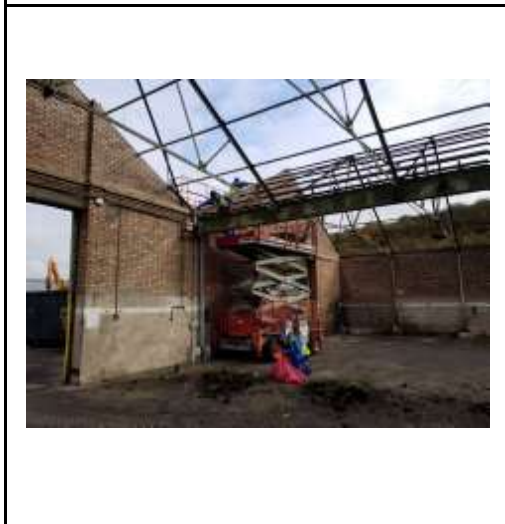
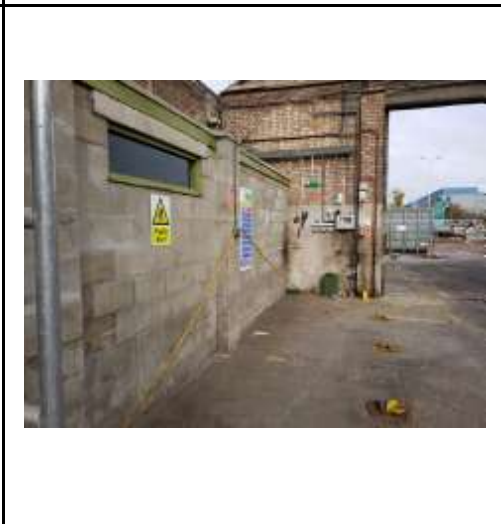
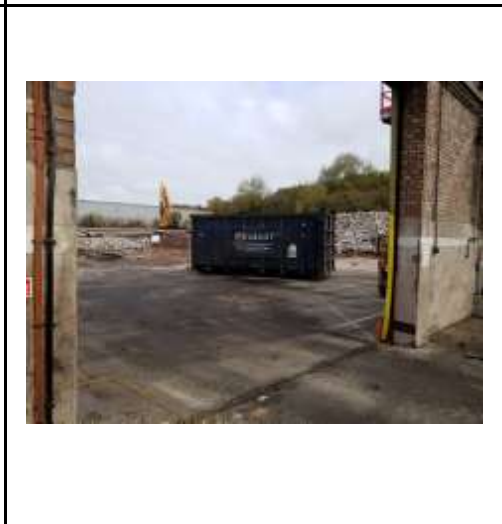
Reason for Photo: General view
Comments:
Roof frame after all roof sheeting removed

Reason for Photo: General view
Comments:
Taken off the last section of cement materials to apex & Flue cowl

Reason for Photo: General view
Comments:
Background pump by roller shutter door

12:45	Site laboratory packed up
12:48	Leave site
	Personal air monitoring result was found to be satisfactory <0.01f/ml
	All asbestos cement corrugated roof sheets were completely removed early morning & the sheets are going to be moved once the operatives have had a good
	check to make sure there's no remaining debris to roofing frames

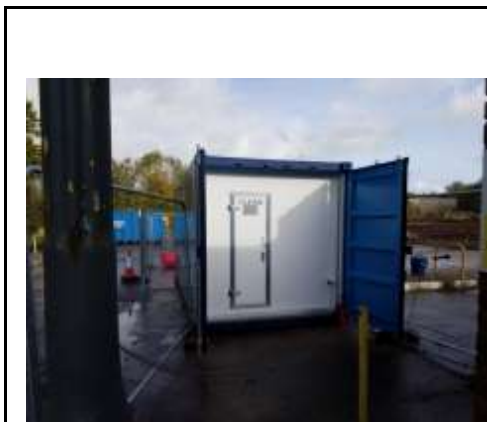
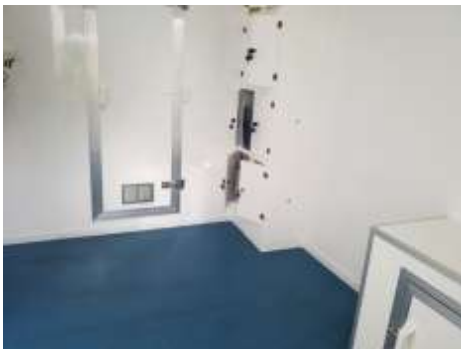
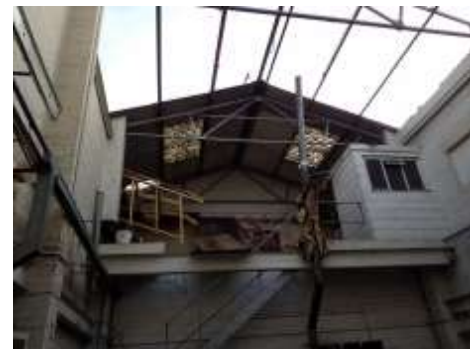
Specially designed 2 stage DCU for Sanctus sites. Shower and NPU within dirty end. Not required to use for none licensable work but due to the nature of Sanctus works in general, the DCU is procedure before, during & after any work involving contaminants & hazardous materials

No asbestos was being removed but sections of the building need to be cleared / demolished before the back section of the asbestos corrugated cement roof sheets are removed.

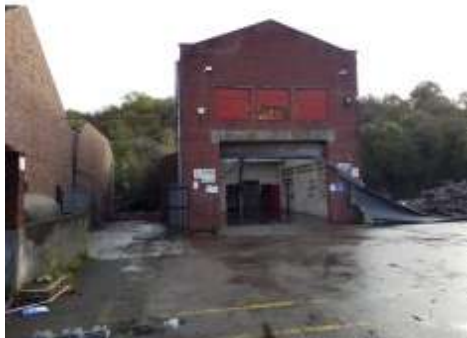
Reason for Photo: General view
